DSD CONTRACT No.: DC/2009/08

CONSTRUCTION OF YUEN LONG SOUTH BRANCH SEWERS AND EXPANSION OF HA TSUEN SEWAGE PUMPING STATION

THE FORTH-SEVENTH RESULTS OF LANDSCAPE AND VISUAL IMPACT MONITORING FOR DECEMBER 2013 (No.47)

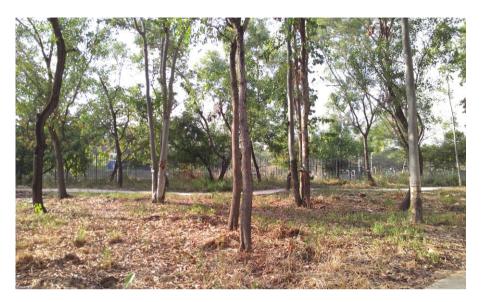
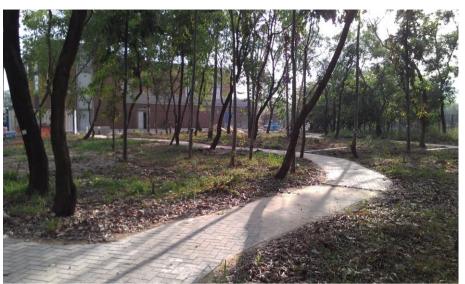
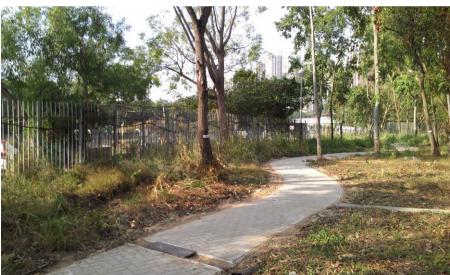
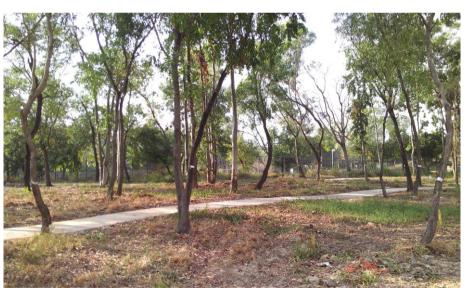
1. All preserved trees are protected in accordance with the specification	ons 🗸				
2. All preserved trees are fenced off properly	\checkmark				
 No construction activities are carried out in the protection zone of the preserved trees 	he 🗸				
Comments:					
All retained trees were fenced off and protected properly within the work	s area of the	site. DSE	is carry	ing out the pres	ervation
and protection.					
Conclusion					***
Landscaping sub-contractor fell and removed total of 35 nos. damaged tr	rees on 12/10/	/2013. Dr	ainage S	ervice Departme	ent confirmed to plan
42 nos. new trees with the following species:			Ü		,
10 nos. of Litsea glutlnosa (潺槁樹)					
10 nos. of Schlma superba (木荷)					
12 nos. of Bichofla polycarpa (重陽木)					
10 nos. of Cinnamomum burmanil (陰香)					
26 nos. of trees were felled and removed on 18 November 2013 under ins	struction of D	rainage S	ervice D	epartment.	
Remarks					100

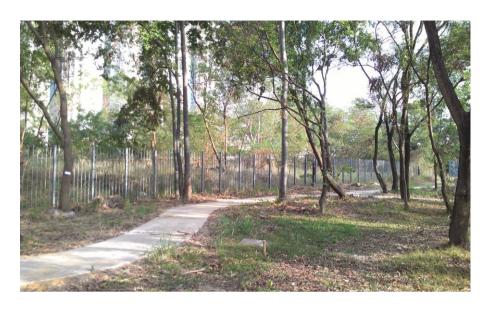
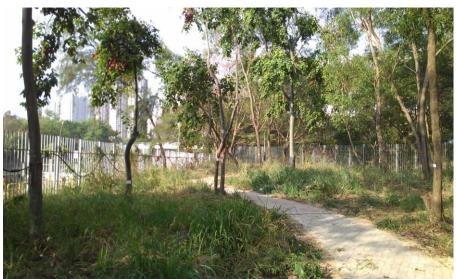
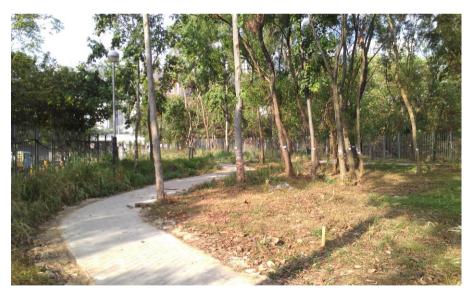
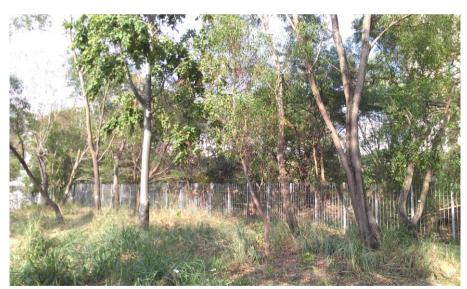
1. All preserved trees are protected in accordance with the specification	ns 🗸				
2. All preserved trees are fenced off properly	\checkmark				-
 No construction activities are carried out in the protection zone of the preserved trees 	ne 🗸				
Comments:					
All retained trees were fenced off and protected properly within the works	s area of the	site. DSI	is carry	ing out the pres	ervation
and protection.					
Conclusion		- Nov	***		
Landscaping sub-contractor fell and removed total of 35 nos. damaged tre	ees on 12/10/	/2013. Dr	ainage Se	ervice Denartme	ent confirmed to plant to
42 nos. new trees with the following species:			amage 5	or vice Departine	an committee to plant to
10 nos. of Litsea glutlnosa (瀑槁樹)					
10 nos. of Schlma superba (木荷)					
12 nos. of Bichofla polycarpa (重陽木)					
10 nos. of Cinnamomum burmanil (陰香)					
26 nos. of trees were felled and removed on 18 November 2013 under inst	ruction of D	rainage S	ervice D	epartment.
