ANNUAL AUDIT REPORT
For
PERMANENT AVIATION FUEL FACILITY
Environmental Permit
EP-262/2007/B

Date of Audit :		04 March 2026
Prepared By :	Tsang Wai Yip, HSE Officer

This Annual Audit reviews the performance of the design arrangements and measures mentioned in Condition 3.5 of the Environmental Permit (EP-262/2007/B).

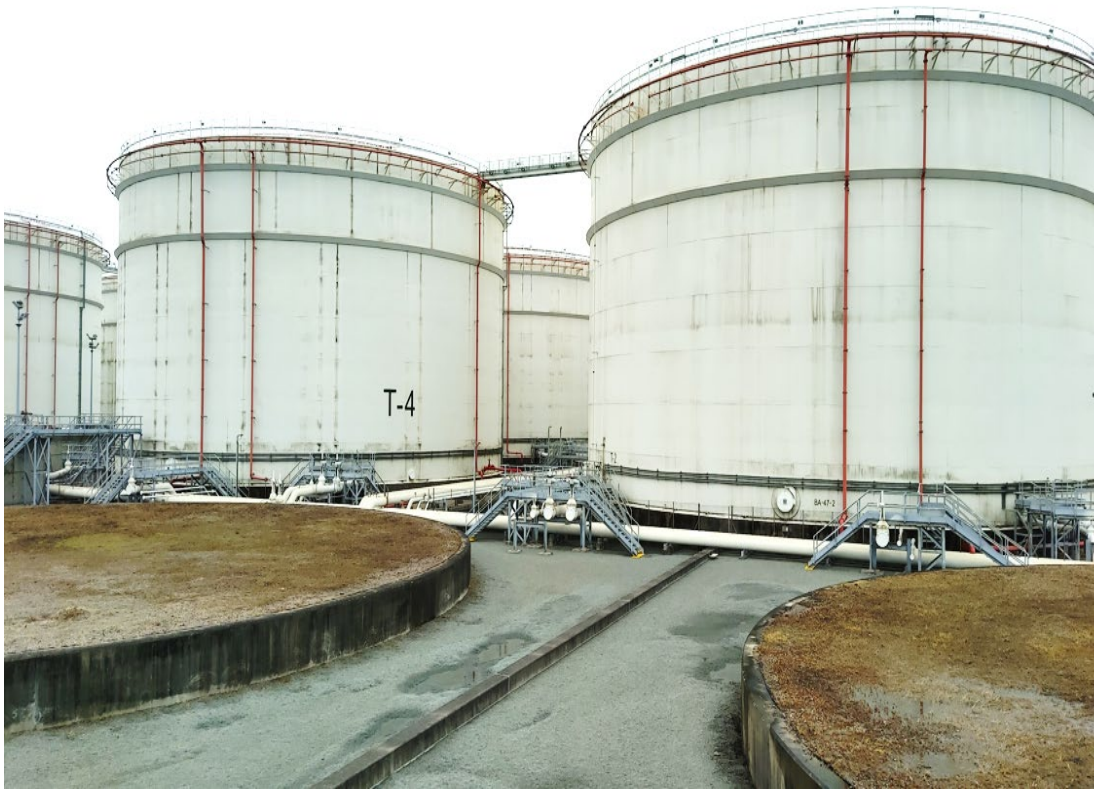
(1) Four tanks are located within bunded compound – Phase 1a

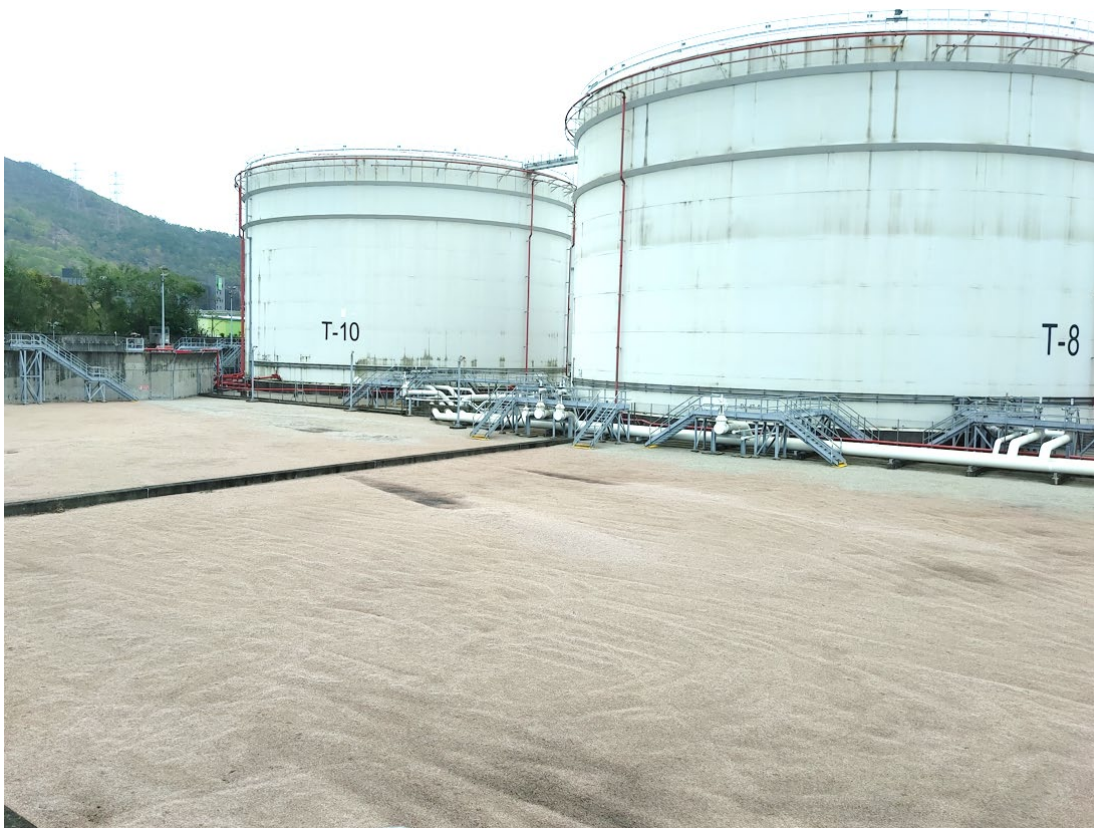
(2) Four tanks are located within bunded compound – Phase 1b

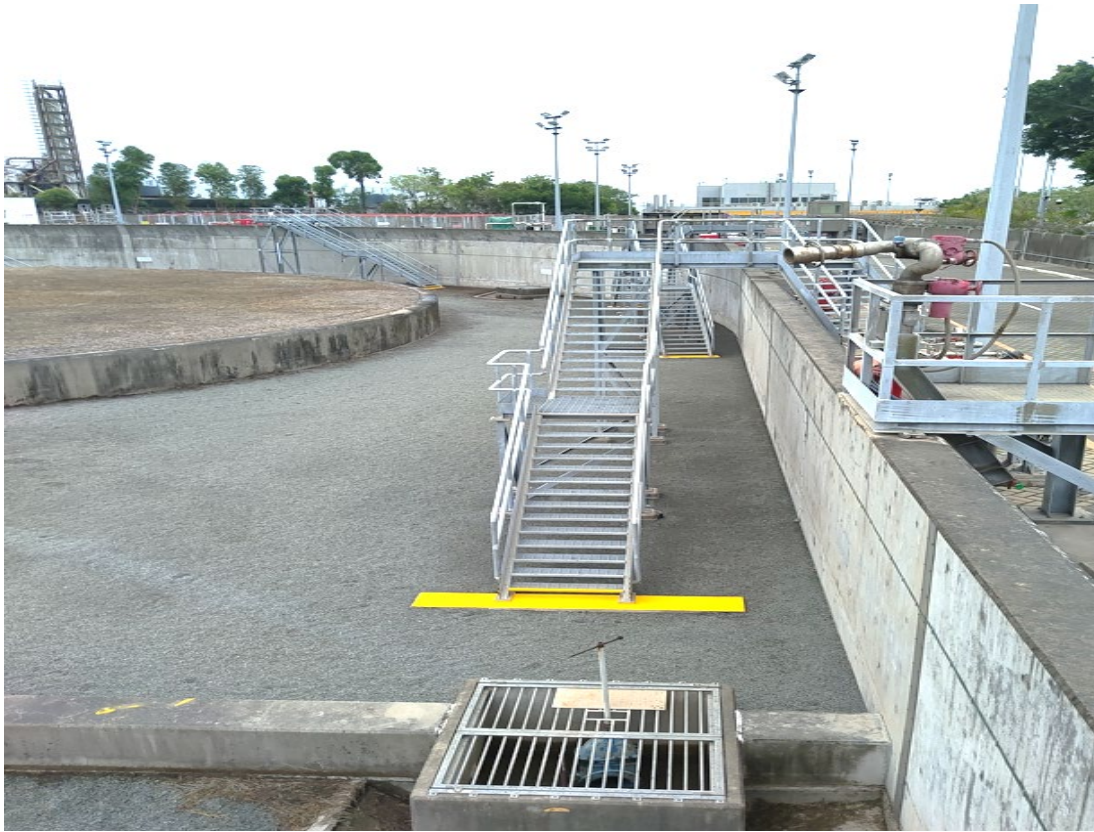
(3) Phase 1a bunded compound is lower than the ground level outside the bunds

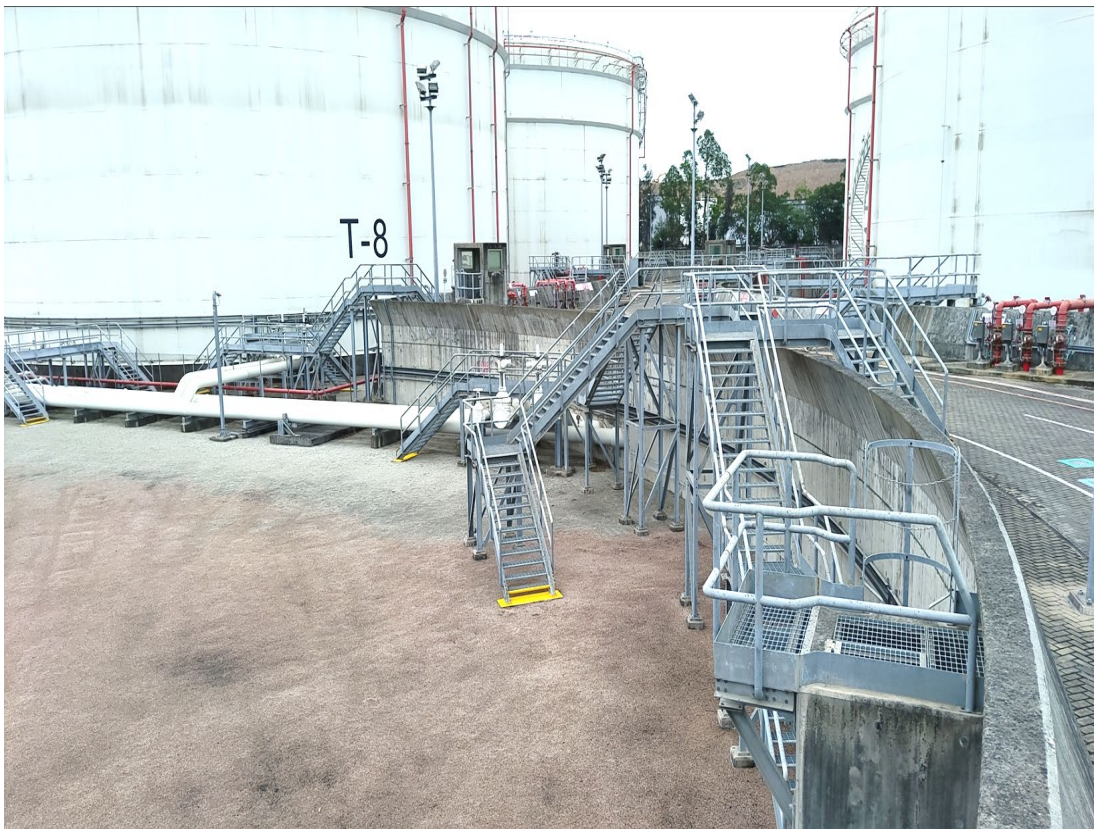
(4) Phase 1b bunded compound is lower than the ground level outside the bunds

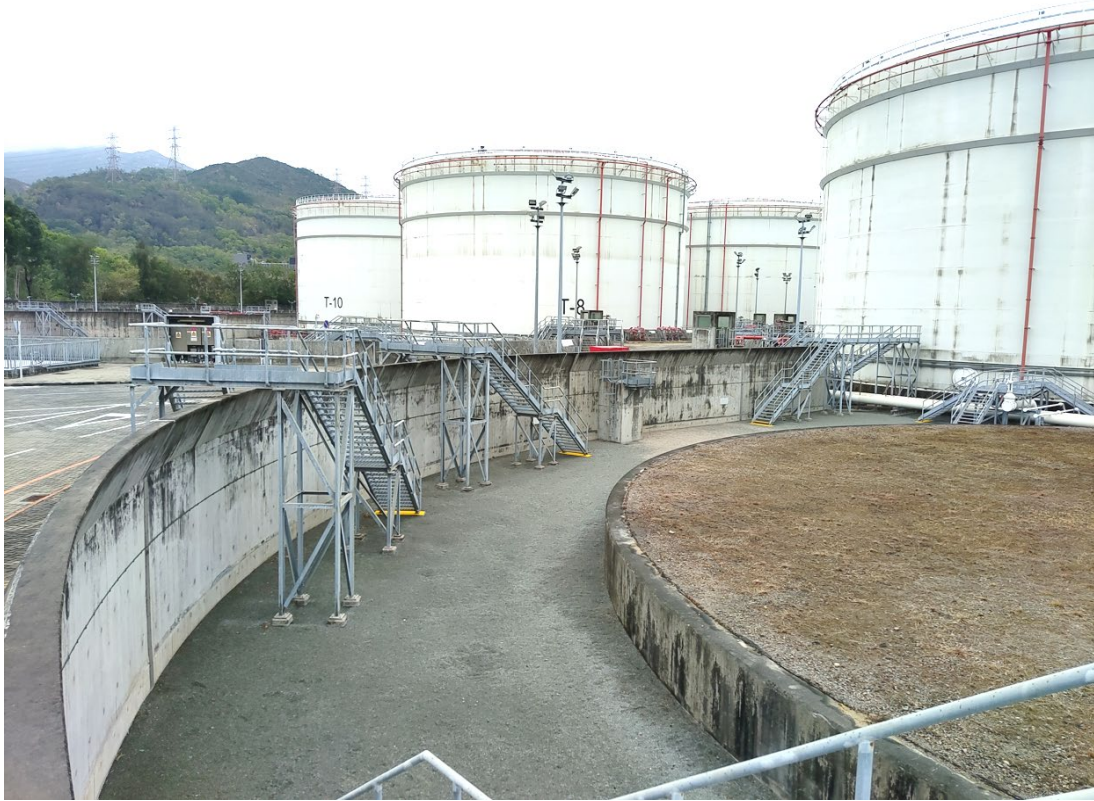
(5) Wave deflector is located at top of the bund

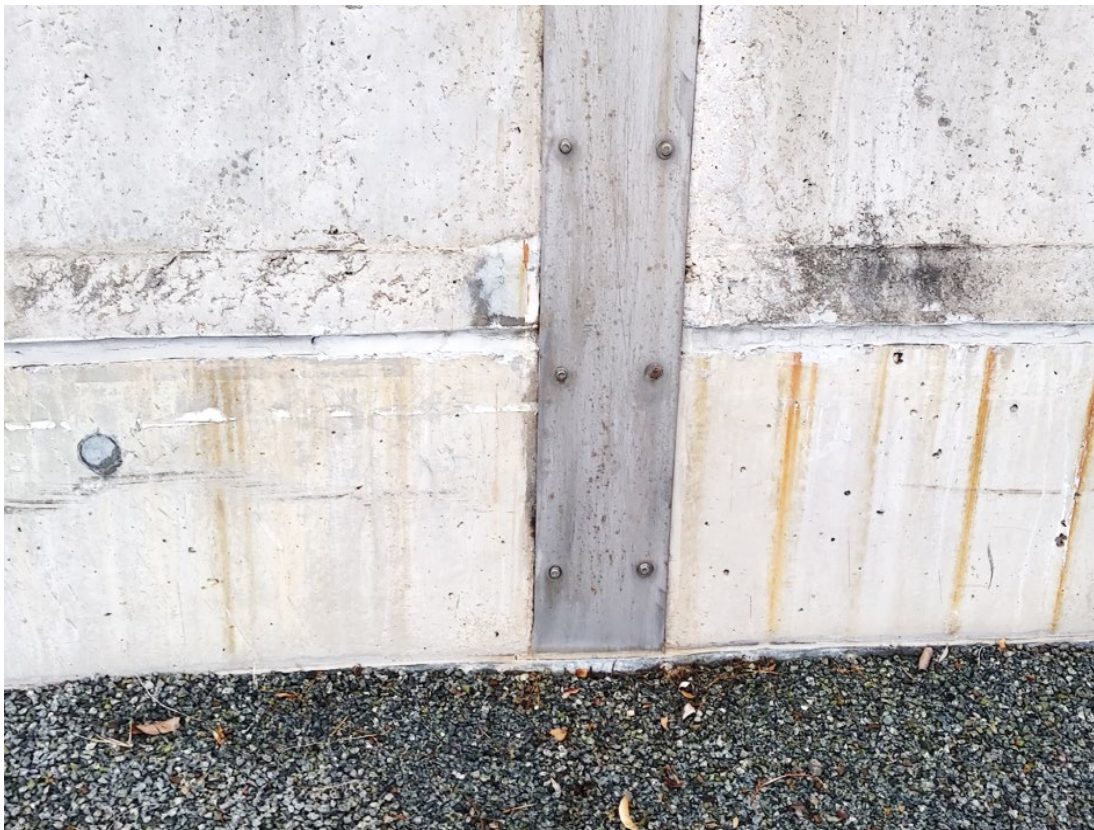
(6) Visible parts of the joints are covered by stainless steel plates on the inside at phase 1a bund

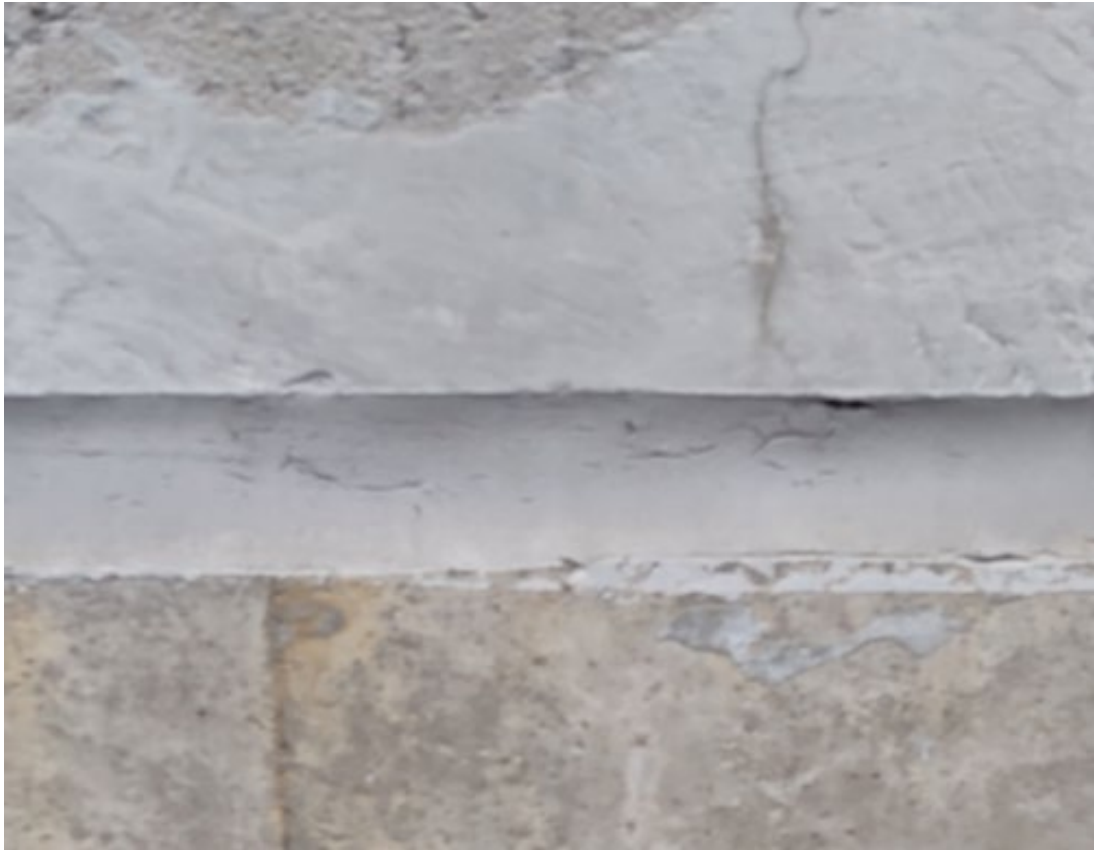
(7) Maintenance works have been performed on sealant at joints

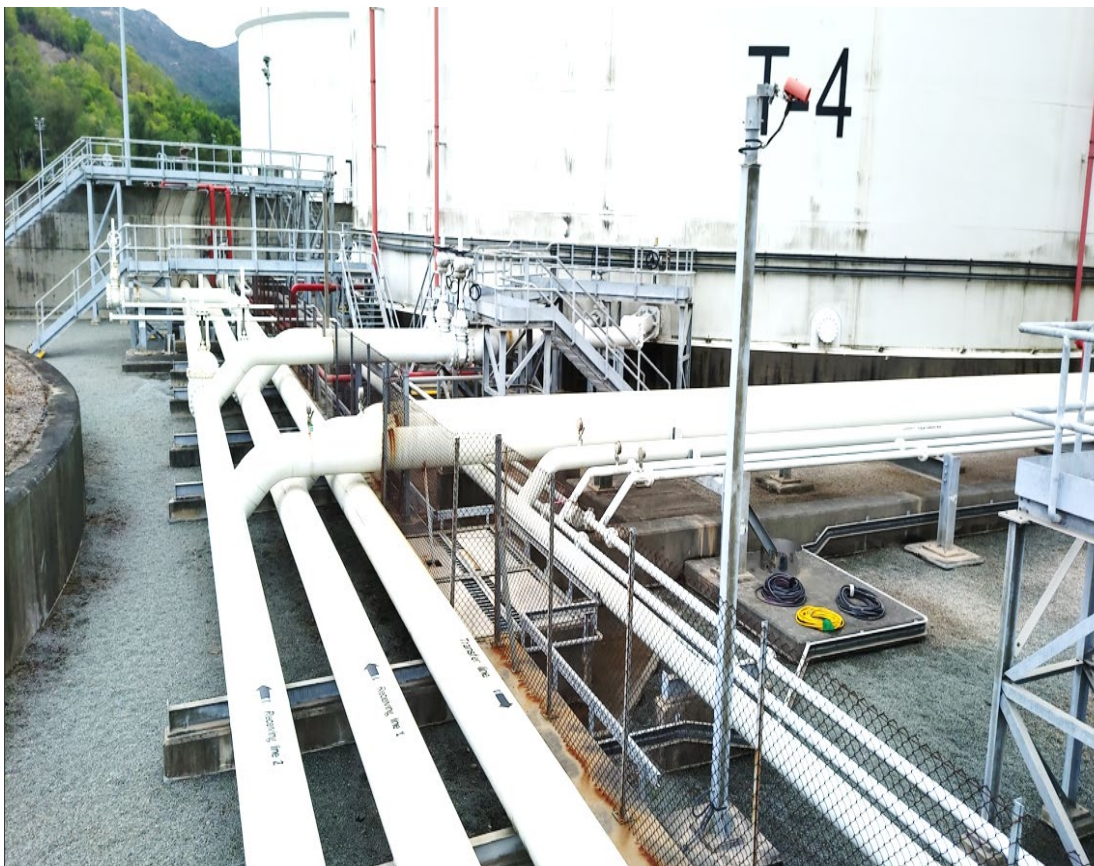
(8) Intermediate bund walls are provided in place near T-01-004

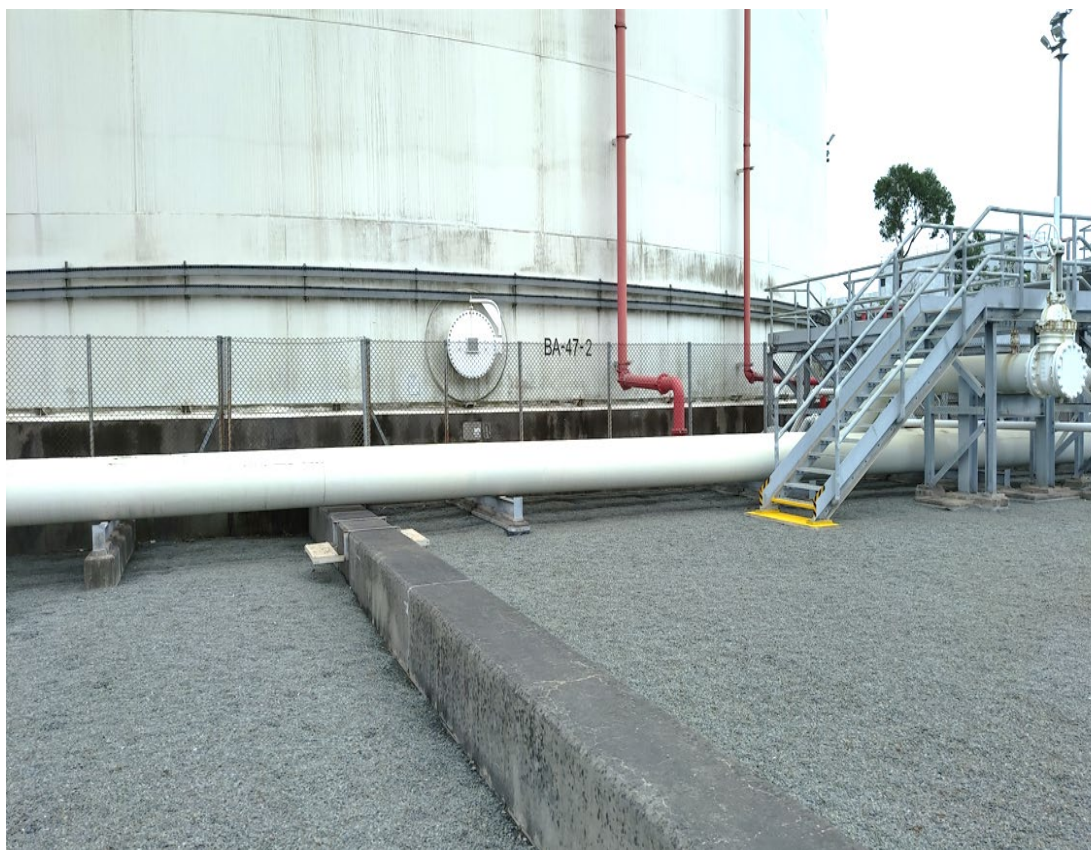
(9) Intermediate bund walls are provided in place near T-01-002

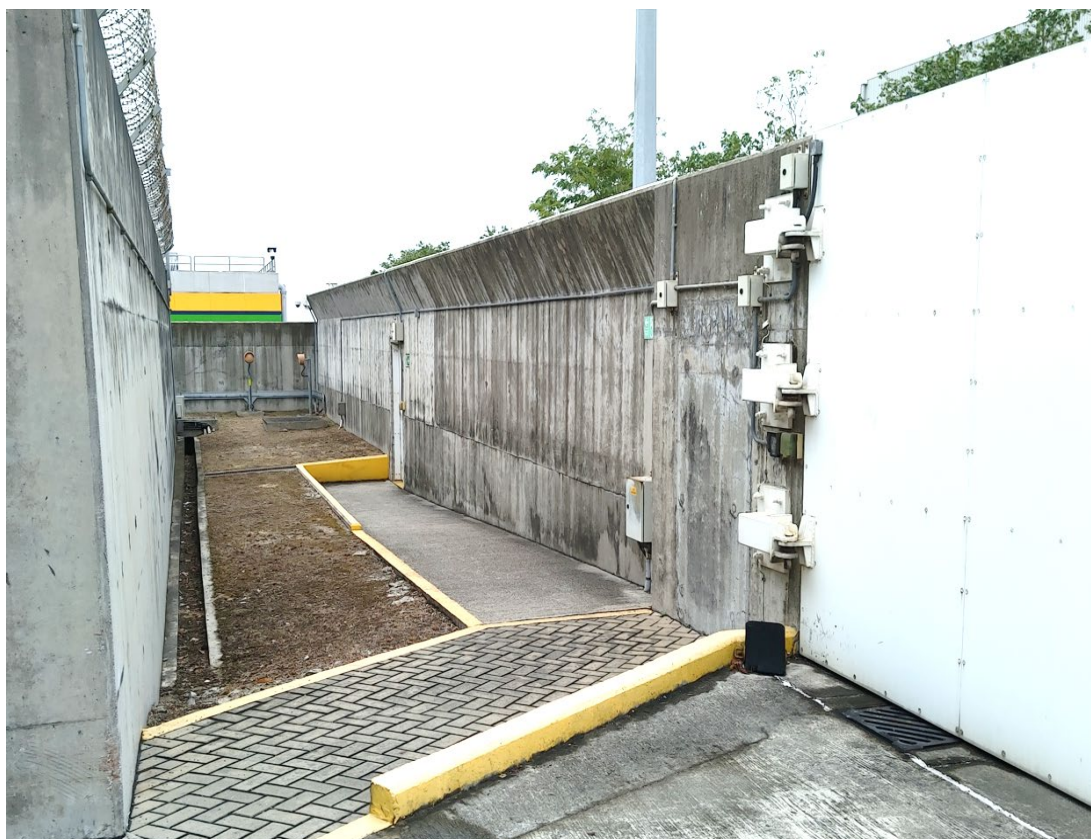
(10) Two impervious security walls are provided outside the bunded compounds

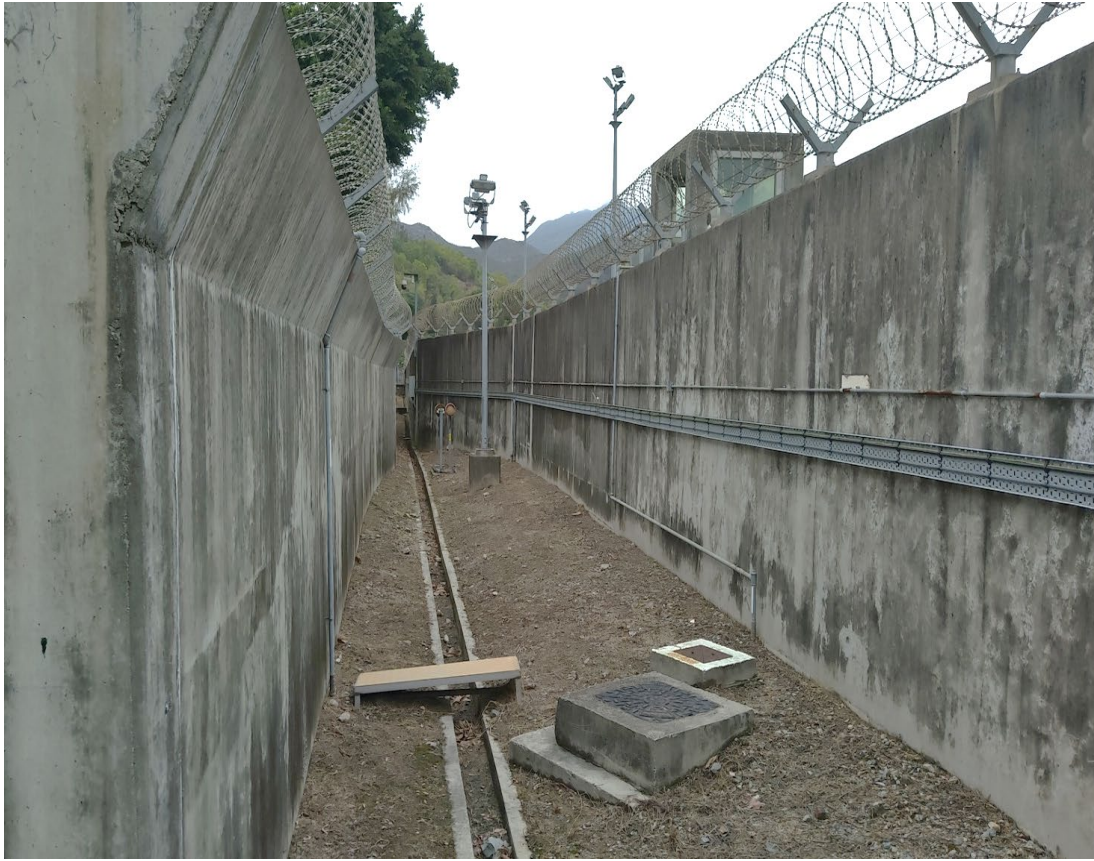
(11) Two impervious security walls are provided outside the bunded compounds

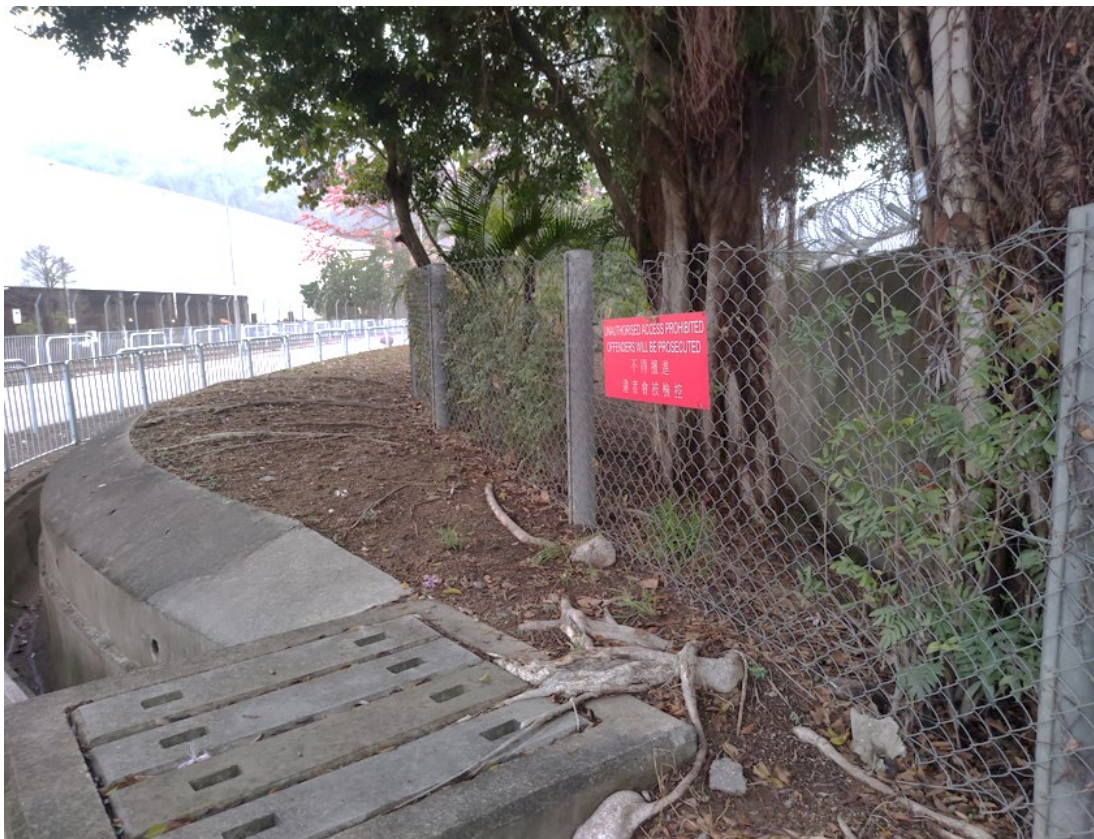
(12) Landscaped berm is maintained at least 1.5m high

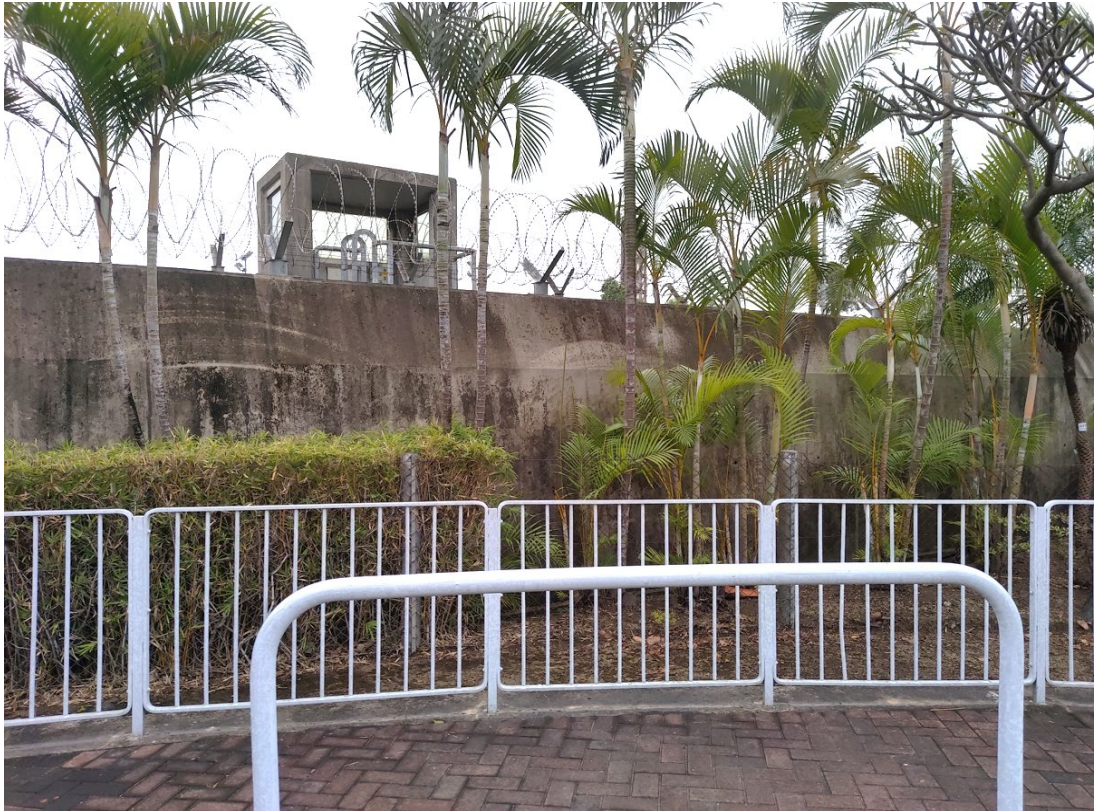
(13) Landscaped berm is maintained at least 1.5m high

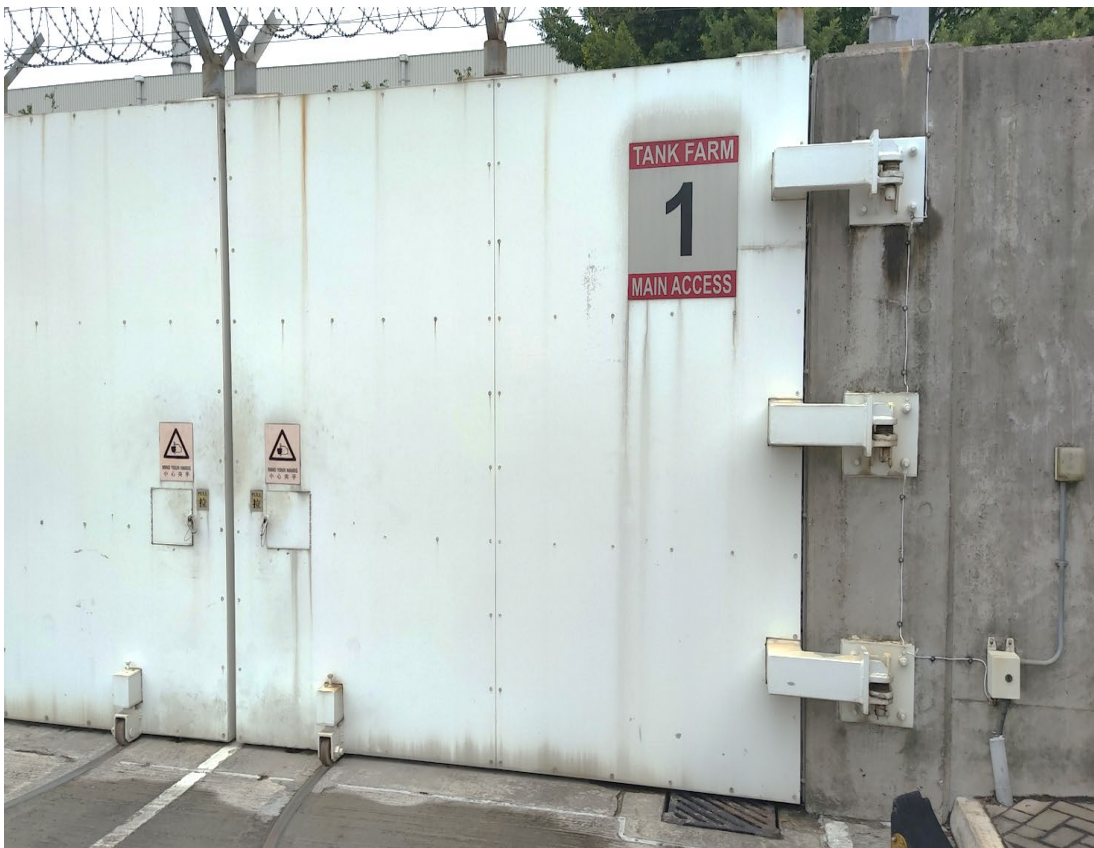
(14) Gates at security walls with sealant are maintained in good condition

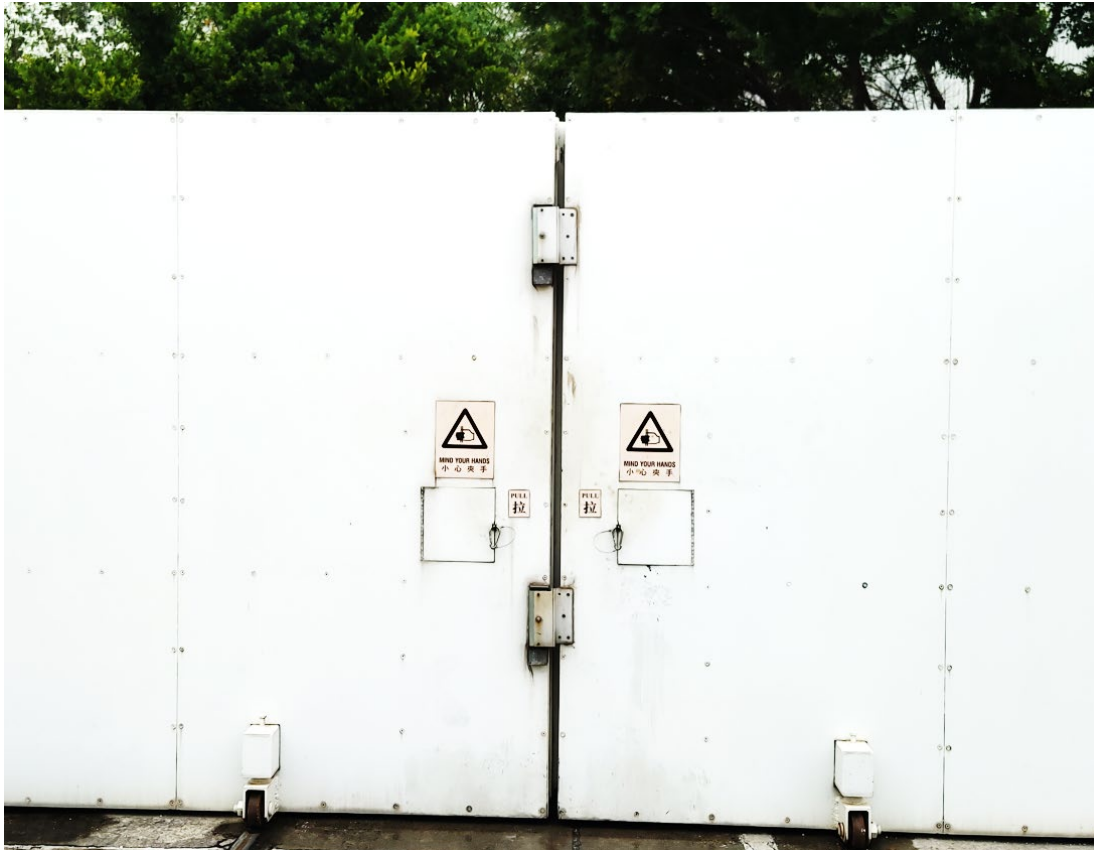
(15) Gates at security walls with sealant are maintained in good condition

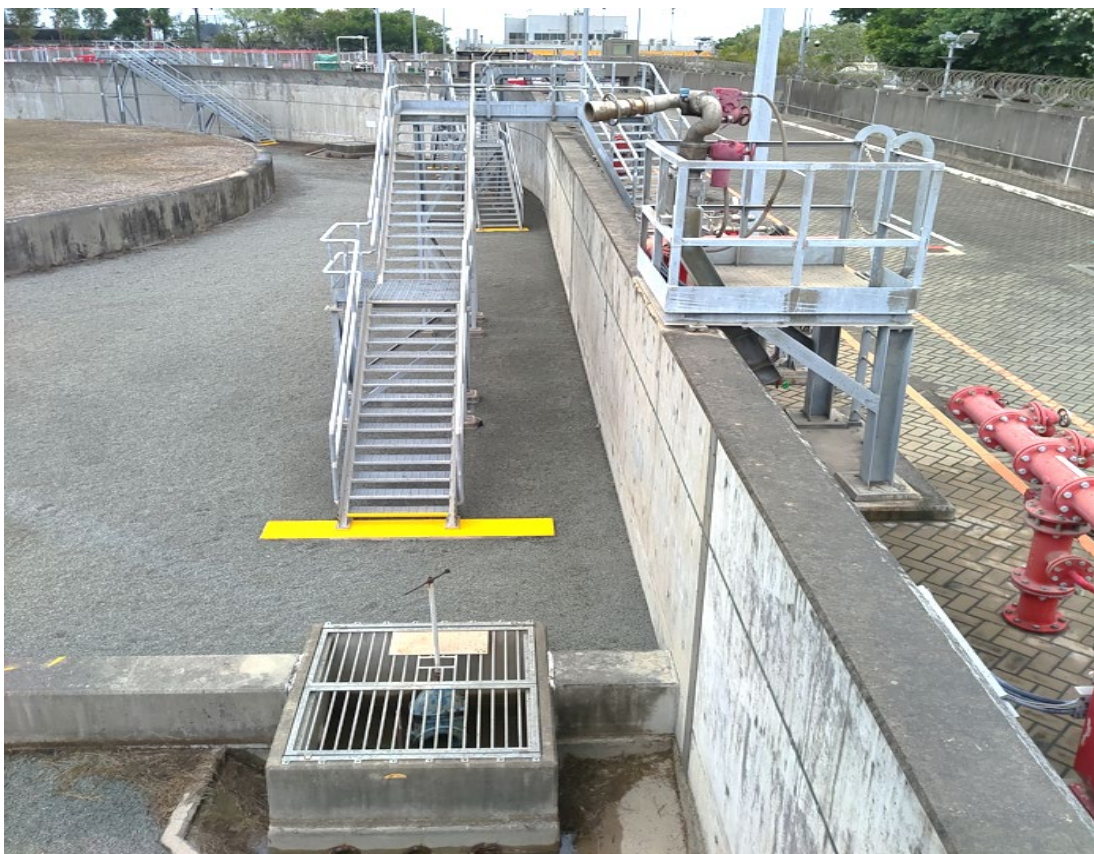
(16) This shows the thickness of the bund wall provided

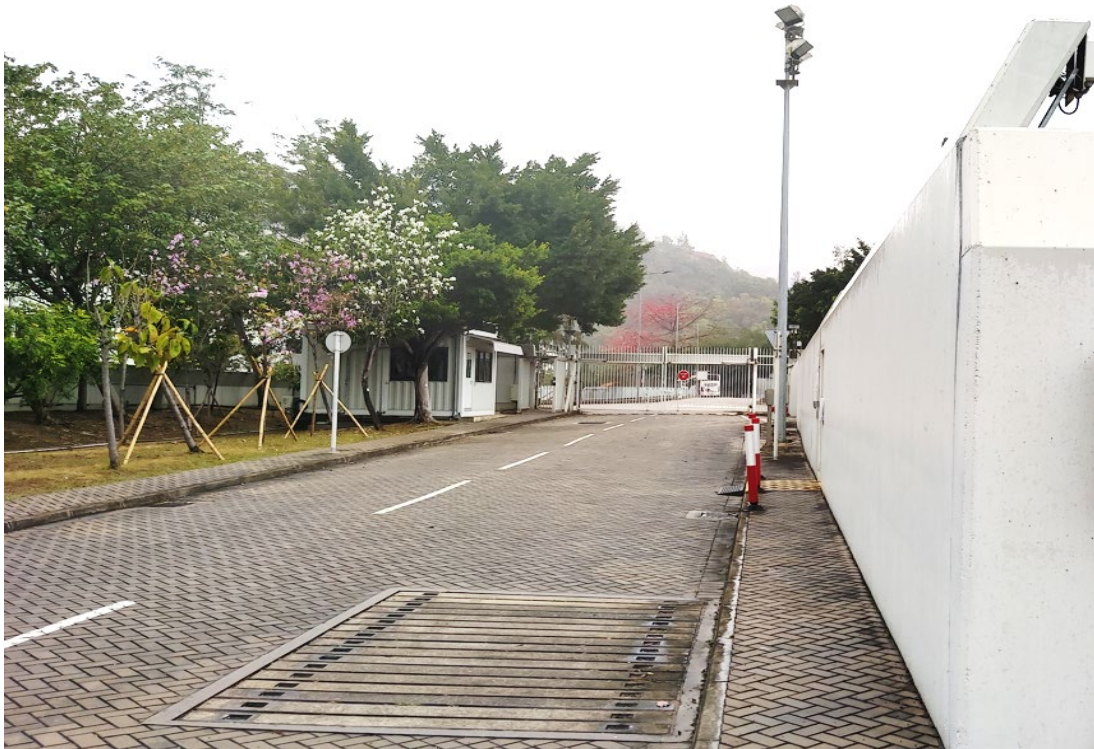
(17) This shows the thickness of the security wall provided

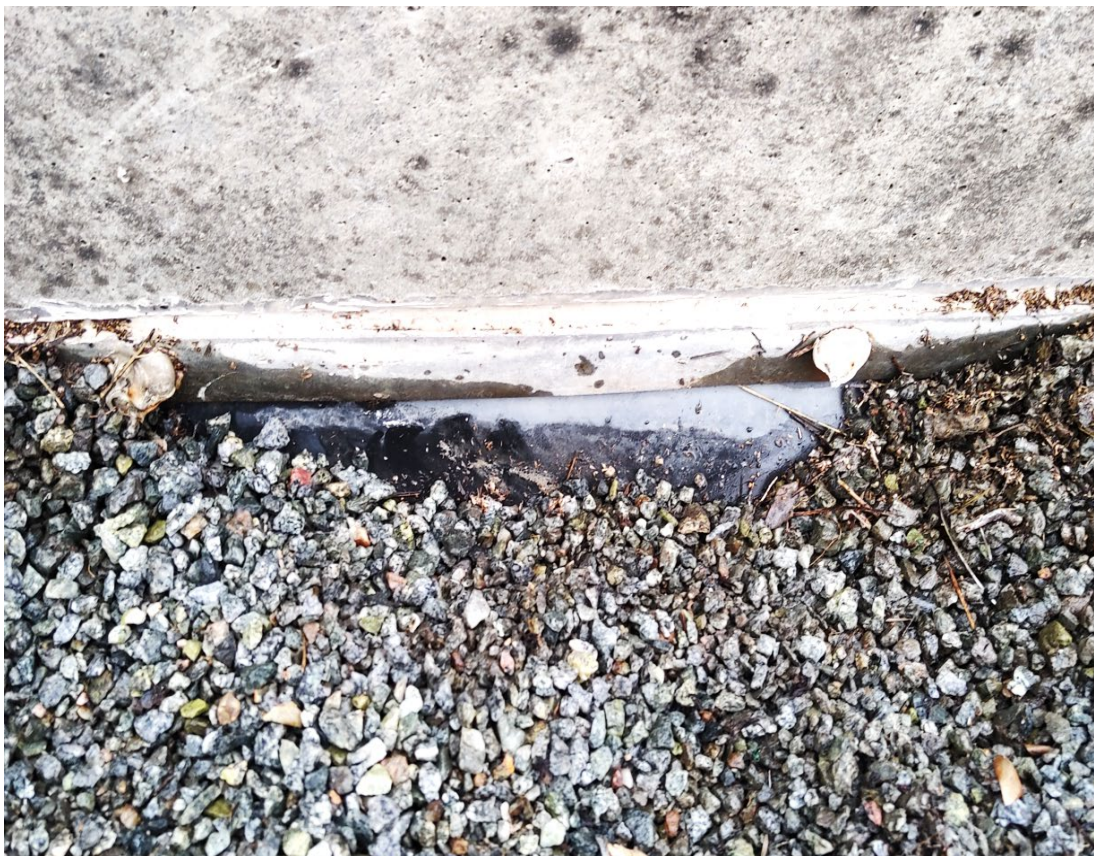
(18) Impervious lining are maintained in good condition

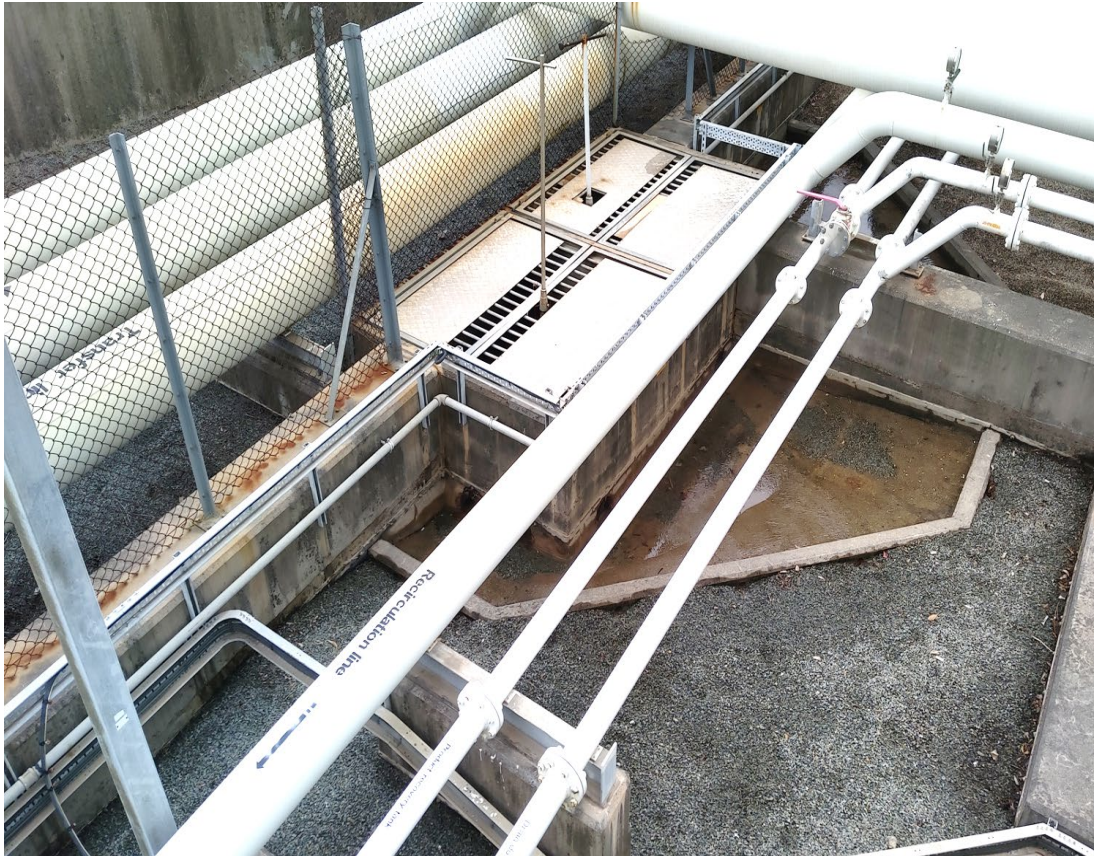
(19) Tank farm is with appropriate gradient and the drainage falls to interceptor for collection

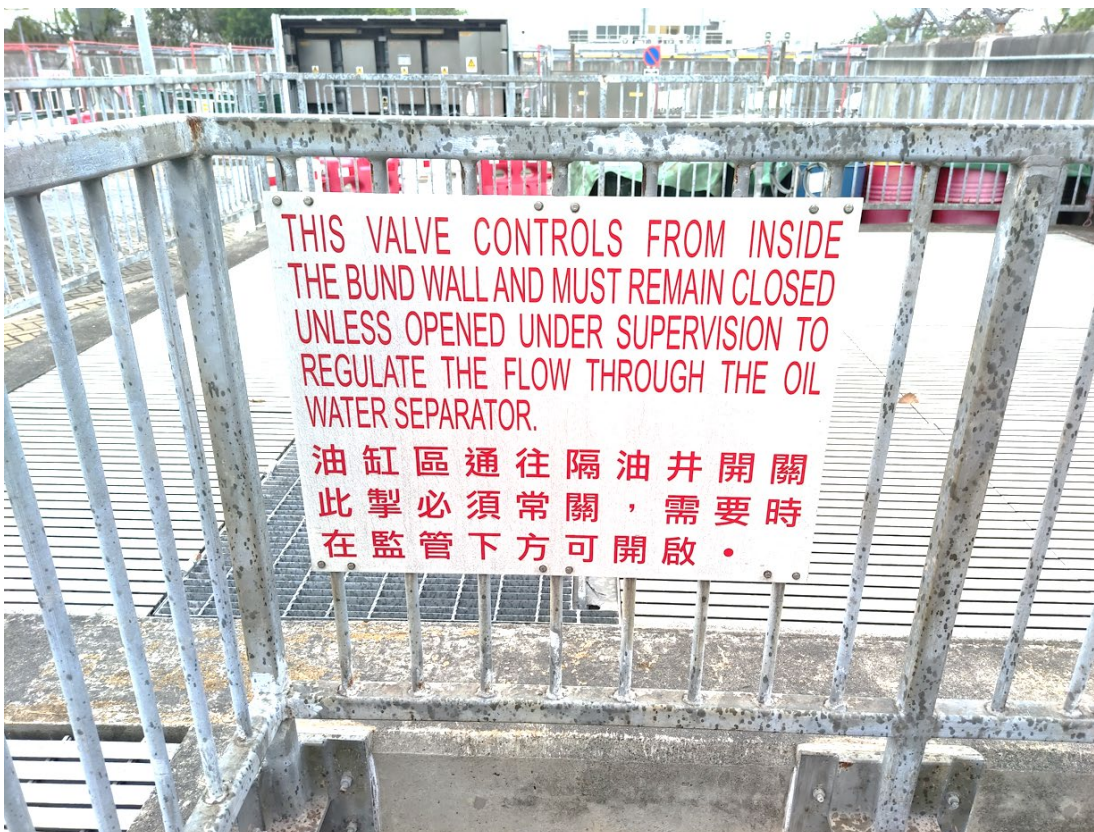
(20) Outlet valve provided for Phase 1a Interceptor with instruction sign to keep “normally closed”

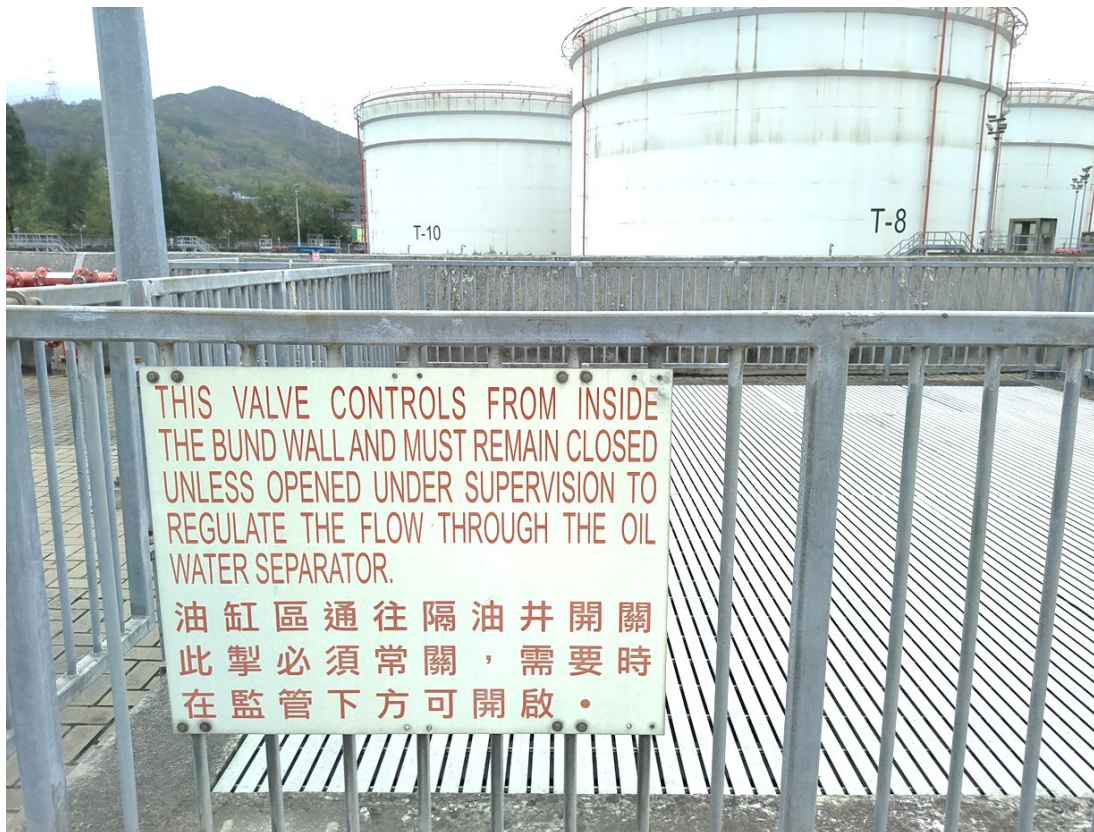
(21) Outlet valve provided for Phase 1b Interceptor with instruction sign to keep “normally closed”

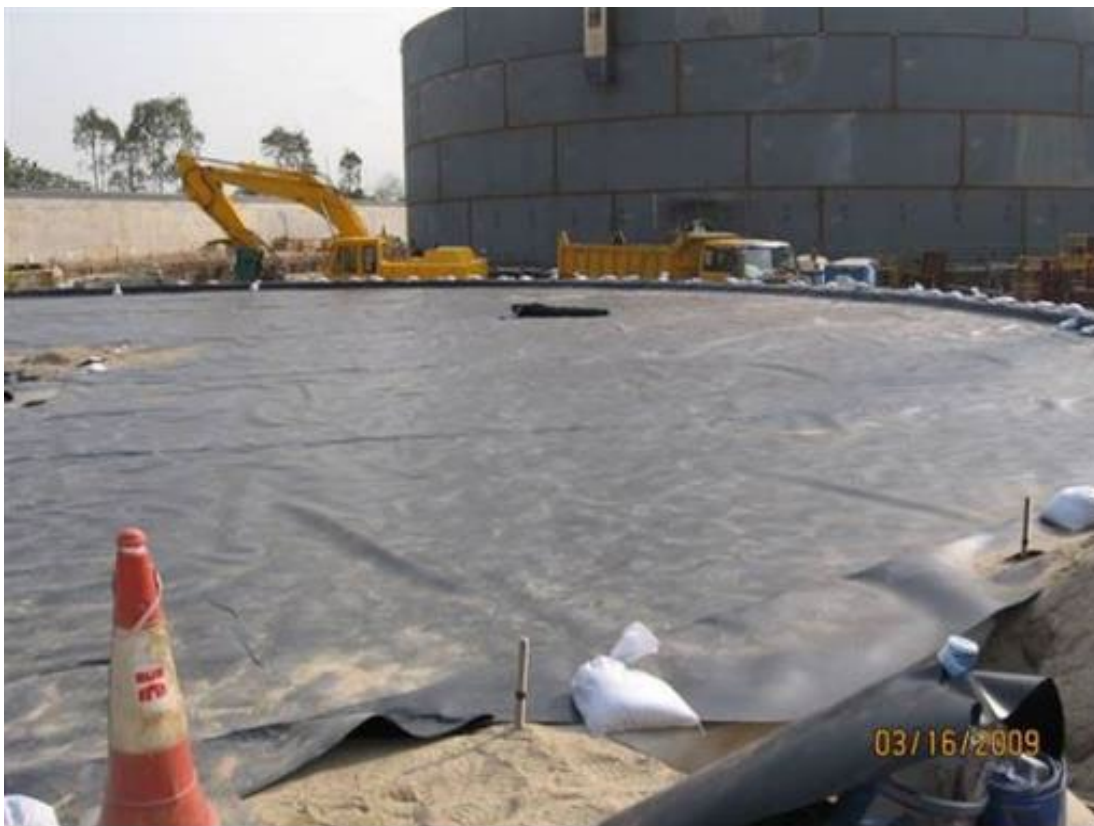
(22) Record photo shows impervious membrane being installed on top of tank foundation

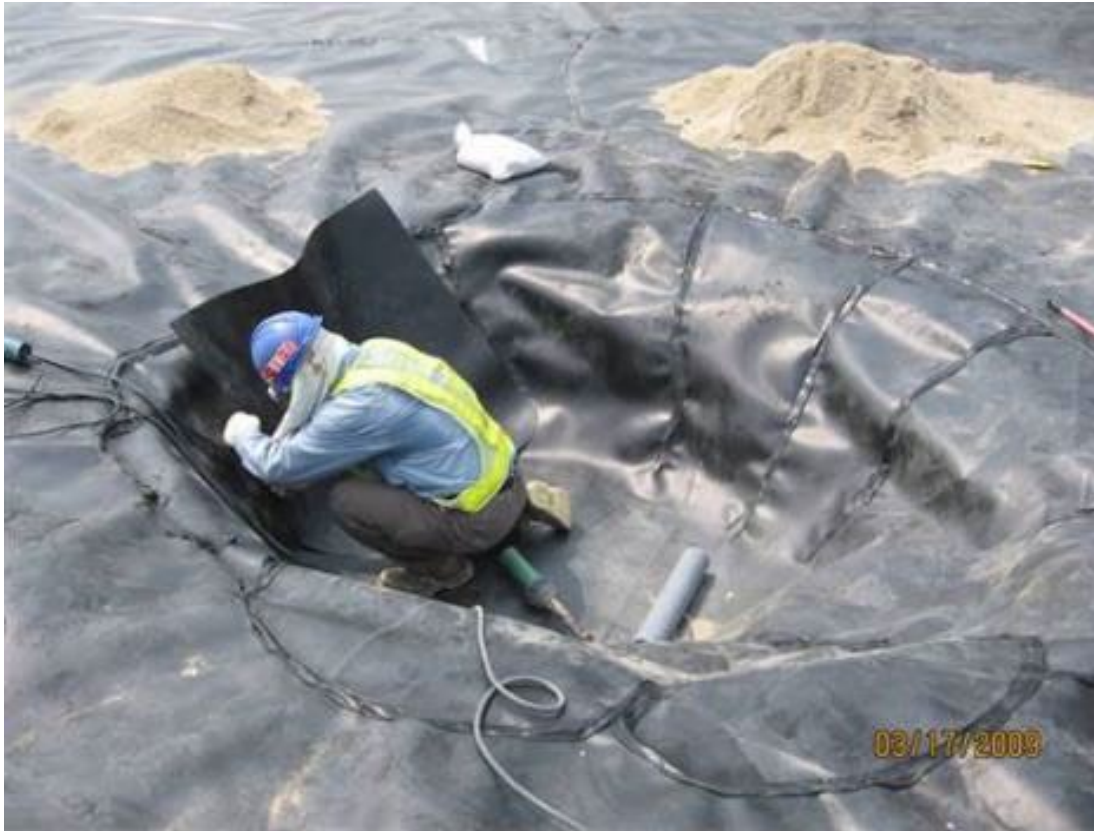
(23) Record photo shows imperious membrane laid at tank center sump with tell-tale pipe embedded for leak detection

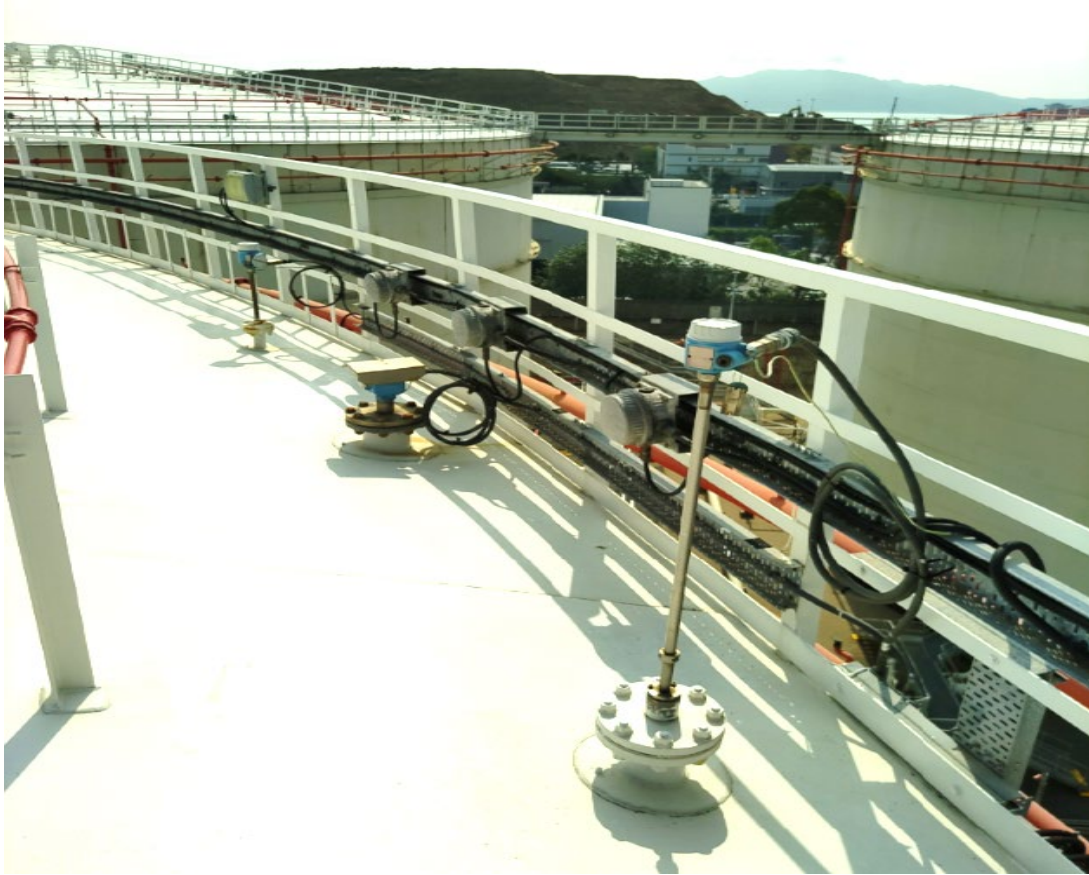
(25) Regular inspection performed on overfilling monitoring device (High-High Level Alarm)
