ANNUAL AUDIT REPORT
For
PERMANENT AVIATION FUEL FACILITY
Environmental Permit
EP-262/2007/B

Date of Audit :		04 March 2026
Prepared By :	Tsang Wai Yip, HSE Officer

This Annual Audit reviews the performance of the design arrangements and measures mentioned in Condition 3.5 of the Environmental Permit (EP-262/2007/B).

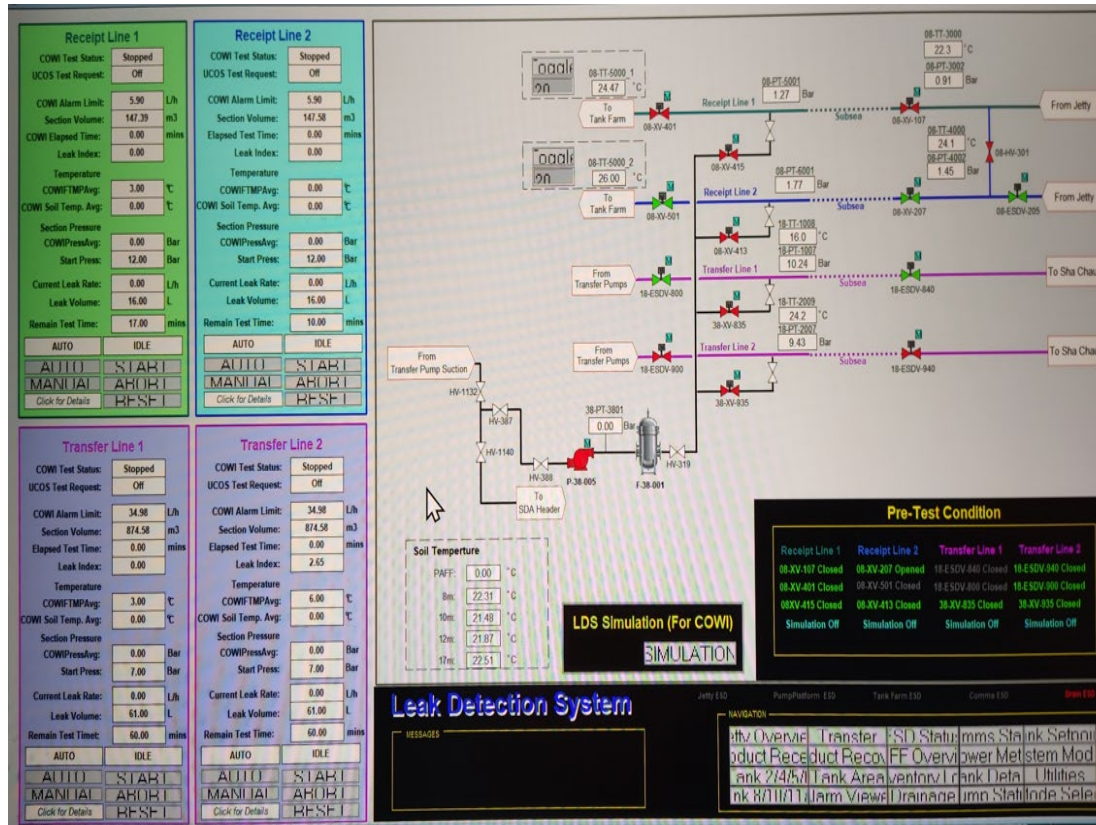
Observation	Result
<p>It was confirmed in the Design Audit Report dated October 2010 that :</p> <ol style="list-style-type: none"> 1. Drawings PAFF/LC/01/DWG/M/0202-3 & 0207 illustrate the installation of pipeline leakage detection system in the subsea pipelines using COWI Stat Leak System software. The test is carried by closing inlet/outlet section of specific pipelines and measure pressure drop within a specified time period within the pipeline. A pressure drop not due to thermal effect may indicate a possible leak in the pipeline and will generate an alarm for immediate investigation. <p>The Leak Detection System and associated instrumentation were installed and the software had been updated by the vendor after the completion of construction in October 2010. Photograph No. 27 shows the Leak Detection System is installed on the computer.</p>	<p>C</p>

(27) Leak detection “COWI Stat Leak System” installed into computer

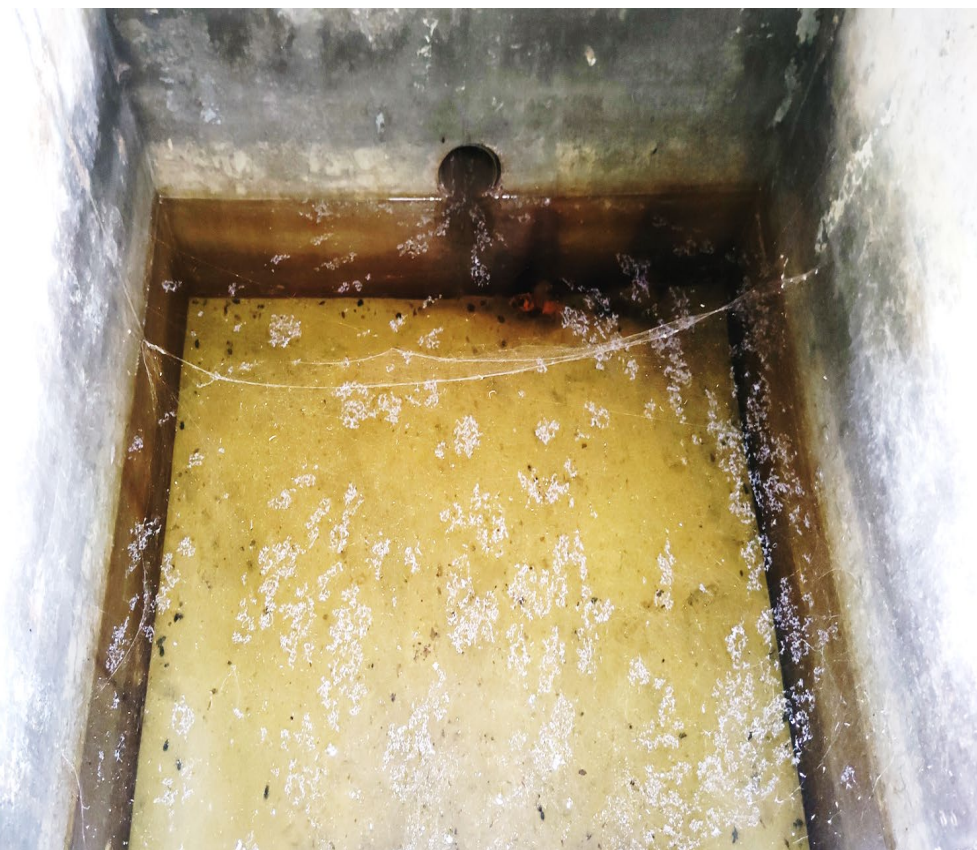
(28) Leak detection tell-tale pipe underneath the storage tank opens out to a collection chamber

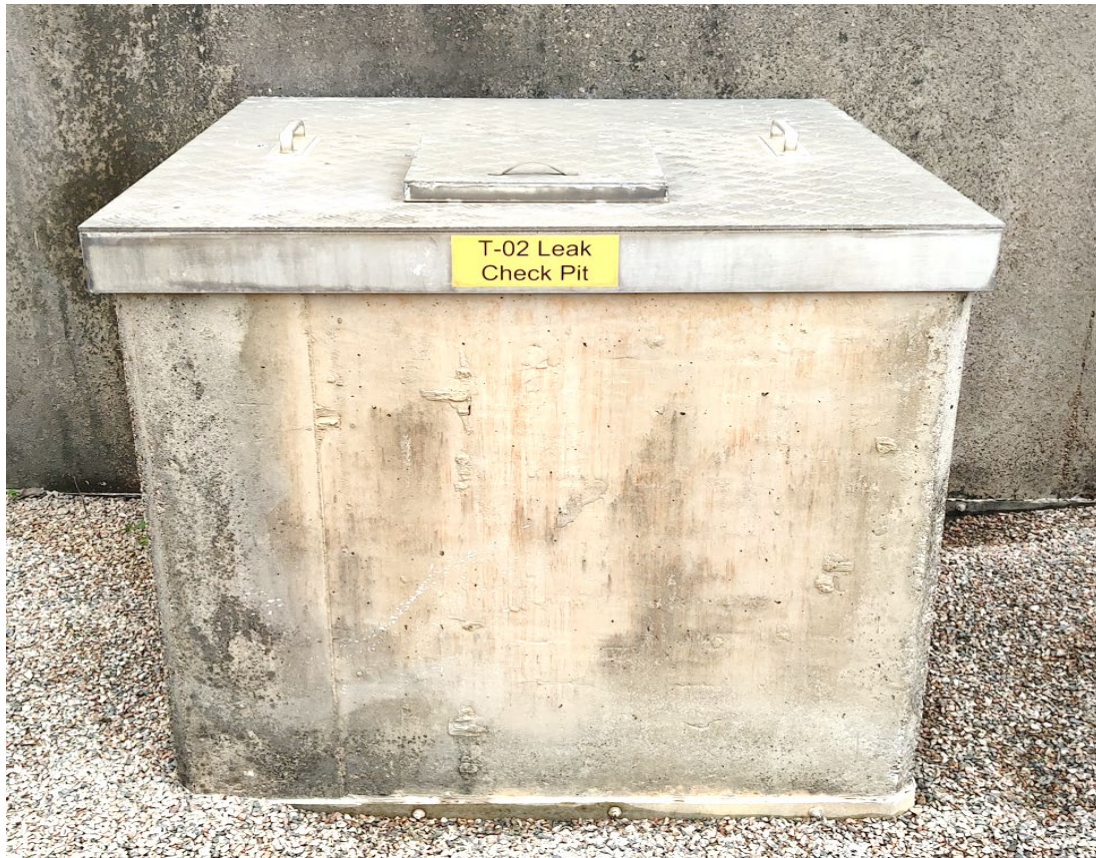
(29) Collection chamber located adjacent to tank foundation is maintained in good condition with periodic inspection

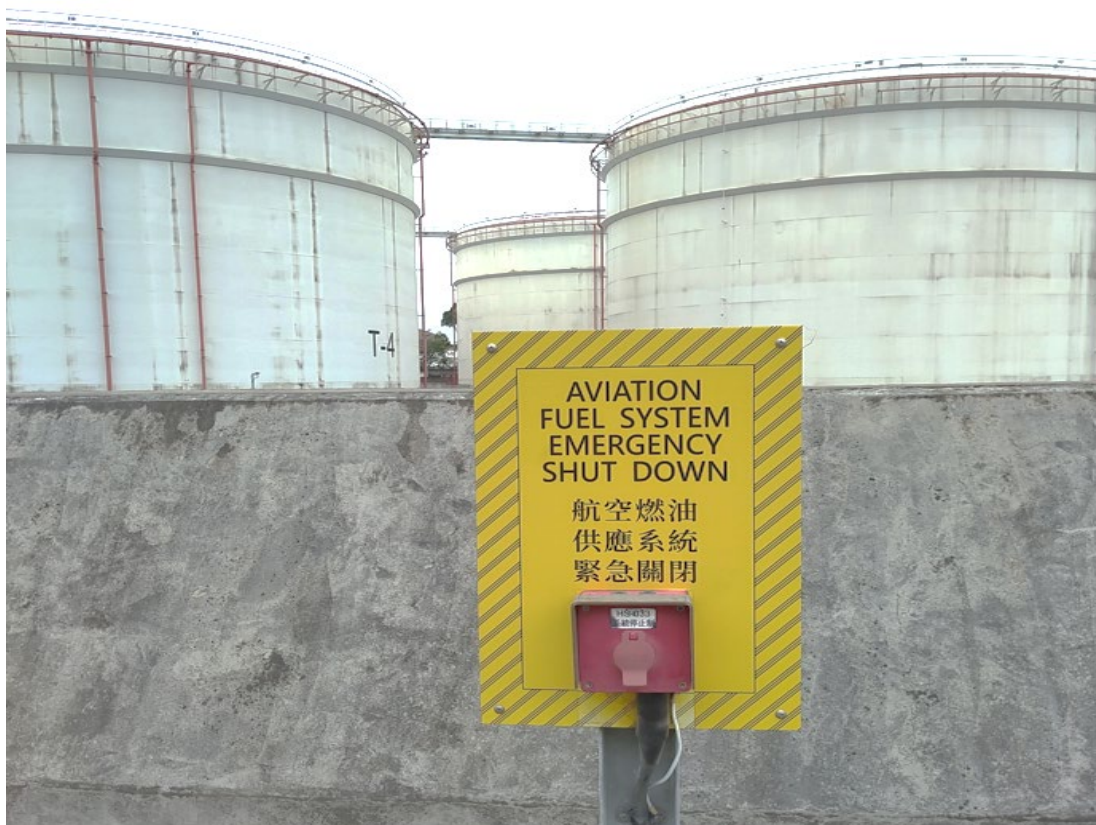
(30) ESD device is maintained in good condition and being tested periodically

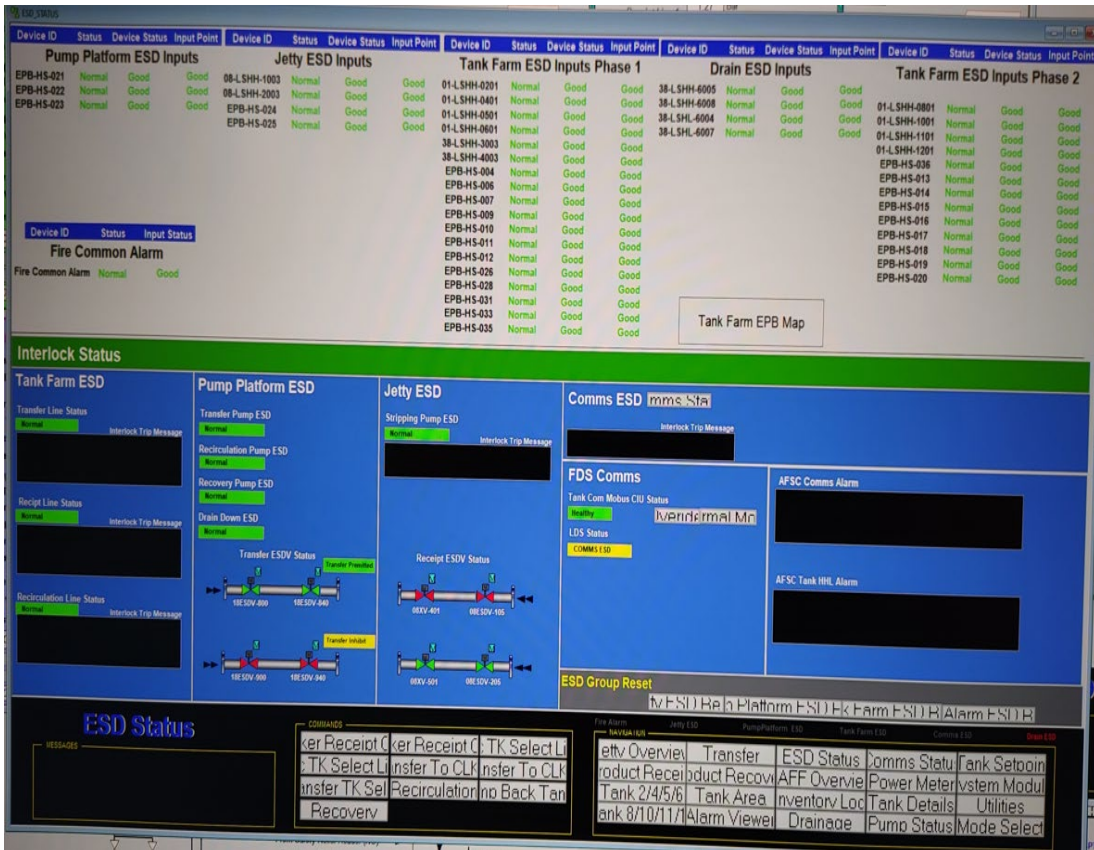
(31) The ESD regular testing as shown in SCADA System

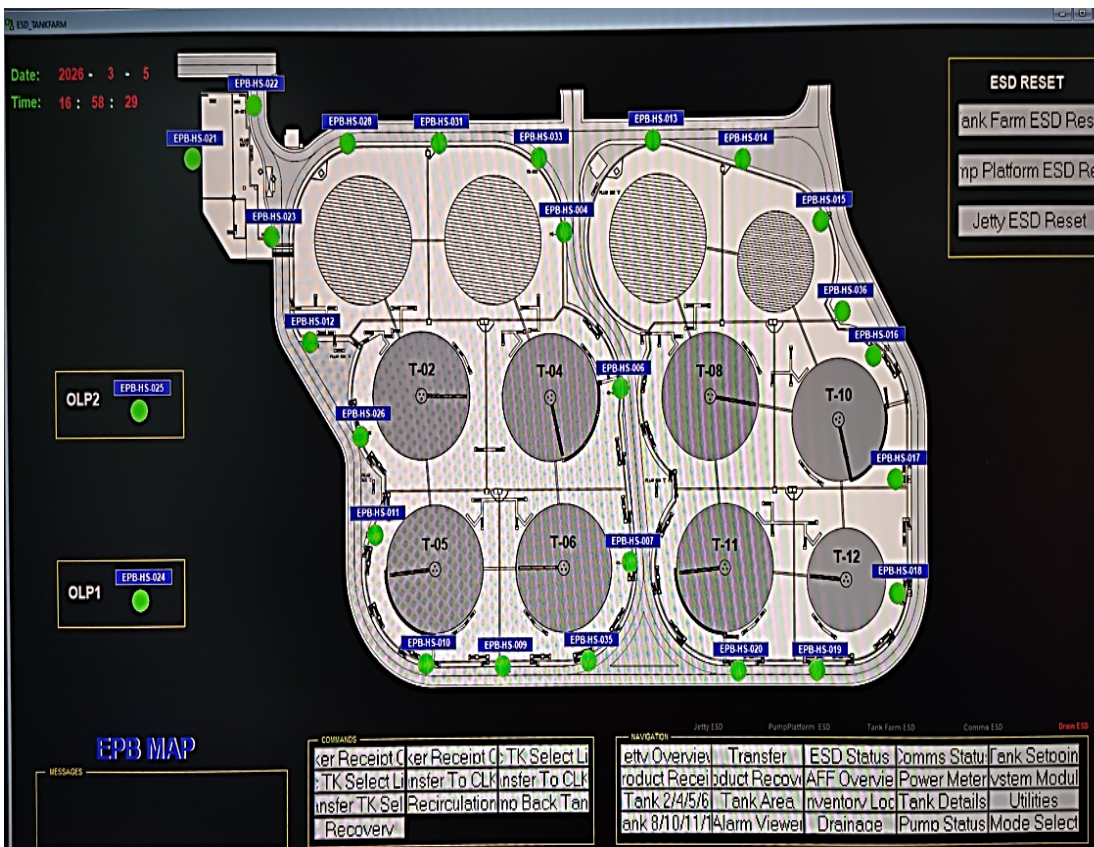
(32) The ESD regular testing as shown in SCADA System

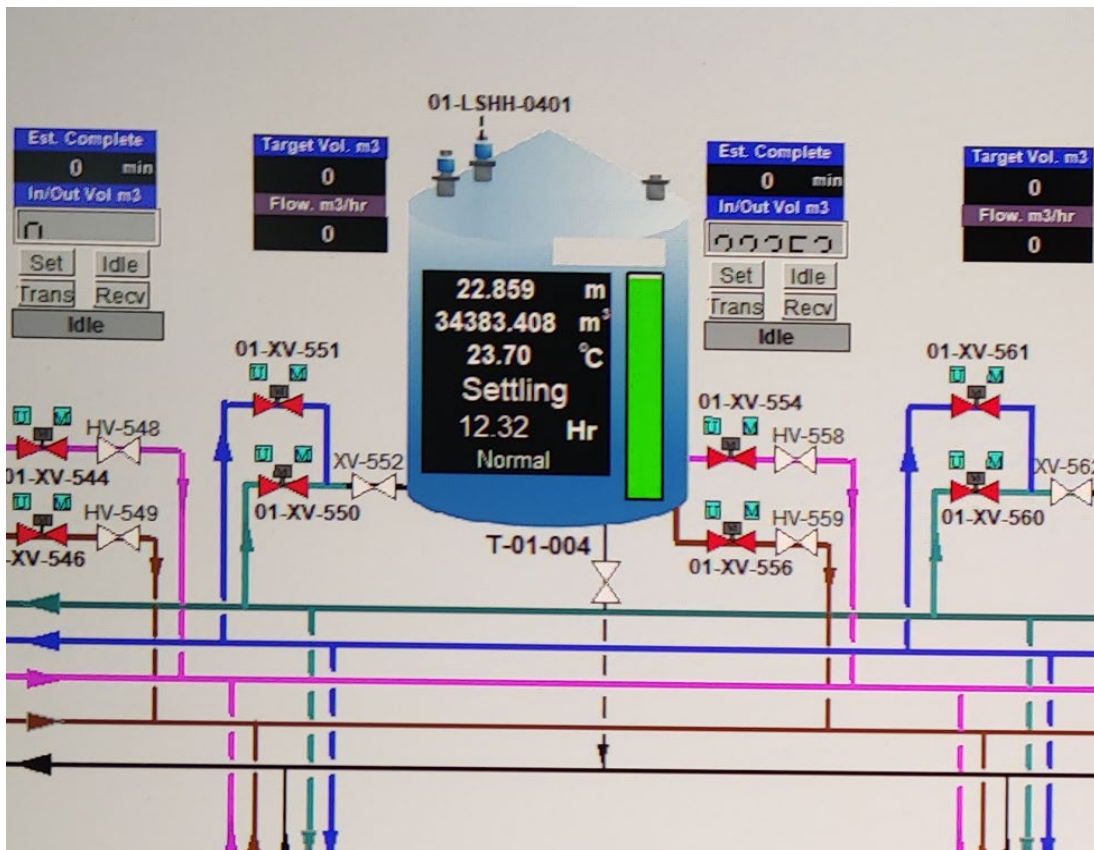
(33) The ESD test signal as shown in SCADA System

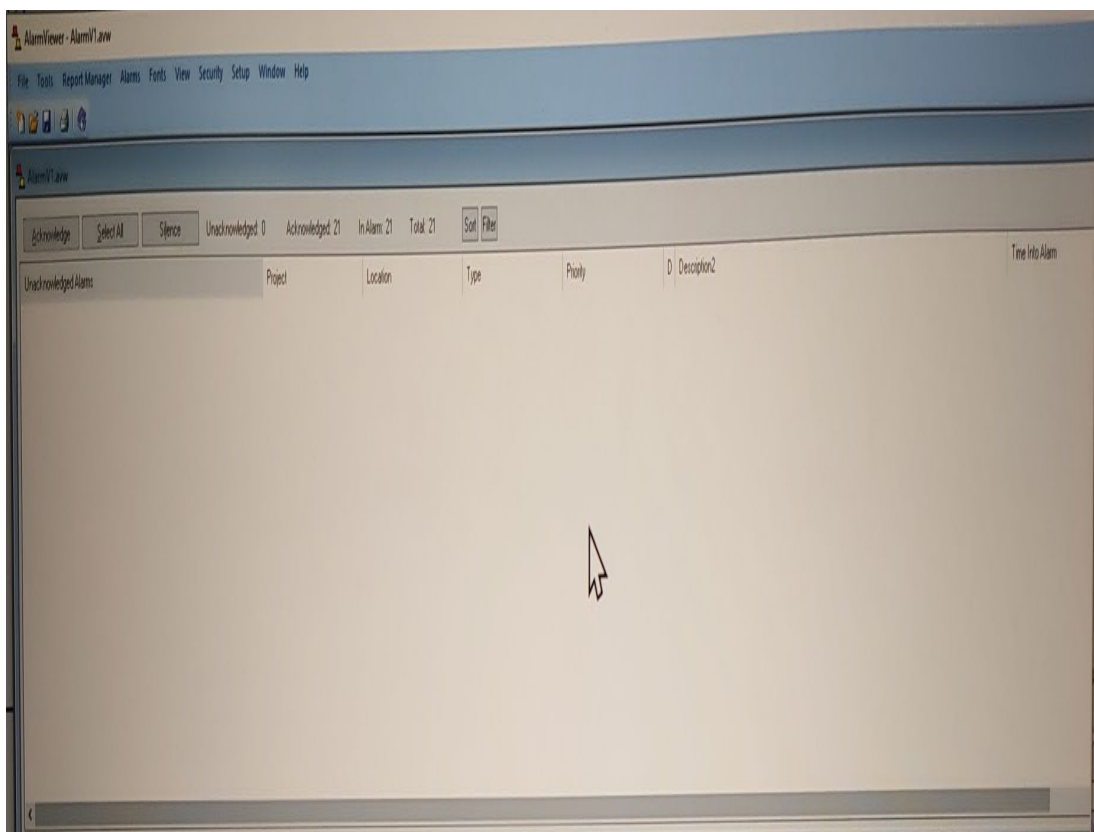
(34) Once the system received ESD test signal, the valves will be closed automatically and shut down the operation as shown in SCADA System

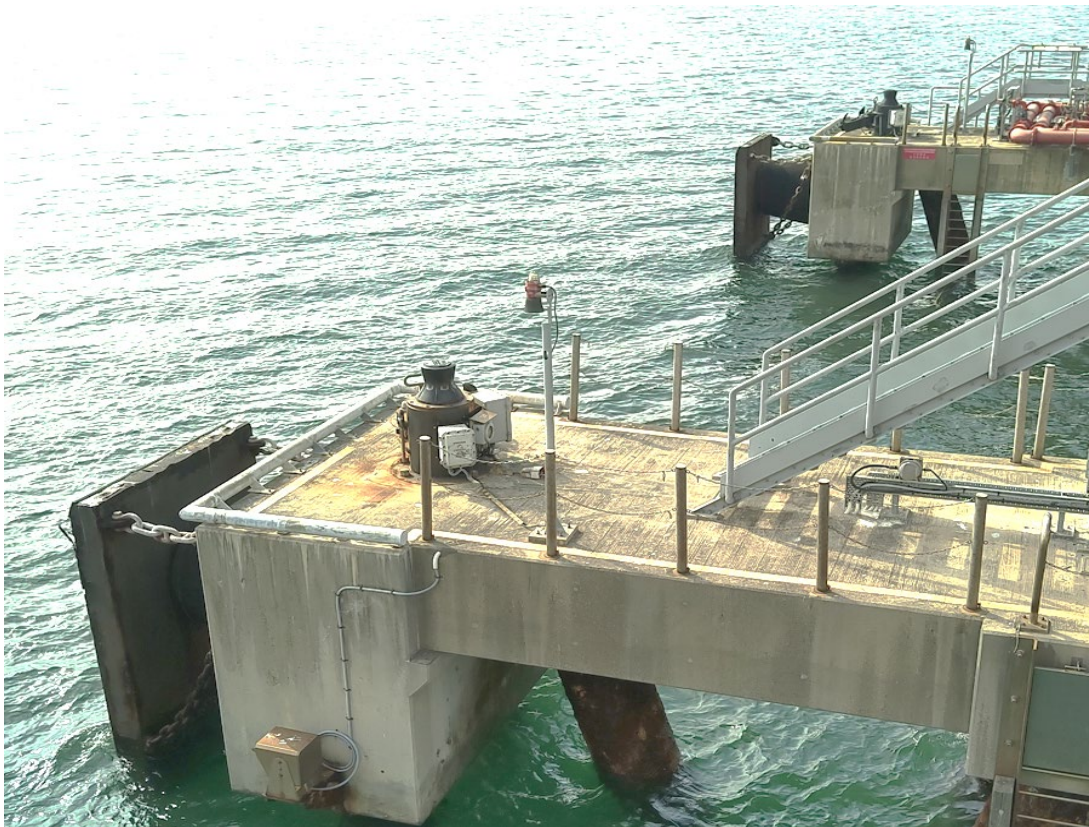
(36) Fenders are installed at sea side of the jetty

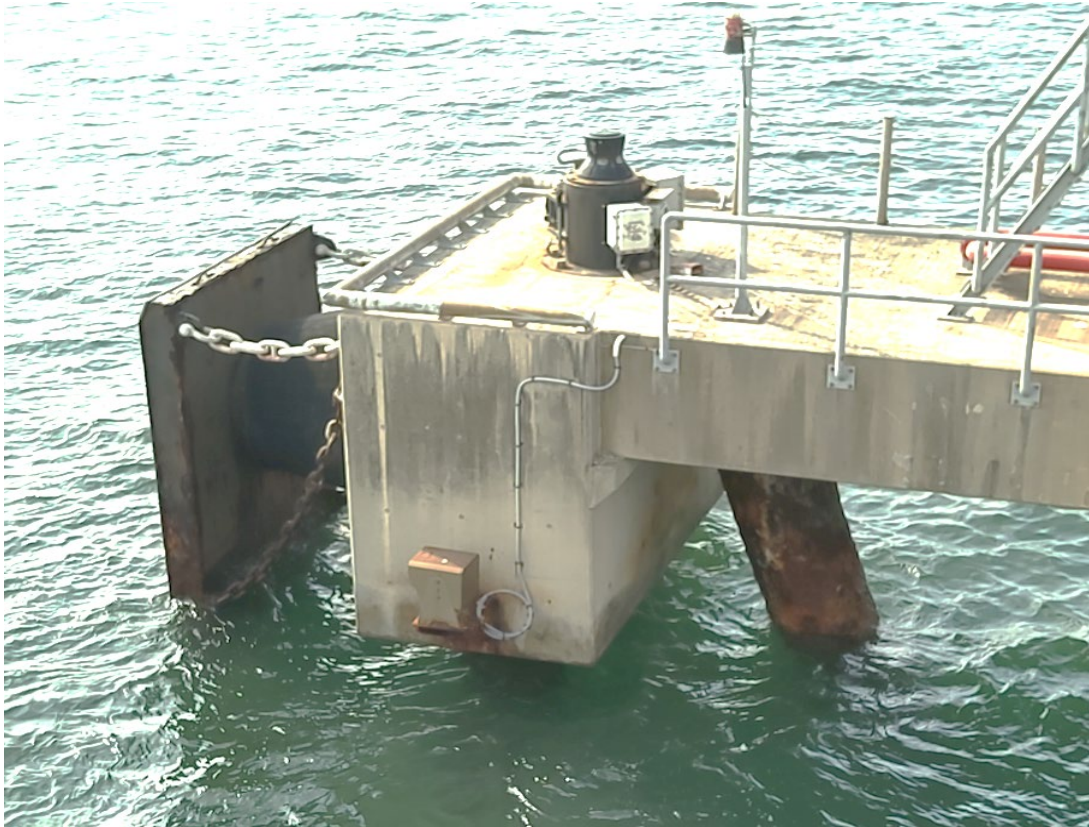
(37) Fenders are installed at sea side of the jetty

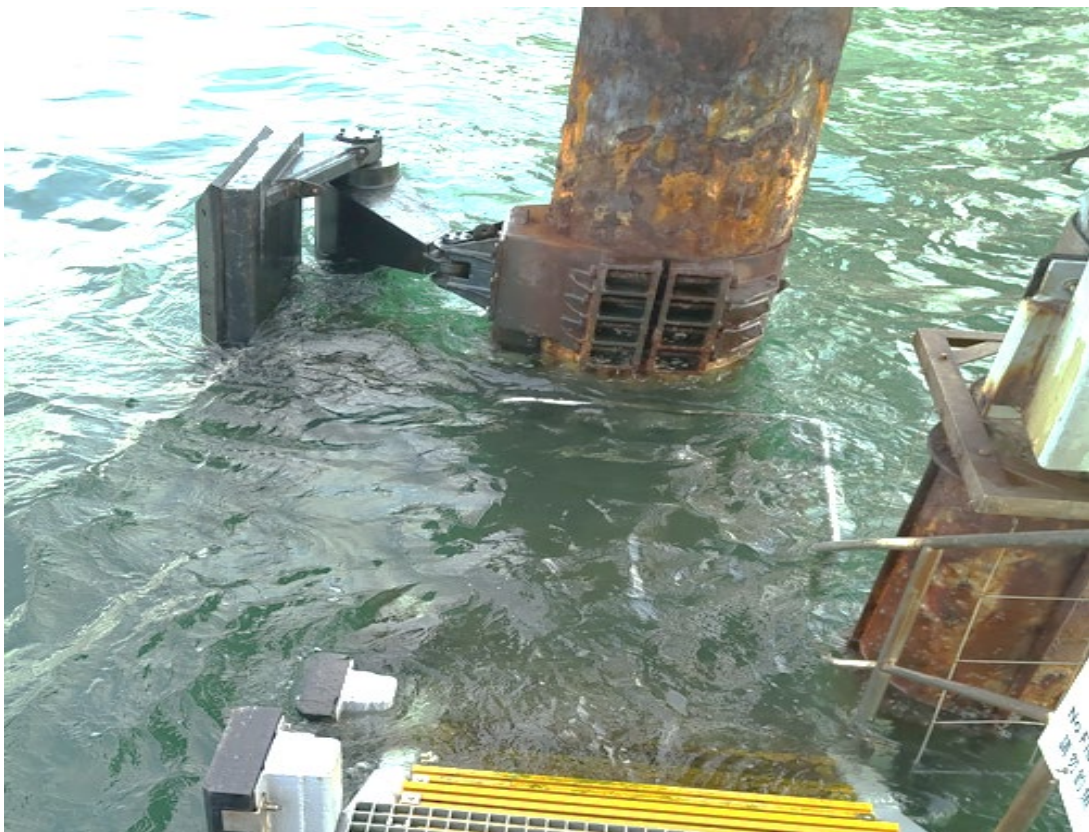
(38) Fenders are installed at shore side of the jetty

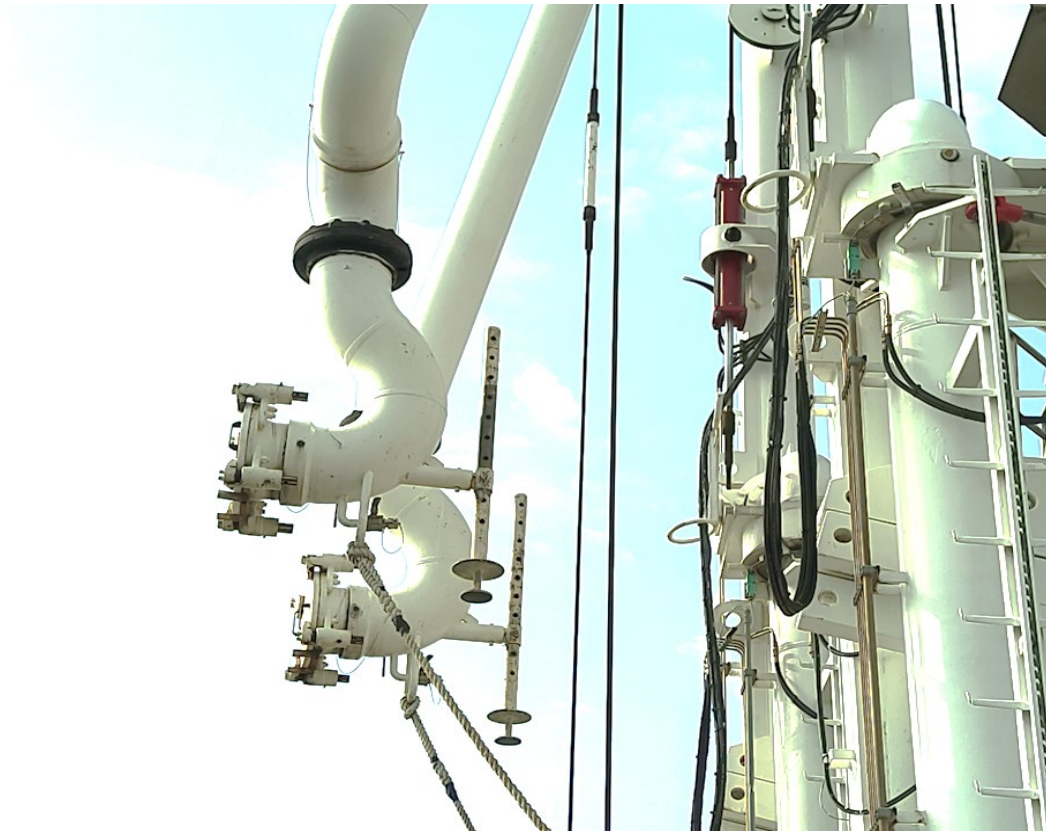
- (39) Slop collection utilities are used for coupling and de-coupling of the loading arms

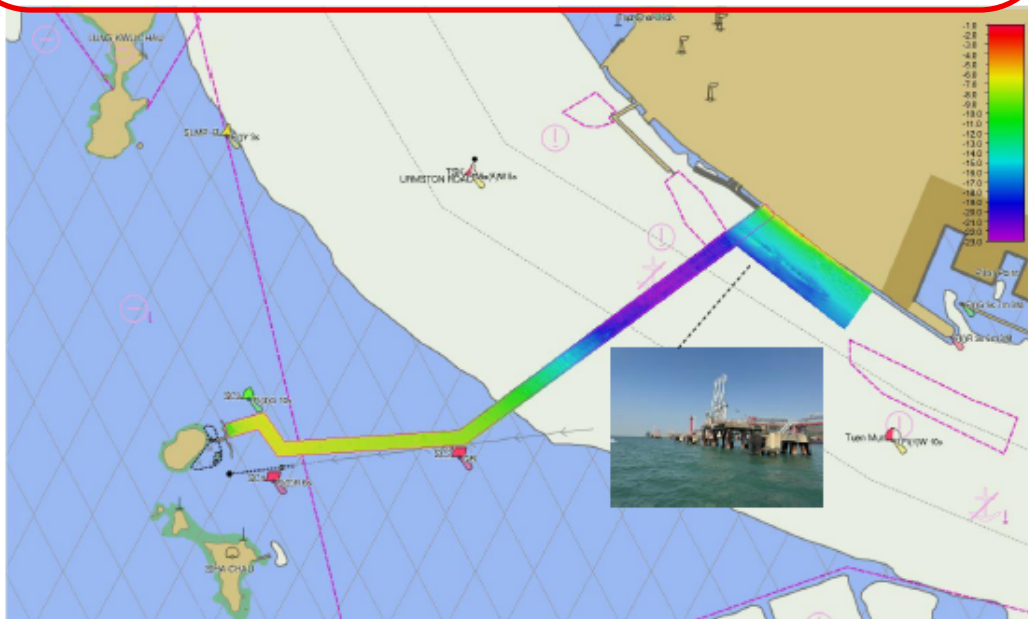
Figure 6: Overview of the bathymetry across the survey area

This survey was conducted on January 24, 2026. The seabed level ranged from -22.3 mPD to -1.1 mPD. The shallowest water is in the eastern seawall area of the survey area. The pipeline crosses the fairway at approximately KP0.6 to KP1.2, which is the deepest part of the survey area, with a seabed level ranging from approximately -20 mPD to -22 mPD. The results, shown as contour plots, cross-sections and long-sections do not show any evidence of damage or major disturbance to the rockfill protection layer covering the pipelines. The current seabed bathymetry is similar to original seabed profile (2007) and to the last survey carried out in 2025. Please refer to [Appendix H](#) for details.
