**Castle Peak Road
Improvement Between
Sham Tseng and Ka
Loon Tsuen,
Tsuen Wan
West Contract No.
HY/99/18**

Monthly Environmental
Monitoring and Audit
Report
October 2003

Monthly Environmental Monitoring and Audit Report - October 2003

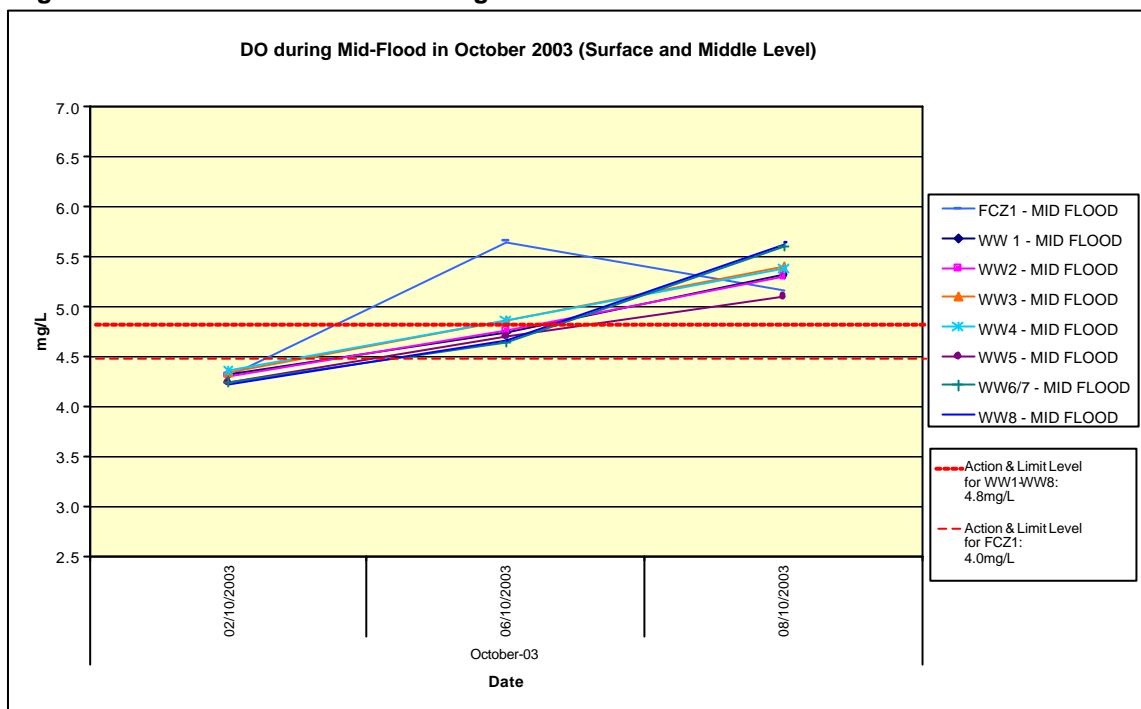
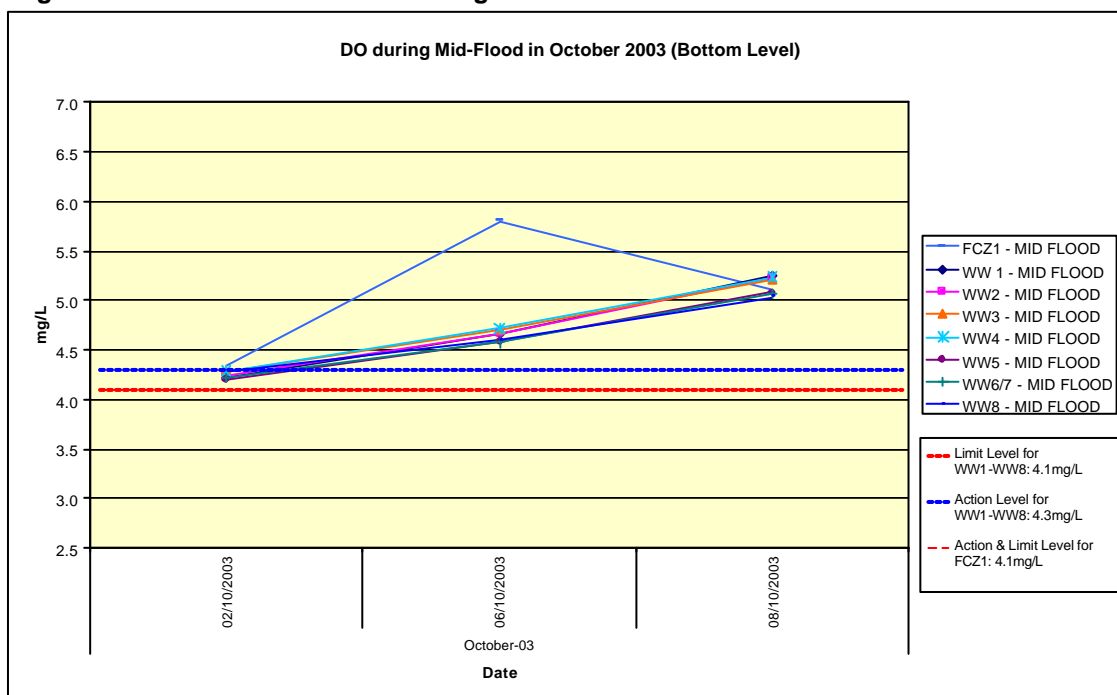
Figure 6-7 DO at bottom level during mid-ebb in October 2003

Figure 6-8 DO at bottom level during mid-flood in October 2003

There were “Reaching of Trigger Value” of Dissolved Oxygen (DO) of marine water quality monitoring in October 2003. The daily records of “Reaching of Trigger value” of DO at different monitoring location and each monitoring tide are detailed in Appendix N.

All “Reaching of Trigger Value” of DO in October 2003 were caused by the natural variation of the marine water quality rather than by the construction activities.

The “Reaching of Trigger Value” of DO recorded at FCZ1 on 2nd and 6th October 2003 were likely caused by the natural variation of marine water quality rather than the marine works of West Contract, as relatively low DO results were also recorded at all other control and impact stations.
