ENVIRONMENTAL MONITORING AND AUDIT REPORT

CONTRACT No. CV/2002/13

FILL BANK AT TUEN MUN AREA 38

JANUARY 2004

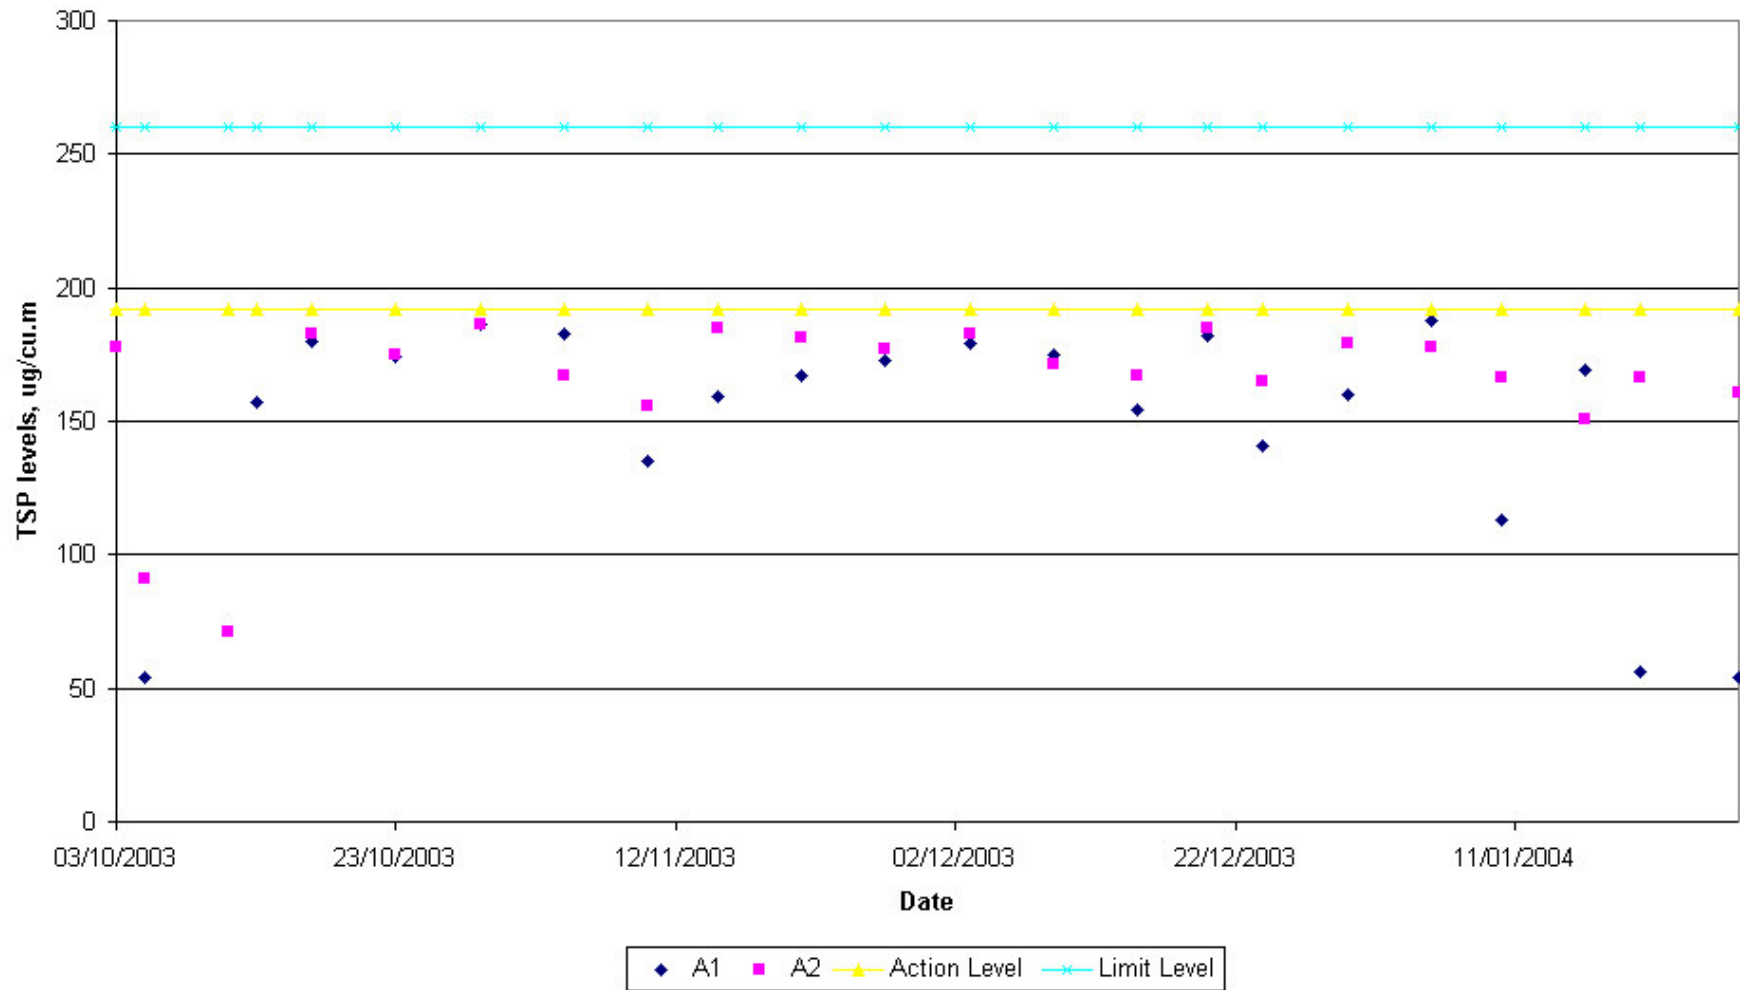
Figure 6.1 - Graphical Plot for 24-hr TSP

No exceedance to set Action and Limit levels for either 24 or 1-Hour TSP monitoring was recorded at air monitoring station A1 and A2 in this reported period.

Elevated results below the Action limit were reported for this month's monitoring data. The Contractor is reminded to implement and maintain all necessary mitigation measures to suppress dust generation.
