Improvements to San Tin Interchange
Environmental Monitoring and Audit

November 2005

**Contract No. HY 2004/09 Improvements to San Tin Interchange
Water Quality Visual Inspection Report**

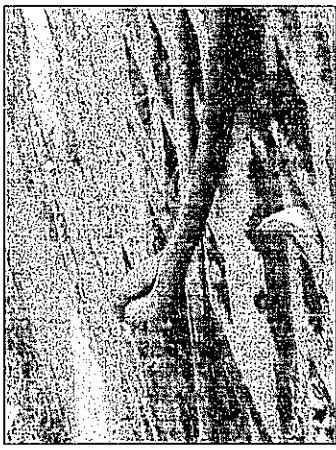
During the inspection on 10th November 2005, water at bottom of pile cap was pumped and discharged into EMDC without sedimentation.

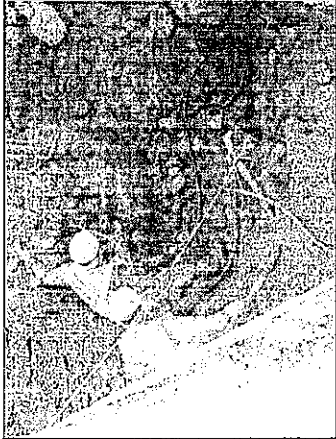
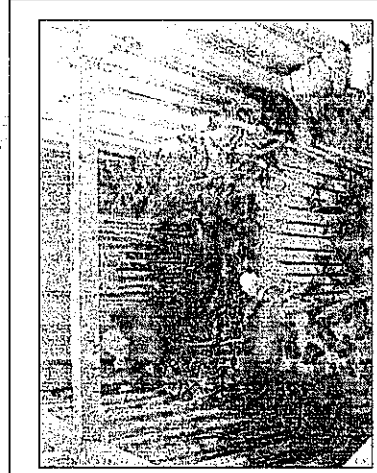
During the follow-up visual inspection conducted on 11th November 2005, the water pipe for discharging water was moved back to bottom of pile cap works area. No direct discharge was observed.
