Environmental Permit No. EP-205/2004
Photo Records of the Completed Landscape and Visual Mitigation Works
for Feature No. 13NW-B/C319 Along Keung Shan Road, Lantau

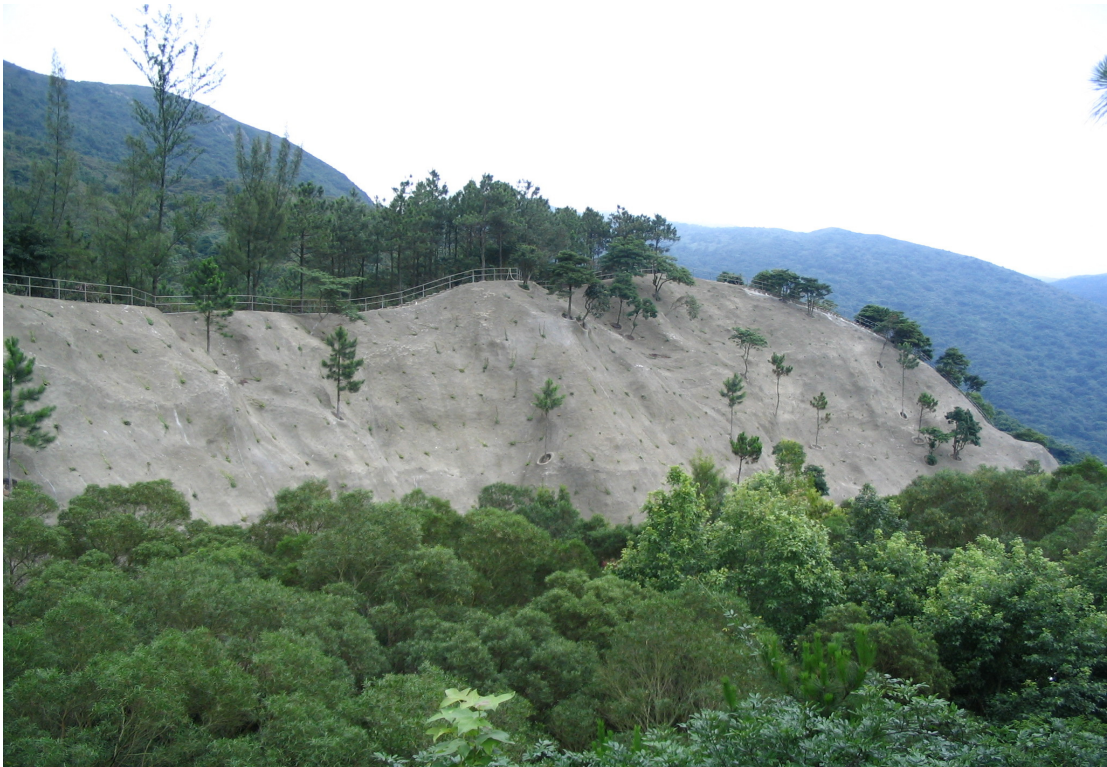
Plate No. 1
General view of the middle portion of the feature

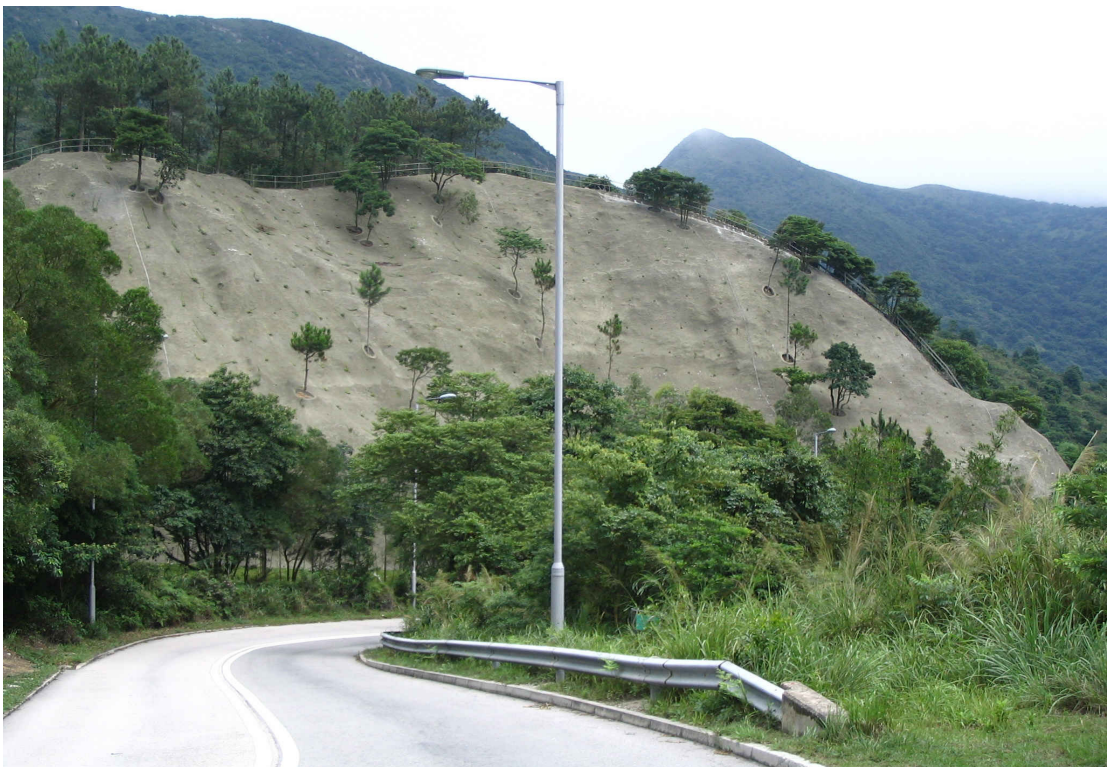
Plate No. 2
General view of the feature from Keung Shan Road

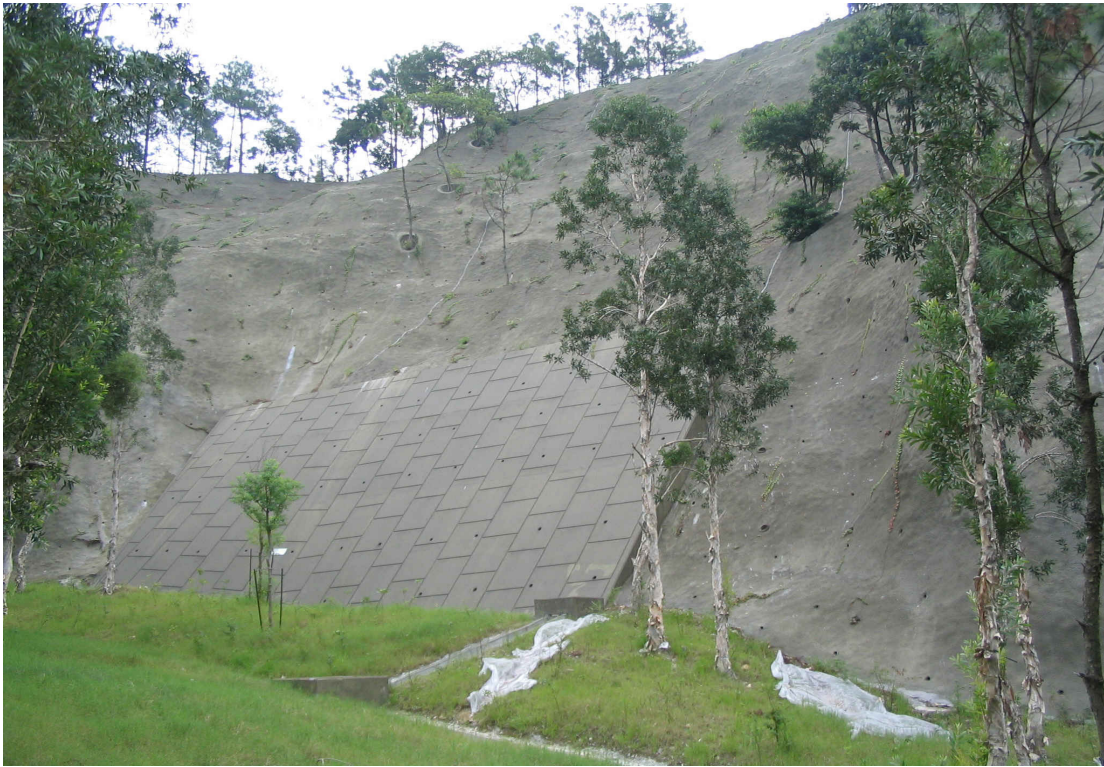
Plate No. 3

View of the colour painted slope surface and skin wall at the middle portion of the feature

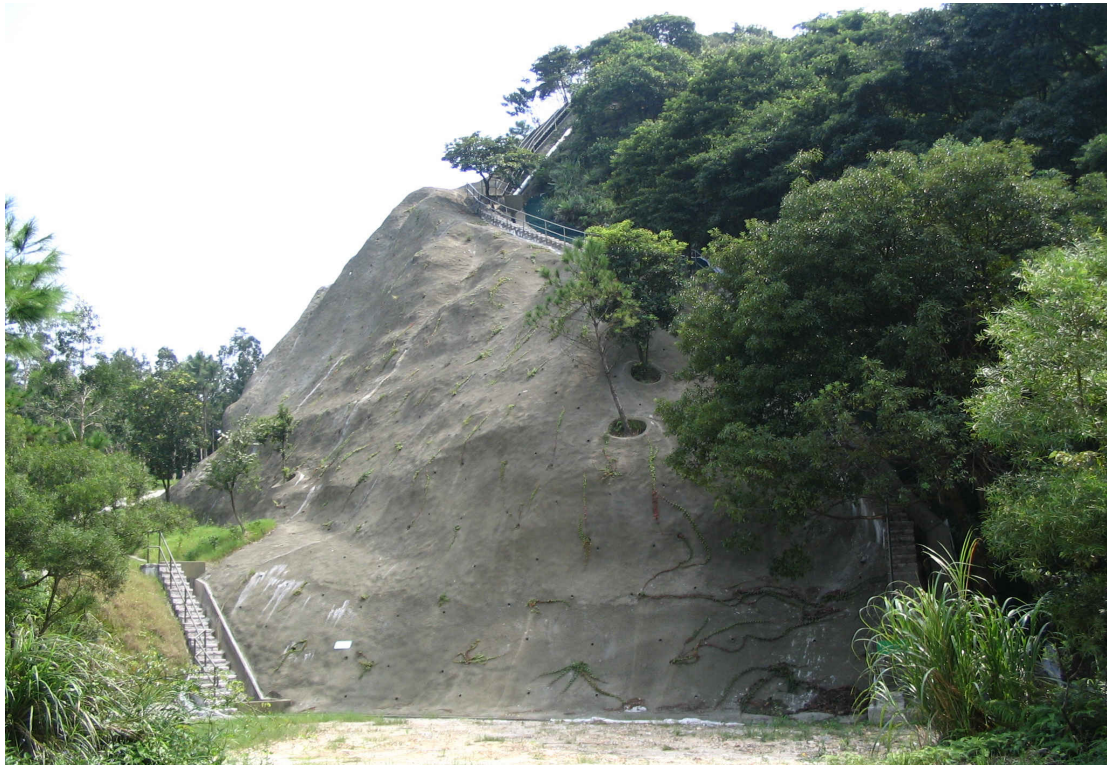
Plate No. 4

General view of the south-western end of the feature

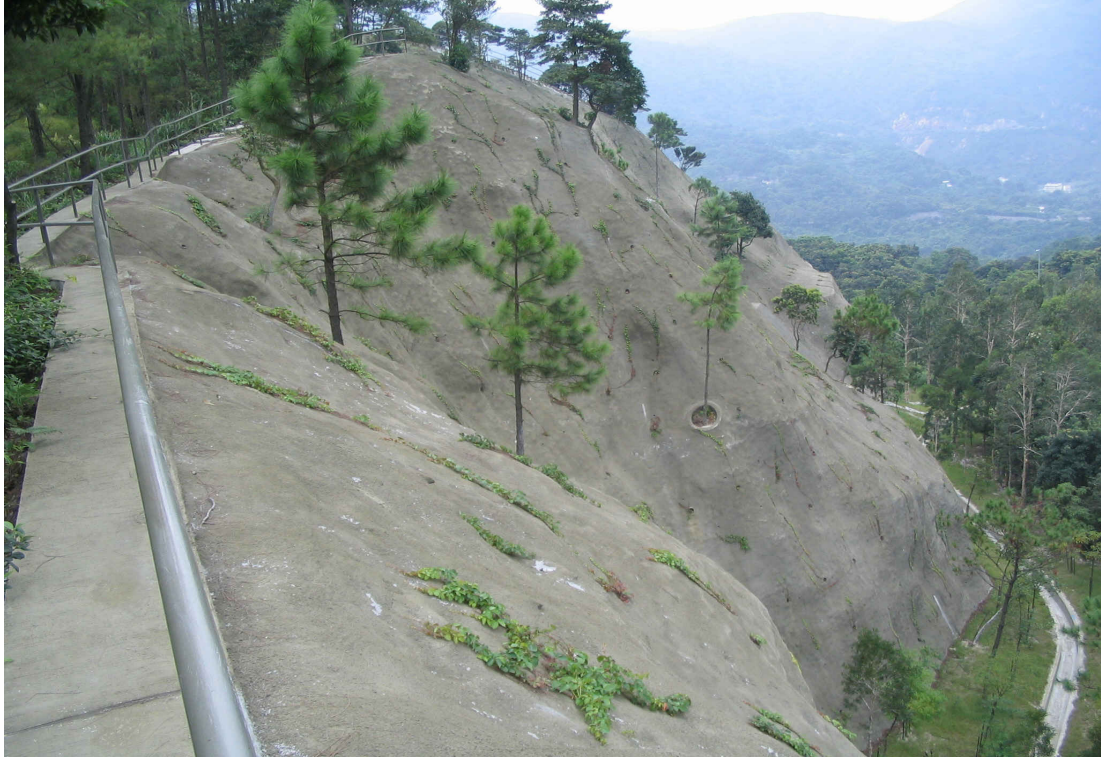
Plate No. 5
Crest view of the slope, with climbers planted over the entire slope surface

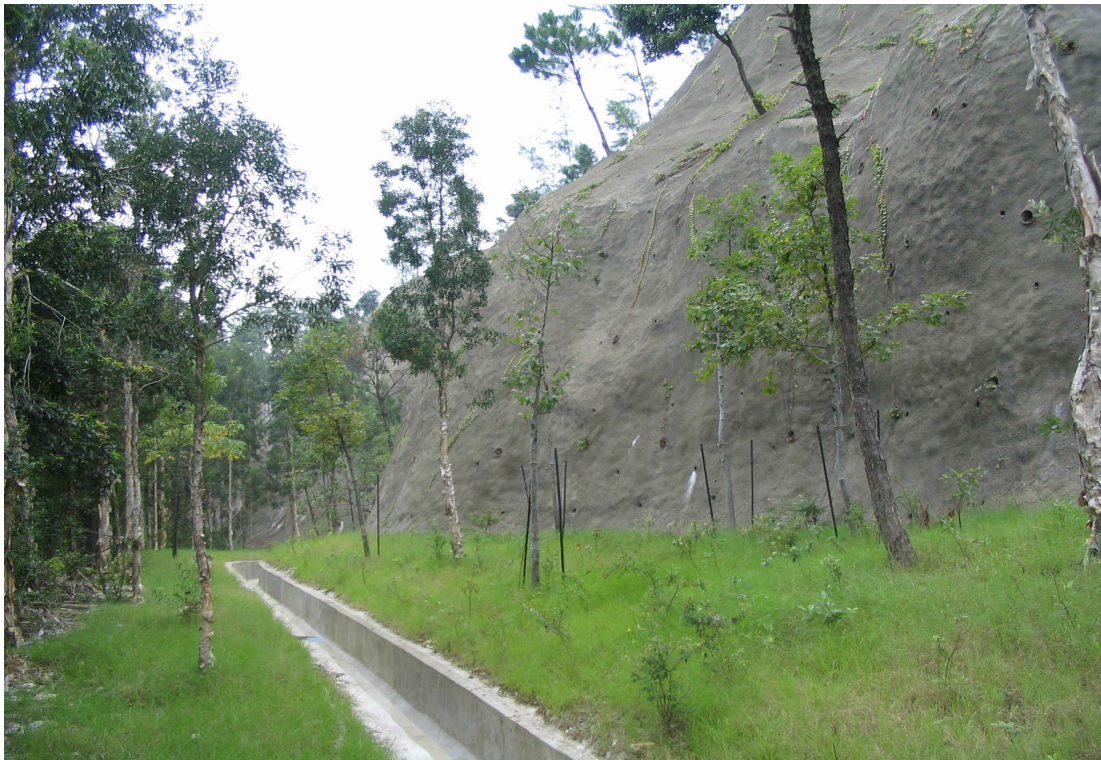
Plate No. 6
Newly planted trees and hydroseeded area along the slope toe

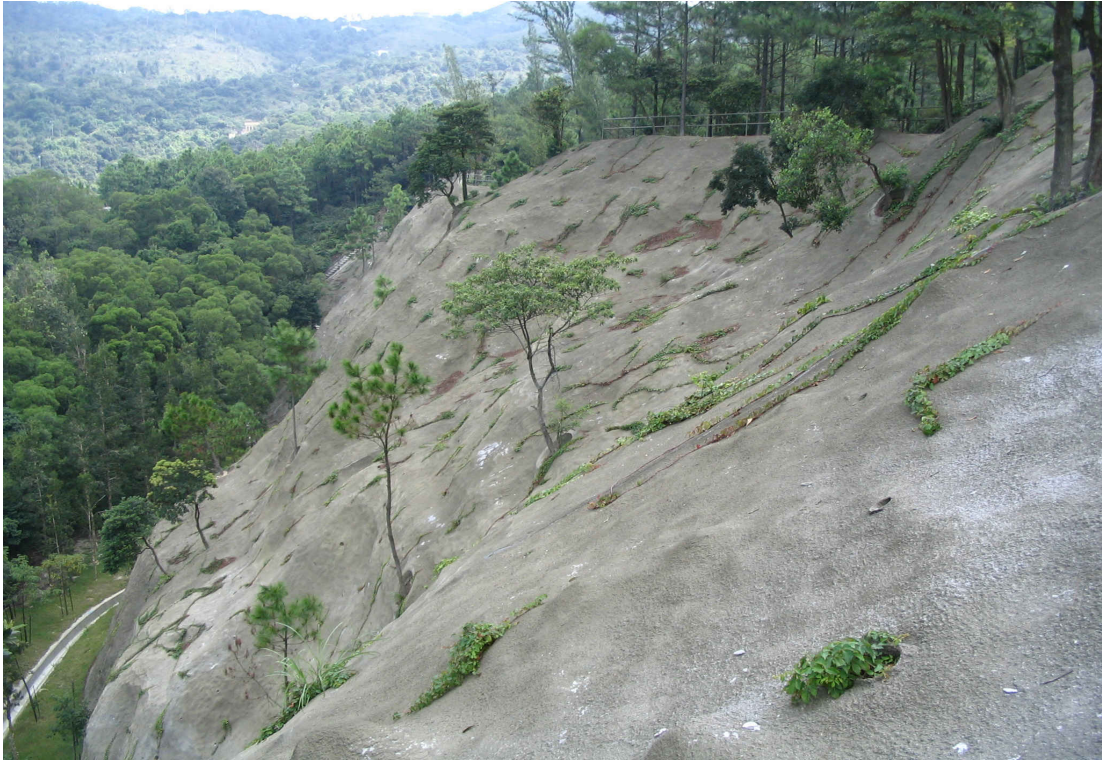
Plate No. 7

All existing trees are preserved in tree rings on the sprayed concrete slope surface

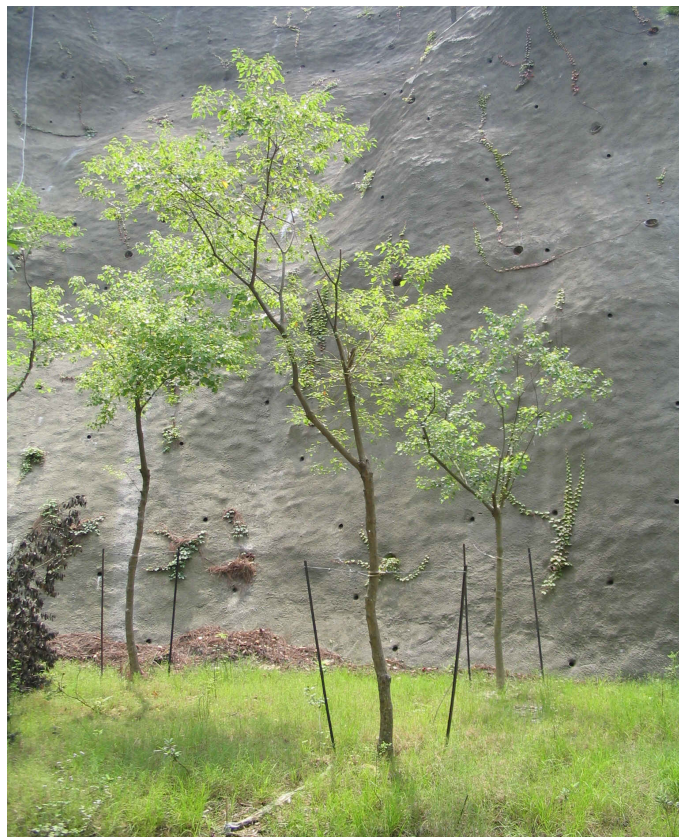
Plate No. 8

View of the newly planted trees along the slope toe

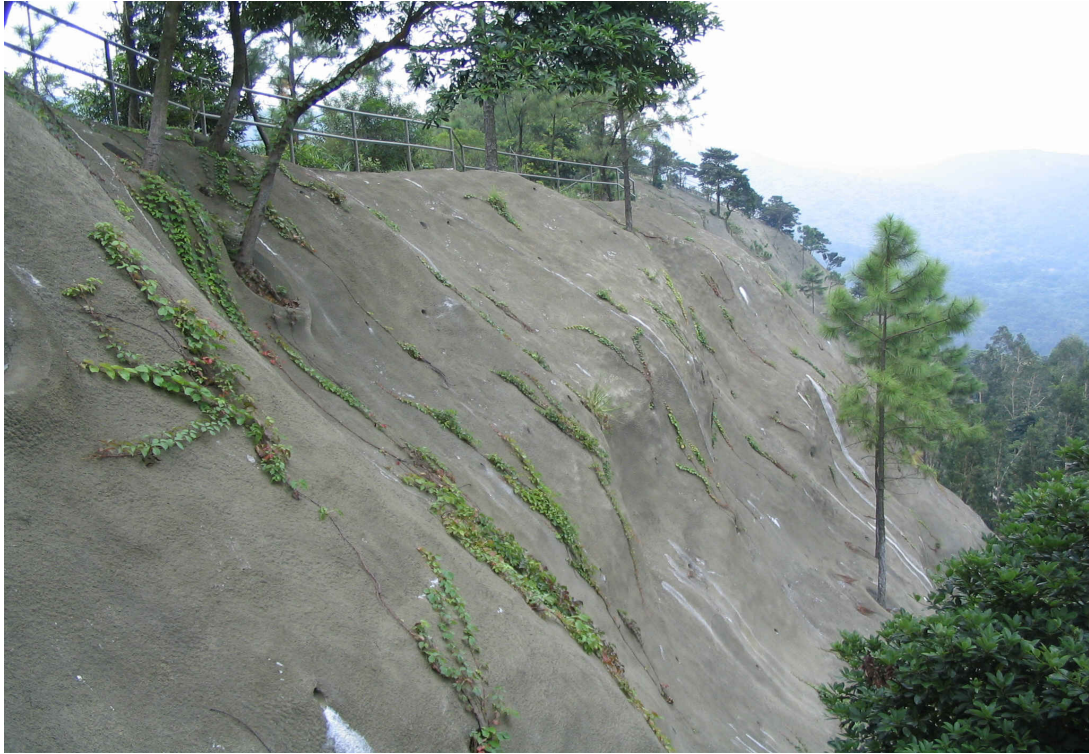
Plate No. 9
General view of the north-eastern portion of the feature

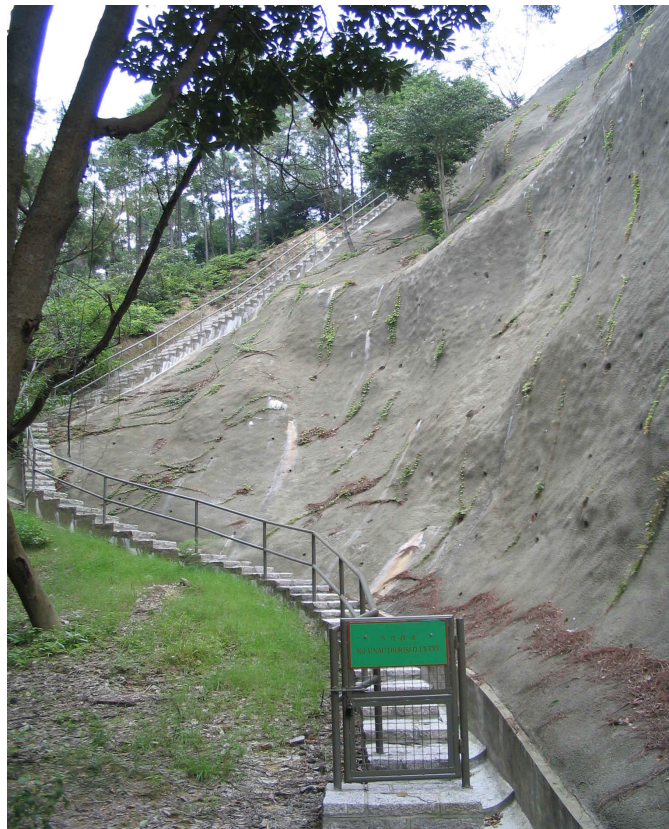
Plate No. 10
View of the north-eastern end of the feature
