Contract No. : EP/SP/52/06
Development of EcoPark in Tuen Mun Area 38

ENVIRONMENTAL MONITORING AND AUDIT

MONTHLY EM&A REPORT for

AUGUST 2006

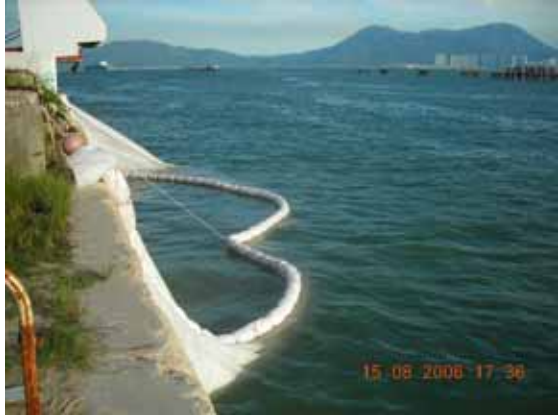
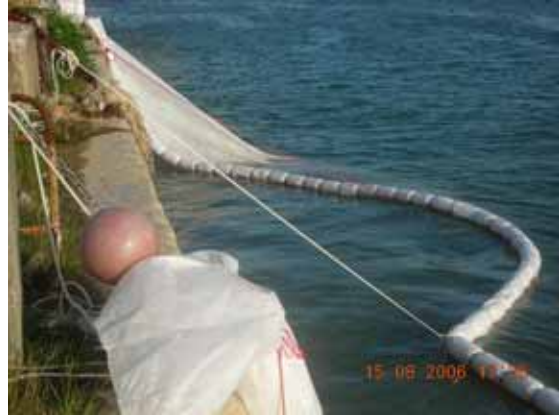
PHOTOS OF SILT CURTAIN AT DISCHARGE POINT

Silted discharge was observed at the Marine Front due to severe weather conditions (typhoon). The Contractor has provided silt removal sand bags at channels to enhance filtering of discharge. Silt curtain was installed at the discharge point at Marine Front, as shown in photos in Appendix 3.

Environmental Protection Department inspected the Site on 04 August 2006 and found that there was inadequate wastewater treatment provided in the Site to meet the requirement of Water Pollution Control Ordinance. The Contractor is reminded to provide the wastewater treatment system such as sedimentation tank for the treatment of silted water.
