SkyCity Golf Course EM&A Monthly Impact Report

March 2006

Report no: 01332R0021

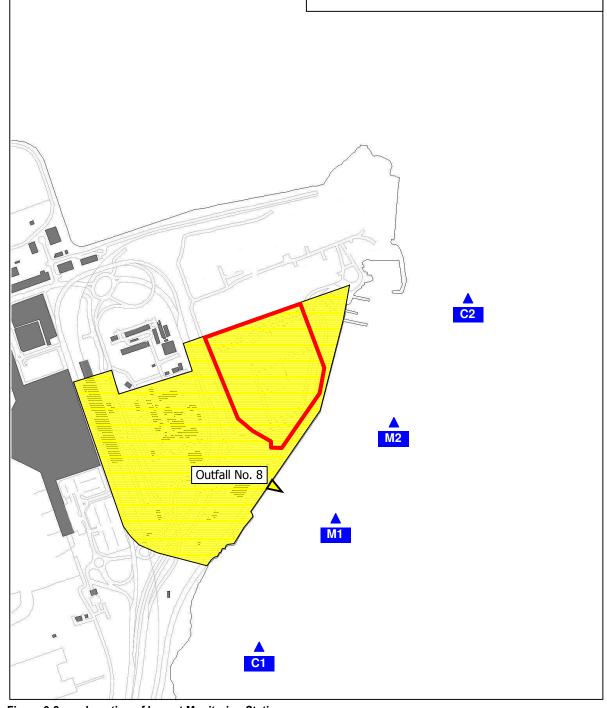
Figure 3-2 Location of Impact Monitoring Stations

Monitoring locations together with grid references are shown in Figure 3-2. Control Stations are designated C1 and C2 and Monitoring Stations are designated M1 and M2.
