SkyCity Nine Eagles Golf Course

Quarterly EM&A Compliance Report

August to October 2011

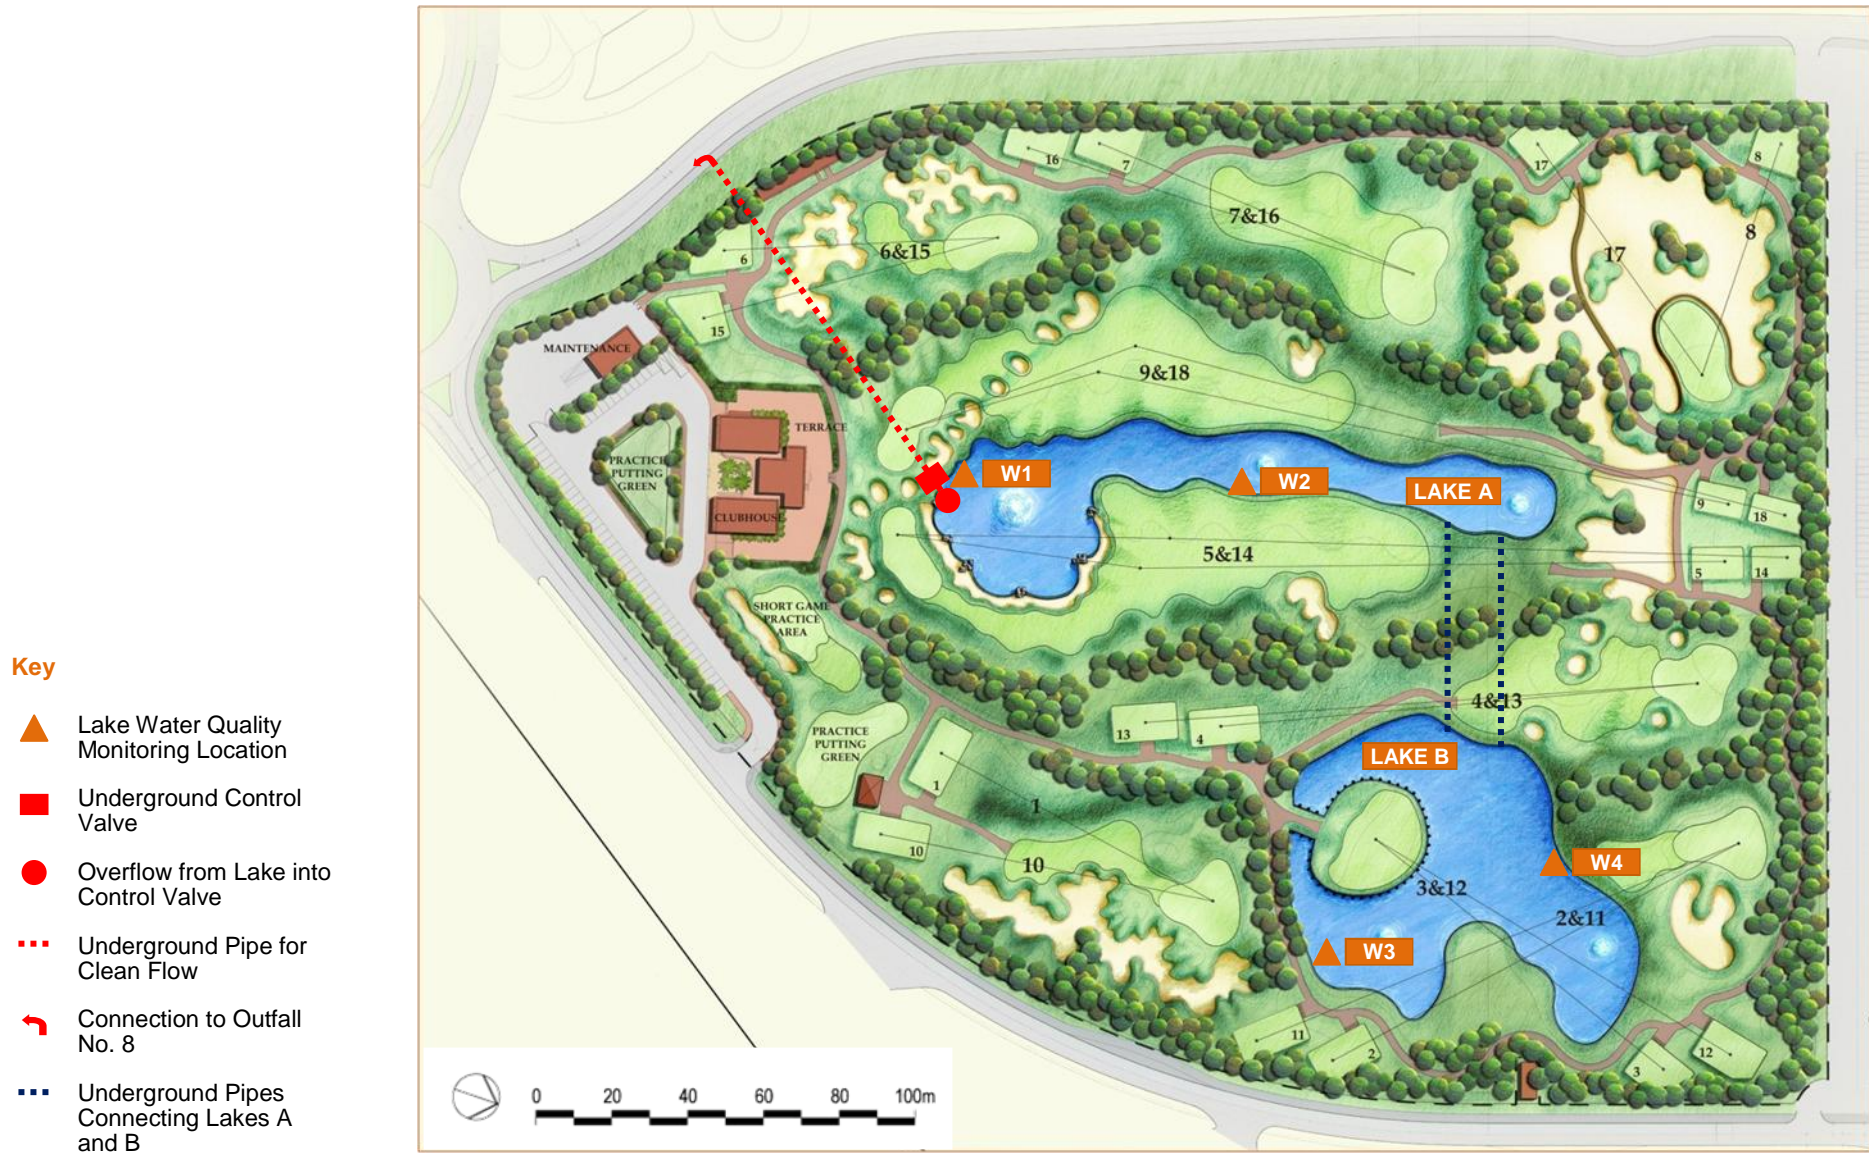
Figure 2-1 Locations for Lake Water Quality Monitoring

In October, there were exceedances of Limit Level for SS at all monitoring locations. There was no exceedance of any other parameters, Therefore, in accordance with the EM&A Manual, the Golf Facility Supervisor was advised that the control valve shall remain closed and there shall be no discharge off-site into the surrounding marine waters until such time as lake water has returned to an acceptable quality.

Based on observation, the exceedances were considered to be due to the continued presence of algae in the water. Algae has grown more quickly in recent months because of higher water temperatures, which have been exacerbated by the black lake liner heating up in direct sunlight and need to reduce lake aeration on the hot windy days to reduce water loss. Water loss has been a problem, with rainfall during the quarter down 60% compared to last year. The lake levels are therefore extremely low, which has further increased the algae concentration.

Bio-Trol has is being applied each month in an attempt to control the algal growth. The application rate will be increased during the next quarter and combined with the expected cooler weather, algal growth will hopefully be reduced in the next quarter.

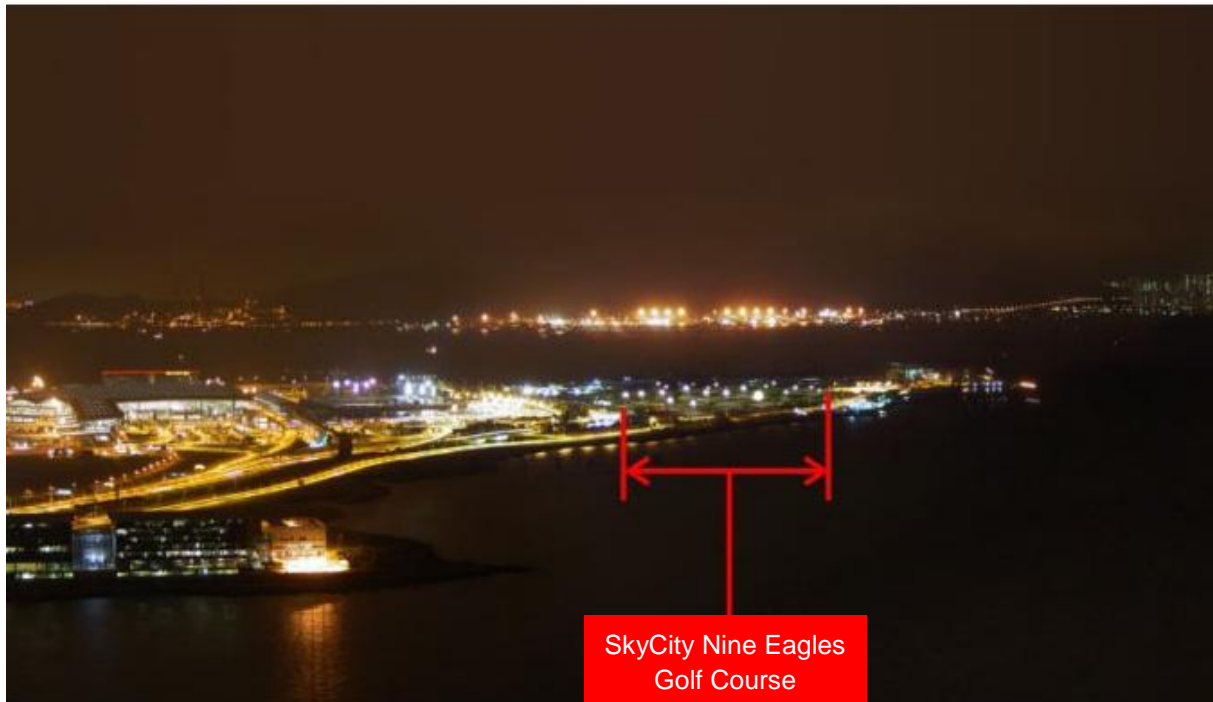
Figure 3-1 Predicted Night-time View from Seaview Crescent, Tung Chung (Excerpt from Figure 3-3 of the Project Profile, July 2005)

- Special Conditions clause 2.9 of Environmental Permit (EP) for the project states: *"Floodlights shall be installed at an angle downwards away from the sensitive receivers including air traffic controllers in the Airport Traffic Control Tower"*
- Section 5.7.2 of the Golf Course Revised Project Profile (which forms part of the EP) states: *".....glare will be avoided by appropriate angling the floodlights onto the course and away from North Lantau New Town and by fixing of visors/louvers to the flood lights to prevent "spillage"....."*

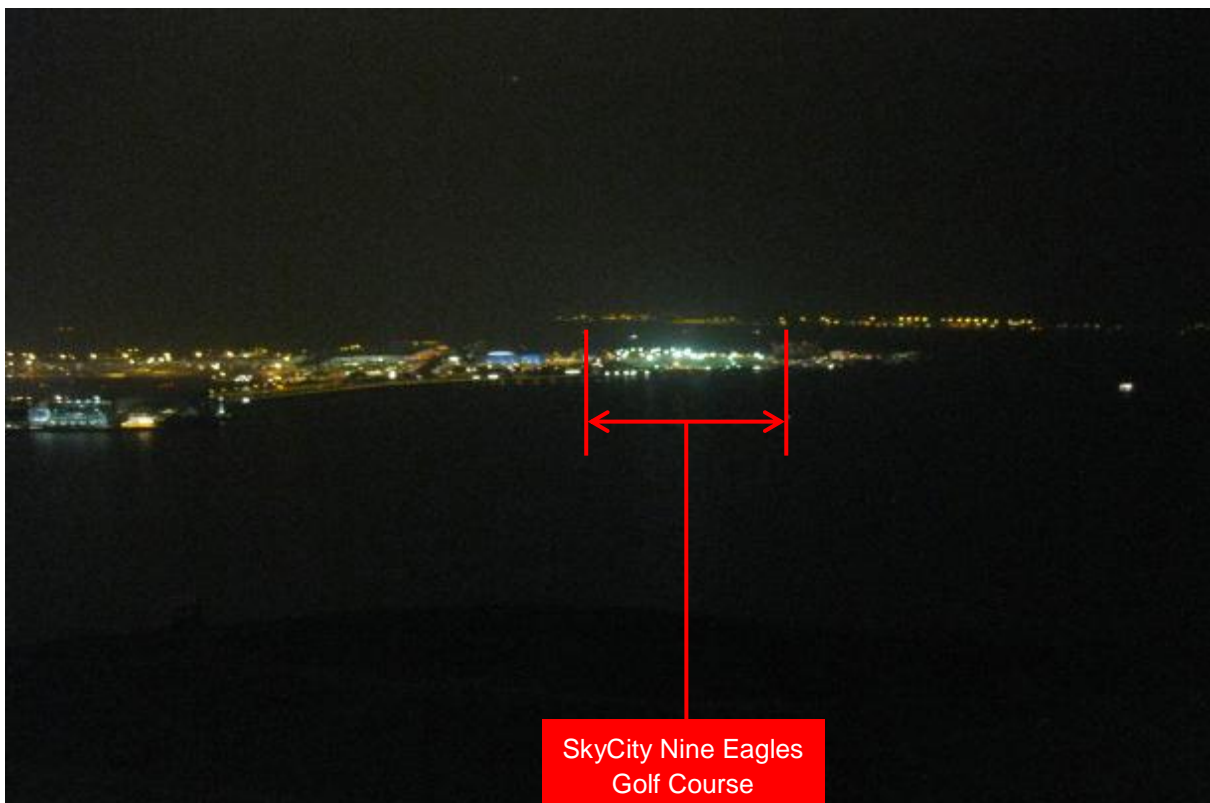
Figure 3-2 Actual Night-time View from Tung Chung, October 2011

During the reporting quarter, a complaint was received from a Tung Chung resident relating to night-time glare from the floodlights at Nine Eagles. Details are as follows:

EPD carried out further investigations on the alleged light pollution from Nine Eagles Golf Course at Tung Chung New Town and found "... the lighting of the golf course is the foremost source of glare on the airport island on Tung Chung residential premises". The Project Proponent also carried out his own investigation of the alleged light pollution.
