# SkyCity Nine Eagles Golf Course

## Quarterly EM&A Compliance Report

November 2011 to January 2012

Project/Deliverable Number:	J481C   D04/05
Project Name:	SkyCity Nine Eagles Golf Course
Report Name:	Quarterly EM&A Compliance Report – November 2011 to January 2012
Report Date:	February 2012
Report for:	Sky City Nine Eagles Golf Course

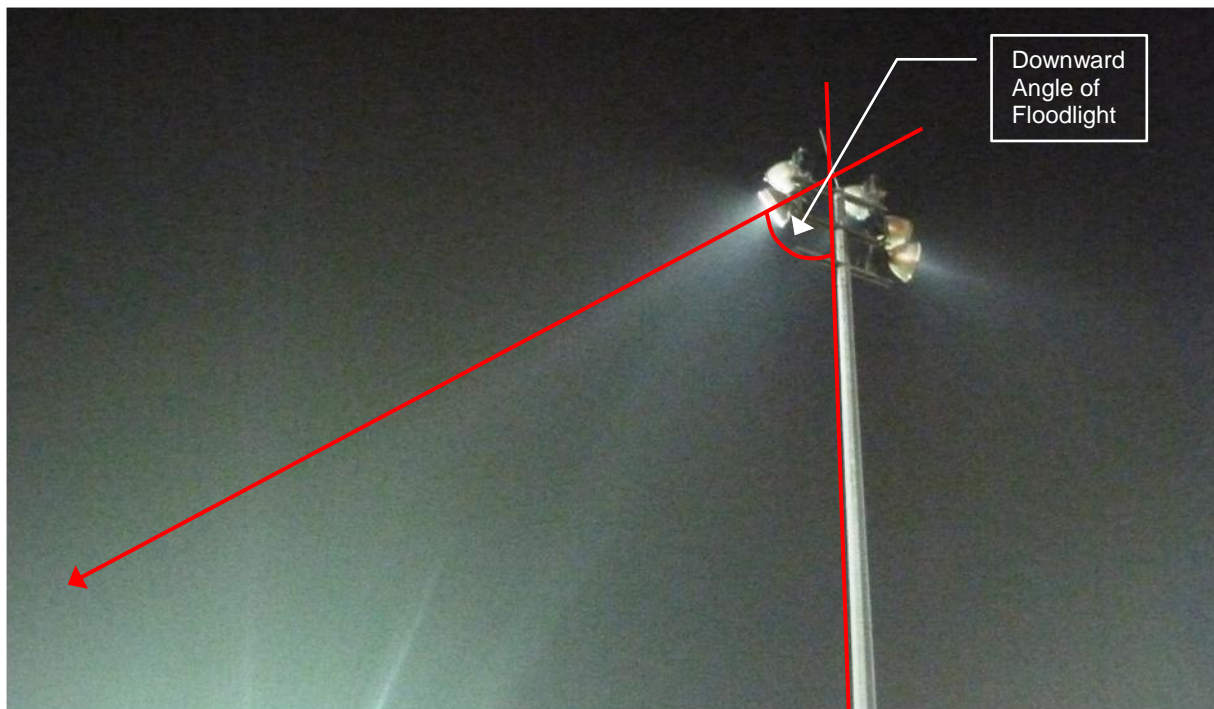
**Figure 3-3** Angle of Typical Floodlight After Re-positioning, 25 November 2011

The group toured the golf course and noted the angle of the floodlighting and also the direction in which the lights were pointing. **Figure 3-3** shows the angle of a typical floodlighting stand (after re-positioning carried out in November) and it can be clearly seen that the floodlights are now angled further towards the golf course. **Figure 3-4** is a view from the golf course towards Tung Chung and clearly shows the floodlights pointing towards the golf course and away from Tung Chung.

Regarding complaint related to night-time glare from the floodlights received in previous quarter, the Golf Course Supervisor adjusted angle of floodlights in order to direct floodlights toward the golf course. No further concerns were received from the complainant or EPD. Based on the reduction of glare achieved by the re-positioning of

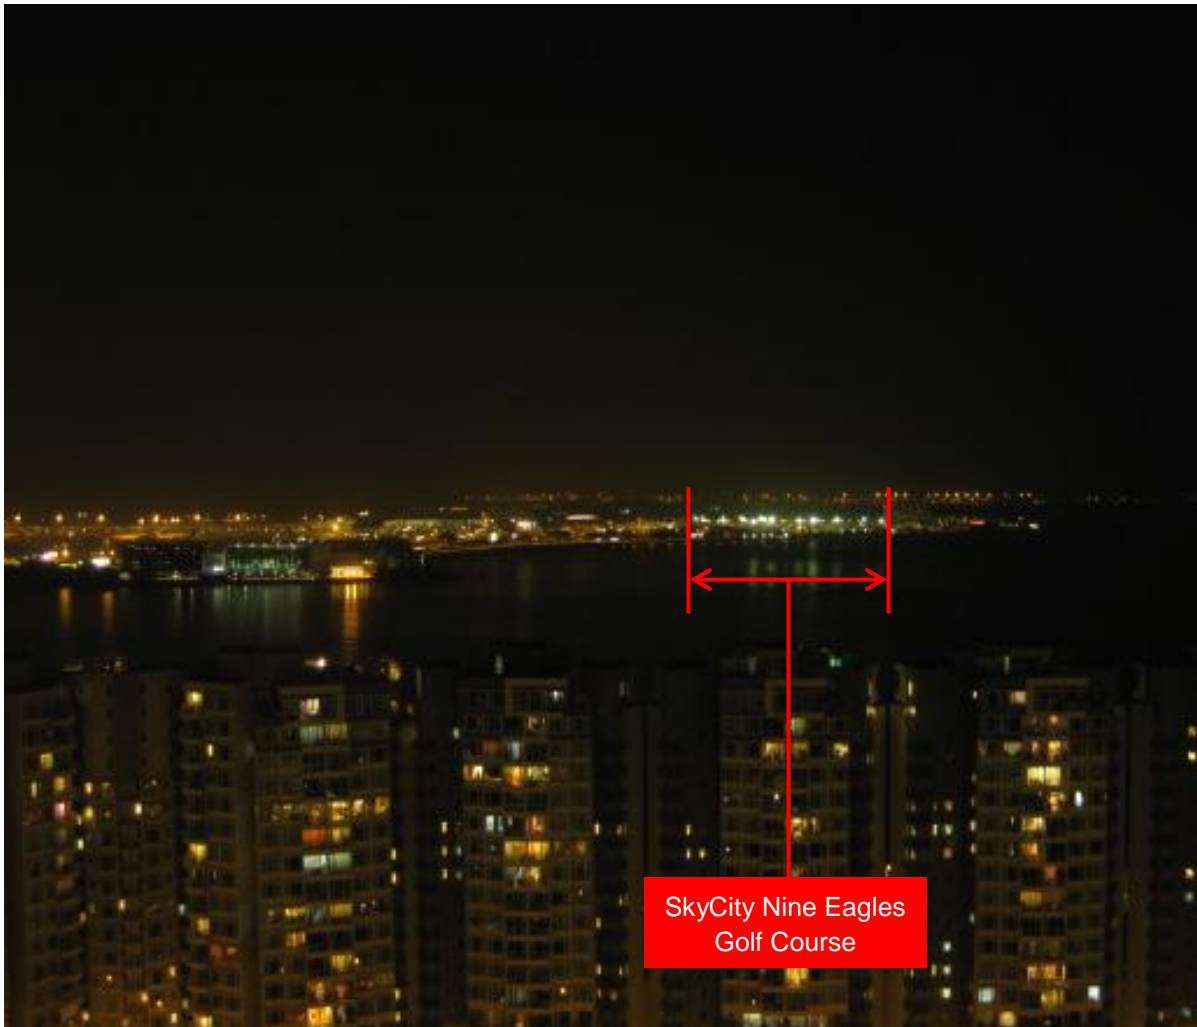
**Figure 3-5** Actual Night-time View from Tung Chung, After Re-positioning of Floodlights, 13 November 2011

the floodlights in November 2011, in response to the complaint, it is considered that the concerns of the complainant and of EPD have been addressed. This complaint is therefore considered to be closed-out.
