PROJECT No.: TCS/00408/08

DSD CONTRACT NO. DC/2007/17
DRAINAGE IMPROVEMENT WORKS IN
CHEUNG PO, MA ON KONG, YUEN KONG SAN TSUEN
AND TIN SAM TSUEN OF YUEN LONG DISTRICT AND
SEWERAGE AT TSENG TAU CHUNG TSUEN, TUEN MUN

MONTHLY EM&A REPORT FOR KT13
(NOVEMBER 2009)

PREPARED FOR
CHINA ROAD & BRIDGE CORPORATION

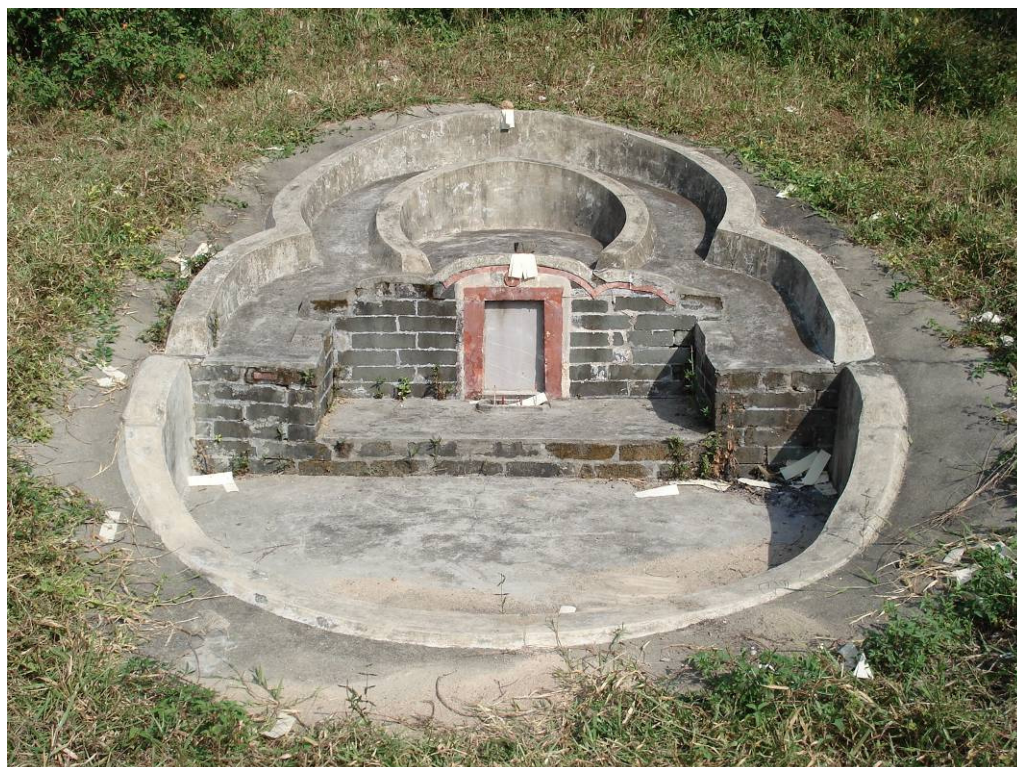
At the time of the monitoring on 31 October 2009, the grave was generally in good condition without weeding problem probably because the descendents of the grave came to sweep and clean the grave during the Chung Yeung Festival a few days prior to the monitoring. *Figure 3.2a* shows the general view of the grave at the time of the site visit.

Figure 3.2a General View (The 'paper money' scattered around the grave proved the descendents just paid a visit to the grave)

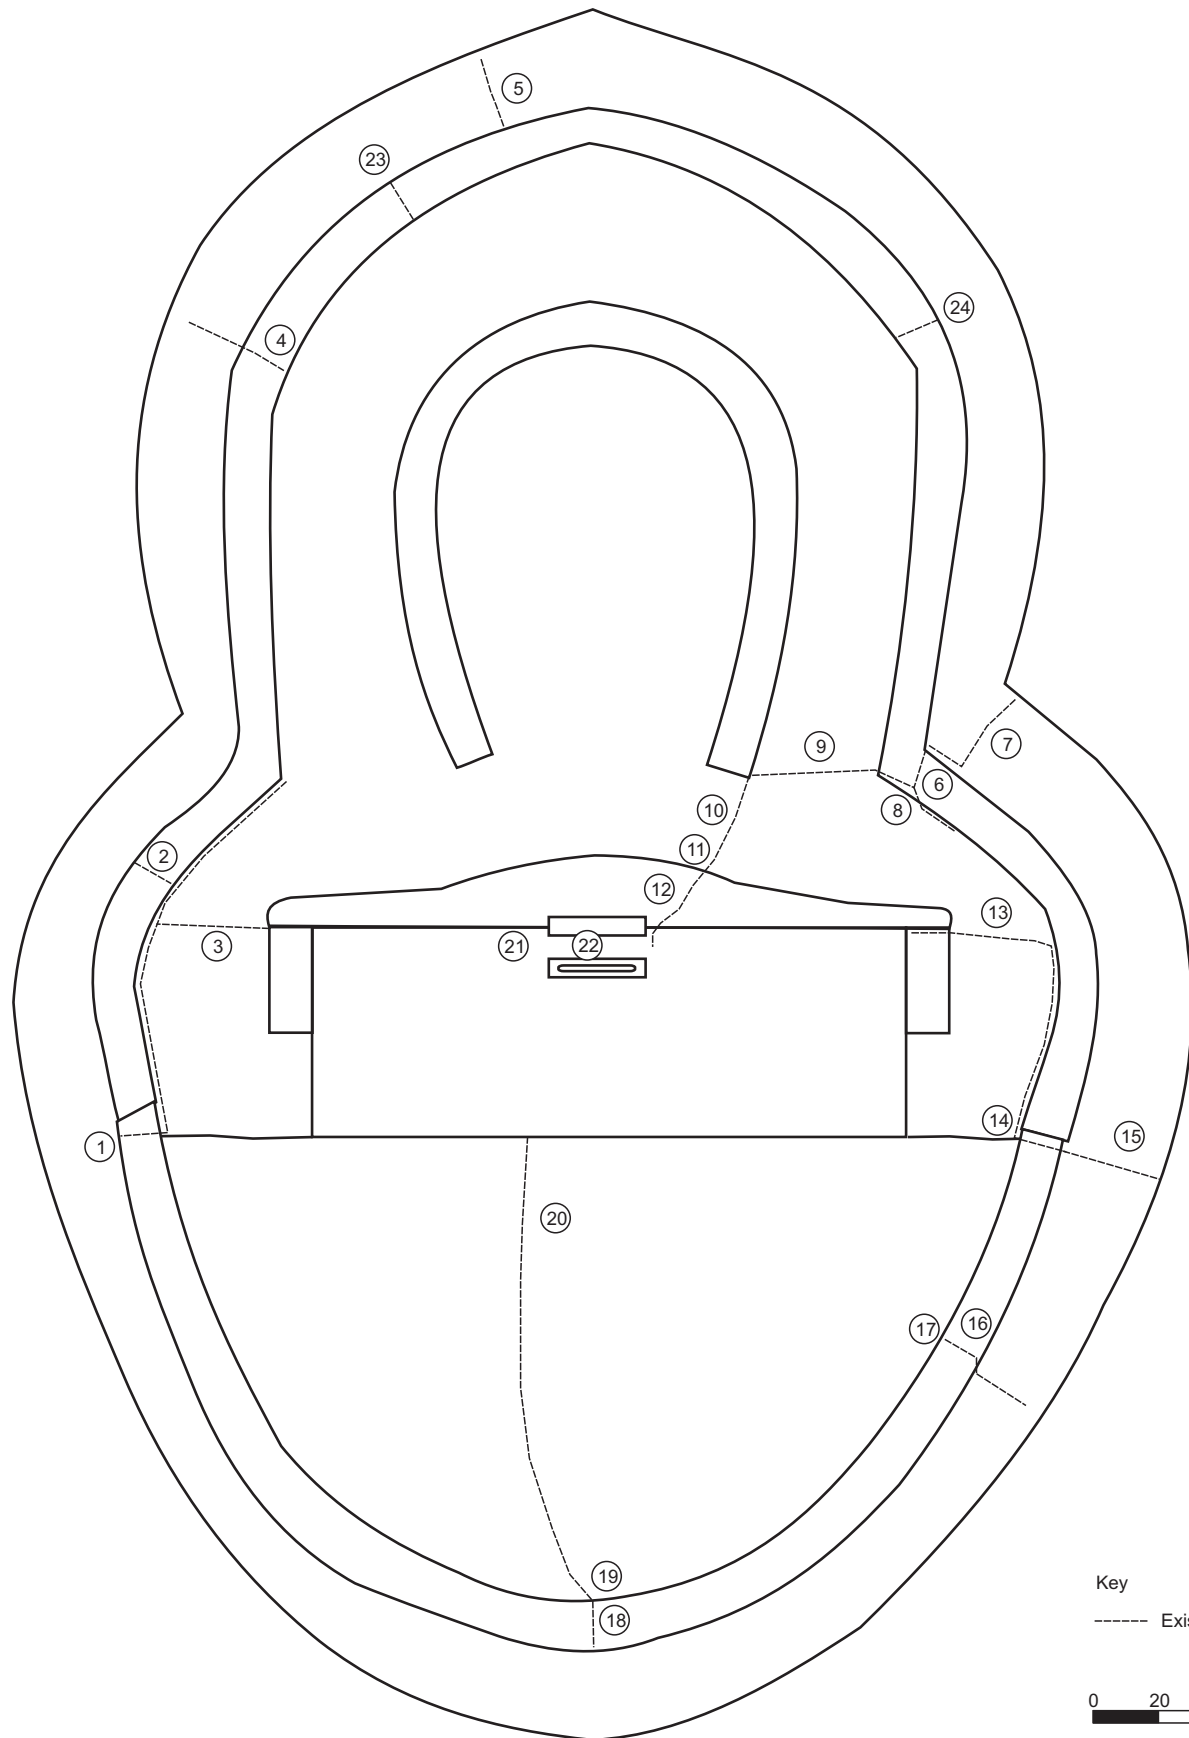
Figure 3.3

Identical to the last condition survey conducted on 31 August 2009, a total of 24 cracks were identified on the cement rendering, mortar of bricks and headstone of the grave. Their locations are shown in *Figure 3.3*. Crack width ranged from hairline to 5.5mm. *Table 3.1* details the cracks identified

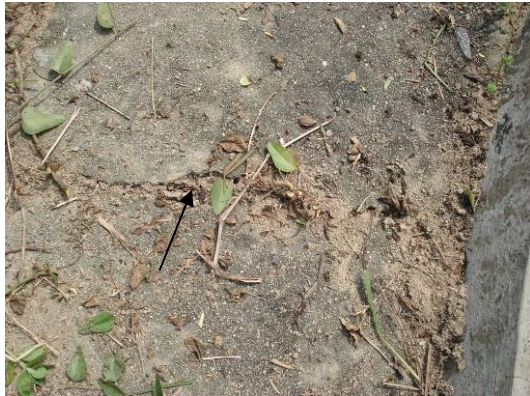
A photograph of a concrete surface with a horizontal crack. A black arrow points to the crack. The crack is wider and more irregular than crack 4.	  A photograph of the same crack in October 2009. The crack shows some slight widening and more irregular edges compared to August.
6	1.6	  A photograph of a concrete surface with a horizontal crack. A black arrow points to the crack. The crack is visible and appears to be in a similar state to August.	  A photograph of the same crack in October 2009. The crack is still visible and appears to have remained stable.

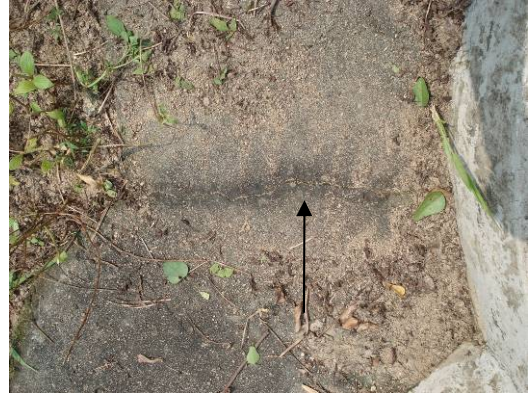
7	1.6

A photograph of a concrete surface with a horizontal crack. A black arrow points to the crack. The crack is visible and appears to be in a similar state to August.

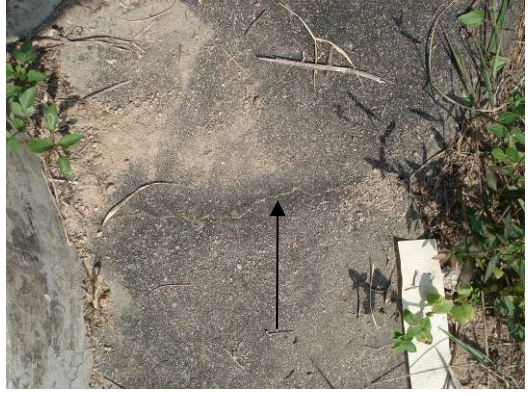
A photograph of the same crack in October 2009. The crack is still visible and appears to have remained stable.

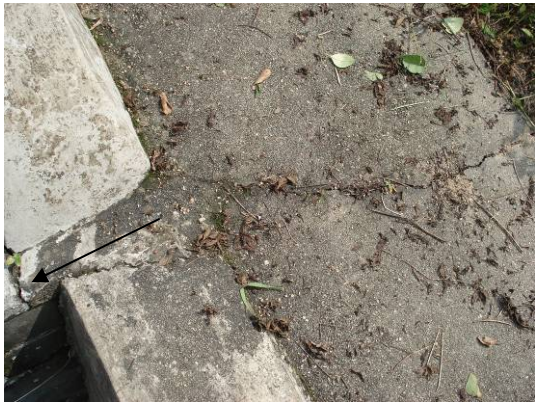
Crack No.	Crack Width (mm)	Photographic Record	
		Condition Survey Undertaken in August 2009	Condition Survey Undertaken in October 2009
14	1.3

A photograph showing a crack in a concrete curb. A black arrow points to the crack. The crack is approximately 1.3 mm wide. The surrounding area is covered with dry leaves and debris.

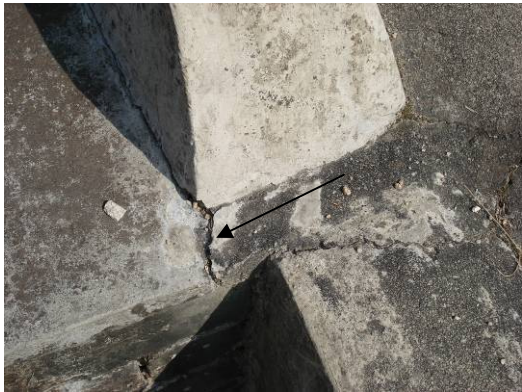
A photograph showing the same crack in the concrete curb as in August 2009. A black arrow points to the crack. The crack appears slightly wider and more pronounced.
15	2

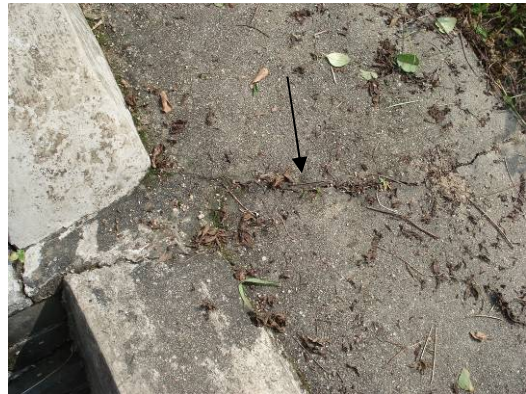
A photograph showing a crack in a concrete curb. A black arrow points to the crack. The crack is approximately 2 mm wide. The surrounding area is covered with dry leaves and debris.

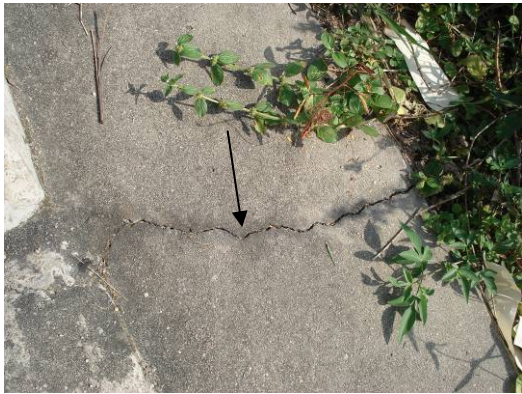
A photograph showing the same crack in the concrete curb as in August 2009. A black arrow points to the crack. The crack appears slightly wider and more pronounced.
16	1.7

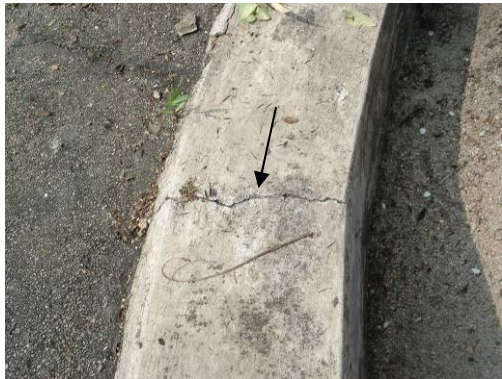
A photograph showing a crack in a concrete curb. A black arrow points to the crack. The crack is approximately 1.7 mm wide. The surrounding area is covered with dry leaves and debris.

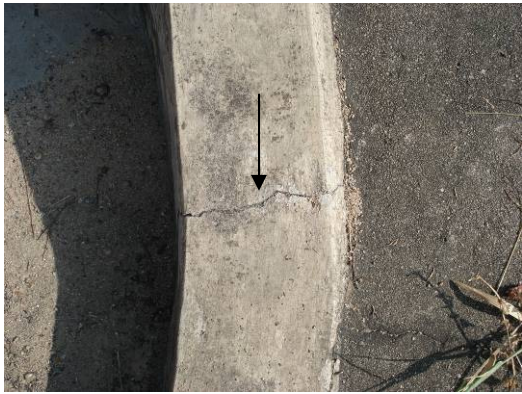
A photograph showing the same crack in the concrete curb as in August 2009. A black arrow points to the crack. The crack appears slightly wider and more pronounced.

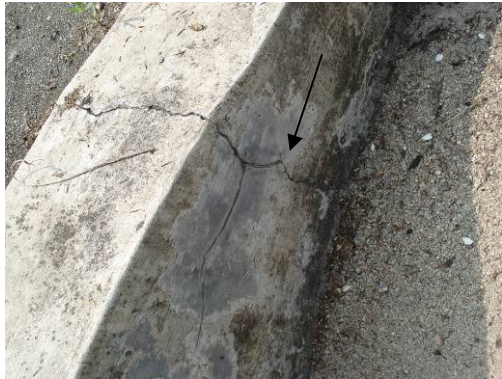
17	1.6

A photograph showing a crack in a concrete curb. A black arrow points to the crack. The crack is approximately 1.6 mm wide. The surrounding area is covered with dry leaves and debris.

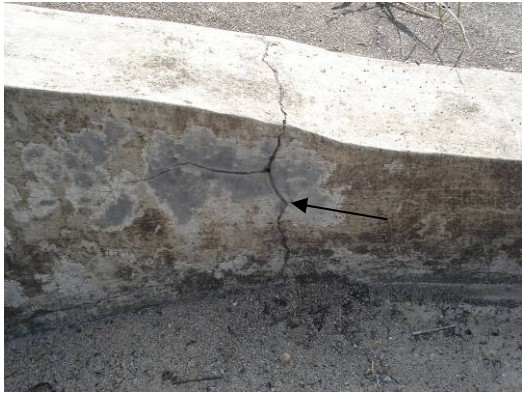
A photograph showing the same crack in the concrete curb as in August 2009. A black arrow points to the crack. The crack appears slightly wider and more pronounced.

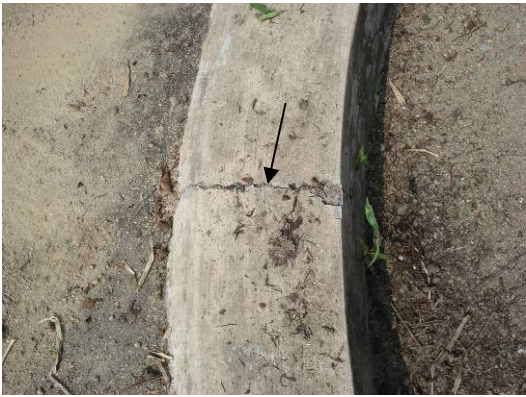
Crack No.	Crack Width (mm)	Photographic Record	
		Condition Survey Undertaken in August 2009	Condition Survey Undertaken in October 2009
18	2

A photograph showing a wide, horizontal crack in a concrete curb. A black arrow points to the crack. The crack is approximately 2 mm wide and runs across the width of the curb. The surrounding concrete is light-colored and shows some surface wear.	  A photograph showing the same crack in the concrete curb as in August 2009. A black arrow points to the crack. The crack appears slightly wider and more irregular in shape compared to the August survey.
19	0.1	  A photograph showing a narrow, horizontal crack in a concrete curb. A black arrow points to the crack. The crack is approximately 0.1 mm wide and runs across the width of the curb. The surrounding concrete is light-colored and shows some surface wear.	  A photograph showing the same crack in the concrete curb as in August 2009. A red arrow points to the crack. The crack appears slightly wider and more irregular in shape compared to the August survey.

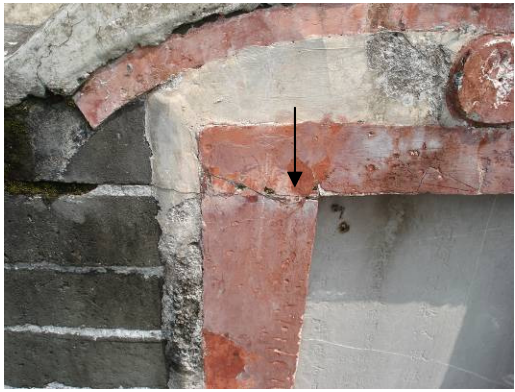
Crack No.	Crack Width (mm)	Photographic Record	
		Condition Survey Undertaken in August 2009	Condition Survey Undertaken in October 2009
21	0.5

A close-up photograph of a crack in a concrete structure. The crack is located at the top of a vertical concrete pillar, where it meets a horizontal concrete beam. The crack is approximately 0.5 mm wide. A black arrow points to the crack. The surrounding concrete is reddish-brown and shows signs of weathering.

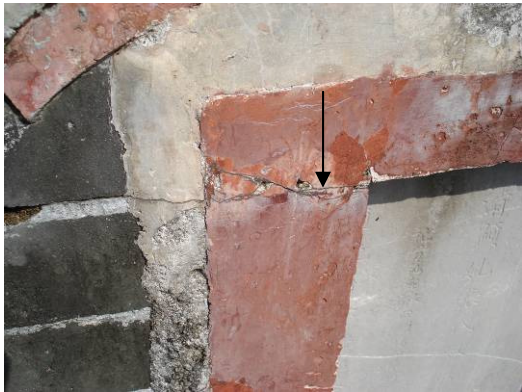
A close-up photograph of the same crack in the concrete structure. The crack is still present and appears to be the same width as in August. A black arrow points to the crack. The surrounding concrete is reddish-brown and shows signs of weathering.
22	Hair-line

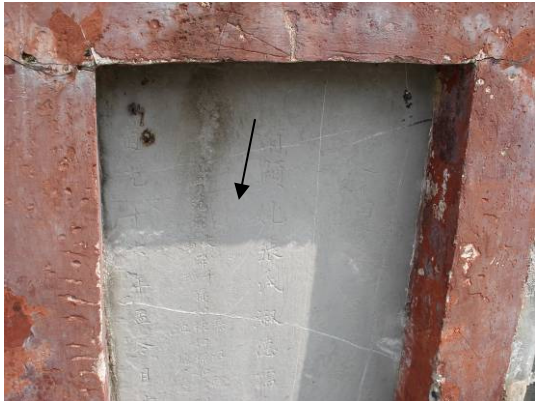
A photograph of a hair-line crack in a concrete wall. The crack is located in the center of a vertical concrete pillar. A black arrow points to the crack. The surrounding concrete is reddish-brown and shows signs of weathering.

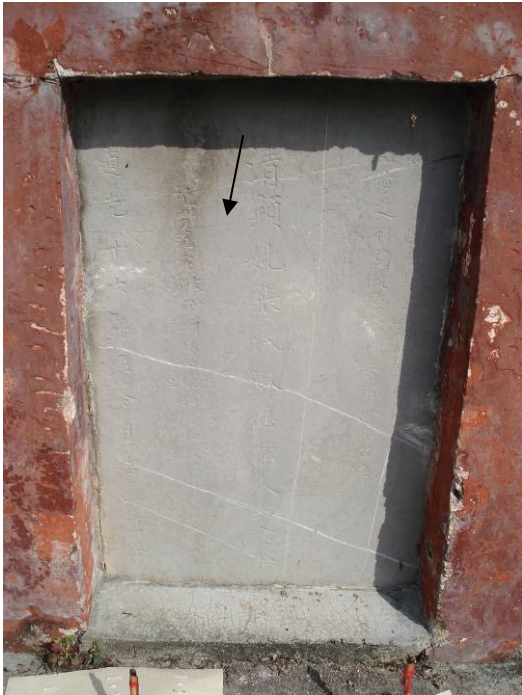
A photograph of the same hair-line crack in the concrete wall. The crack is still present and appears to be the same width as in August. A black arrow points to the crack. The surrounding concrete is reddish-brown and shows signs of weathering.

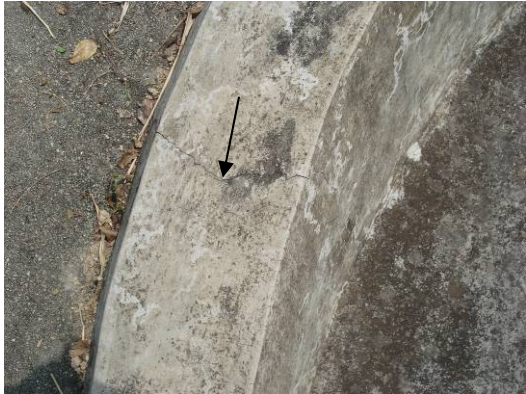
23	Hair-line

A photograph of a hair-line crack in a concrete wall. The crack is located in the center of a vertical concrete pillar. A black arrow points to the crack. The surrounding concrete is reddish-brown and shows signs of weathering.

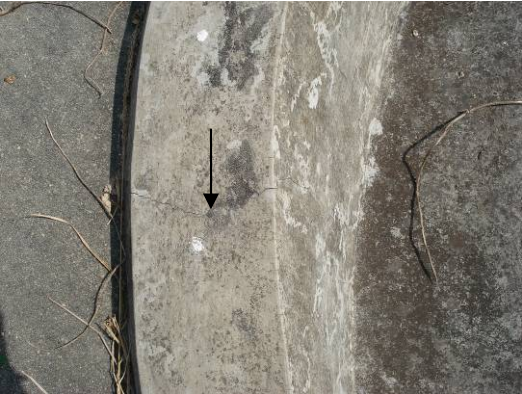
A photograph of the same hair-line crack in the concrete wall. The crack is still present and appears to be the same width as in August. A black arrow points to the crack. The surrounding concrete is reddish-brown and shows signs of weathering.

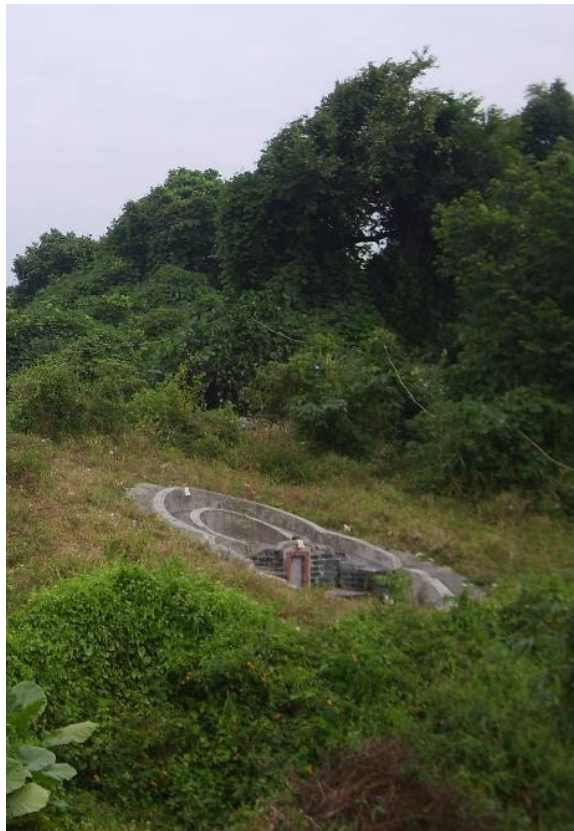
Figure 3.2b Dense Vegetation Around the Historic Grave

During this survey, no new significant cracks were identified and no existing cracks were observed to have been widened. However, some micro-hairline cracks were identified on the grave. The cracks were tiny surface rendering cracks which were so insignificant that they could only be seen in close distance and would not induce structural damage to the grave. Although the construction work of the Contract had started within 100m area from the grave, in view of the surrounding dense vegetation and the grave being exposed (see *Figure 3.2b*), these cracks are likely to be caused by weathering (such as raining, intermittent heating and cooling) or root encroachment of overgrown vegetation (e.g. Crack No. 5).

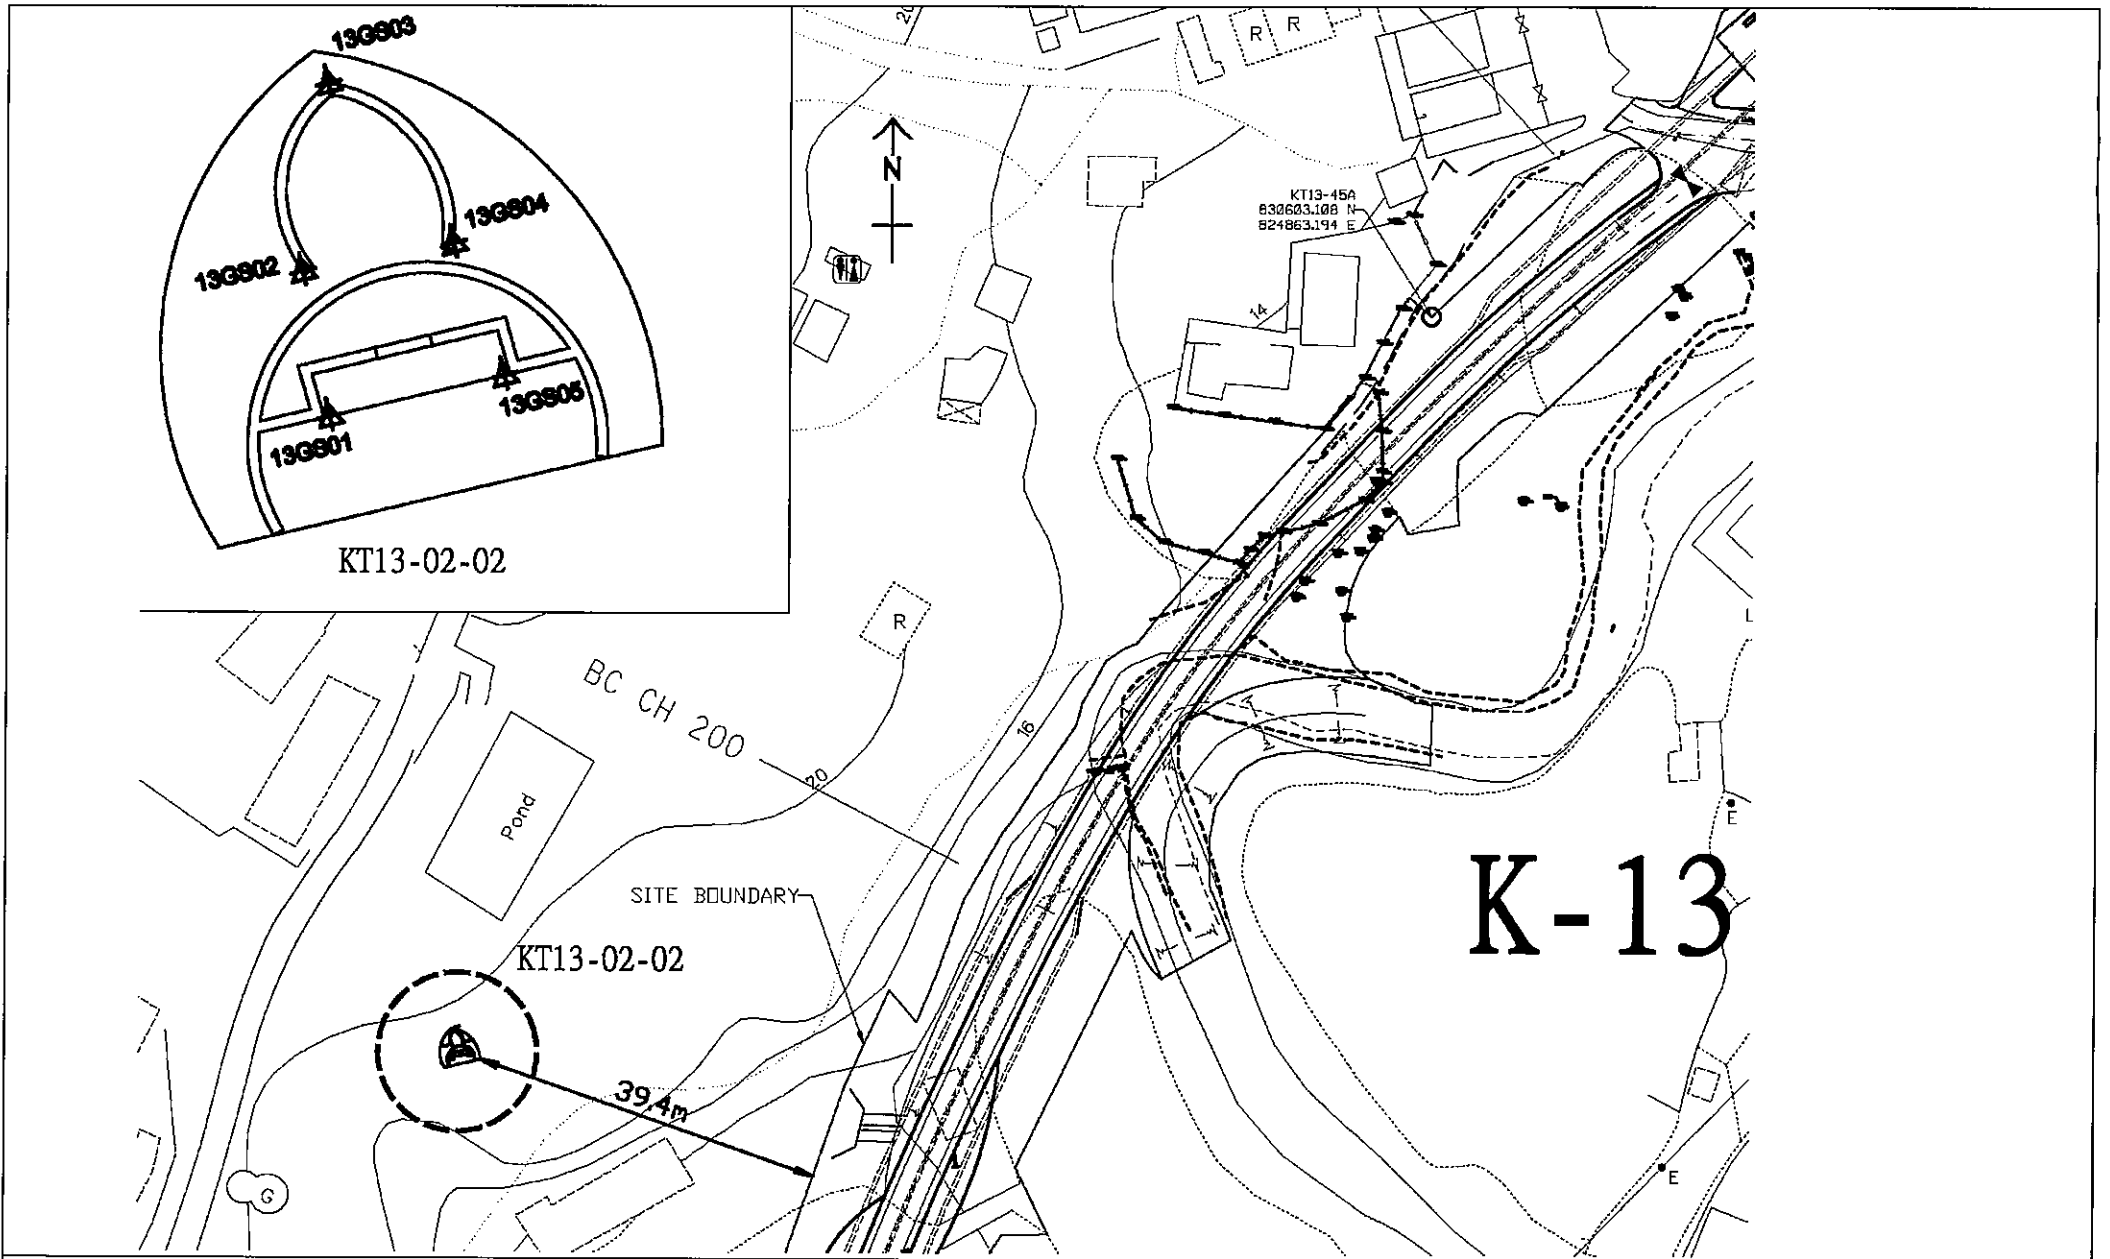
Figure 3.4

Apart from these cracks, no major signs of settlement of the foundations or structural cracks were identified. In order to establish the baseline condition of the grave for monitoring of potential ground settlement, five settlement markers (13GS01 to 13GS05) were established (without damaging the physical grave) to record the coordinates and elevations of the grave (see *Figure 3.4*). The recorded points are presented in the *Table 3.2*.

Point	Northing	Easting	Elevation (mPD) Initial Reading (Taken on 31 August 2009)	Elevation (mPD) Updated Reading (Taken on 31 October 2009)	Difference (mm)
13GS01	830520.25	824754.57	19.222	19.222	0
13GS02	830521.54	824754.32	19.985	19.987	2
13GS03	830523.21	824754.54	20.644	20.643	-1
13GS04	830521.79	824755.67	19.943	19.943	0
13GS05	830520.61	824756.12	19.211	19.210	-1
