PROJECT No.: TCS/00408/08

DSD CONTRACT NO. DC/2007/17
DRAINAGE IMPROVEMENT WORKS IN
CHEUNG PO, MA ON KONG, YUEN KONG SAN TSUEN
AND TIN SAM TSUEN OF YUEN LONG DISTRICT AND
SEWERAGE AT TSENG TAU CHUNG TSUEN, TUEN MUN

MONTHLY EM&A REPORT FOR KT13
(FEBRUARY 2010)

PREPARED FOR
CHINA ROAD & BRIDGE CORPORATION

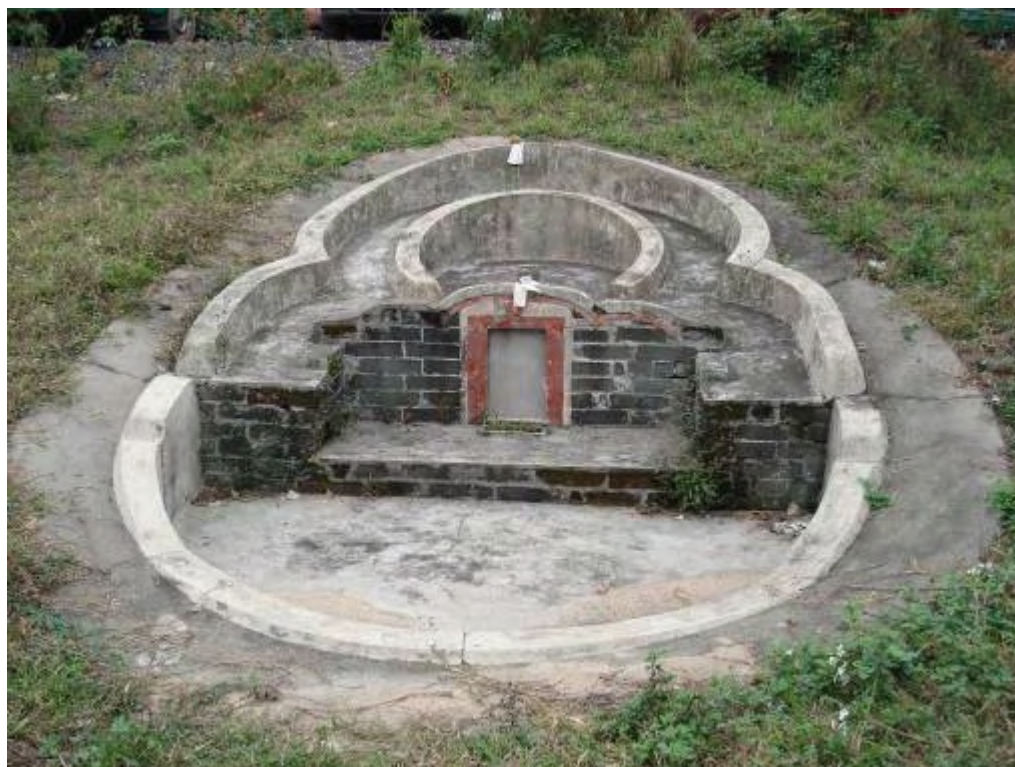
Figure 3.2a Front View

At the time of the monitoring on 9 January 2010, the grave was generally in good condition with little weeding problem. *Figure 3.2a* shows the general view of the grave at the time of the site visit.

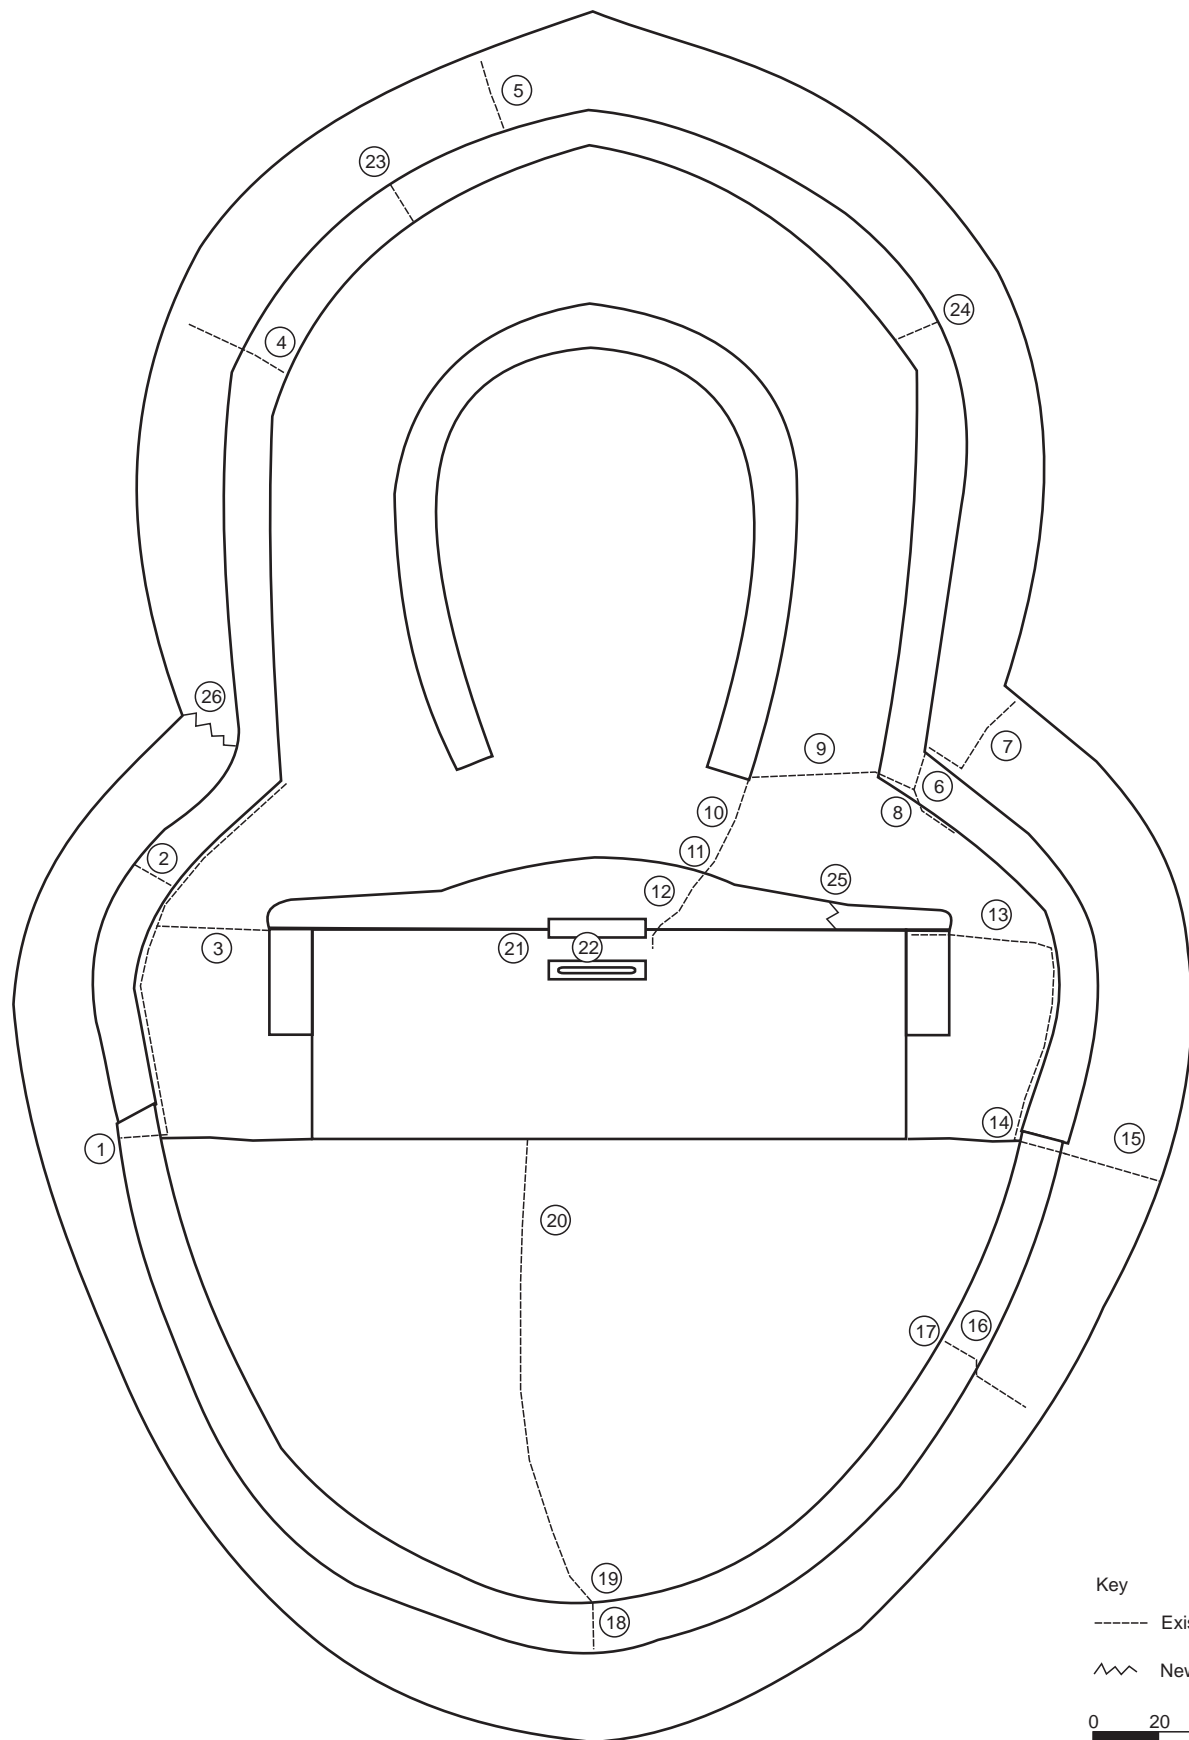
Figure 3.3

A total of 26 cracks (two of which were believed to happen just recently) were identified on the cement rendering, mortar of bricks and headstone of the grave. Their locations are shown in *Figure 3.3*. Crack width ranged from hairline to 5.5mm. *Table 3.1* details the cracks identified on the grave photographically and compares the cracks identified during last condition survey and those in this survey.

Plan of the Historic Grave Showing Existing Cracks
(as at 9 January 2010)

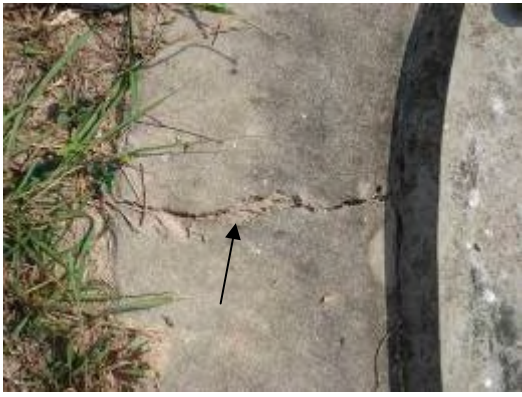
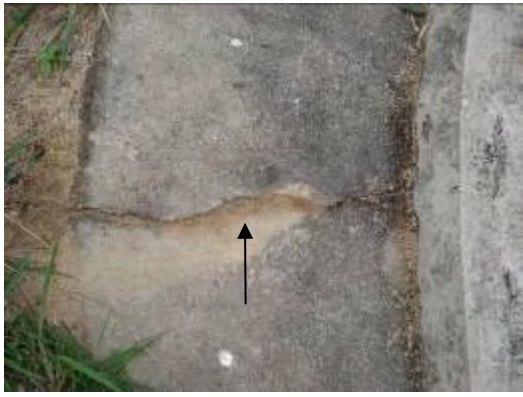
| Crack No. | Crack Width (mm) | Photographic Record | |
|---|---|---|---|
| 5 | 5.5 | | |

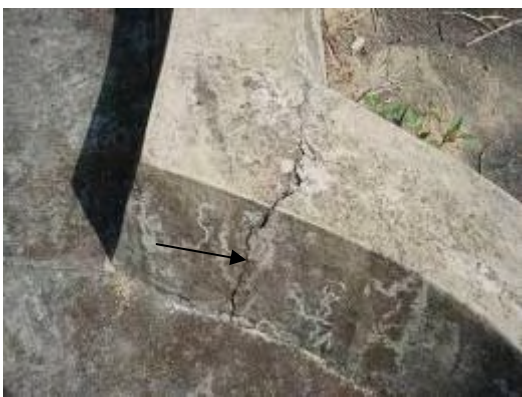
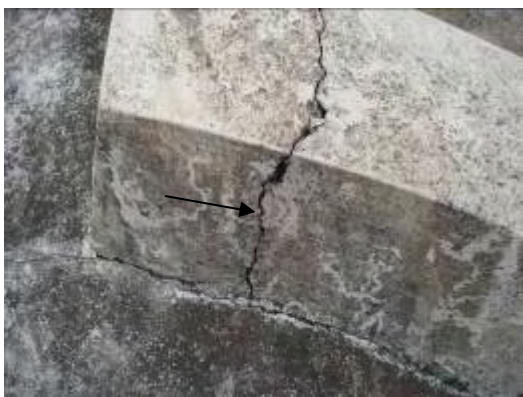
| Crack No. | Crack Width (mm) | Photographic Record | |
|---|---|---|---|
| 8 | Previous Width: 1.2 New Width: 1.5 | | |

During this survey, two new cracks (i.e. Crack Nos. 25 and 26) were identified and two existing cracks were observed to have been widened (e.g. Crack Nos. 4 and 8). However, the remaining cracks are micro-hairline cracks which were tiny surface rendering cracks that they could only be seen in close distance and would not induce structural damage to the grave. In view of the surrounding dense vegetation and the grave being exposed, existing cracks are likely to be intensified by weathering (such as raining, intermittent heating and cooling) or root encroachment of overgrown vegetation. Furthermore, it was reported that a platform was being built by an unknown third party at north of the grave without prior notice on 4 and 5 November

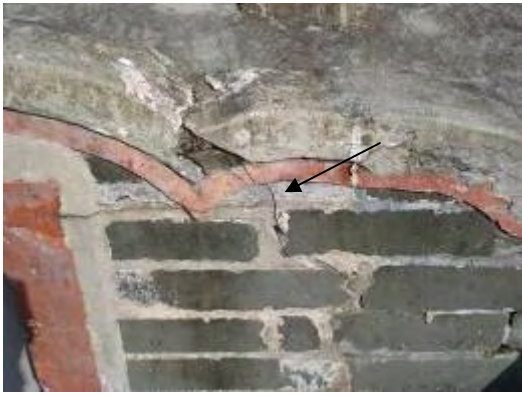
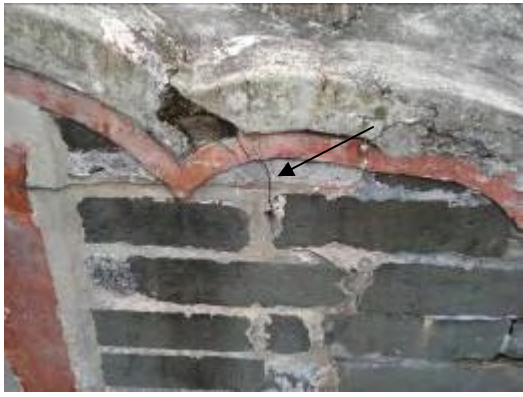
| Crack No. | Crack Width (mm) | Photographic Record | |
|---|---|---|---|
| 12 | 1.6 | A photograph showing a crack in a concrete structure with a red-painted surface. An arrow points to the crack. | A photograph showing the same crack in the same structure, with an arrow pointing to it. |

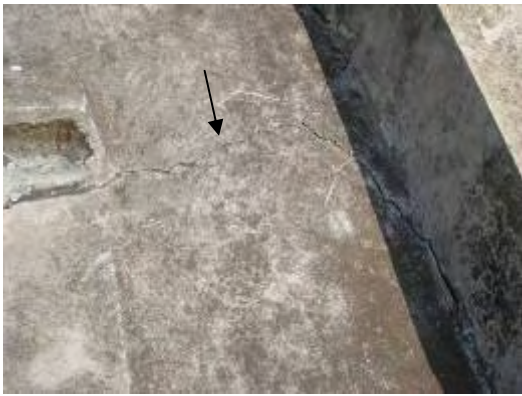
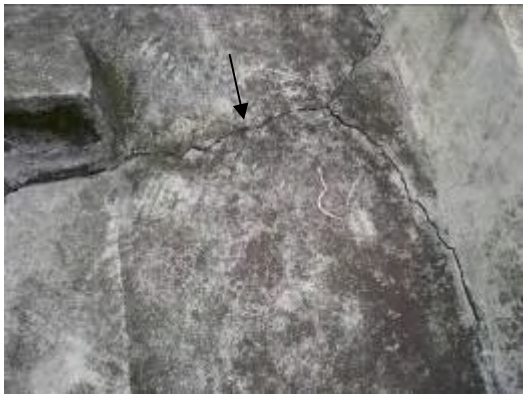
| Crack No. | Crack Width (mm) | Photographic Record | |
|---|---|---|---|
| 13 | 2.9 | A photograph showing a crack in a concrete surface. An arrow points to the crack. | A photograph showing the same crack in the same surface, with an arrow pointing to it. |

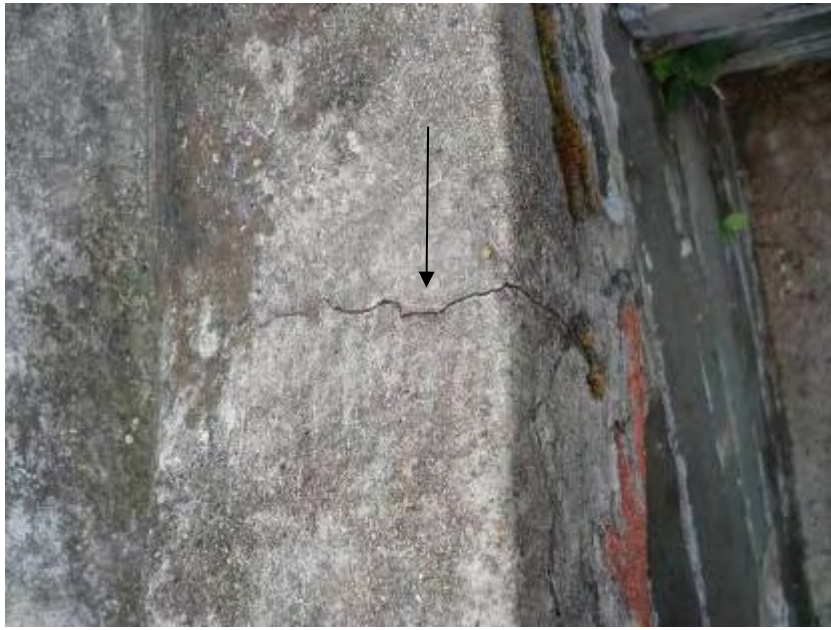
| Crack No. | Crack Width (mm) | Photographic Record | |
|---|---|---|---|
| 25 | Hair-line | | |

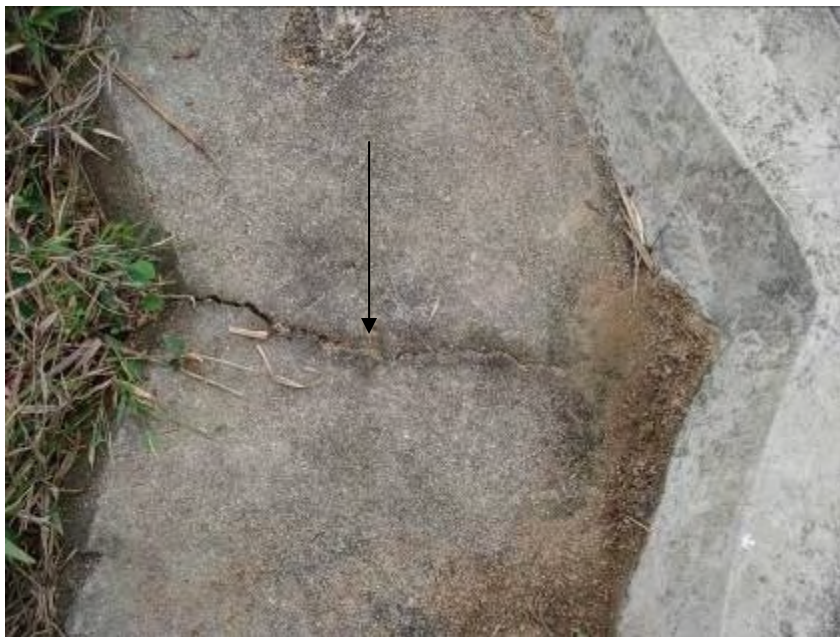
| Crack No. | Crack Width (mm) | Photographic Record | |
|---|---|---|---|
| 26 | 1 | | |

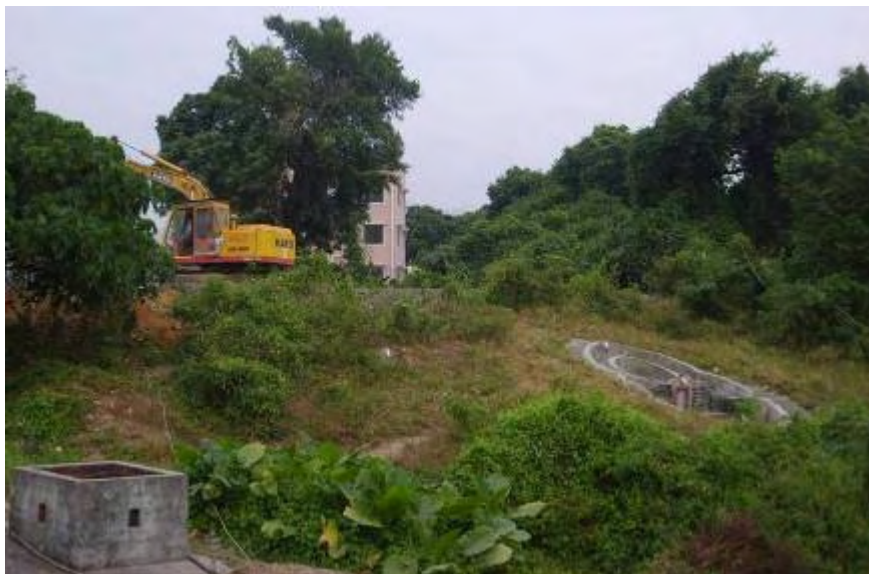
2009. Such site clearance and construction activities were in close proximity to the grave (approximately 3m) and excavator was used (*Figure 3.2b*). Moreover, it was observed that vehicles were parked on the newly built platform at the time of monitoring on 9 January 2010 (*Figure 3.2c*). As such, the additional cracks being found in this survey (i.e. Crack Nos. 25 and 26) are believed to be triggered by these recent human activities. *Figures 3.2d* and *3.2e* show the views of the platform used as car park.

Figure 3.2b A platform was being constructed adjacent to the grave with an excavator moving around it (photo taken on 4 Nov 2009).

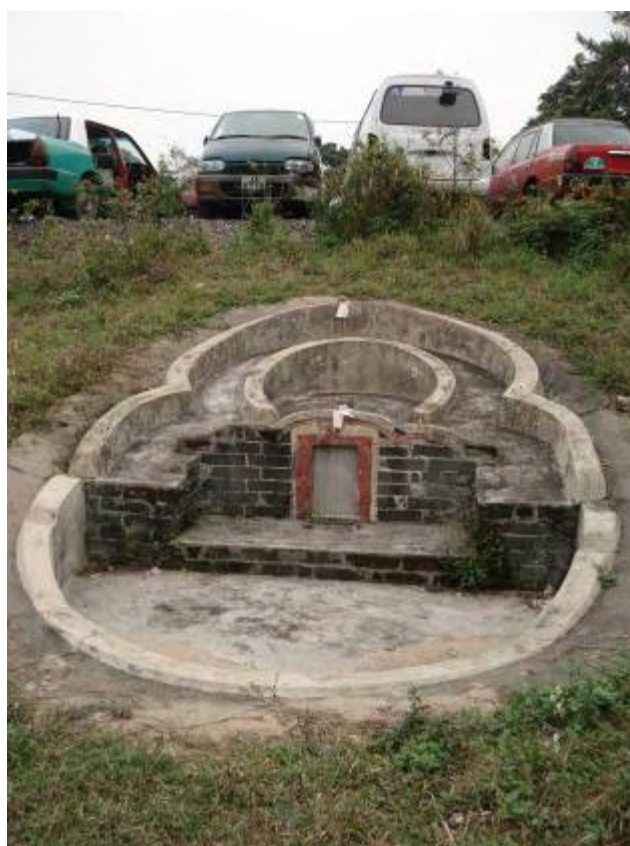
Figure 3.2c The grave is situated very near the newly built platform (photo taken on 9 January 2010)

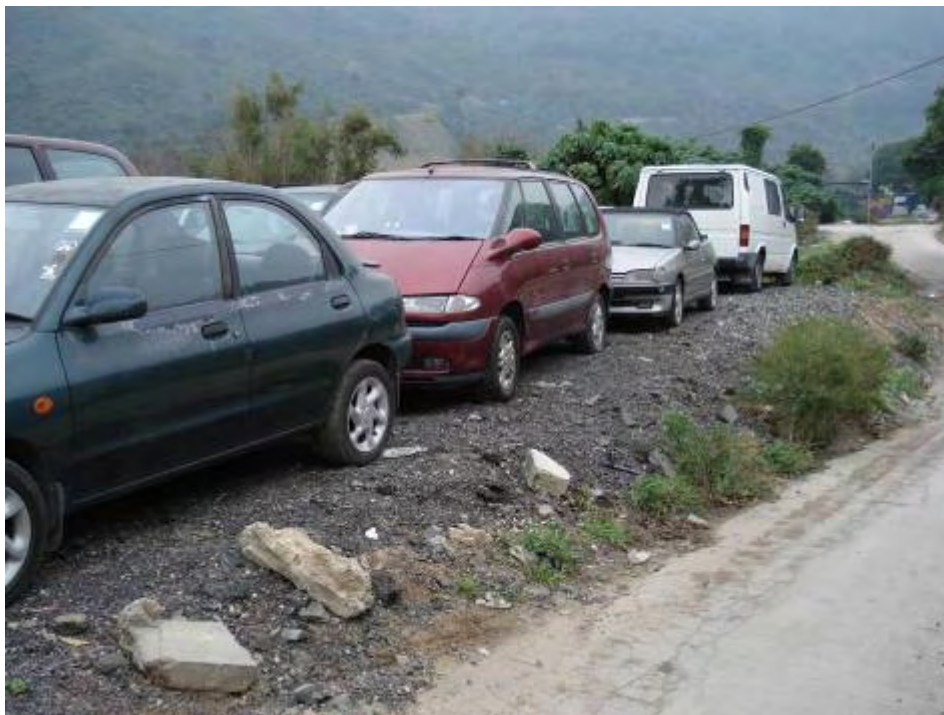
Figure 3.2d Front view of the platform used as a temporary car park adjacent to the road near the grave (photo taken on 9 Jan 2010).

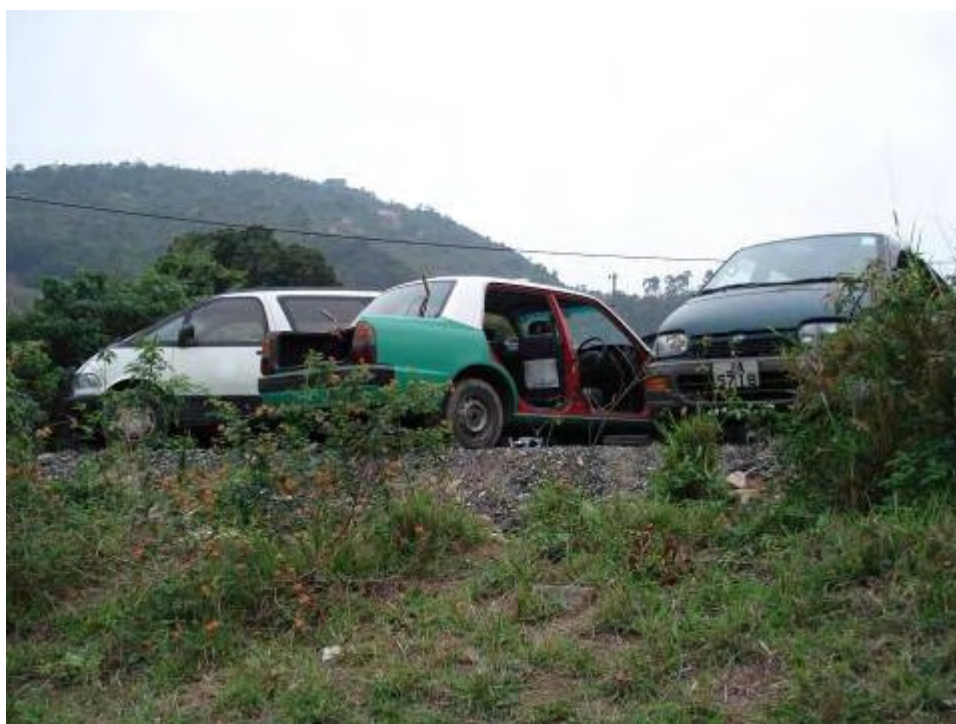
Figure 3.2e Rear view of the platform used as a temporary car park above the grave (photo taken on 9 Jan 2010).

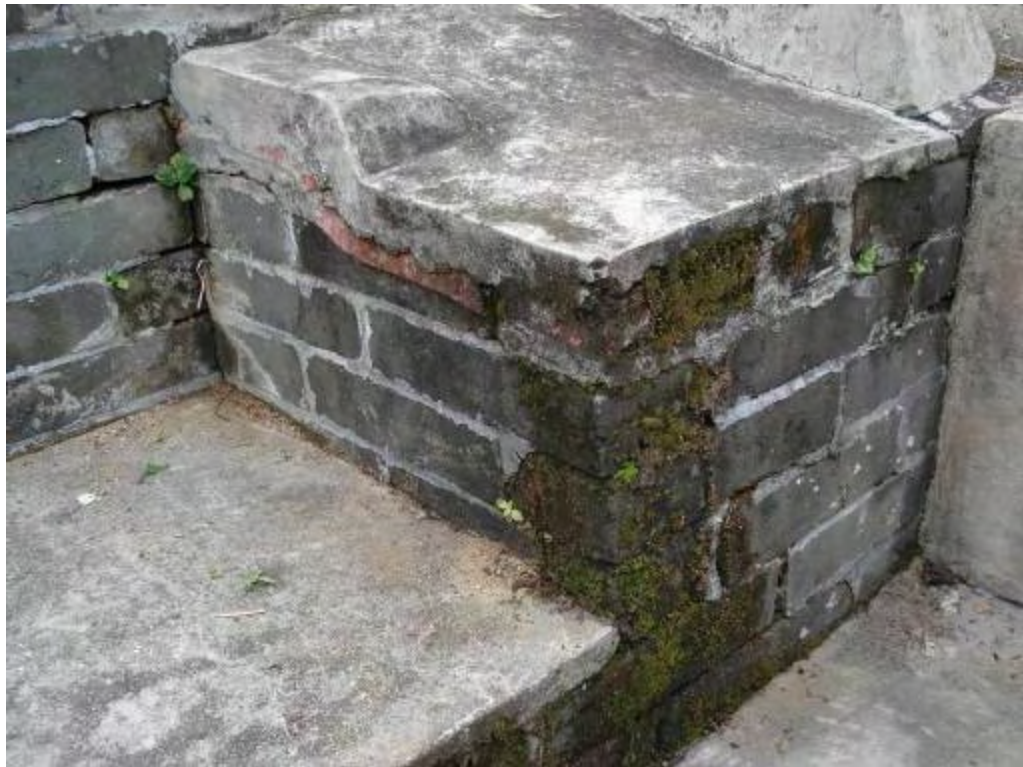
Apart from the cracks on cement rendering mentioned above, the cracks on the cement mortar of bricks of the grave have also been observed. It is also noted that some cement mortar of the grave bricks had recently been moulded probably by the descendants. *Figure 3.2f* shows the general conditions of the cement mortar of bricks and *Figure 3.2g* shows the comparison of original and new cement mortar.

Figure 3.2f *Condition of cement mortar of grave bricks at the right hand side of the headstone. Cement mortar and bricks are covered with overgrown vegetation (photo taken on 9 January 2010).*

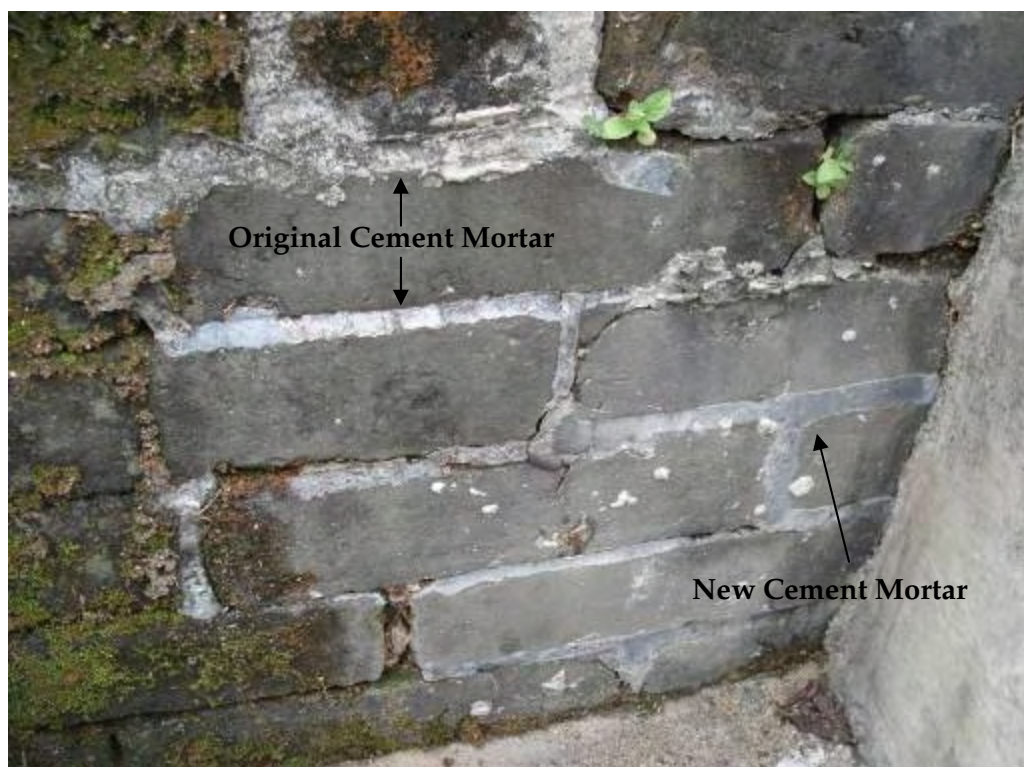
Figure 3.2g *Comparison of original and new cement mortar of grave bricks (photo taken on 9 January 2010)*
