PROJECT No.: TCS/00408/08

DSD CONTRACT NO. DC/2007/17
DRAINAGE IMPROVEMENT WORKS IN
CHEUNG PO, MA ON KONG, YUEN KONG SAN TSUEN
AND TIN SAM TSUEN OF YUEN LONG DISTRICT AND
SEWERAGE AT TSENG TAU CHUNG TSUEN, TUEN MUN

MONTHLY EM&A REPORT FOR KT13
(MARCH 2010)

Condition Survey of the Grave during Construction Phase

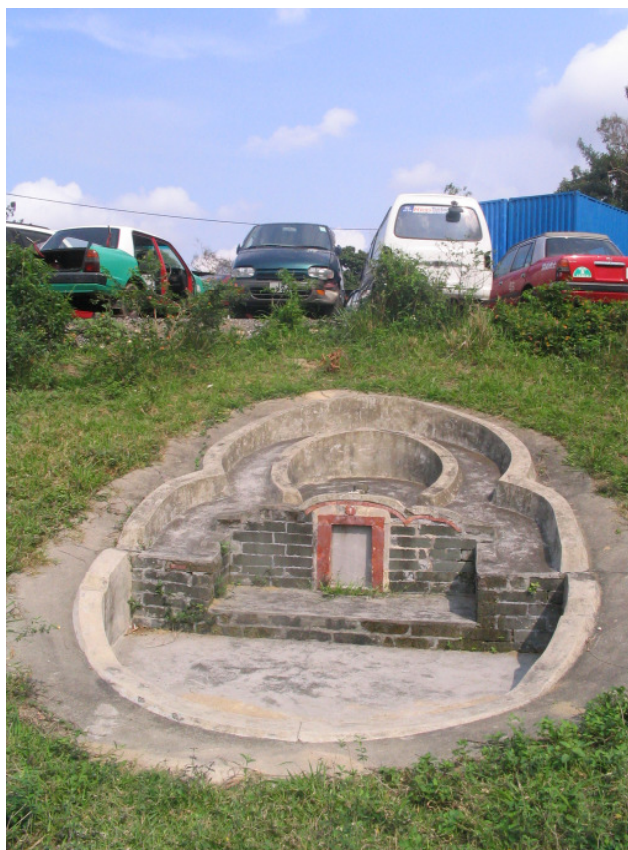
Figure 3.1 Front View

At the time of the monitoring on 27 February 2010, the grave was generally in good condition with little weeding problem. *Figure 3.1* shows the general view of the grave at the time of the site visit.

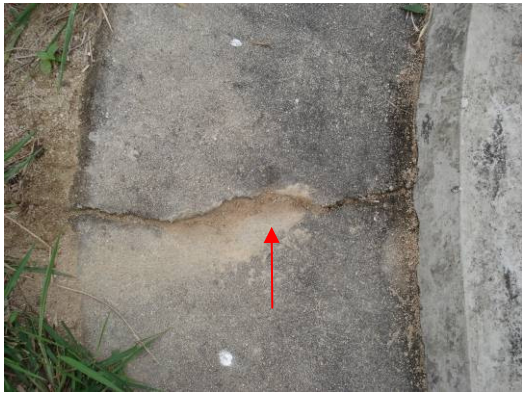
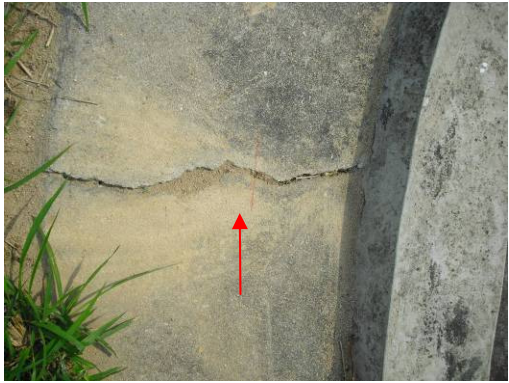
Crack No.	Current Crack Width (mm)	Photographic Record	
		Condition Survey Undertaken on 9 January 2010	Condition Survey Undertaken on 27 February 2010
5	5.6

No new cracks are identified during this condition survey. The crack widths for 17 cracks out of the 26 cracks as shown in *Table 3.1* remain unchanged. However, the remaining cracks were recorded to have slightly widened (mostly less than 1mm). The cracks width changes are presented in *Table 3.2*.

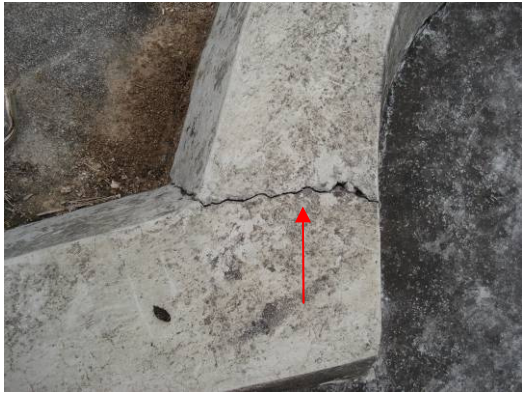
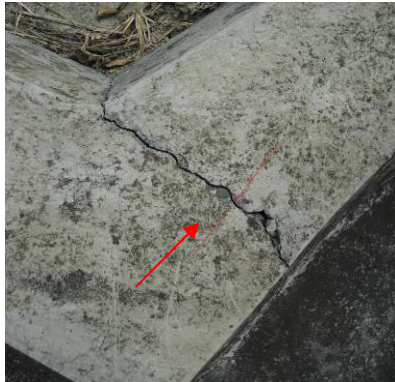
A photograph showing the same crack in the concrete surface. A red arrow points upwards to the crack. The crack appears slightly wider than in the January photo.
6	1.6

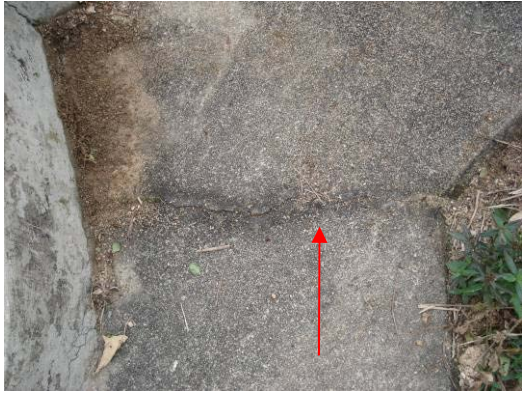
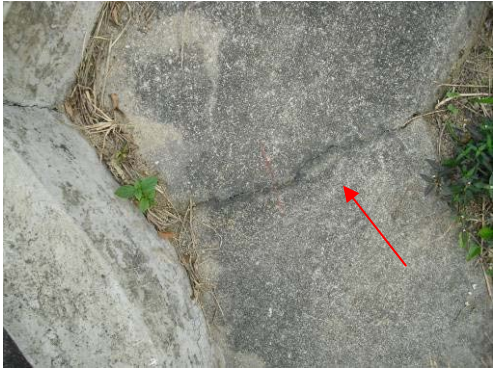
A photograph showing the same crack in the concrete curb. A red arrow points upwards to the crack. The crack appears slightly wider than in the January photo.
7	1.7

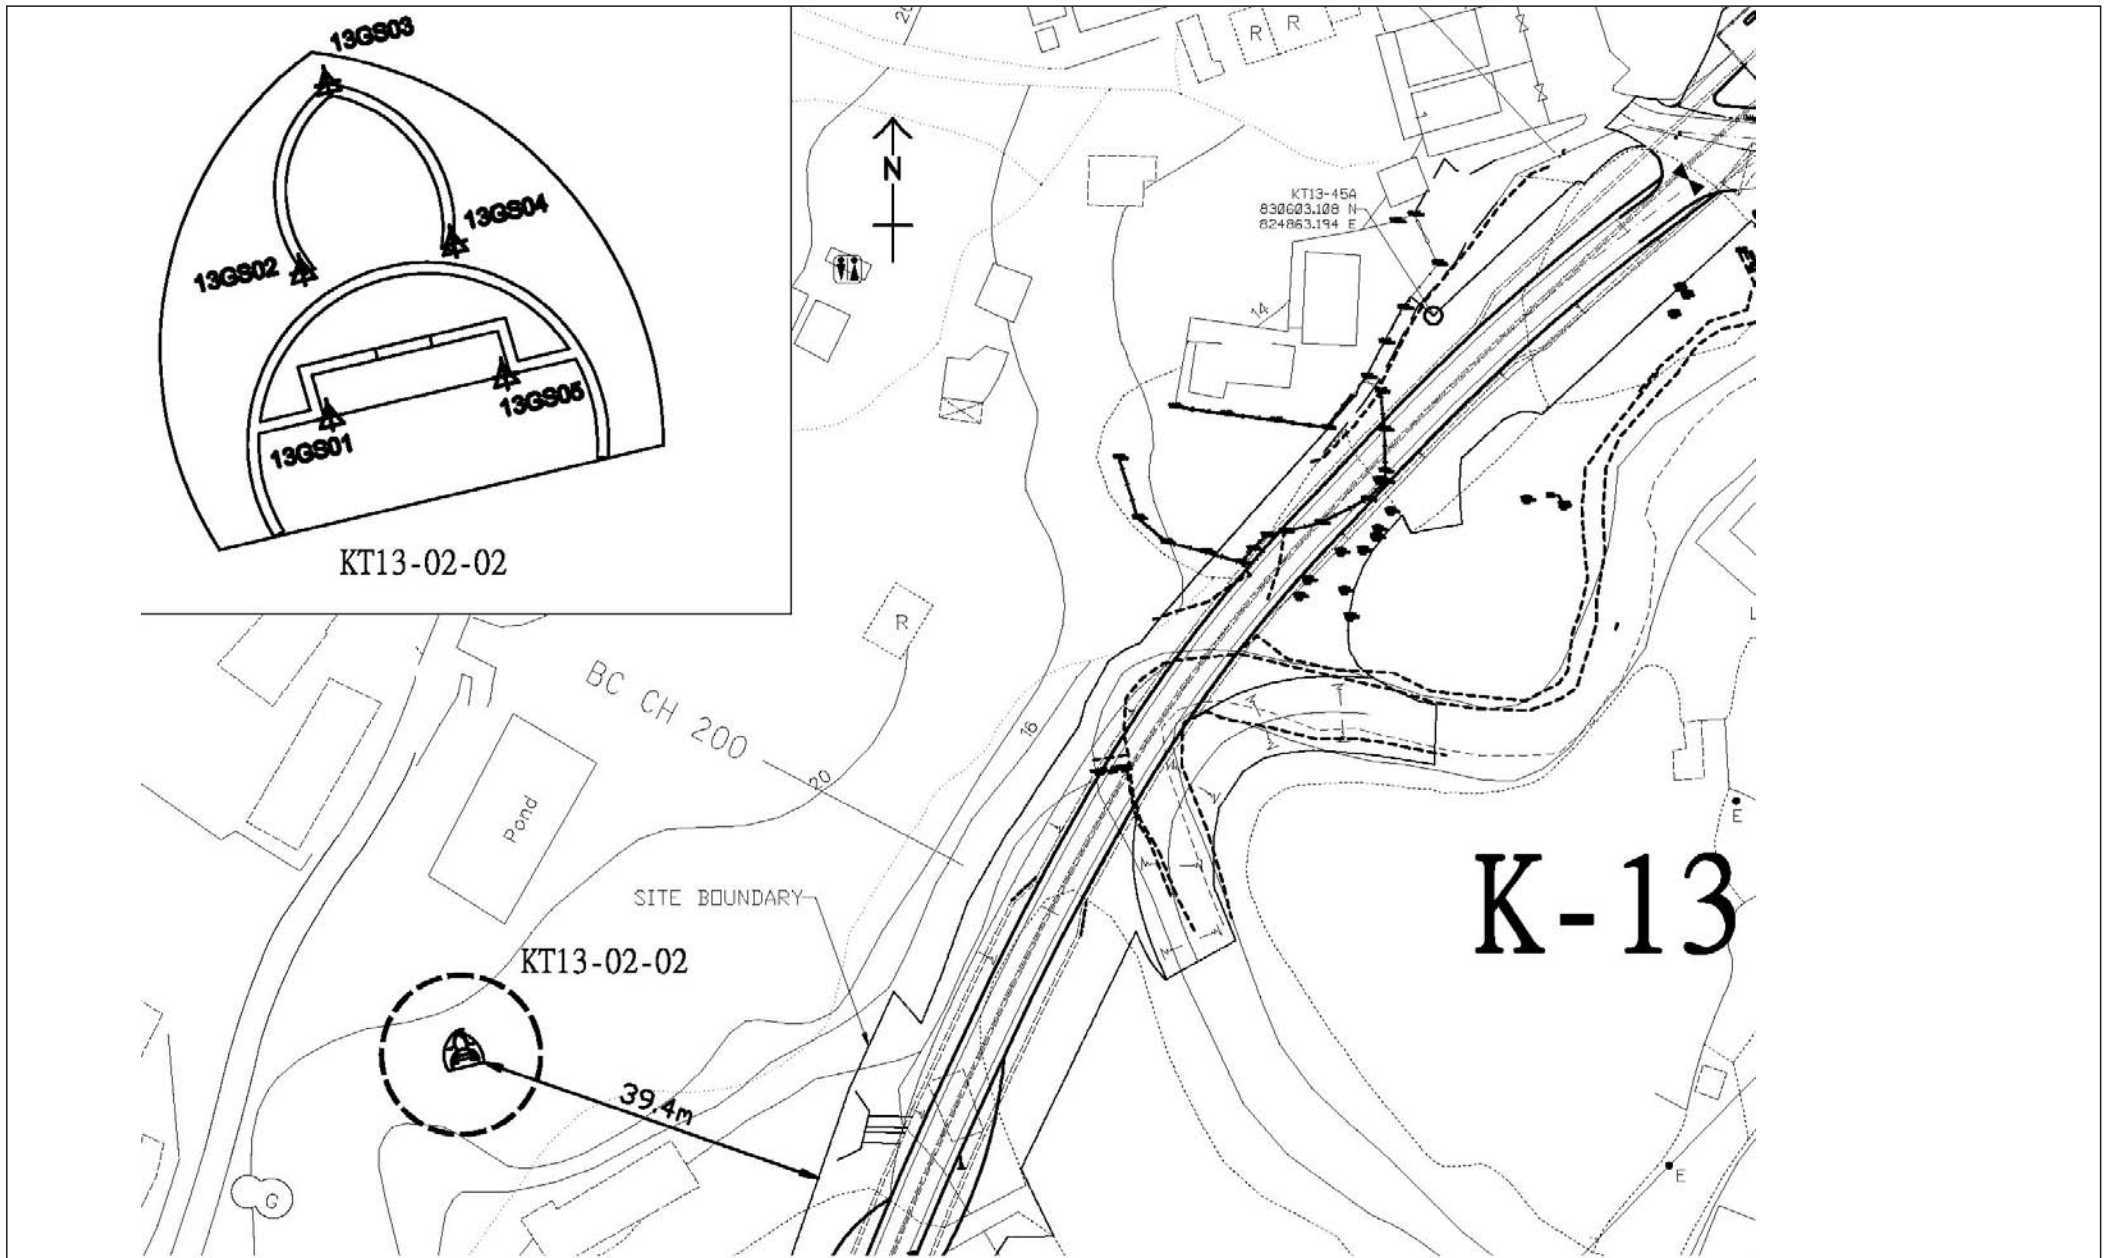
Figure 3.3

Point	Northing	Easting	Elevation (mPD) Initial Reading (Taken on 31 August 2009)	Elevation (mPD) Updated Reading (Taken on 27 February 2010)	Difference (mm)
13GS01	830520.25	824754.57	19.222	19.222	0
13GS02	830521.54	824754.32	19.985	19.985	0
13GS03	830523.21	824754.54	20.644	20.643	-1
13GS04	830521.79	824755.67	19.943	19.944	1
13GS05	830520.61	824756.12	19.211	19.210	-1

Location of Settlement Marker Points
