PROJECT No.: TCS/00408/08

DSD CONTRACT NO. DC/2007/17
DRAINAGE IMPROVEMENT WORKS IN
CHEUNG PO, MA ON KONG, YUEN KONG SAN TSUEN
AND TIN SAM TSUEN OF YUEN LONG DISTRICT AND
SEWERAGE AT TSENG TAU CHUNG TSUEN, TUEN MUN

MONTHLY EM&A REPORT FOR KT13
(JUNE 2010)

Scope: Condition survey and settlement monitoring of a Qing Dynasty Grave.

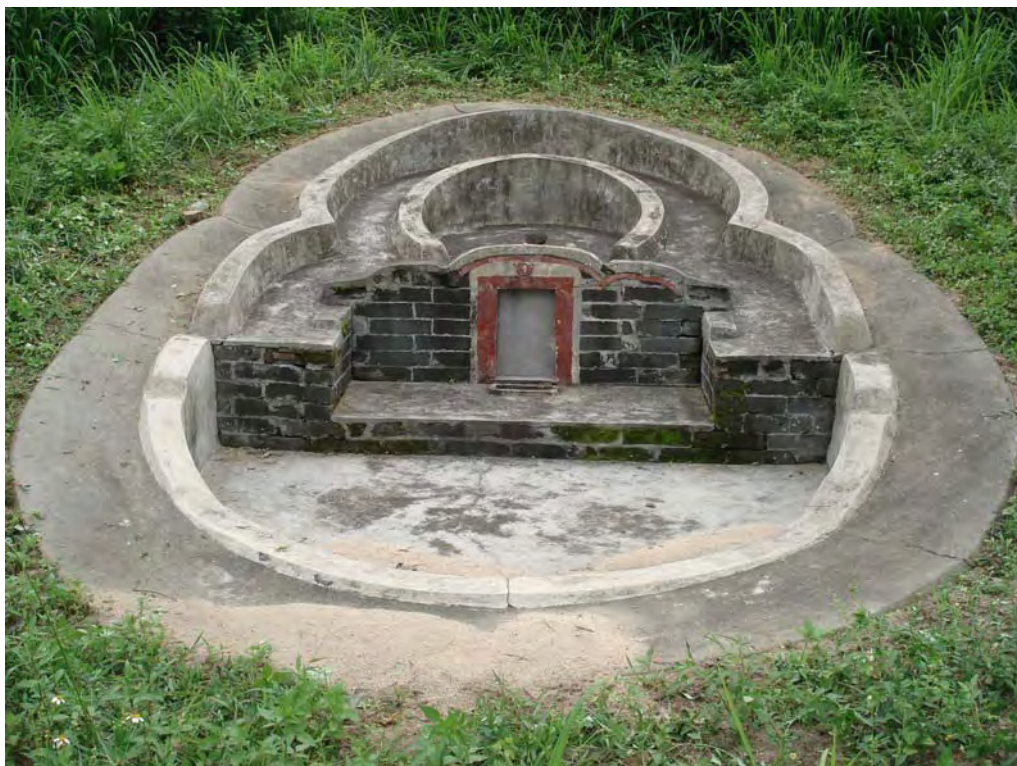
Figure 3.1 Front View

At the time of the monitoring on 5 June 2010, the grave was generally in good condition with limited weeding problem. *Figure 3.1* shows the general view of the grave at the time of the site visit.

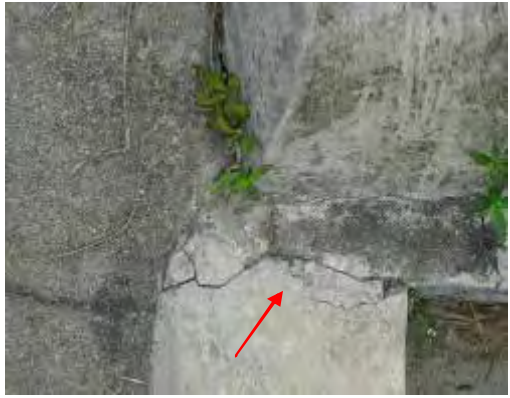
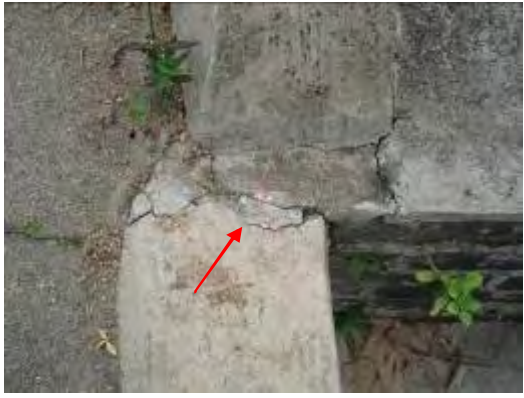
Crack No.	Current Crack Width (mm)	Photographic Record	
		Condition Survey Undertaken on 27 February 2010	Condition Survey Undertaken on 5 June 2010
1	1

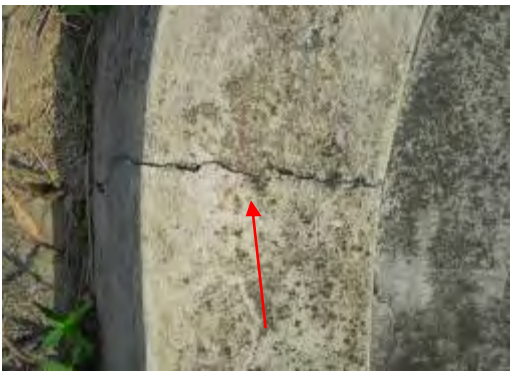
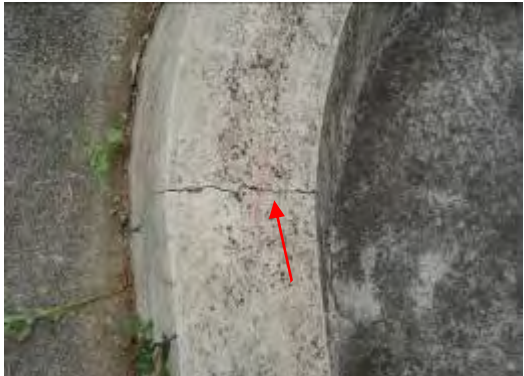
A photograph showing the same crack as in the previous image. A red arrow points to the crack. The crack appears slightly wider and more irregular.
2	2

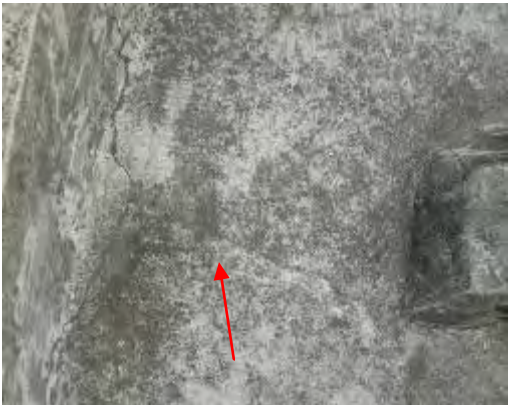
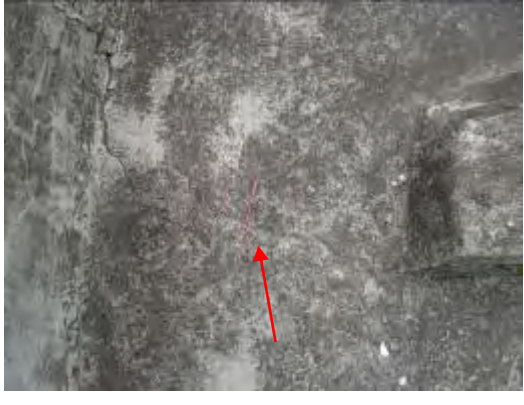
A photograph showing the same crack as in the previous image. A red arrow points to the crack. The crack appears slightly wider and more irregular.
3	1.5

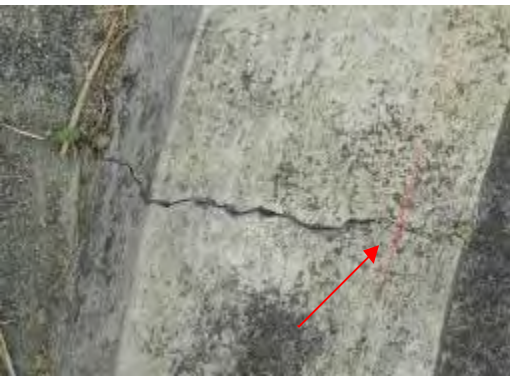
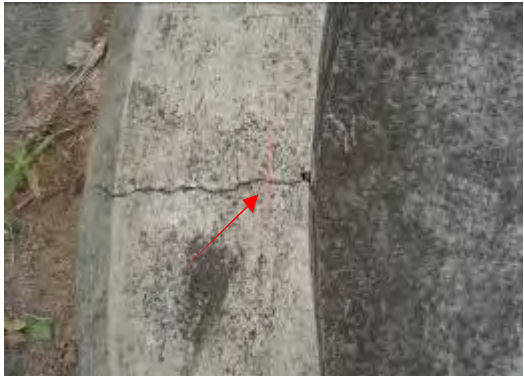
4	1.5

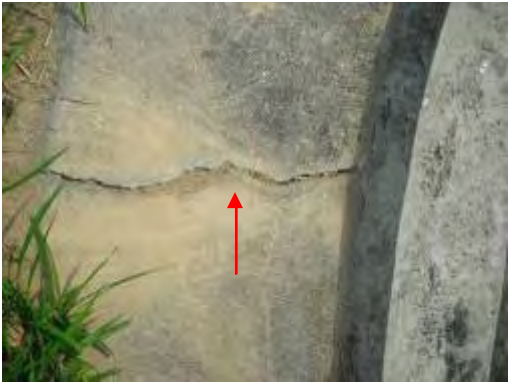
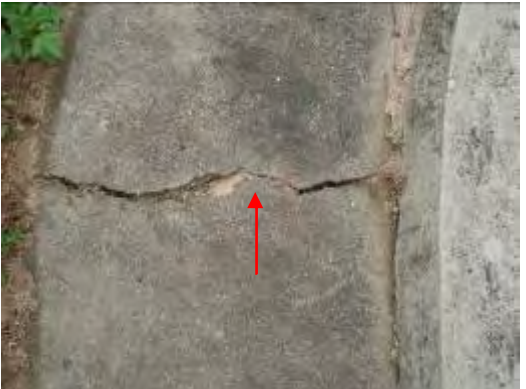
Crack No.	Current Crack Width (mm)	Photographic Record	
		Condition Survey Undertaken on 27 February 2010	Condition Survey Undertaken on 5 June 2010
5	5.6

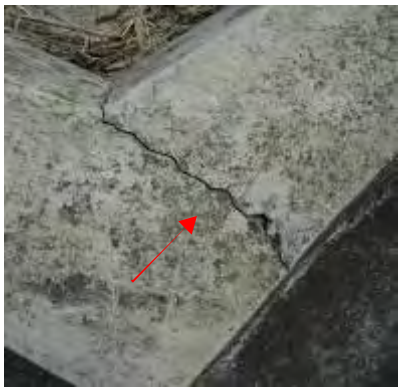
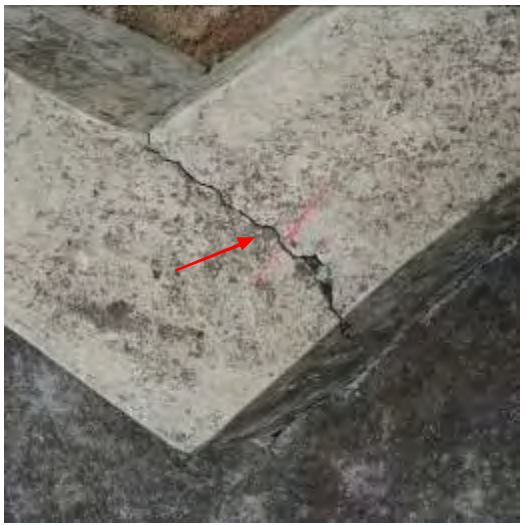
A photograph showing the same horizontal crack in the concrete surface. A red arrow points to the crack.
6	1.6

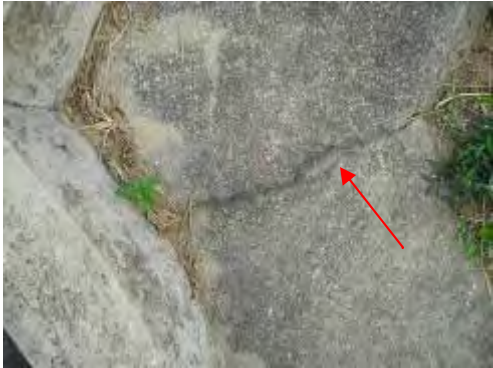
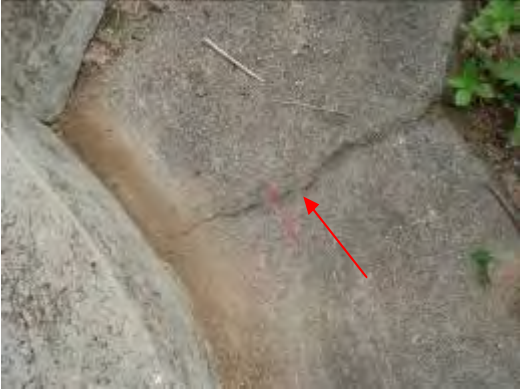
A photograph showing the same diagonal crack in the concrete surface. A red arrow points to the crack.
7	1.7

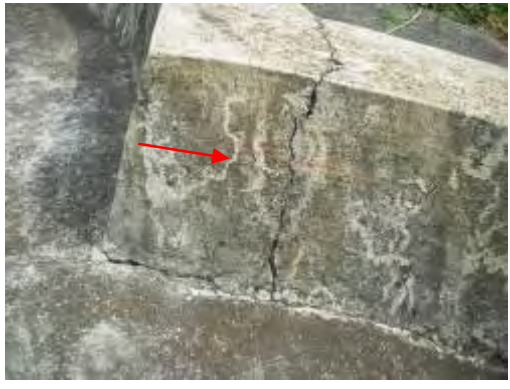
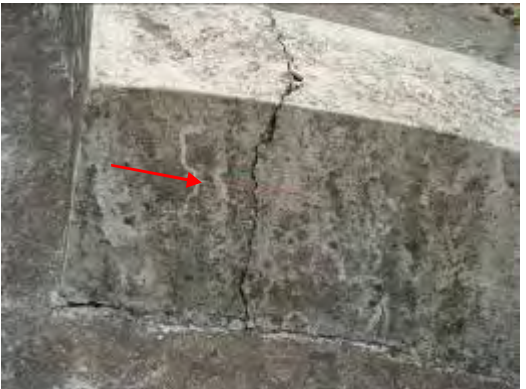
A photograph showing the same horizontal crack in the concrete surface. A red arrow points to the crack.
8	1.5

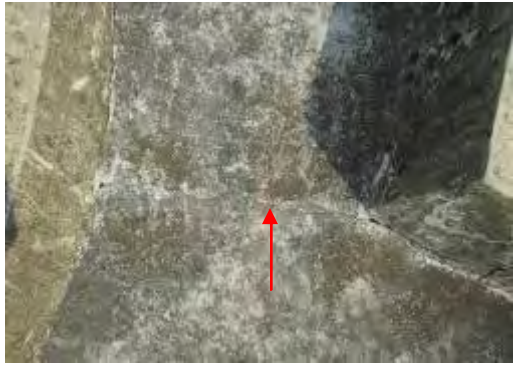
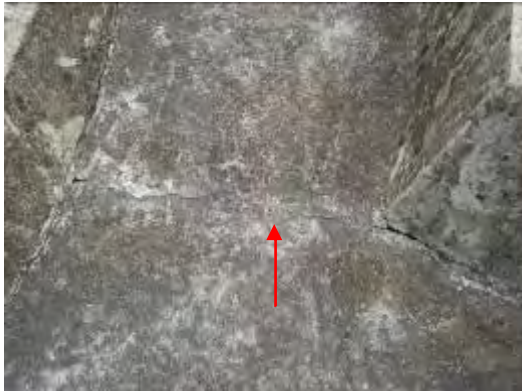
Crack No.	Current Crack Width (mm)	Photographic Record	
		Condition Survey Undertaken on 27 February 2010	Condition Survey Undertaken on 5 June 2010
9	0.5

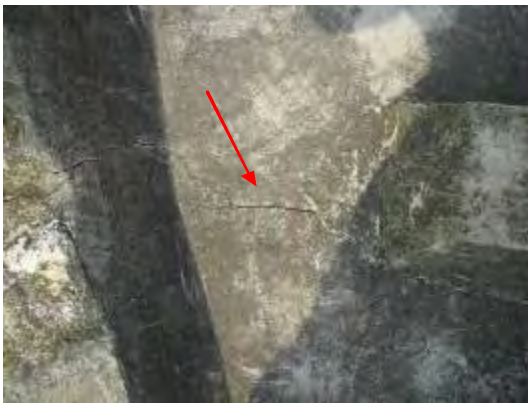
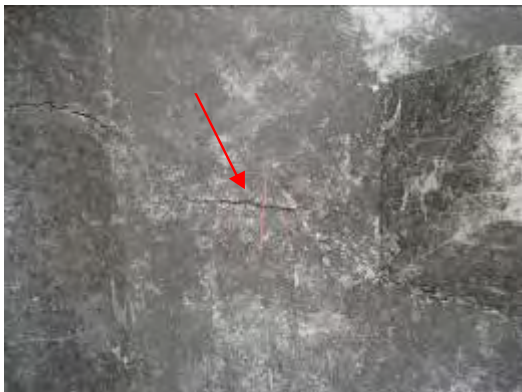
A photograph showing the same crack in the concrete surface. A red arrow points to the crack. The crack appears slightly wider and more irregular than in the previous photo.
10	1

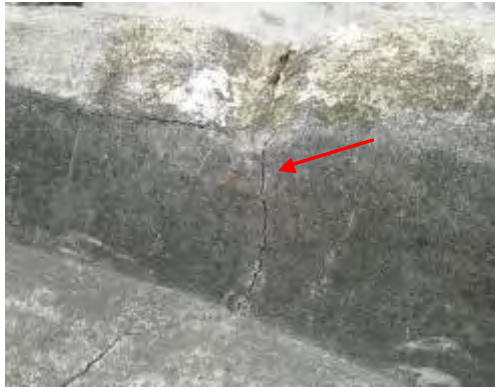
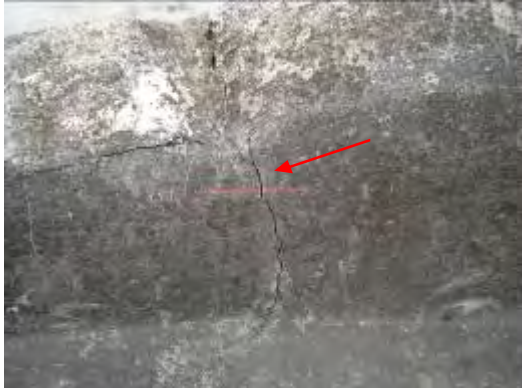
A photograph showing the same crack in the concrete surface. A red arrow points to the crack. The crack appears wider and more irregular than in the previous photo.
11	1.5

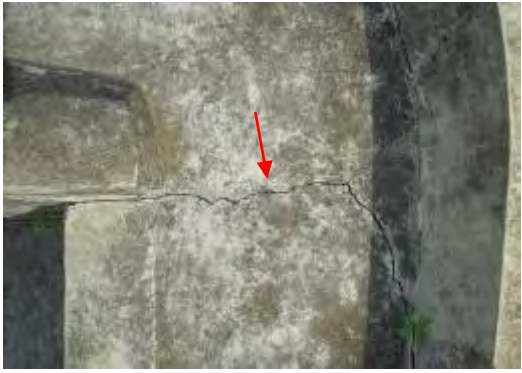
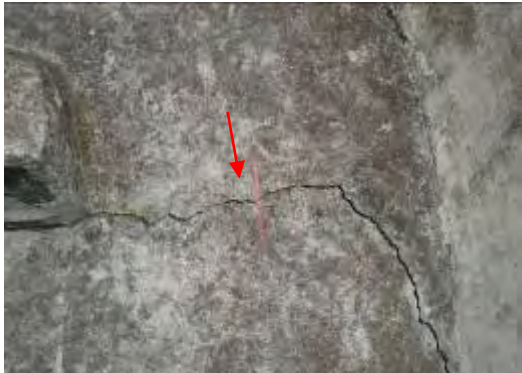
Crack No.	Current Crack Width (mm)	Photographic Record	
		Condition Survey Undertaken on 27 February 2010	Condition Survey Undertaken on 5 June 2010
13	2.9

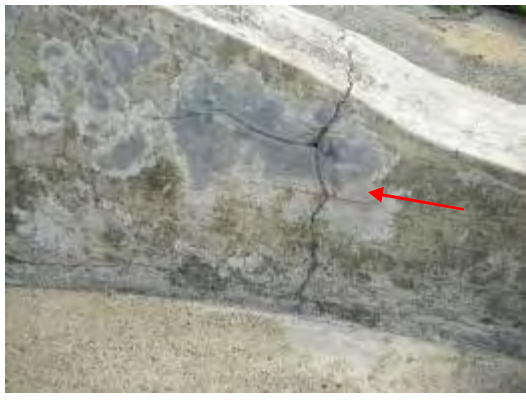
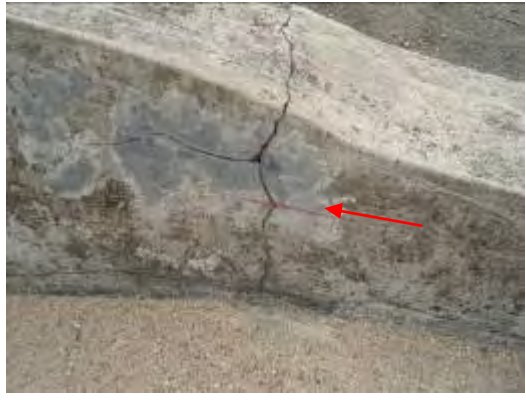
Crack No.	Current Crack Width (mm)	Photographic Record	
		Condition Survey Undertaken on 27 February 2010	Condition Survey Undertaken on 5 June 2010
17	1.7

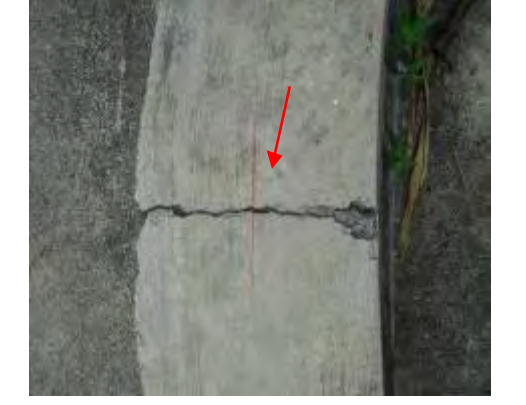
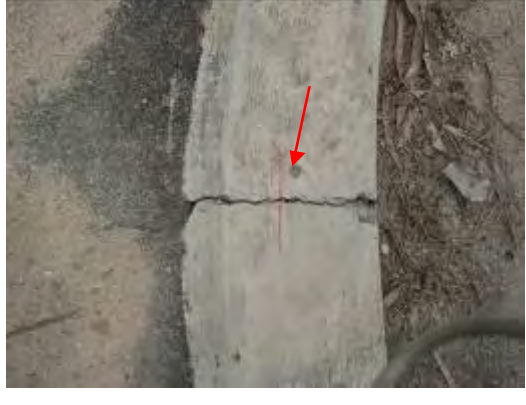
A photograph showing the same crack in the same location. A red arrow points to the crack. The crack appears slightly wider than in the February 2010 photo.
18	2

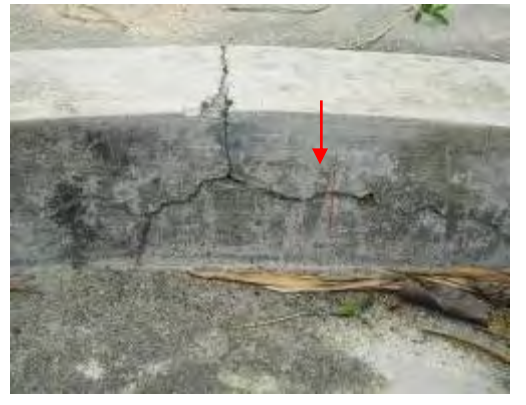
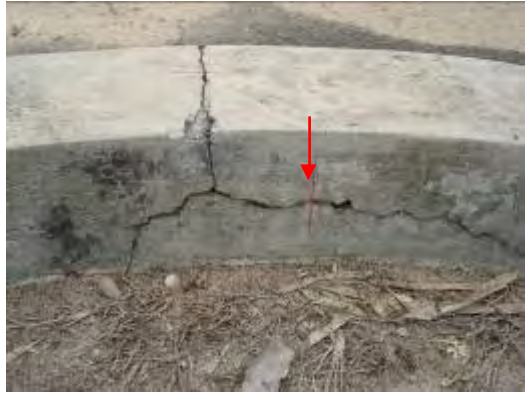
A photograph showing the same horizontal crack. A red arrow points to the crack. The crack width appears consistent with the February 2010 photo.
19	0.5

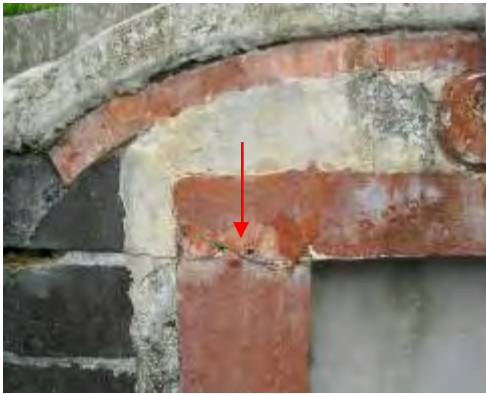
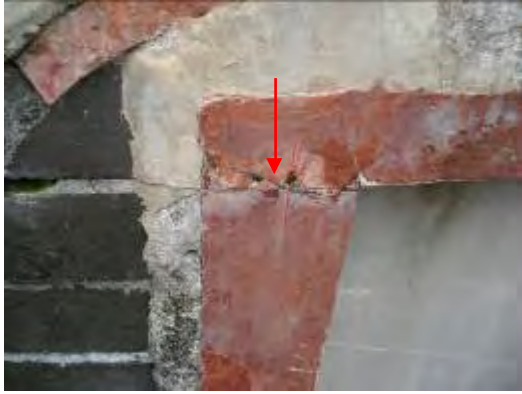
Crack No.	Current Crack Width (mm)	Photographic Record	
		Condition Survey Undertaken on 27 February 2010	Condition Survey Undertaken on 5 June 2010
21	0.5

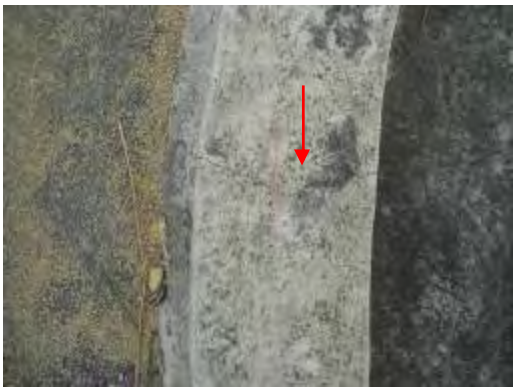
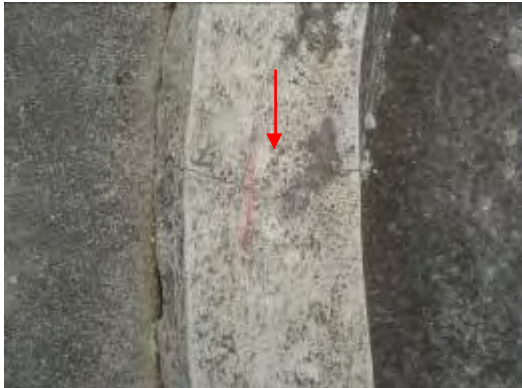
A photograph of the same concrete surface. A red arrow points to the hair-line crack, which remains very fine and is barely visible.
23	Hair-line

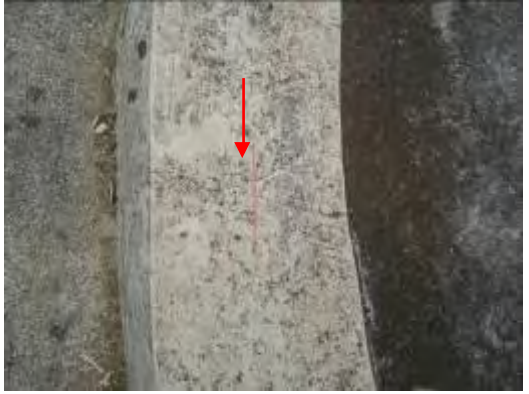
Crack No.	Current Crack Width (mm)	Photographic Record	
		Condition Survey Undertaken on 27 February 2010	Condition Survey Undertaken on 5 June 2010
24	Hair-line

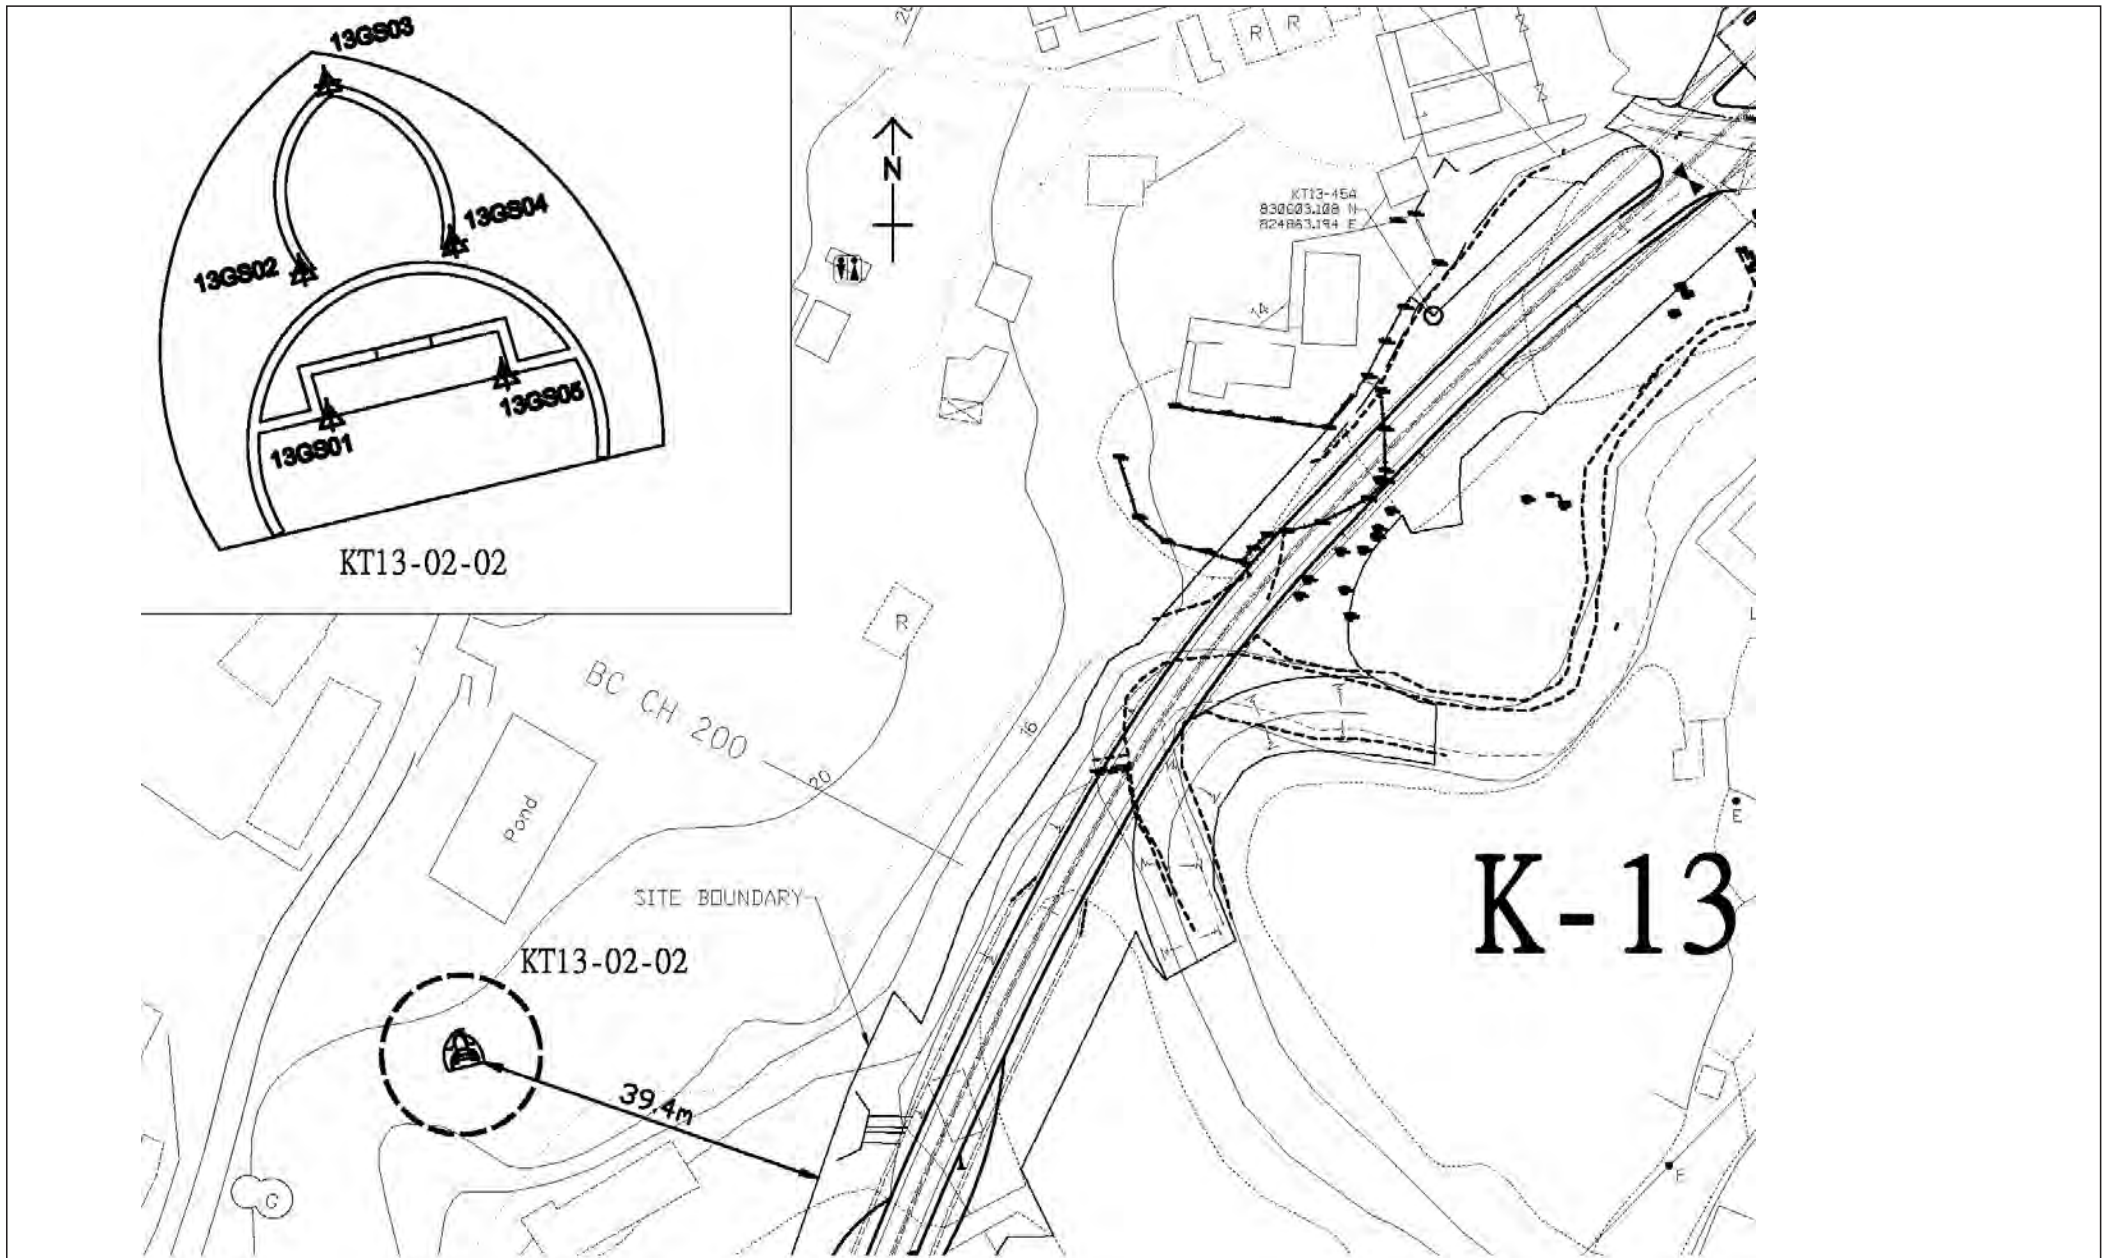
Figure 3.3 Location of Settlement Marker Points

Table 3.3 *Record of Five Settlement Marker Points of the Historic Grave on 5 June 2010*

Point	Northing	Easting	Elevation (mPD) Initial Reading (Taken on 31 August 2009)	Elevation (mPD) Updated Reading (Taken on 5 June 2010)	Difference (mm)
13GS01	830520.25	824754.57	19.222	19.222	0
13GS02	830521.54	824754.32	19.985	19.986	1
13GS03	830523.21	824754.54	20.644	20.643	-1
13GS04	830521.79	824755.67	19.943	19.944	1
13GS05	830520.61	824756.12	19.211	19.210	-1
