PROJECT No.: TCS/00408/08

DSD CONTRACT NO. DC/2007/17  
DRAINAGE IMPROVEMENT WORKS IN  
CHEUNG PO, MA ON KONG, YUEN KONG SAN TSUEN  
AND TIN SAM TSUEN OF YUEN LONG DISTRICT AND  
SEWERAGE AT TSENG TAU CHUNG TSUEN, TUEN MUN

MONTHLY EM&A REPORT FOR KT13  
(NOVEMBER 2010)

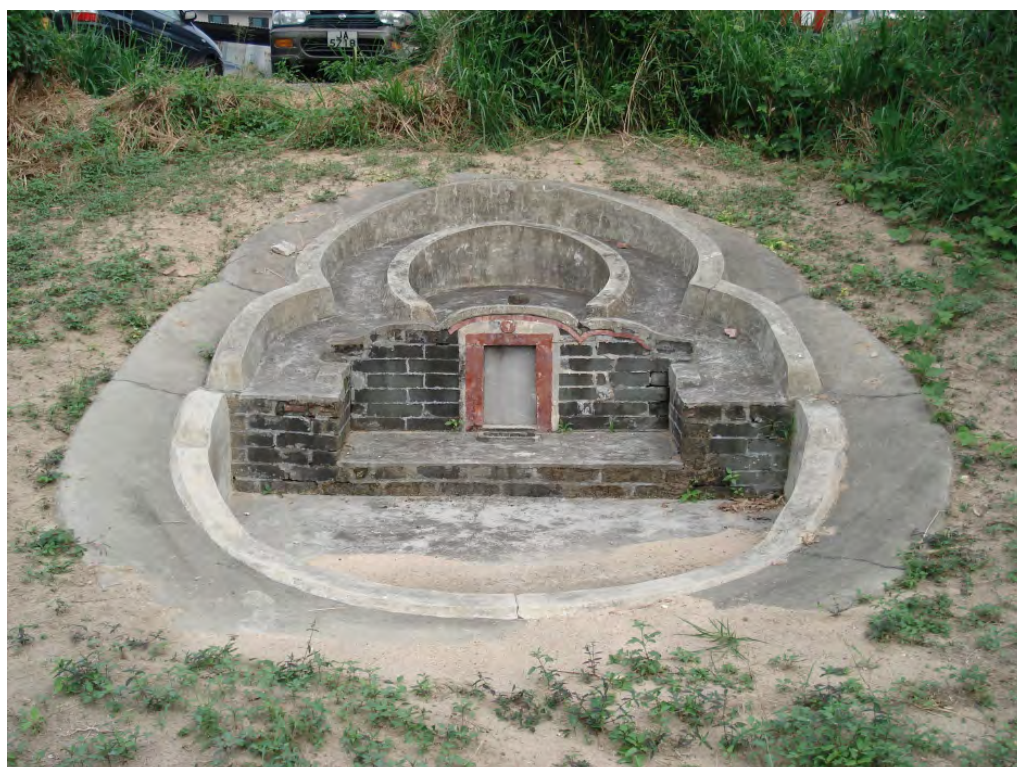
*Figure 3.1 Front View*

At the time of the monitoring on 23 October 2010, the grave was in good condition with very little weeding problem. This is probably because the descendents of the grave had swept it during the Chung Yeung Festival a week ago before the monitoring. *Figure 3.1* shows the general view of the grave.

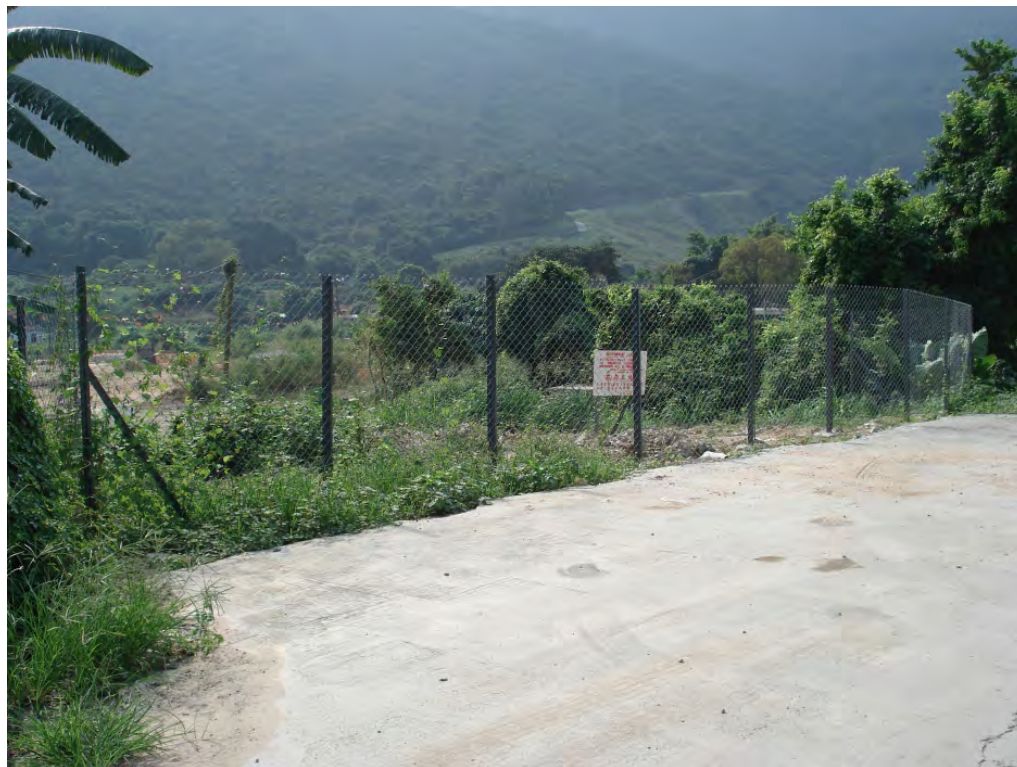
**Figure 3.3** *General view of the fence restricting trespassing, dumping or unlawful occupation on the concerned Government land near the grave.*

As reported in the last condition survey report, the site clearance at a place approximately 67m away from the grave in its southwest direction by an unknown third party took place on 19 August 2010. After the occurrence of the site clearance activity, it was reported by the Contractor via letter dated 29 September 2010 that during their site inspection on the same day they noted the concerned area had been fenced off and a sign board had been erected by District Lands Office, Yuen Long (DLO, Yuen Long). It is considered that the erection of the fence and sign board is to prevent people from trespassing, dumping or unlawful occupation on the concerned Government land. *Figures 3.3* and *3.4* show the general view of the recently erected fence and the sign board.
