PROJECT No.: TCS/00408/08

DSD CONTRACT NO. DC/2007/17  
DRAINAGE IMPROVEMENT WORKS IN  
CHEUNG PO, MA ON KONG, YUEN KONG SAN TSUEN  
AND TIN SAM TSUEN OF YUEN LONG DISTRICT AND  
SEWERAGE AT TSENG TAU CHUNG TSUEN, TUEN MUN

MONTHLY EM&A REPORT FOR KT13  
(DECEMBER 2010)

Date	Reference No.	Prepared By	Certified by
13 January 2011	TCS00408/08/600/R1549v2

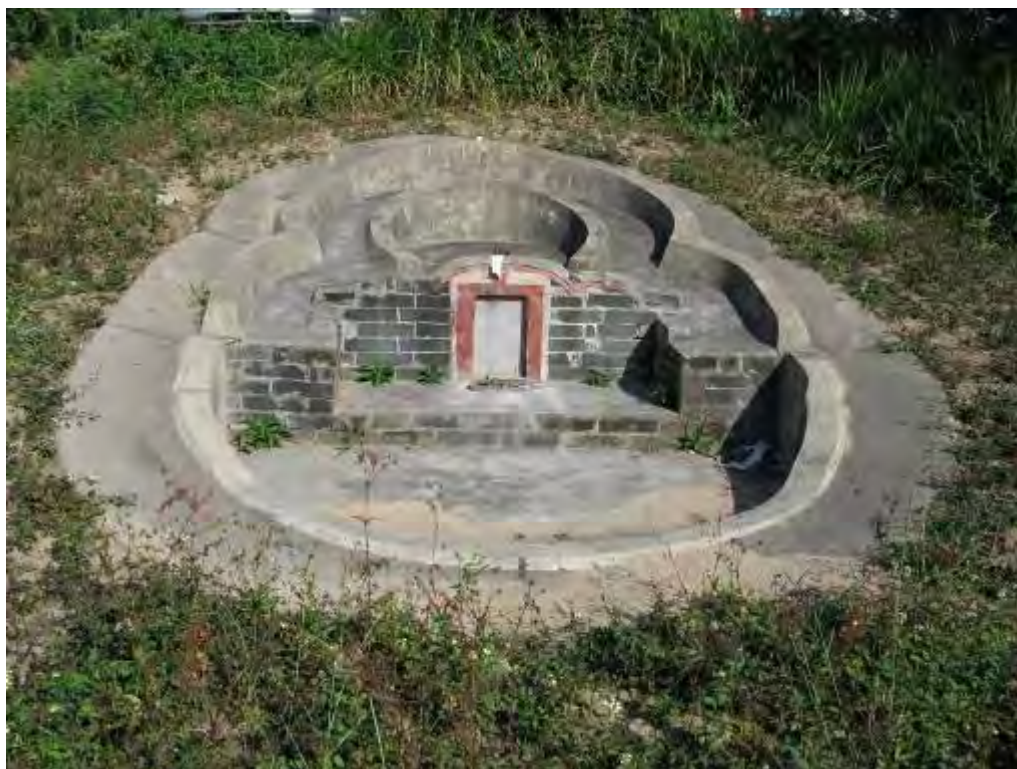
*Figure 3.1 Front View*

At the time of the monitoring on 18 December 2010, the grave was in good condition with little weeding problem. *Figure 3.1* shows the general view of the grave.

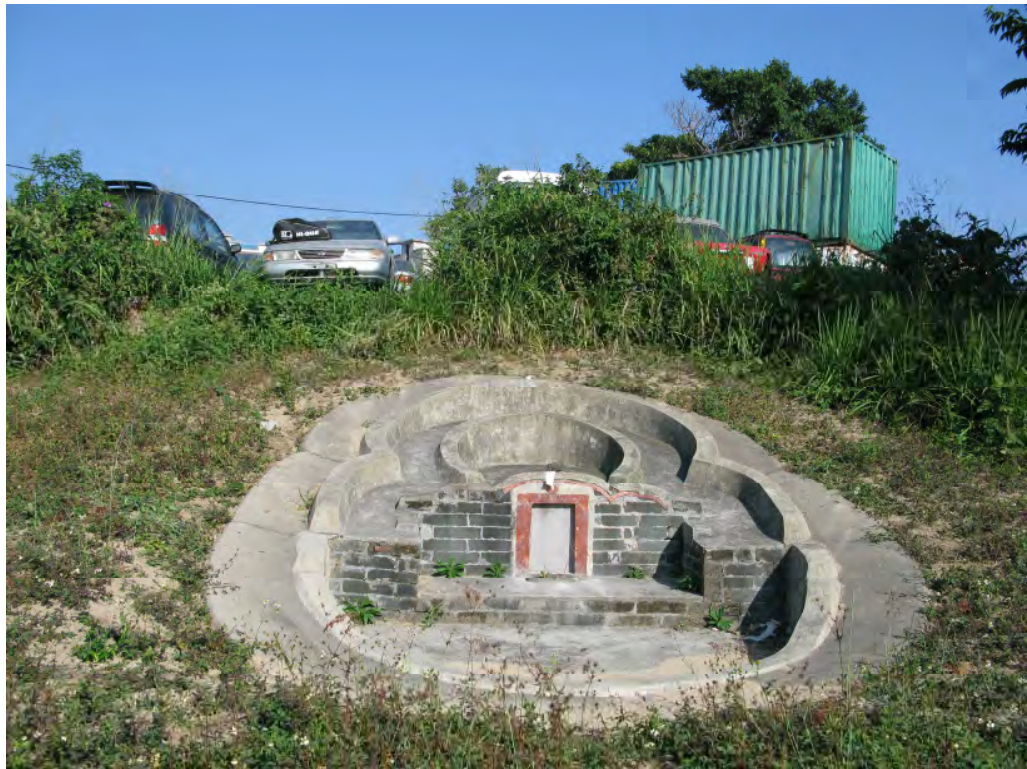
In view of the surrounding dense vegetation and the grave being exposed, existing cracks are likely to be slightly widened by weathering (such as raining, intermittent heating and cooling), root encroachment of overgrown vegetation and the platform built by an unknown third party adjacent to the grave used as a car park since November 2009. *Figures 3.3* and *3.4* show the general views of the platform on the day of monitoring on 18 December 2010.

*Figure 3.3 View of the platform and the vehicles thereupon from the grave*

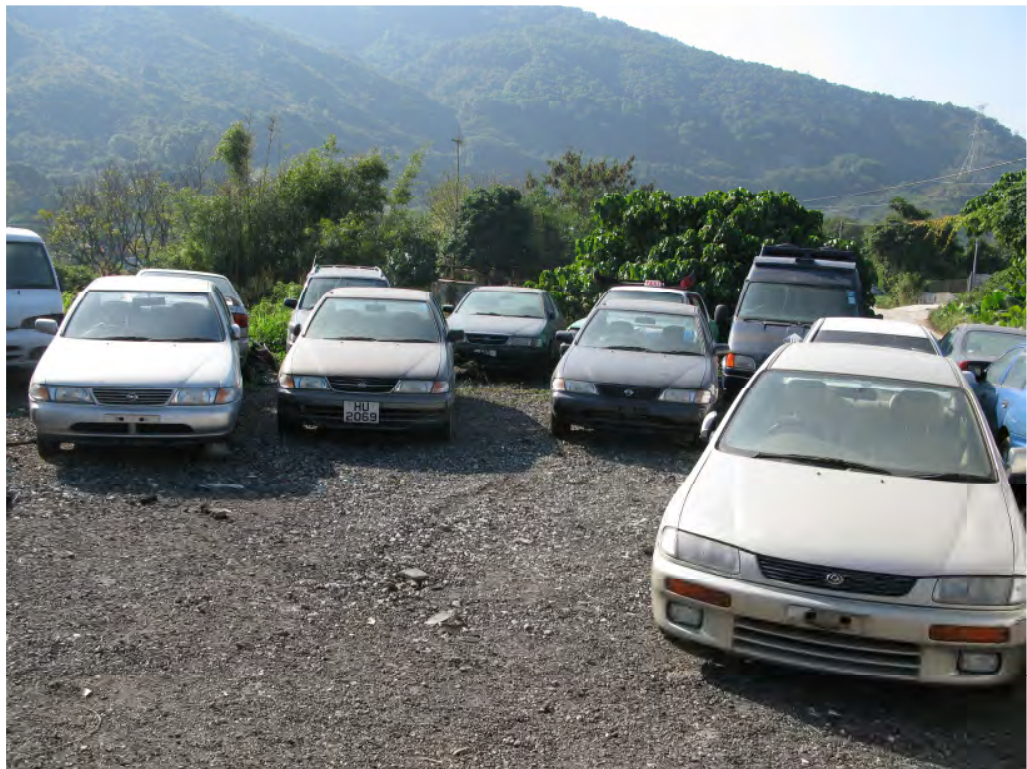
*Figure 3.4 General view of the platform used as a car park*

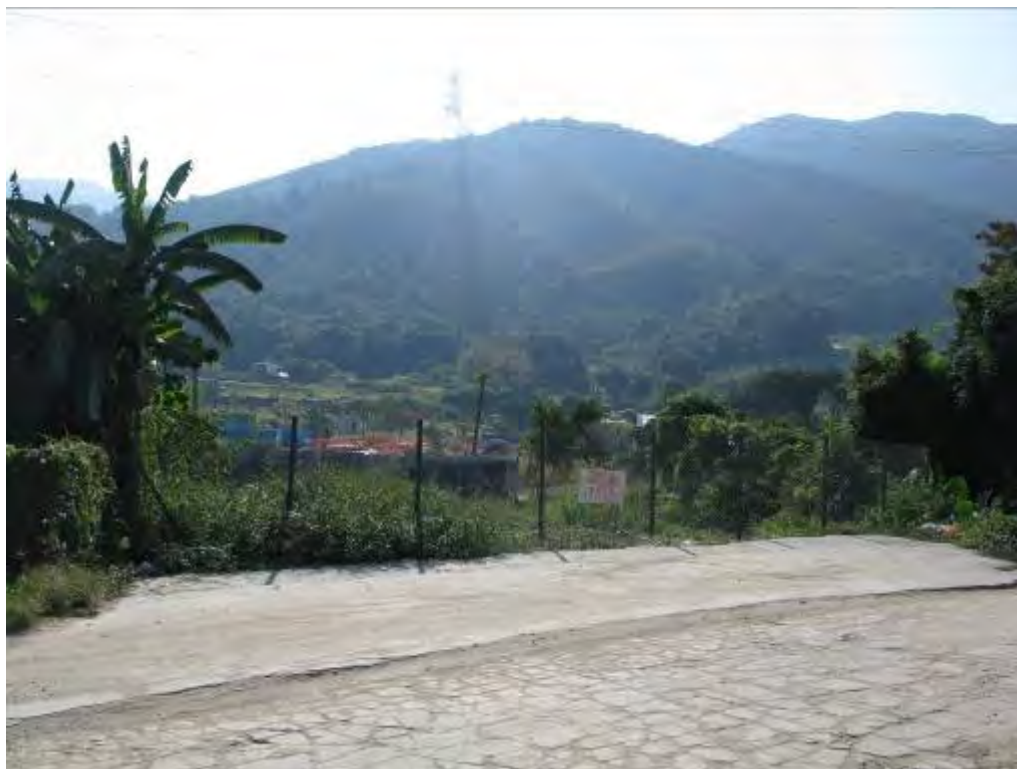
Furthermore, as first reported in the condition survey dated 21 August 2010, the site clearance at a place approximately 67m away from the grave in its southwest direction by an unknown third party took place on 19 August 2010. After the occurrence of the site clearance activity, it was reported by the Contractor via letter dated 29 September 2010 that during their site inspection on the same day they noted the concerned area had been fenced off and a sign board had been erected by District Lands Office, Yuen Long (DLO, Yuen

Long). It is considered that the erection of the fence and sign board is to prevent people from trespassing, dumping or unlawful occupation on the concerned Government land. Figures 3.5 and 3.6 show the general view of the recently erected fence and the sign board on the day of monitoring on 18 December 2010.

*Figure 3.5 General view of the fence restricting trespassing, dumping or unlawful occupation on the concerned Government land near the grave.*

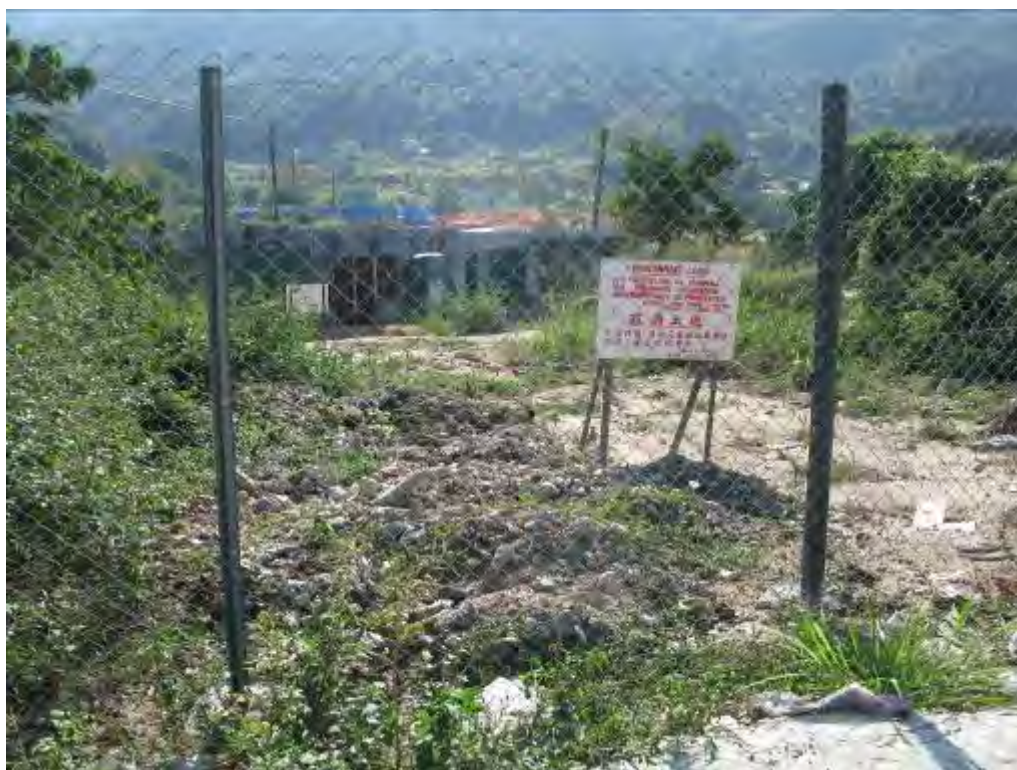
*Figure 3.6 The sign board erected by DLO, Yuen Long near the grave*

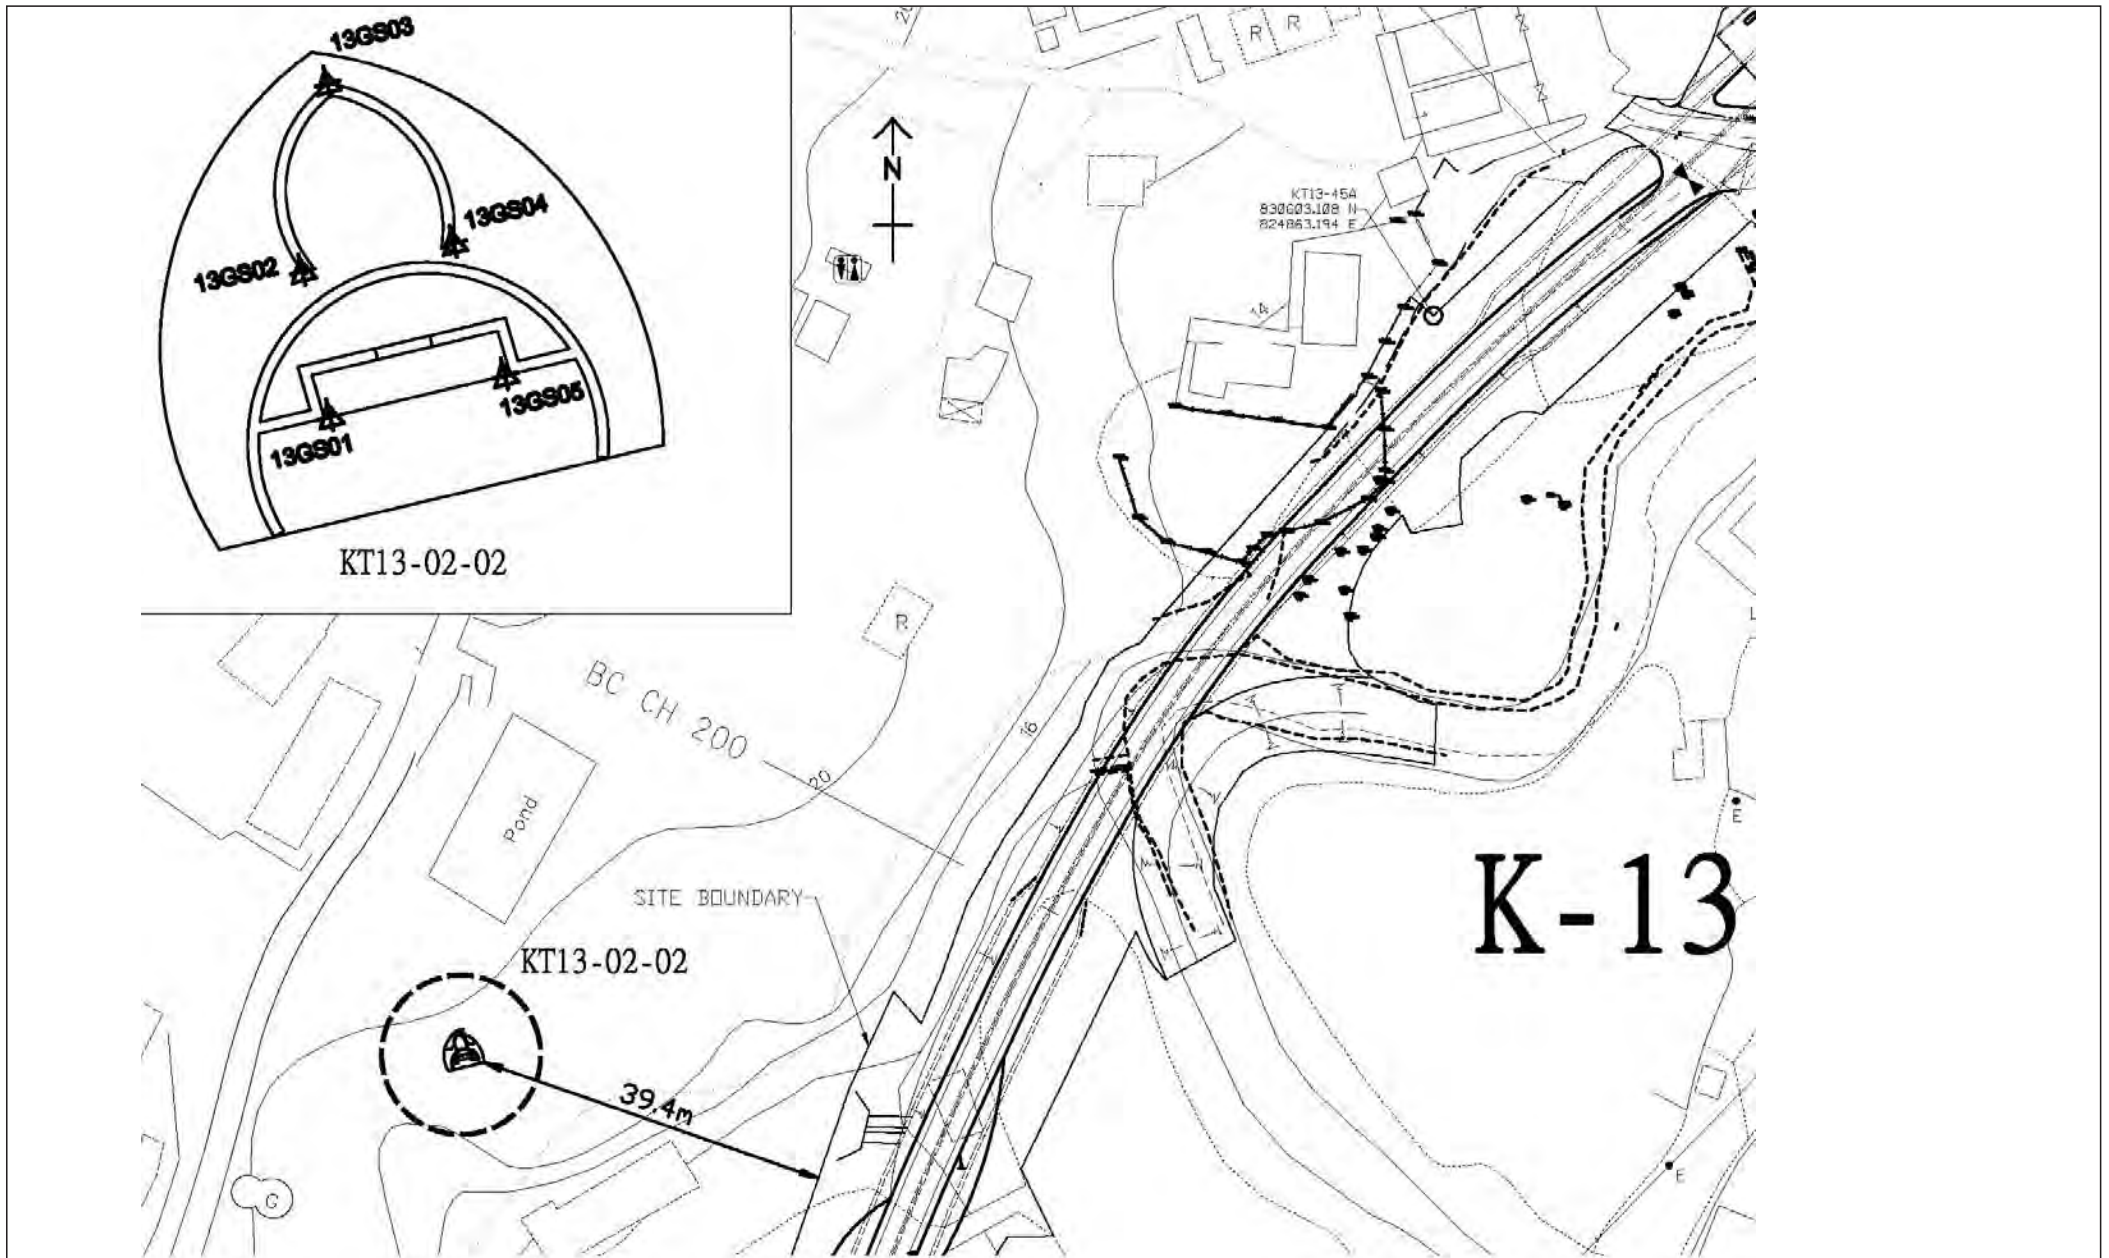
Figure 3.7

Point	Northing	Easting	Elevation (mPD) Initial Reading (Taken on 31 August 2009)	Elevation (mPD) Updated Reading (Taken on 18 December 2010)	Difference (mm)
13GS01	830520.25	824754.57	19.222	19.223	+1
13GS02	830521.54	824754.32	19.985	19.985	0
13GS03	830523.21	824754.54	20.644	20.644	0
13GS04	830521.79	824755.67	19.943	19.944	+1
13GS05	830520.61	824756.12	19.211	19.211	0

Location of Settlement Marker Points
