DSD CONTRACT NO. DC/2007/17
DRAINAGE IMPROVEMENT WORKS IN
CHEUNG PO, MA ON KONG, YUEN KONG SAN TSUEN
AND TIN SAM TSUEN OF YUEN LONG DISTRICT AND
SEWERAGE AT TSENG TAU CHUNG TSUEN, TUEN MUN

MONTHLY EM&A REPORT FOR KT13
(MARCH 2011)

Condition Survey of the Grave during Construction Phase

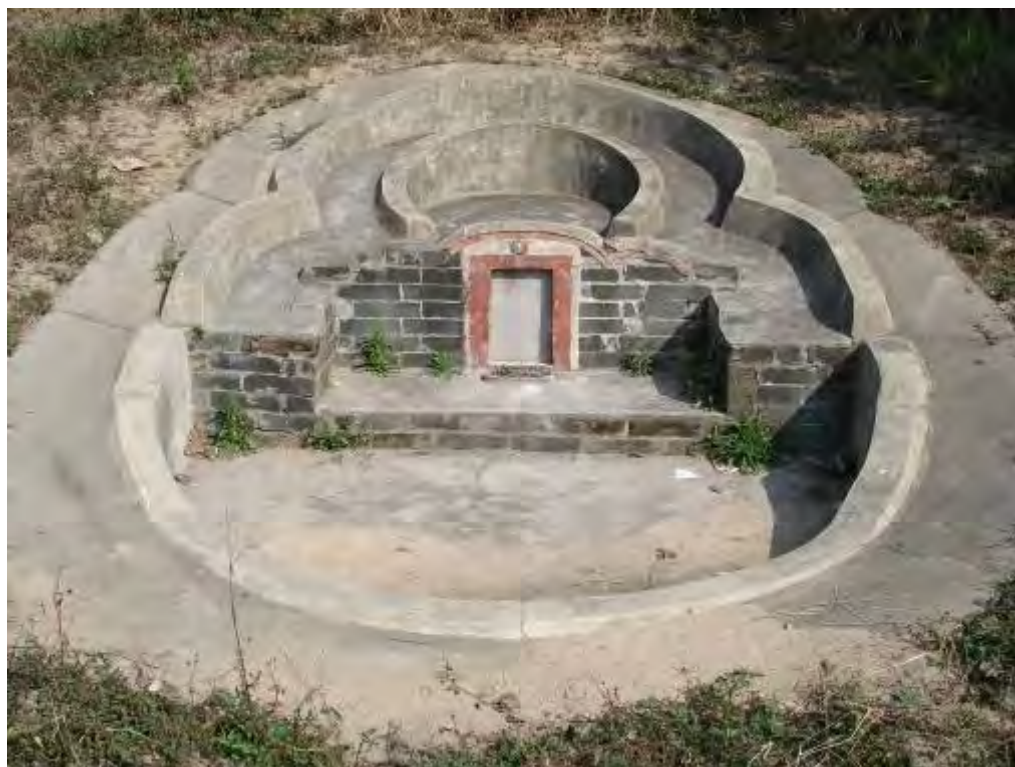
Figure 3.1 Front View

At the time of the monitoring on 26 February 2011, the grave was in good condition with limited weeding problem. *Figure 3.1* shows the general view of the grave.

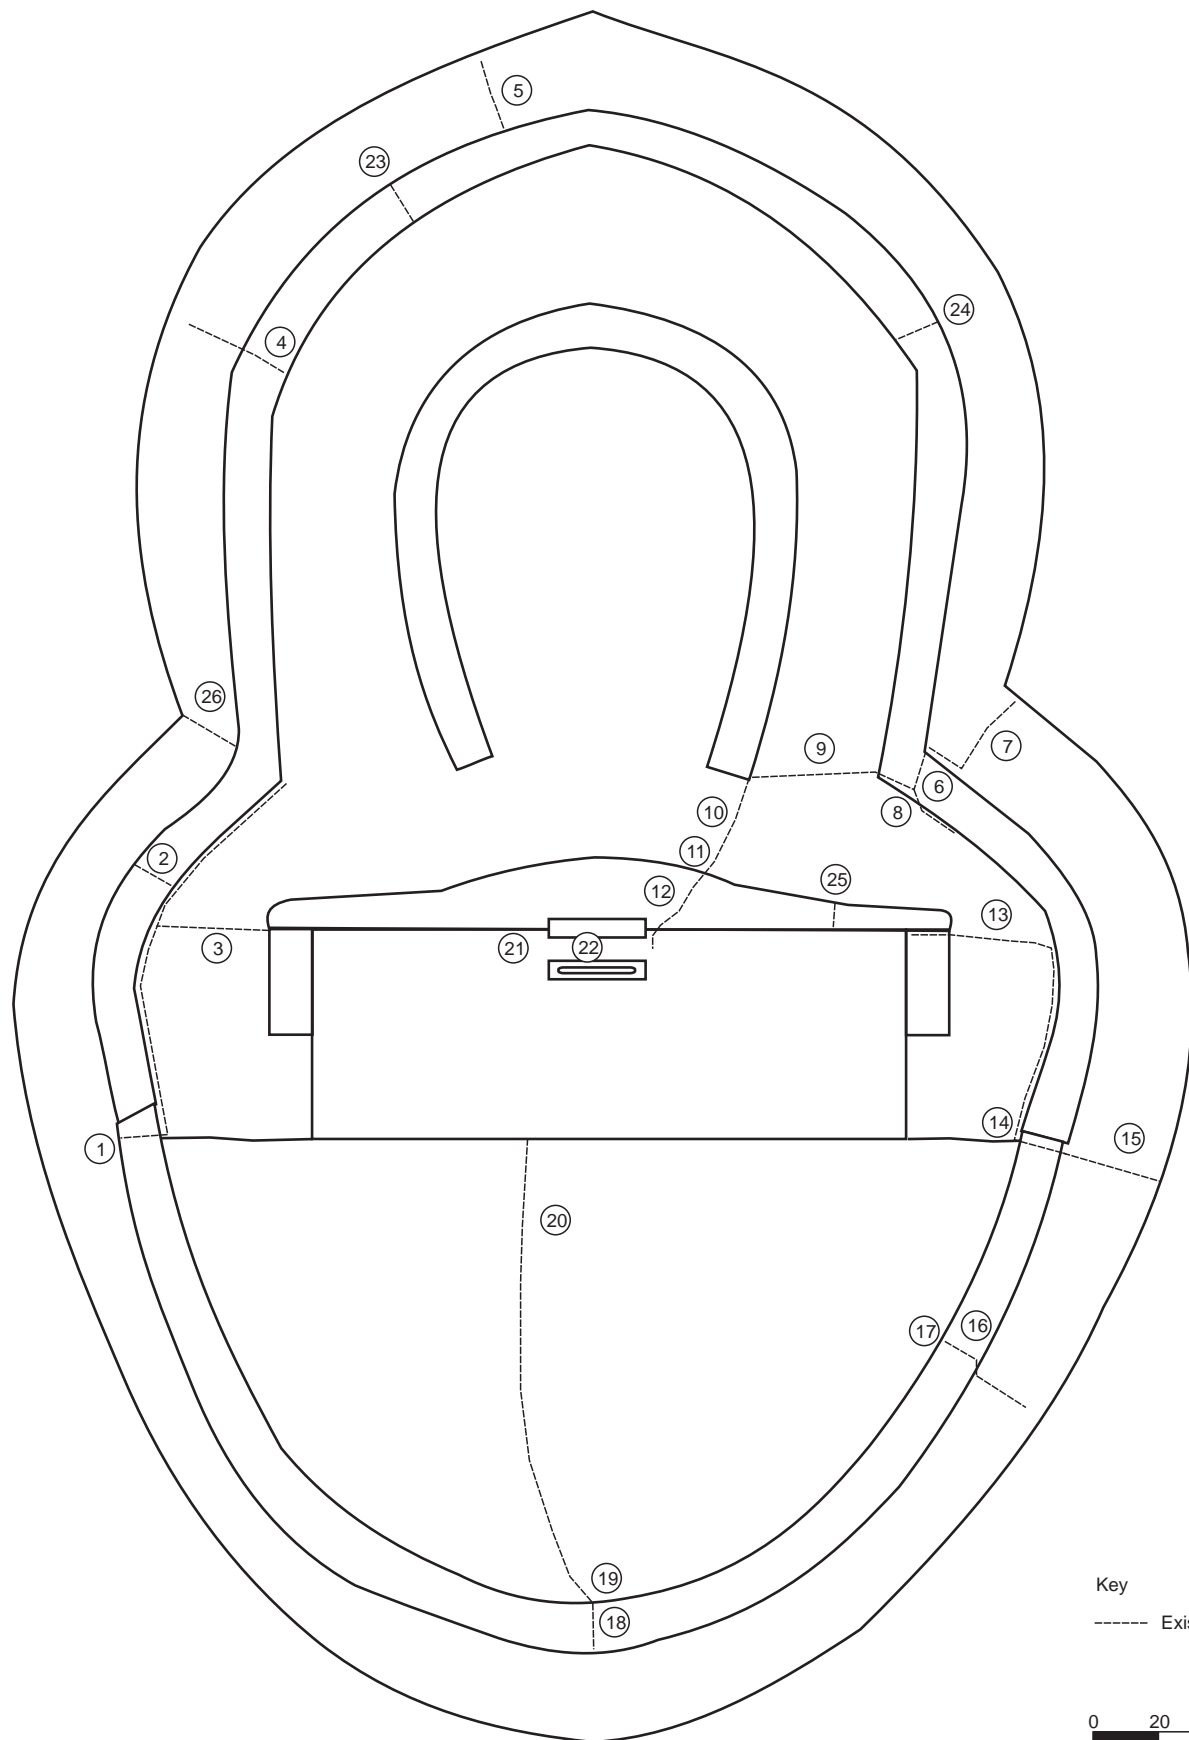
Figure 3.2

A total of 26 cracks were identified on the cement rendering, mortar of bricks and headstone of the grave. Their locations are shown in *Figure 3.2*. Crack width ranged from hairline to 5.6mm. *Table 3.1* details the cracks identified on the grave photographically and compares the cracks identified during last condition survey and those in this survey.

Plan of the Historic Grave Showing Existing Cracks
(as at 26 February 2011)

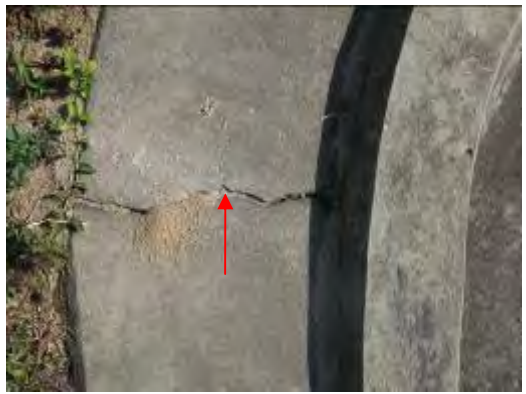
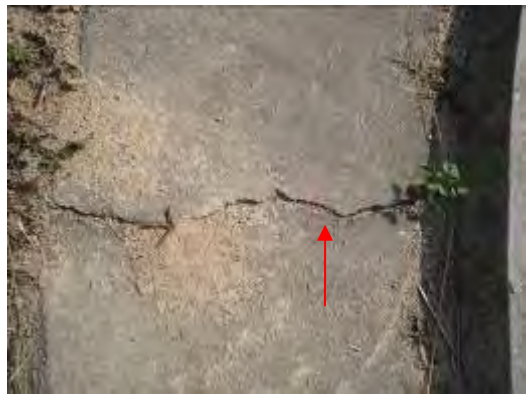
Crack No.	Current Crack Width (mm)	Photographic Record	
		Condition Survey Undertaken on 18 December 2010	Condition Survey Undertaken on 26 February 2011
5	5.6

No new cracks are identified during this condition survey. The crack widths for 22 cracks out of the 26 cracks as shown in *Table 3.1* remain unchanged. However, four cracks were recorded to have very slightly widened (0.1mm-0.2mm). The crack width change is presented in *Table 3.2*.

In view of the surrounding dense vegetation and the grave being exposed, existing cracks are likely to be slightly widened by weathering (such as raining, intermittent heating and cooling), root encroachment of overgrown vegetation and the platform built by an unknown third party adjacent to the grave used as a car park since November 2009. *Figures 3.3* and *3.4* show the general views of the platform.

The settlement monitoring suggested that there is no settlement or differential settlement at the grave and therefore the slight increase of crack width is unlikely due to the construction works. The slight increase of the crack width will not affect the structural integrity of the grave. However, they

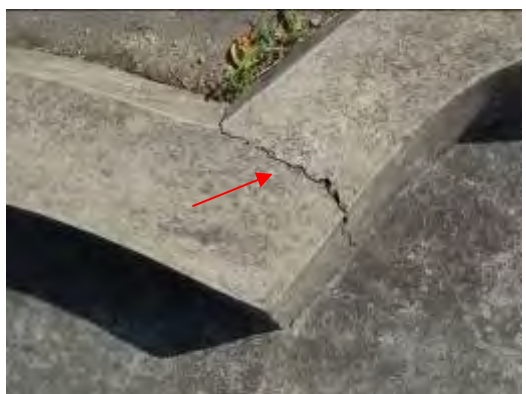
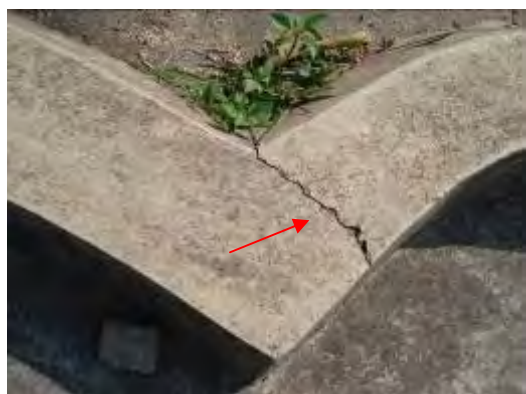
A photograph showing the same horizontal crack in the concrete surface. A red arrow points to the crack. The crack width appears to have increased compared to the 2010 survey.
6	1.6

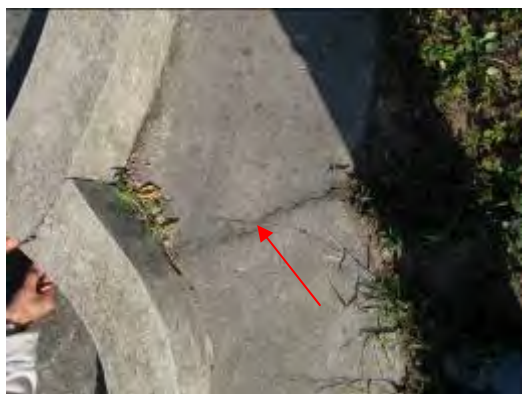
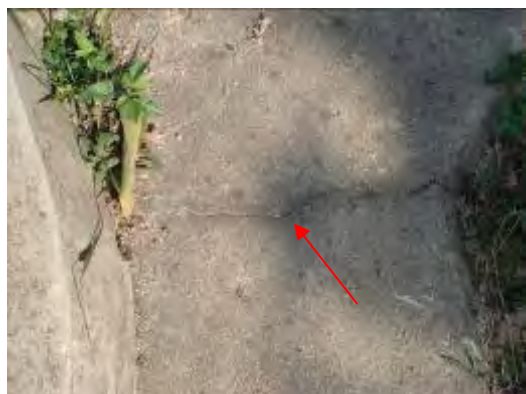
A photograph showing the same diagonal crack in the concrete curb. A red arrow points to the crack. The crack width appears to have increased compared to the 2010 survey.
7	1.7

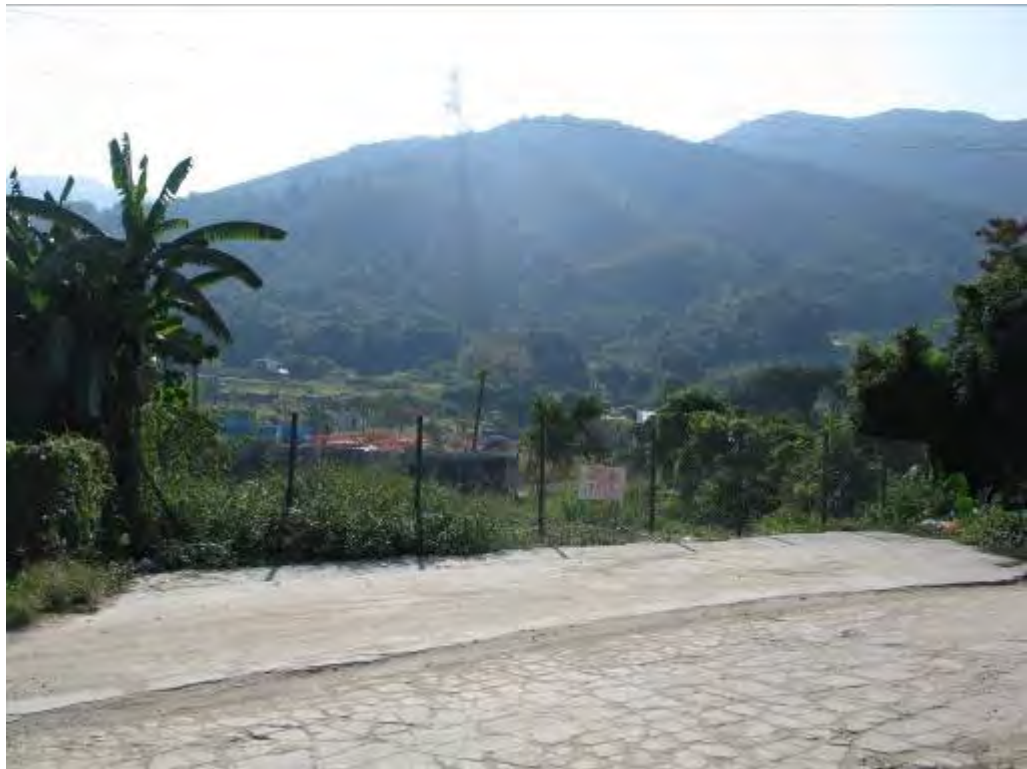
Furthermore, as first reported in the condition survey dated 21 August 2010, the site clearance at a place approximately 67m away from the grave in its southwest direction by an unknown third party took place on 19 August 2010. After the occurrence of the site clearance activity, it was reported by the Contractor via letter dated 29 September 2010 that during their site inspection on the same day they noted the concerned area had been fenced off and a sign board had been erected by District Lands Office, Yuen Long (DLO, Yuen Long). It is considered that the erection of the fence and sign board is to prevent people from trespassing, dumping or unlawful occupation on the concerned Government land. *Figures 3.5 and 3.6 show the general view of the recently erected fence and the sign board.*

Figure 3.5 General view of the fence restricting trespassing, dumping or unlawful occupation on the concerned Government land near the grave.

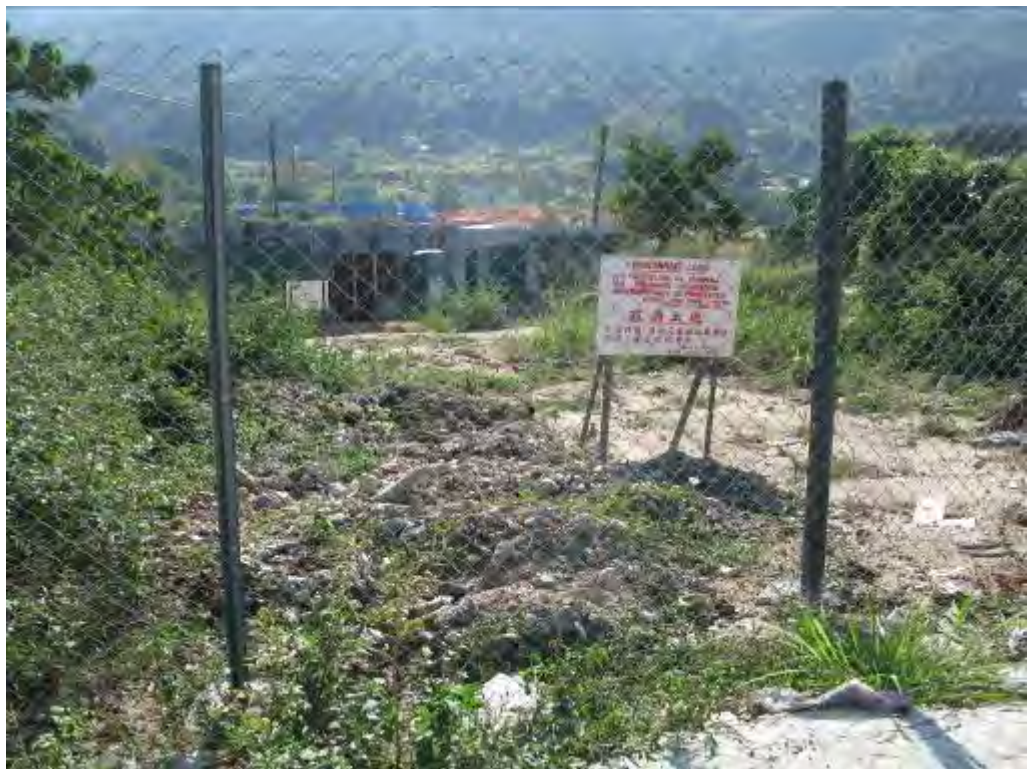
Figure 3.6 The sign board erected by DLO, Yuen Long near the grave

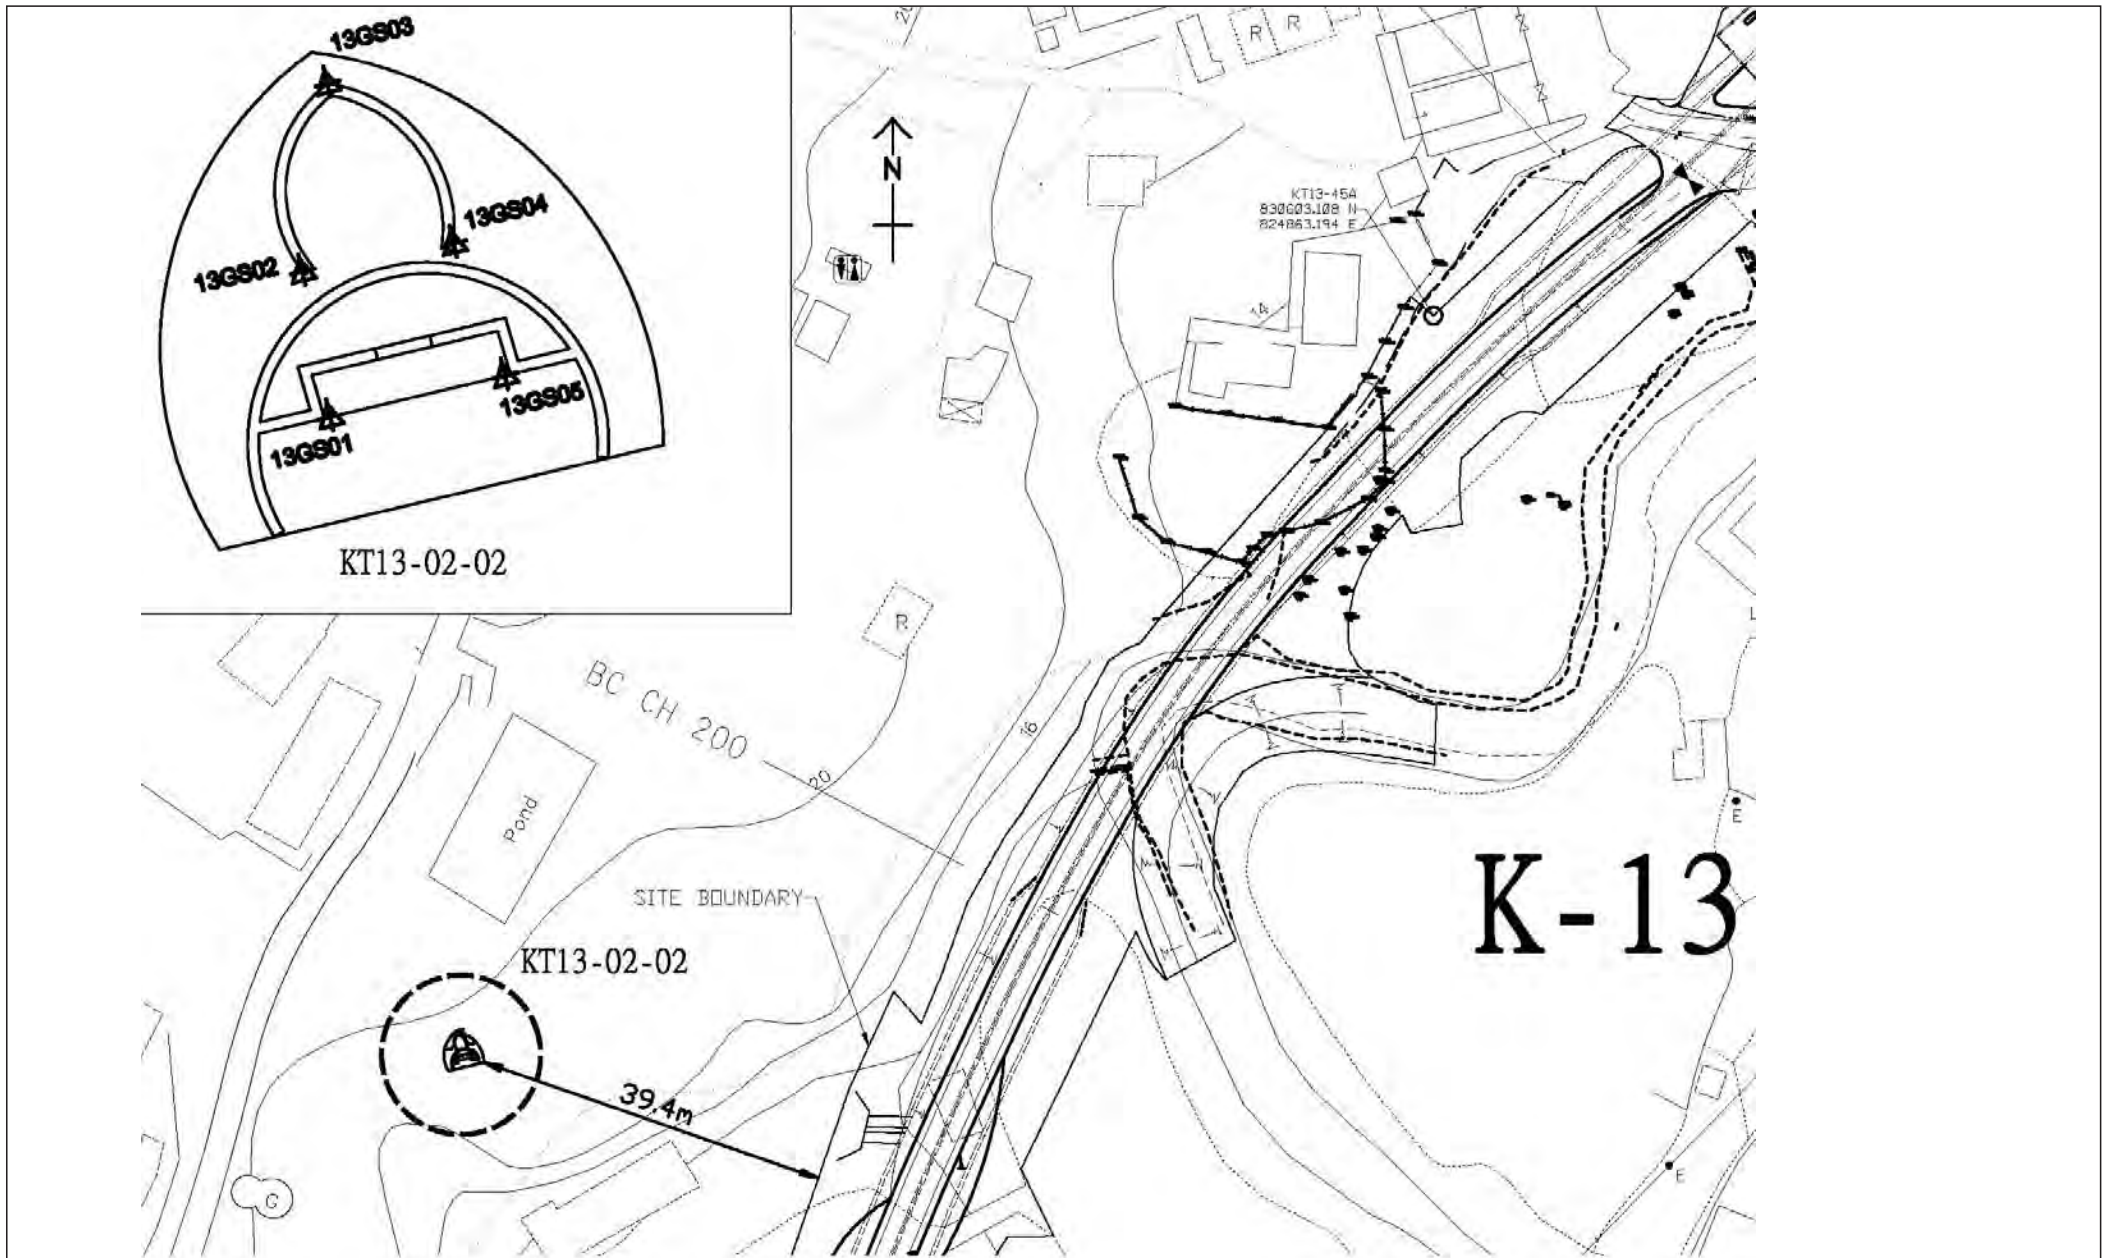
Figure 3.7

Point	Northing	Easting	Elevation (mPD) Initial Reading (Taken on 31 August 2009)	Elevation (mPD) Updated Reading (Taken on 26 February 2011)	Difference (mm)
13GS01	830520.25	824754.57	19.222	19.222	0
13GS02	830521.54	824754.32	19.985	19.986	+1
13GS03	830523.21	824754.54	20.644	20.643	-1
13GS04	830521.79	824755.67	19.943	19.944	+1
13GS05	830520.61	824756.12	19.211	19.211	0
