PROJECT No.: TCS/00408/08

DSD CONTRACT NO. DC/2007/17
DRAINAGE IMPROVEMENT WORKS IN
CHEUNG PO, MA ON KONG, YUEN KONG SAN TSUEN
AND TIN SAM TSUEN OF YUEN LONG DISTRICT AND
SEWERAGE AT TSENG TAU CHUNG TSUEN, TUEN MUN

MONTHLY EM&A REPORT FOR KT13
(JUNE 2011)

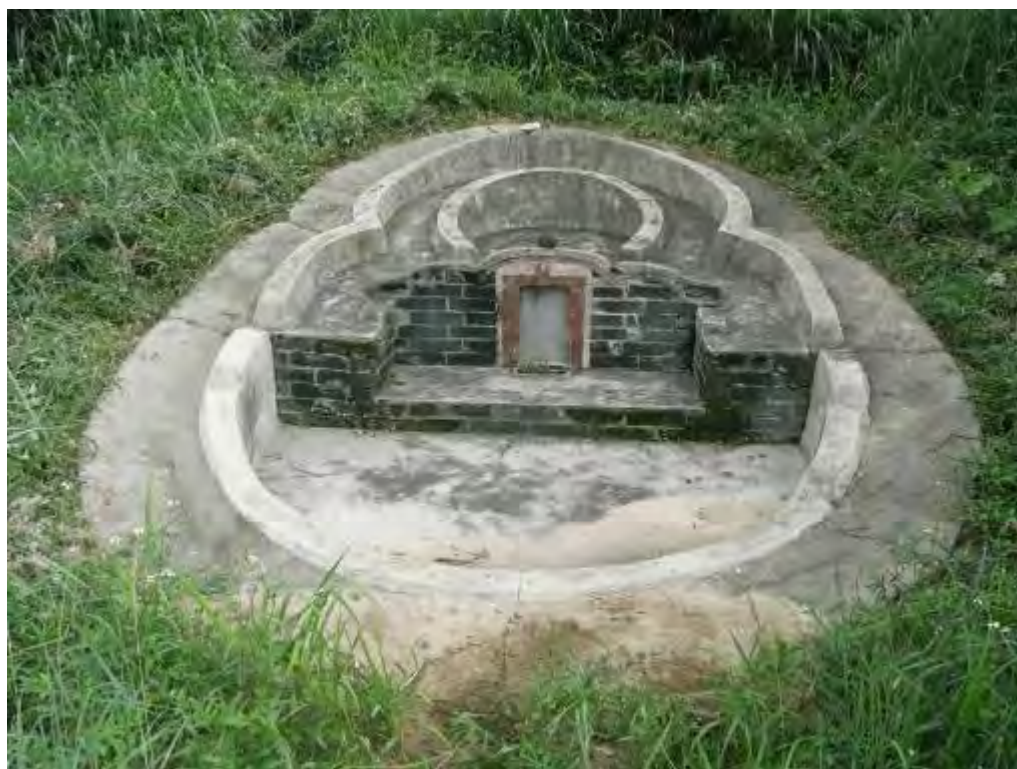
Figure 3.1 Front View

At the time of the monitoring on 25 June 2011, the grave was in good condition with rather serious weeding problem. *Figure 3.1* shows the general view of the grave after weeding.

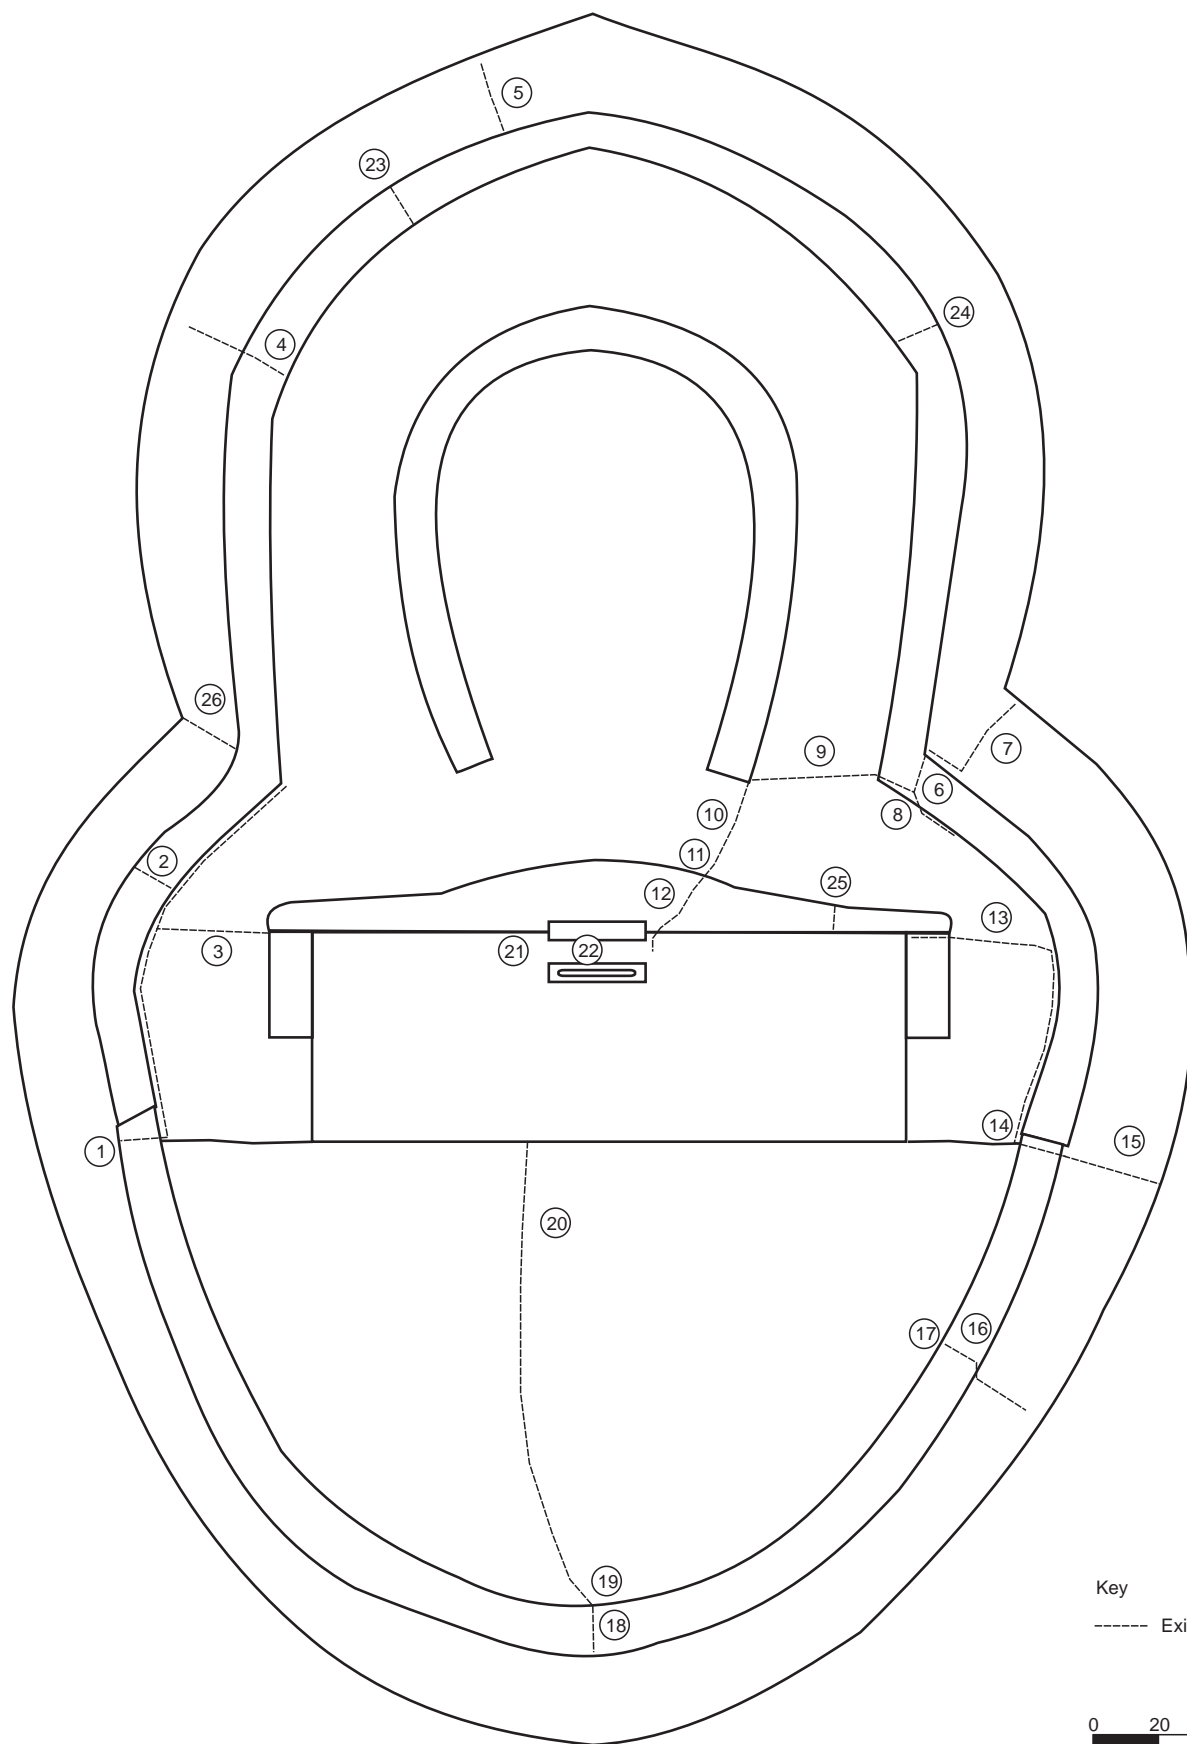
Figure 3.2

A total of 26 cracks were identified on the cement rendering, mortar of bricks and headstone of the grave. Their locations are shown in *Figure 3.2*. Crack width ranged from hairline to 5.6mm. *Table 3.1* details the cracks identified on the grave photographically and compares the cracks identified during last condition survey and those in this survey.

Plan of the Historic Grave Showing Existing Cracks
(as at 25 June 2011)

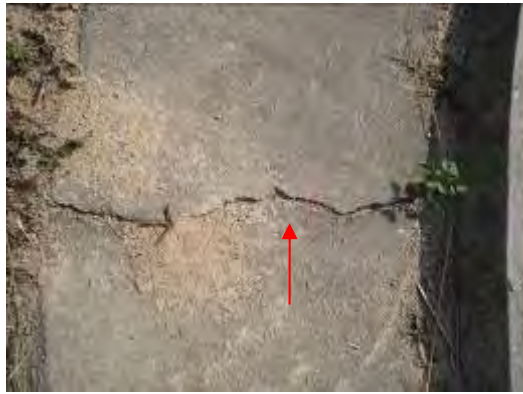
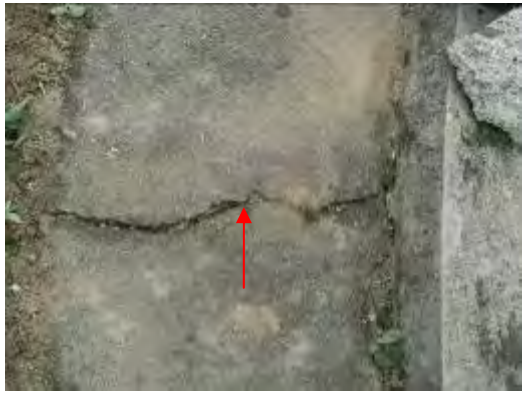
Crack No.	Current Crack Width (mm)	Photographic Record	
		Condition Survey Undertaken on 26 February 2011	Condition Survey Undertaken on 25 June 2011
5	5.6

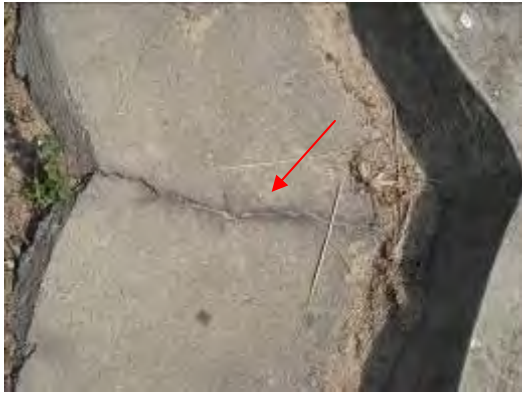
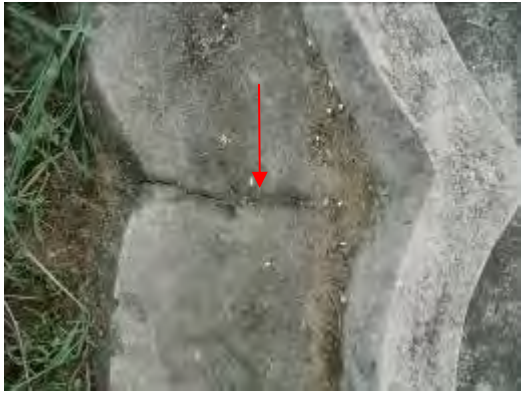
26	2.55

No new cracks are identified during this condition survey. The crack widths for 23 cracks out of the 26 cracks as shown in *Table 3.1* remain unchanged. However, three cracks were recorded to have very slightly widened (0.05mm-0.1mm). The crack width change is presented in *Table 3.2*.

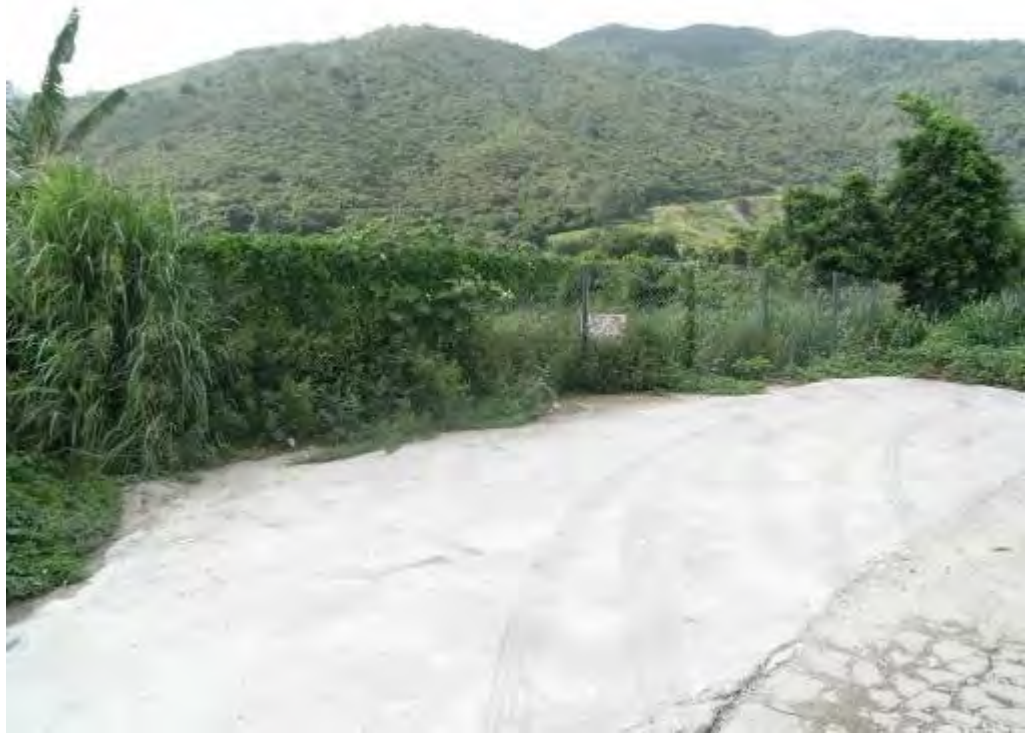
Figure 3.5 *General view of the fence restricting trespassing, dumping or unlawful occupation on the concerned Government land near the grave (photo taken on 25 June 2011)*

Furthermore, as first reported in the condition survey dated 21 August 2010, the site clearance at a place approximately 67m away from the grave in its southwest direction by an unknown third party took place on 19 August 2010. After the occurrence of the site clearance activity, it was reported by the Contractor via letter dated 29 September 2010 that during their site inspection on the same day they noted the concerned area had been fenced off and a sign board had been erected by District Lands Office, Yuen Long (DLO, Yuen Long). It is considered that the erection of the fence and sign board is to prevent people from trespassing, dumping or unlawful occupation on the concerned Government land. *Figures 3.5 and 3.6 show the general view of the recently erected fence and the sign board.*
