**YUNG SHUE WAN AND  
SOK KWU WAN VILLAGE SEWERAGE,  
STAGE 1 WORKS**

**QUARTERLY EM&A  
SUMMARY REPORT NO.5**

**(JUNE TO AUGUST 2009)**

Report No.: ENA90703

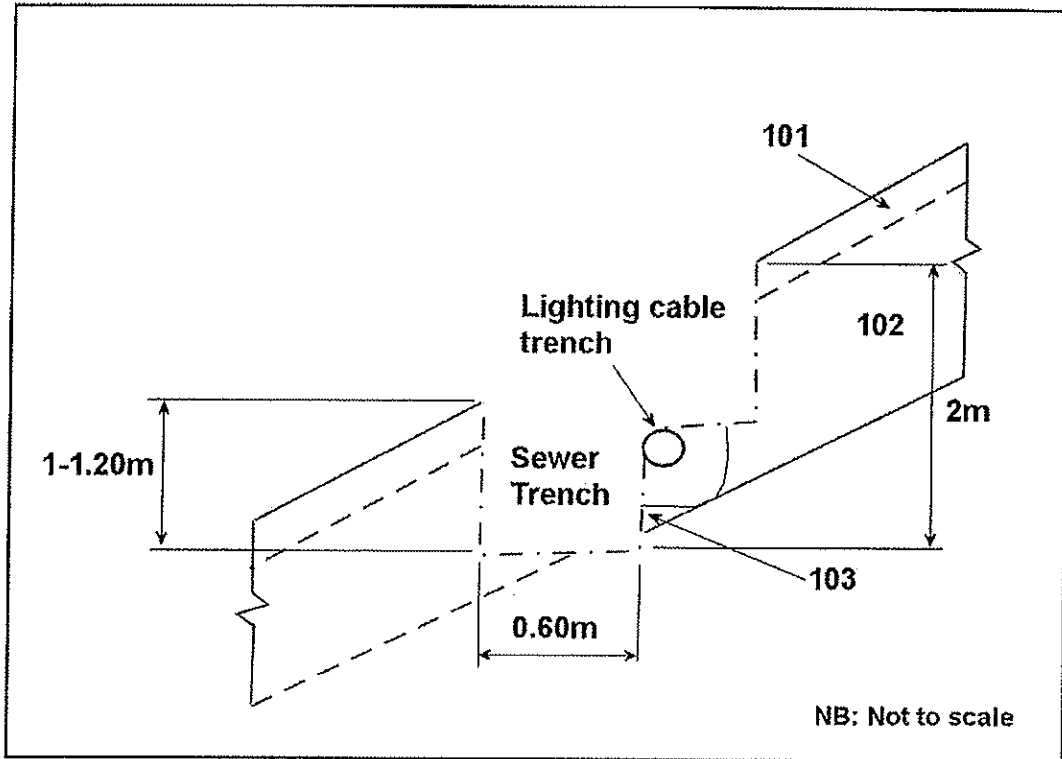
Figure 4: Transverse sketch section of sewer trench in environs of MH S53 – looking north

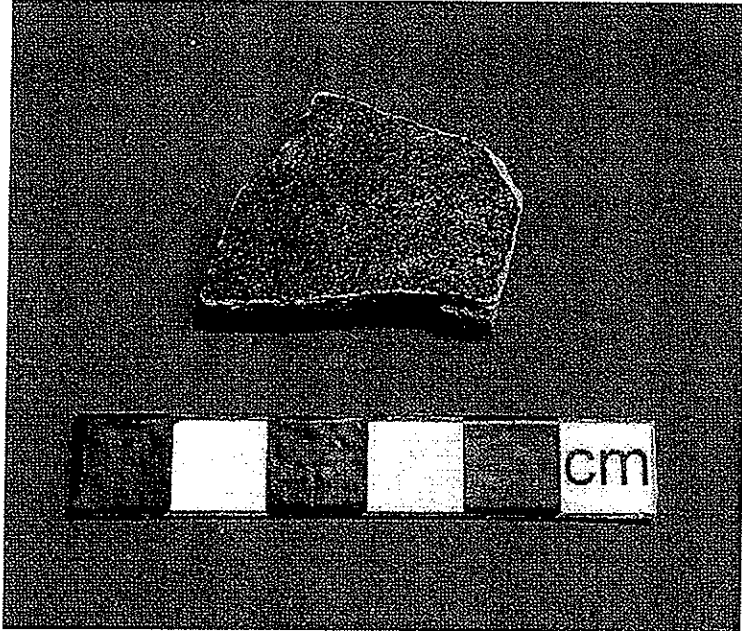
The lower two deposits were completely sterile and can be interpreted as *in situ* decaying granite (103), overlain by an associated clay-rich layer (102), which had all the appearances of mass-transported decayed granite (slope deposits). Sealing the above granite-derived layers was a naturally-accumulating forest soil (101). No cultural horizons/deposits were identified, but one undiagnostic sherd of village ware pottery was recovered from the surface of 101 (see Plate 7).

Plate 7: Undiagnostic village ware sherd found on surface of topsoil 101

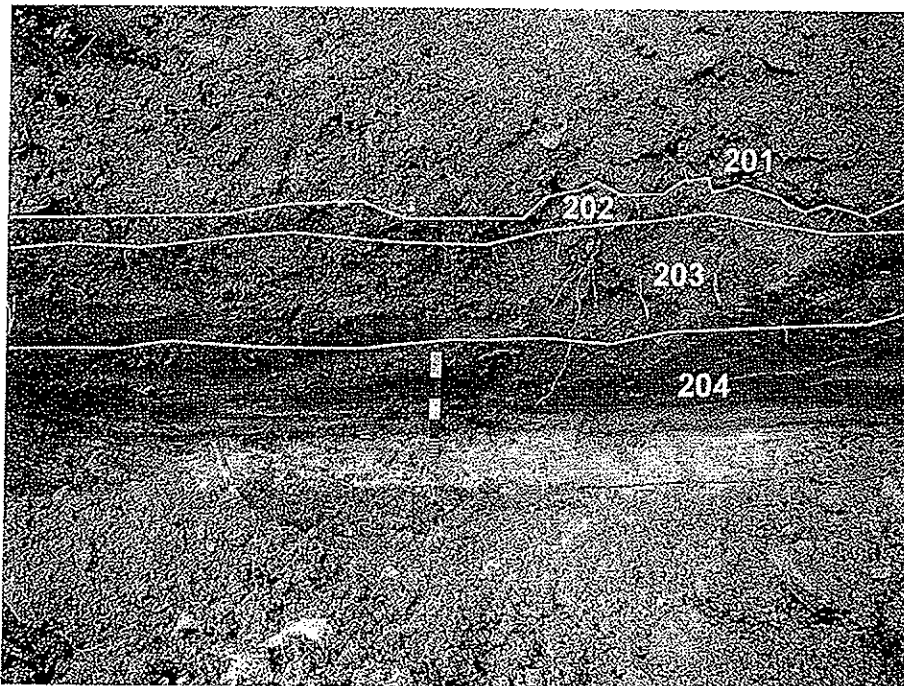
Plate 11: East facing section in environs of MH S51A

Between MH S51 and S52 – in the environs of MH S51A, the sequence was as follows: c.0.60m thick (at l.o.e.) strong brown (7.5YR 5/6) slightly gravelly clay (204); overlain by a c.0.50m thick layer of reddish yellow (7.5YR 6/8) very gravelly clay (203); which was covered by an approximately 0.1m thick greyish brown (10YR 5/2) slightly sandy, clayey silt (202), which was in turn sealed by the concrete raft surfacing of the footpath (201) – see Plates 11 and 12. A modern water pipe was noted running along the eastern side of the sewer trench and an electricity cable along the west, but neither was allocated a context number.

The lower two deposits (204 & 203) were completely sterile and can be interpreted as mass-transported decayed granite, with clay-rich layer 204 perhaps reflecting water-borne finer material and layer 203 a more gravelly debris flow-type component. Layer 202 can be interpreted as a thin forest soil equivalent to 101 above. On the upper portion of the alignment, between MH S50 and S51, Layer 202 had apparently been removed during levelling works for the path. No finds were recovered and no cultural horizons/deposits were therefore identified.
