PROJECT No.: TCS/00553/11

CONTRACT NO. DC/2010/02 –
DRAINAGE IMPROVEMENT IN SHUEN WAN AND
SHEK WU WAI

MONTHLY ENVIRONMENTAL MONITORING AND
AUDIT REPORT (NO.41) – NOVEMBER 2014

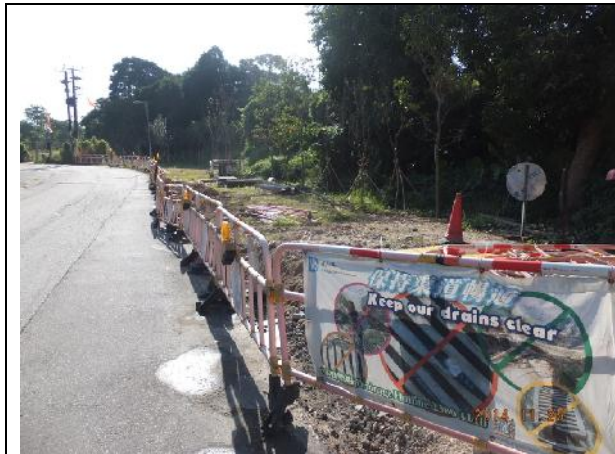
Photo 1 – Temporary hoardings have been erected along Tung Tsz Road opposite to Wai Ha.

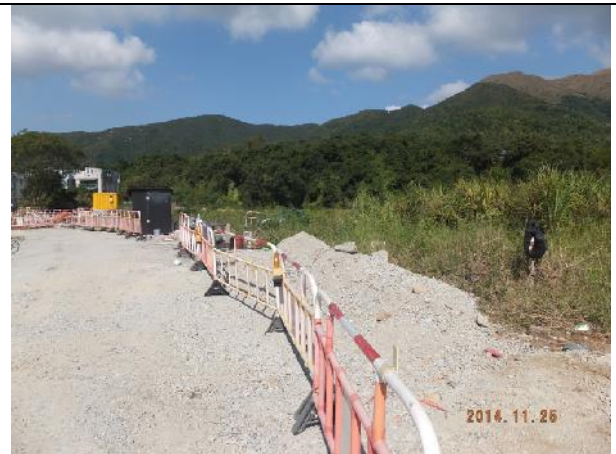
Photo 2 – Temporary hoardings have been erected along the access road from Tung Tsz Road to Treasure Spot Garden II.

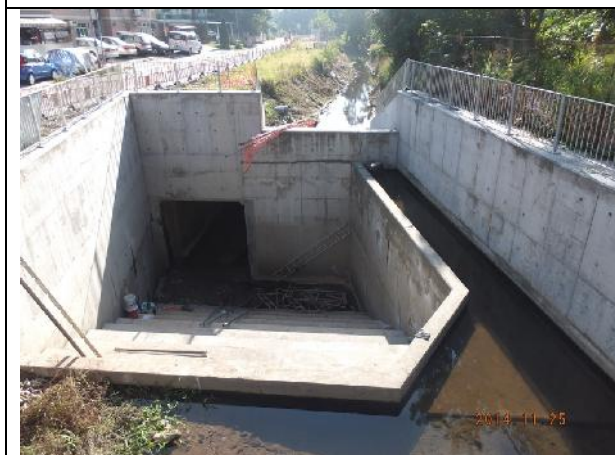
Photo 3 – No active construction works was carried out in the built box culvert and its associated structure.

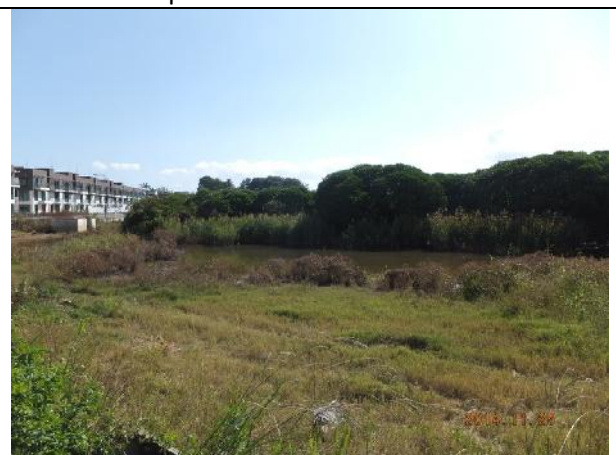
Photo 4 – No construction work was conducted in an extensive area opposite to Treasure Spot Garden II, and the area was naturally vegetated with grass and a tidal pond was maintained.

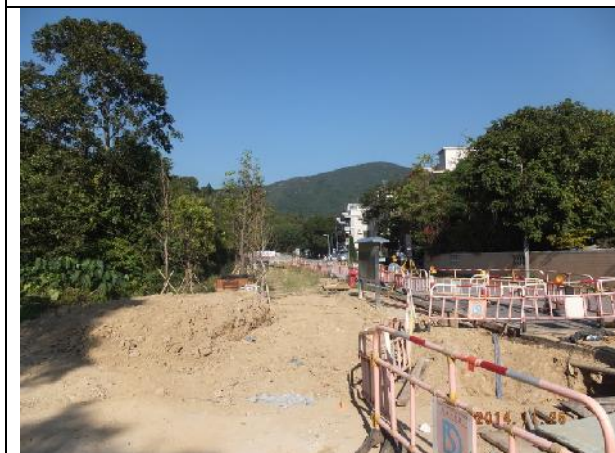
Photo 5 – No construction work was conducted in area opposite to Wai Ha.

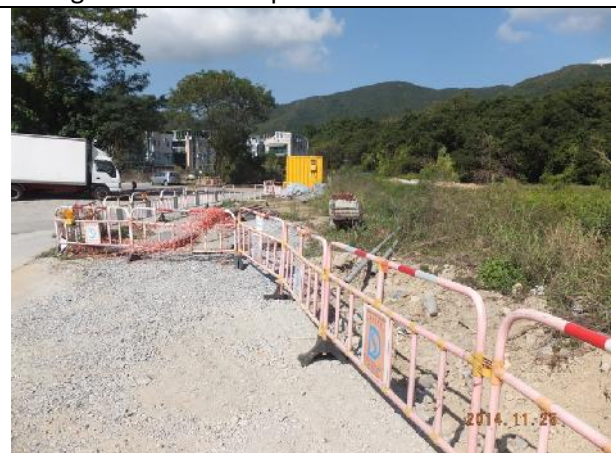
Photo 6 – Minor civil work was continued along the access path leading from Tung Tsz Road to Treasure Spot Garden II.

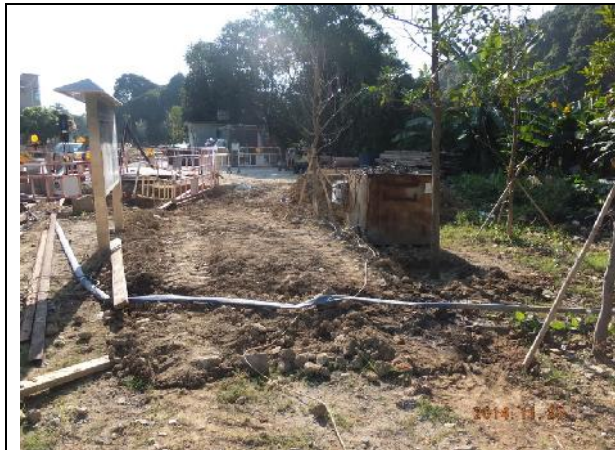
Photo 7 – Minor civil work was conducted for building a refuse collection point opposite to Wai Ha area.

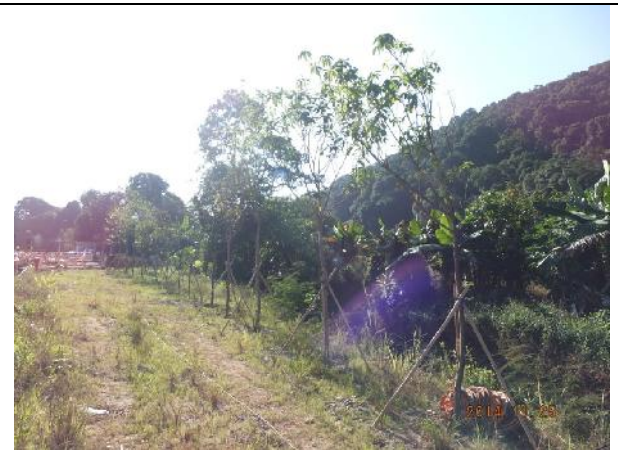
- 3.6.13 All compensatory trees were planted in October 2014 (**Photos 8-9**), leaving replacement of individual trees of poor condition to be conducted in the wet season. Transplantation stock and poor health condition were noted on some trees (such as *Litsea glutinosa* and *Sapium sebiferum*), but planted trees *Hibiscus tiliaceus*, *Celtis sinensis* and *Ficus virens* were in generally fair condition.

Photo 8 – Compensatory trees were planted in area opposite to Wai Ha.

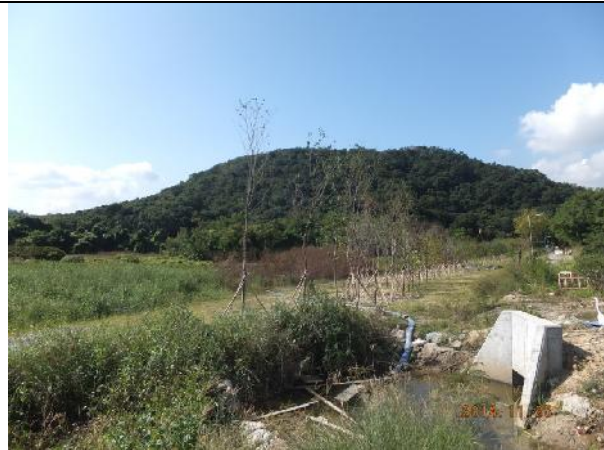
Photo 9 – Compensatory trees were planted in area opposite to Treasure Spot Garden II.

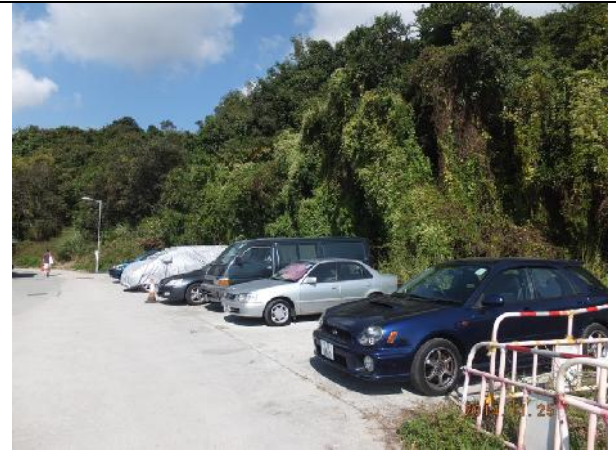
Photo 10 – Temporary parking area has still been maintained at the end of the access path to Treasure Spot Garden Phase II.

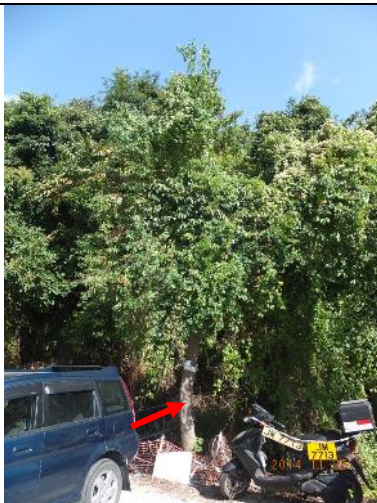
Photo 11 – The untagged tree (indicated by Red arrow) was guyed at the edge of the parking area within a Tree Protection Zone.

3.6.22 As the concrete paved temporary parking area at Treasure Spot Garden Phase II was close to the untagged tree, the roots may be damaged and hence the stability of the tree would be affected. The tree may also be damaged by the parking vehicles. Therefore, the Contractor is advised to maintain the tree protection measures and establish a warning sign to remind the driver to beware of the presence of tree within the tree protection zone. The health and stability of the tree should also be monitored by the Contractor regularly throughout the construction phase.

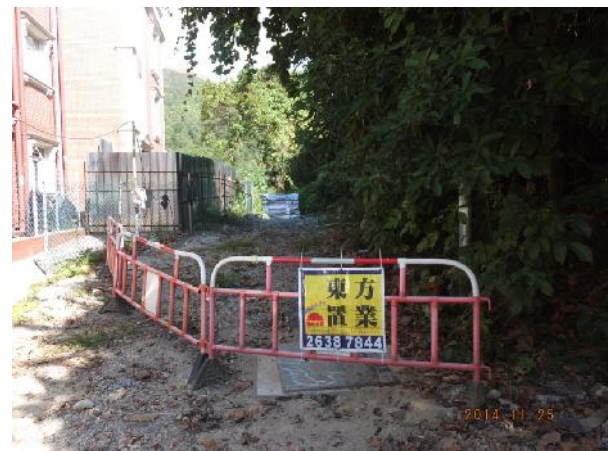
Photo 12 – Construction works have been stopped at the end of the Treasure Spot Garden II near the retained tree T103 and it was surrounded by temporary construction barriers.

- 3.6.18 For the retained tree T103, if practical, it is recommended to remove the overgrown climbers on the tree canopy so as to reduce the crown load supported by this tree. The Contractor should have close monitoring of the stability and health condition of this tree. In addition, the Contractor should remove the remaining stones or construction materials that have been piled close to the trunk flare as soon as possible, and all stockpiled materials should be removed away from the tree once the civil work would be completed in a few months later.

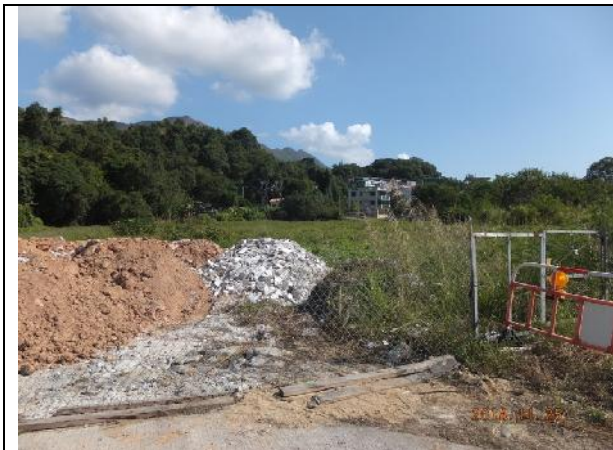
Photo 13 – A fenced area has been seen on the field next to the construction site along the access to Treasure Spot Garden II since March 2014.

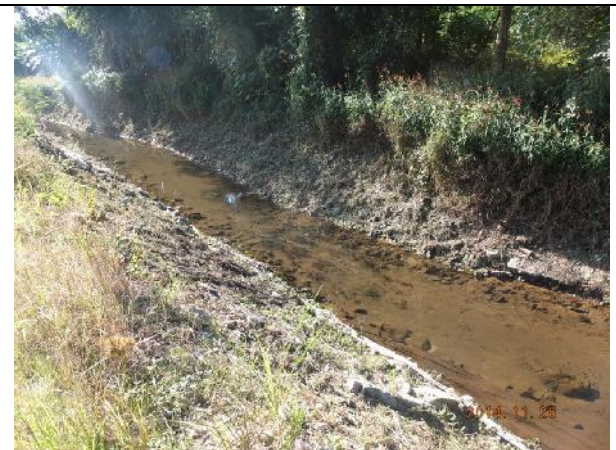
Photo 14 - The river water was clear in the upper stream section of Wai Ha River.

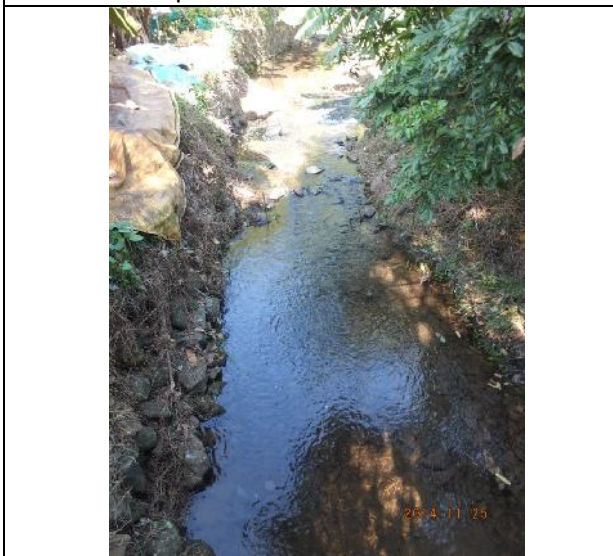
Photo 15 – The river water in the upper stream was clear near the tree group T138-T141.

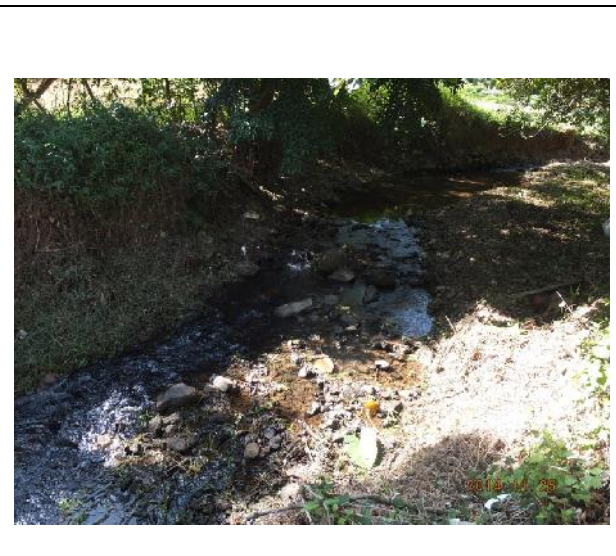
Photo 16 – No direct water discharge into the upper stream of Wai Ha River was observed.

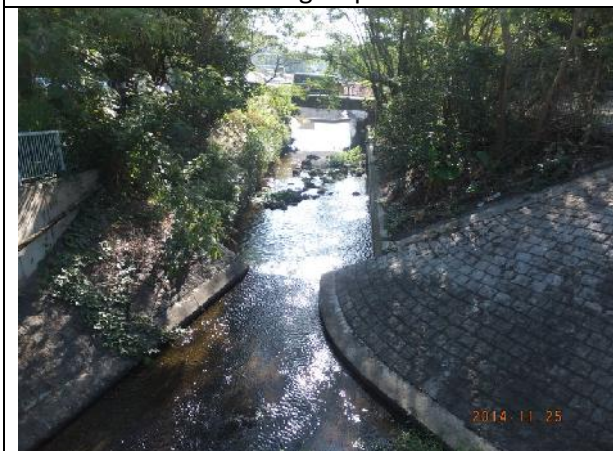
- 3.4.2 Major construction works in Contract 2 works area were completed, leaving comparatively minor civil works conducted in area near Treasure Spot Garden II and some next to Wai Ha. No used water has been released from the works area nearby Wai Ha River. The river water was clear (**Photos 14-16**).
- 3.4.3 As noted in Section 3.3, water used to clean the underground box culvert and the associated drainage pipes was discharged through the drainage outfall to the marsh area. As informed by the Contractor, such discharge was a temporary work only and similar observation was not noted on 25th November 2014.
- 3.4.4 No direct water discharge into the upper stream of Wai Ha River was observed as all major construction works in Contract 2 works area have been completed (**Photo 17**).

Photo 17 – No direct water discharge into the upper stream of Wai Ha River was observed as all major construction works in Contract 2 works area have been completed.

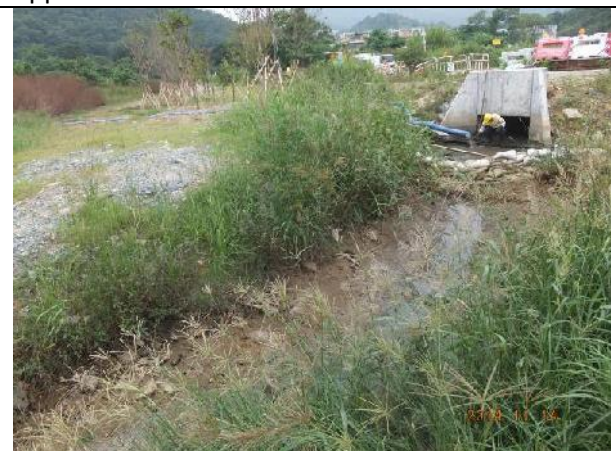
Photo 18 – Water used to clean the underground box culvert was discharged through the drainage outfall to the tidal marsh area.

- 3.4.6 The Contractor should have *ad hoc* inspection and emergency measures for any accidental spillage of polluted fluid, contaminants or grease from the construction sites. It is also recommended to overlay PVC liners along the site edge and remove any surplus sand and gravels deposited in the beds and tank so as to prevent the impact of the unclear discharge on the nearby vegetated area.

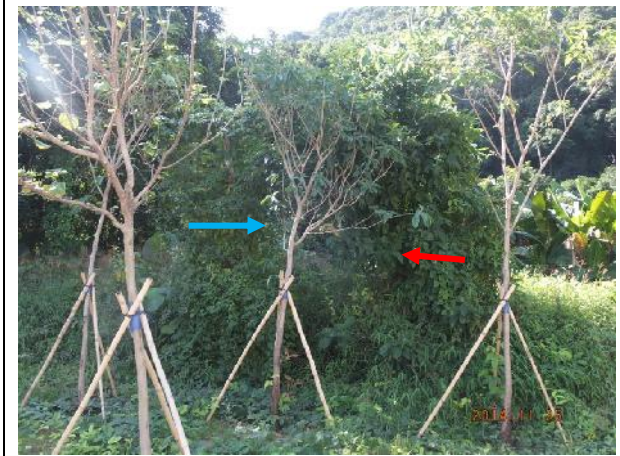
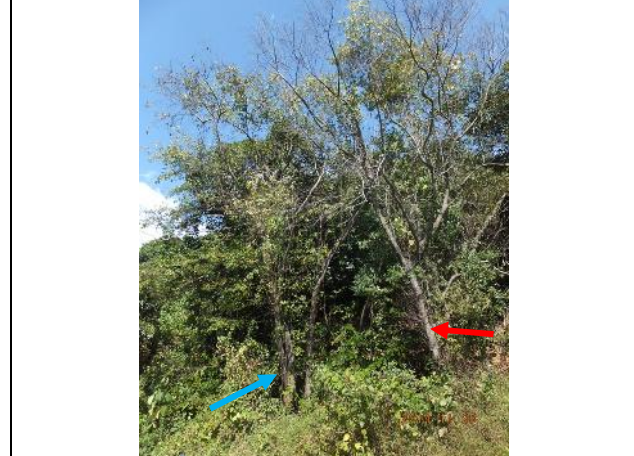
- 3.6.4 As reported in the submitted Reports, the retained trees T167 (*Litsea monopetala*) and T168 (*Celtis sinensis*) were topped after the vegetation clearance in the surrounding works area in November 2013. Both of them have been monitored since the topping incident, and both were in fairly poor health condition with vigorous development of epicormics along trunks or branches (**Photo 19**). Tree canopies of T167 and T168 were only formed by these watersprouts.

<p>Photo 19 – Topped trees T167 (indicated by Red arrow) and T168 (indicated by Blue arrow) were in poor health condition with vigorous development of epicormics.</p>	<p>Photo 20 – T093 (Red arrow) and T094 (Blue arrow) on the slope. One of the co-dominant trunks of T093 showed significant defoliation and poor health condition.</p>

- 3.6.20 Tree topping (like the case for T025, T167 and T168 reported previously) should be prohibited and the Contractor should appoint qualified landscape contractor to perform appropriate pruning practice. The pruning works should follow any local, national or international standards for pruning works and relevant tree remedial works. Given that the tree roots of T025 could be damaged by previous sheet piling works and the topped tree exists with unbalanced tree form, the long-term tree stability and health condition should be checked after the removal of the guying in October 2014. The Contractor should have close monitoring of tree stability with regard to its unbalanced tree form and health condition. Meanwhile, the Contractor and sub-contractor should carefully design the civil works. Any coming civil works

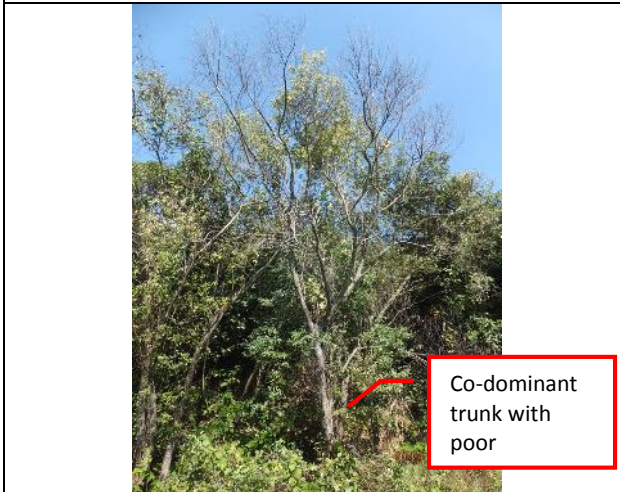
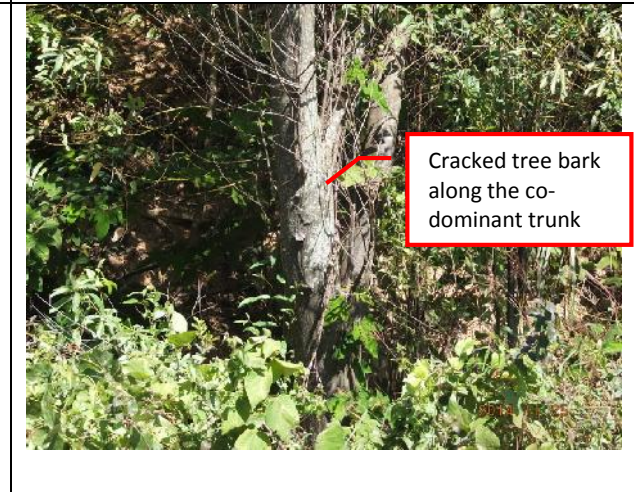
- 3.6.5 Temporary storage of construction materials close to the trunk flares of T093 and T094 (both *Litsea cubeba*) was removed in June 2014 in accordance with the recommendation listed in the submitted *Monthly EM&A Reports*. The previously discharged cement mortar on the soil has been covered by ground vegetation as inspected since August 2014 (**Photo 20**). The tree health of T093 has been declining since June 2014. No foliage has been observed on the main tree canopy since October 2014, and the previously developed watersprouts found on the tree trunk were very weak. Cracked tree bark was noted along the tree trunk and branches of

- one co-dominant trunk of T093, with sign of termite infestation noted along the lower tree trunk of this co-dominant trunk (**Photos 21-22**). The Contractor would remove the hazardous tree trunk and its canopy in early December 2014, leaving the relatively healthy co-dominant trunk of T093 pointing towards the forested area.

<p>Photo 21 – Close up view of the co-dominant tree trunk of T093 with poor condition.</p>	<p>Photo 22 – Close up view of the cracked tree bark along the lower tree trunk of T093.</p>

3.6.21 With regard to poor health and structural condition of a tree T093 and its tree fall zone may influence the public using the access path leading to Treasure Spot Garden II, the Contractor is recommended to remove the whole hazardous co-dominant trunk and its canopy of T093 as soon as possible so as to remove the risk of whole tree failure influencing the targets. As informed by the Contractor, this tree part would be removed in early December 2014.

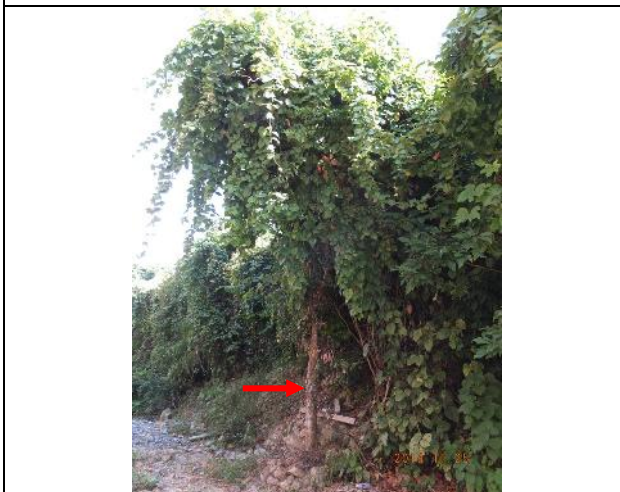
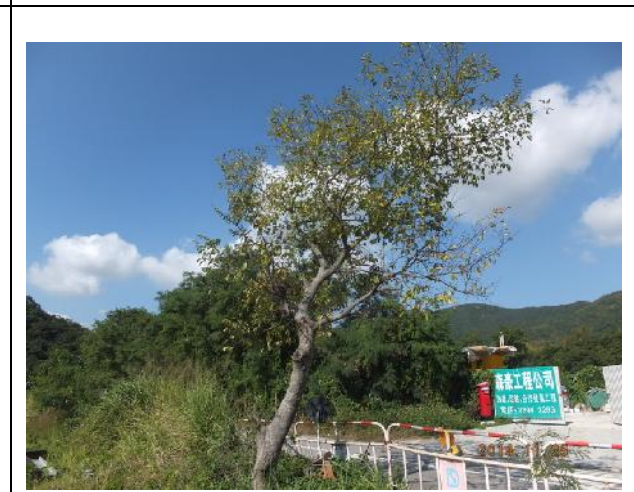
- 3.6.6 Construction works at the end of the Treasure Spot Garden have been stopped since July 2014 and minor civil work would be resumed in the coming months based on the information from the Contractor. As observed in November 2014, no additional piling of excavated soil and rocks was noted at the trunk flare of T103 (**Photo 23**), but a few wooden plates were still found close to the root flare. According to the information from the Contractor, the construction materials would be removed soon, while any stockpiled stones nearby the trunk flare of T103 would be removed once the civil work to be completed a few months later.

- 3.6.7 Sheet piling works were conducted within the tree root zone of a retained tree T025 (*Celtis sinensis*) in June 2013. Due to the close proximity of the erected sheet piles to the tree, root damage by previous sheet piling works was anticipated. The tree was also over-pruned in June 2013. It had been temporarily guyed by strings so as to provide additional support to the tree until September 2014. As observed in November 2014, the tree was quite stable at its location and it was in fair health condition (**Photo 24**).

<p>Photo 23 – No additional piling of excavated soil and rock was noted at the trunk flare of T103.</p>	<p>Photo 24 – The guying on the retained tree T025 was removed after mid-October 2014, and the tree was in fair condition.</p>

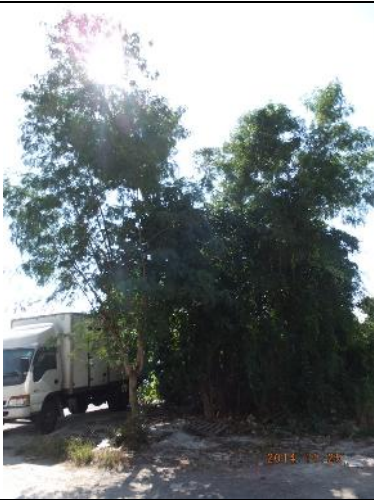
- 3.6.8 Concrete pavement, which was applied for additional parking area for the villagers, was still observed close to the root flare of the tree group T089-091, and the trees were in fair condition (**Photo 25**).

<p>Broken branch hanging within the canopies of the tree group</p>
<p>Photo 25 – Concrete pavement maintained for parking area for the villagers was still observed around the tree group T089-T091.</p>	<p>Photo 26 – One broken branch was noted hanging within the tree canopies of tree group T099-T102.</p>

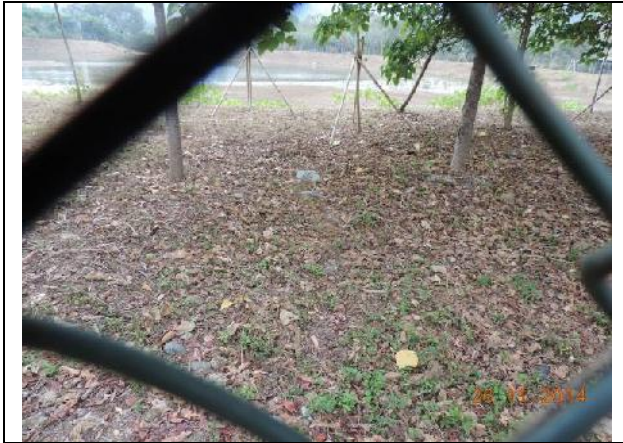
3.6.15 As Area C under Contract 1 of the Project has been formally handed over to AFCD for management and maintenance since October 2012, no access into the ECA is allowed. Two transplanted shrubs of *Pavetta hongkongensis* (PH-01 and PH-03) were inspected through the fence of Tung Tsz Nursery. PH01 has remained in satisfactory condition (**Photo 30**). The previously cut PH03 (cut during grass cutting by a third party who maintain the ECA) was cut again as observed in November 2014 (**Photo 31**).

Photo 31 – The transplanted shrub of *Pavetta hongkongensis* (PH03) was cut by the third party during the recent grass cutting work within Area C.
