CONTRACT NO. DC/2009/22
DRAINAGE IMPROVEMENT WORKS IN SHUEN WAN

CONTRACT NO. DC/2010/02
DRAINAGE IMPROVEMENT WORKS IN SHUEN WAN
AND SHEK WU WAI

MONTHLY ENVIRONMENTAL MONITORING AND
AUDIT REPORT FOR OPERATION PHASE-
MAY 2015

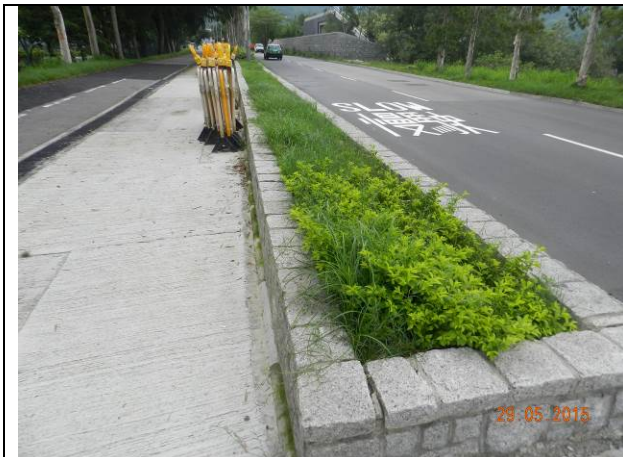
4.1.1 The roadside planters in Ting Kok Road were hydroseeded and planted with shrubs *Duranta erecta* which were in fair condition as observed in May 2015 (**Photo A1**).

4.7.1 The reinstatement works for the original access paths, ground of the nursery beds, basic nursery utility (such as irrigation pipes and lamp posts), shelters for potted plants, planters for transplanting trees, and wire mesh fences within the nursery were finished in Area B as observed in May 2015 (**Photo A6**). Some of the individual tree planters in the Nursery were broken, but the maintenance of these planters were already handed over and accepted by the Nursery in December 2014. The planters along Ting Kok Road were also reinstated (**Photo A1**).

Photo A1 – Planters at Ting Kok Road were hydroseeded and planted with shrubs.

4.1.3 The roadside planters in Ting Kok Road were handed over to Highway Department and under maintenance by the corresponding party. No further recommendation on the growth performance of these planters is given from the current observation.

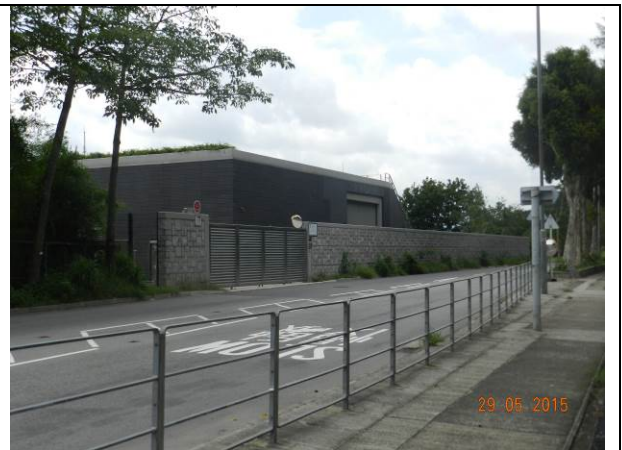
4.2.1 As observed in May 2015, the architectural design of the pump house generally follows the proposed materials and color (e.g. a wall of clay cladding to facilitate the development of climbers for vertical greening) as stated in the approved Landscape Plan (**Photo A2**).

Photo A2 – General appearance of the pump house in Area A.

4.2.2 No specific recommendation is required for this mitigation measure.

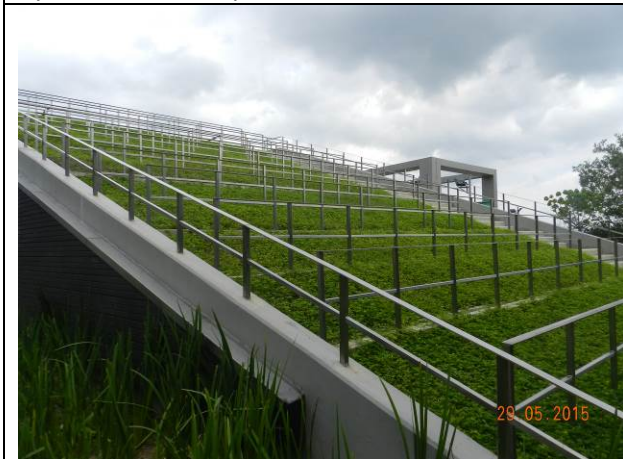
4.3.1 As observed in May 2015, the planted ground cover *Arachis duranensis* on the green roof was in fair condition (**Photo A3**). Other landscape design (including the planting of ground cover *Iris tectorum*, creeping climbers *Ficus pumila* and *Parthenocissus dalzielii*, shrubs *Ficus microcarpa* (Golden Leaf) and trees *Cinnamomum burmannii* were also in fair condition (**Photo A4**).

Photo A3 – View of sloping area with ground cover in the pump house.

4.3.2 The daily operation of the pump house were handed over to Drainage Services Department and under maintenance by corresponding party. No further recommendation is given from the current observation on the landscape planting within the pump house.

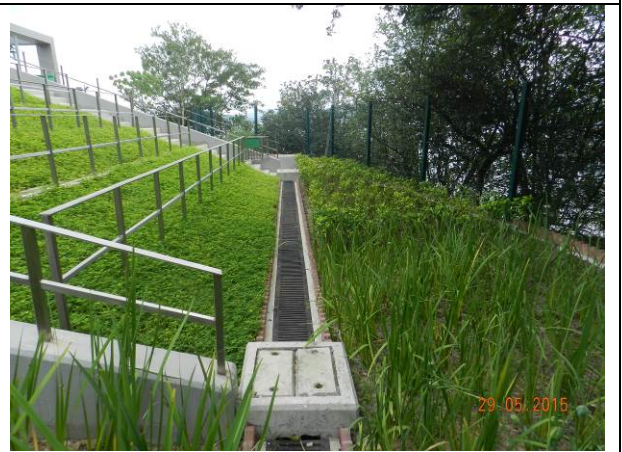
Photo A4 – Landscape design such as *Iris tectorum* and *Ficus microcarpa* (Golden Leaf) were in fair condition.

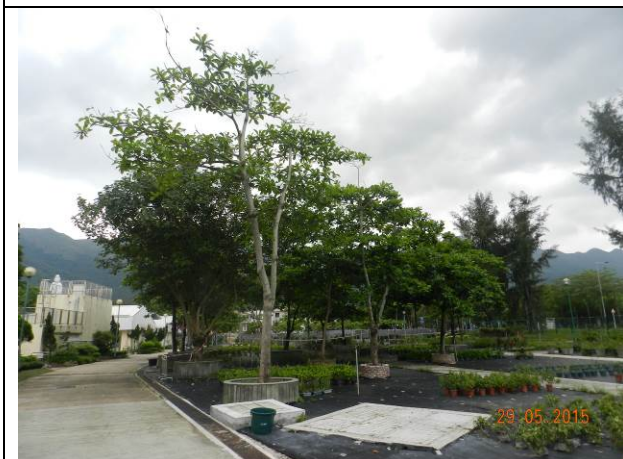
4.5.1 Transplantation of trees was finished during the early construction phase of Contract 1 (**Photo A5**). The health performance of these transplanted trees had been regularly monitored and reported during the construction phase. Any trees of poor performance were reported to the Contractor and replaced accordingly. Area B was handed over to Tung Tze Nursery after the construction phase, and the transplanted trees were under the maintenance of the Nursery Operator.

4.5.2 Some of the locations of the transplanted trees were different from those proposed in the approved Landscape Plan. Moreover, as reported during the construction phase, gap was observed between the root balls of some transplanted trees and the inner surface of their newly built planters. However, these trees were accepted by the Nursery Operator.

4.5.3 The remaining retained and transplanted trees within the nursery were maintained generally in fair condition, with no significant damage on tree crowns, trunks and roots observed during the monitoring in May 2015.

Photo A5 – Example of transplanted trees in Area B.

4.5.5 Area B was handed over to Tung Tze Nursery which will provide routine maintenance of these transplanted trees. No further recommendation is given under this mitigation measures.

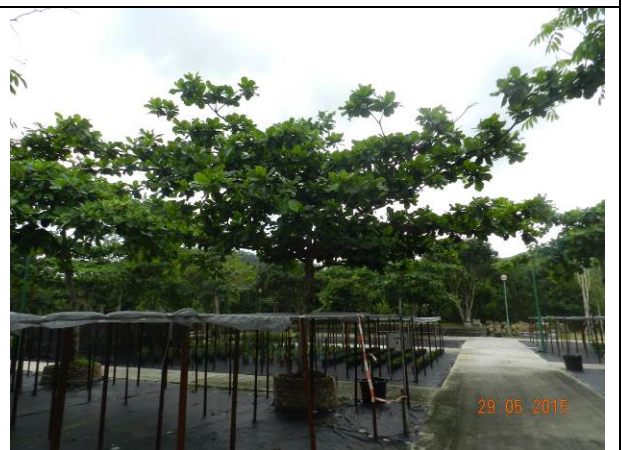
Photo A6 – Example of the completed reinstatement works within the nursery (such as lamp posts, shelters for potted plants and new planters for the transplanted tree).

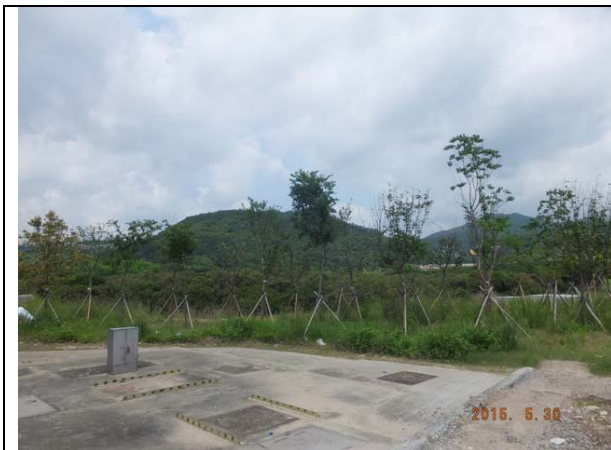
Photo B1 – Overall view of the compensatory trees planted opposite to San Tau Kok.

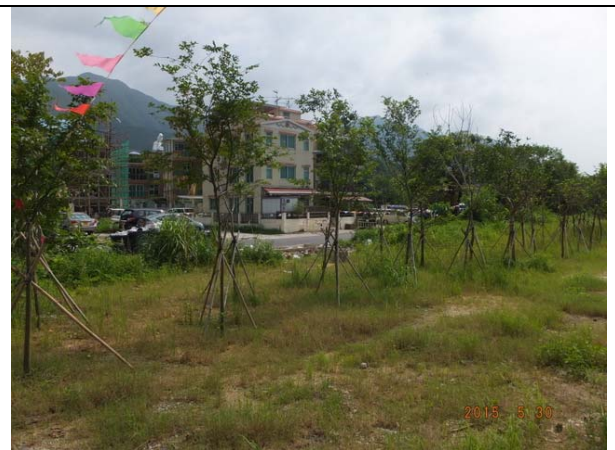
Photo B2 – Overall view of the compensatory trees planted opposite to Wai Ha.

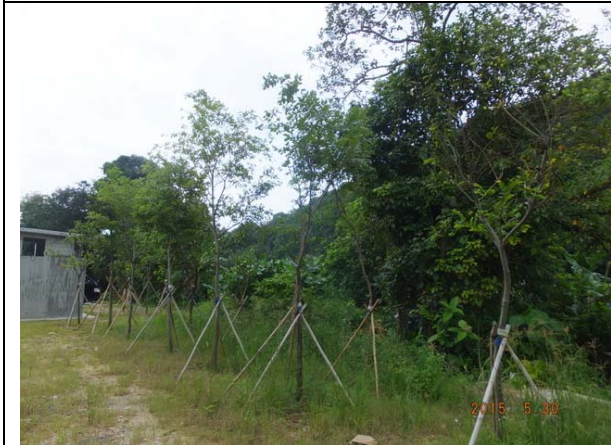
Photo B3 – Overall view of the compensatory trees planted opposite to Wai Ha.

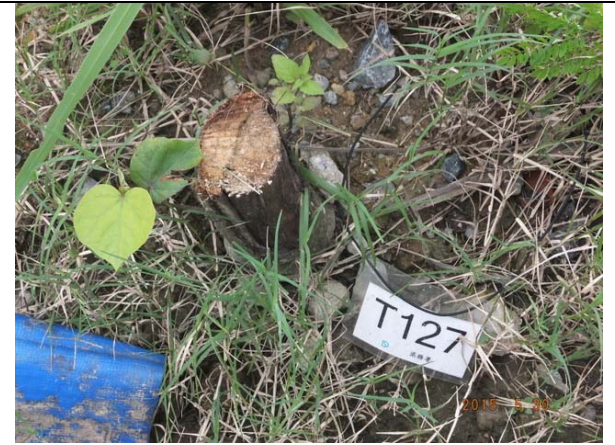
Photo B4 – A tagged compensatory tree *Hibiscus tiliaceus* was removed.

- 5.4.4 For the replacement of the removed compensatory tree due to previous tree failure under adverse weather, the Contractor and DSD will further liaise with the LandsD for any further follow-up action in replacing such compensatory tree within the handed over areas.

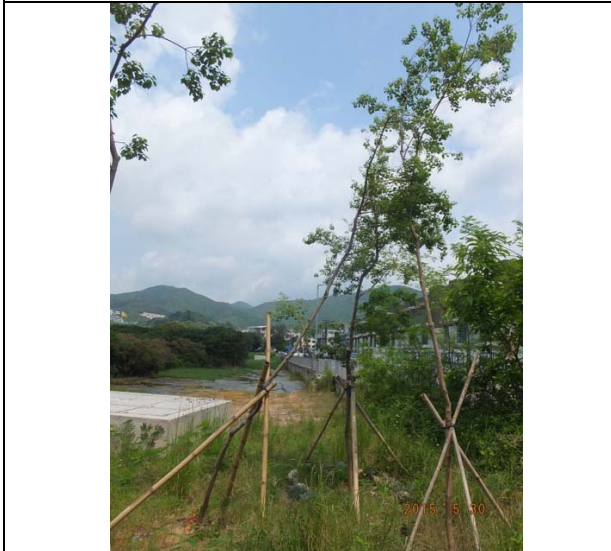
Photo B5 – A leaning compensatory tree was noted during the quarterly inspection.

should inform and discuss with the corresponding government department. While such negotiation is on-going and anticipated to be settled in the coming quarter, if practical, it is recommended to have regular watering for all planted compensatory trees by the appointed landscape contractor within the establishment period. The landscape contractor should replant the leaning tree trunks upright during the routine maintenance practice and should regularly check the stability and condition of the bamboo stakes used to support the compensatory trees. They should also remove the climbers on the bamboo stakes. Trees of less satisfactory health and/or structural condition should be replaced prior to the end of the establishment period of the trees.

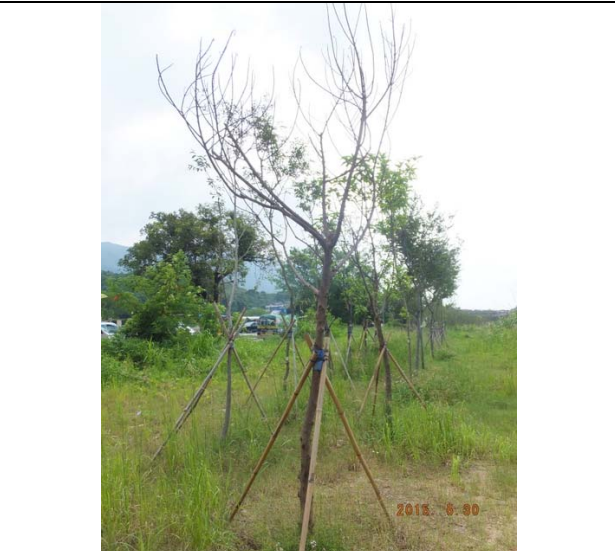
Photo B6 – No leaves were noted on a compensatory tree.

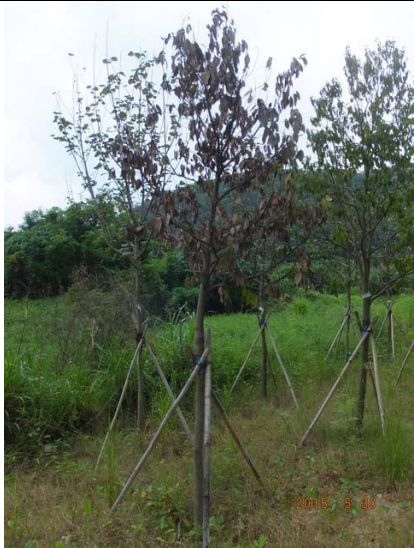
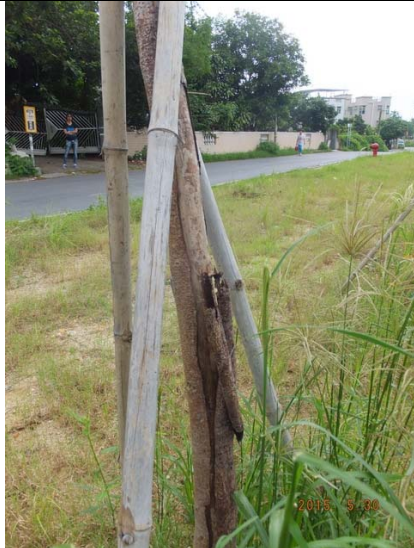
5.4.1 A total of 207 tagged compensatory trees were planted under Contract 2, and the planting work and replacement of trees with poor condition were completed in the end of the construction phase. The health conditions of these compensatory trees were generally in fair condition (**Photos B1-B3**). However, one of the compensatory tree *Hibiscus tiliaceus* (tree tag no. T127) was removed (**Photo B4**), this may due to previous tree failure under adverse weather. Four trees showed leaning tree trunks with unstable root balls (**Photo B5**). Some trees either showed wilt or no leaves in tree canopies (**Photos B6-B7**), or with tree defects, such as decayed wood on tree trunks and cracked tree bark (**Photos B8-B10**).

<p>Photo B7 – A compensatory tree showed wilt leaves in the whole tree canopy.</p>	<p>Photo B8 – A compensatory tree with peeled tree bark and decayed wood.</p>

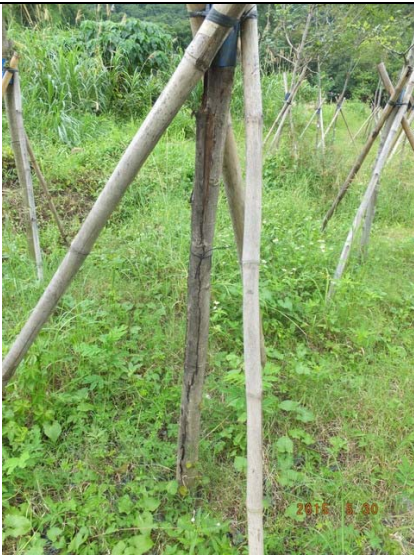
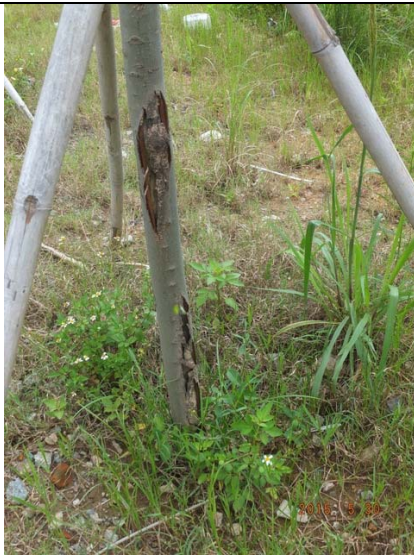
<p>Photo B9 – A compensatory tree with cracked tree bark.</p>	<p>Photo B10 – A compensatory tree with decayed wood.</p>

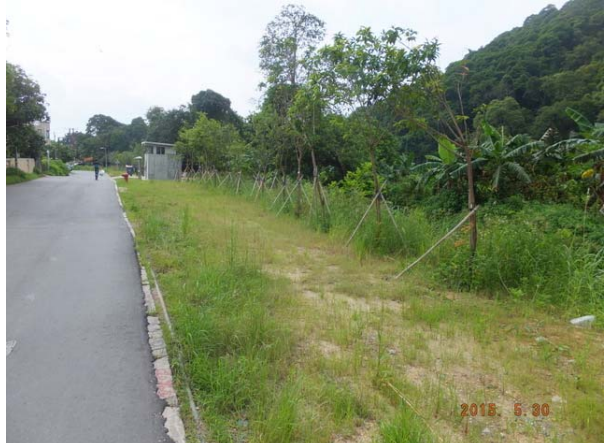
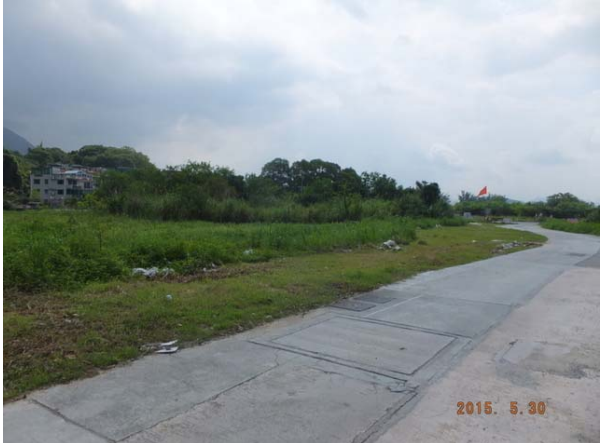
5.4.2 No shrub planting was proposed in the approved Landscape Plan, while hydroseeding was applied on the reinstated soil ground above the alignment of the box-culvert along Tung Tsz Road (**Photo B11**), as well as the reinstated area above the drain pipe along the access path leading towards Treasure Spot Garden II (**Photo B12**). Grass germination in these hydroseeded areas was in fair condition, and other native grass species have also naturally established in these areas.

<p>Photo B11 – The soil ground above the alignment of box-culvert was reinstated and hydroseeded.</p>	<p>Photo B12 – The reinstated area above the drain pipe along the pipe along the access path leading towards the village was hydroseeded.</p>

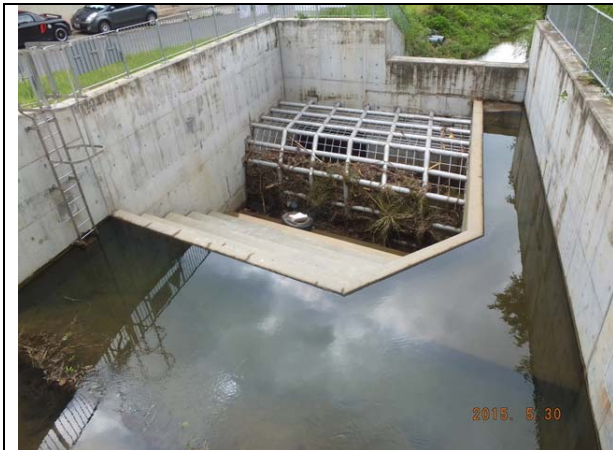
Photo B13 – The box culvert and the associated drainage work were completed at the upper part of Wai Ha River.

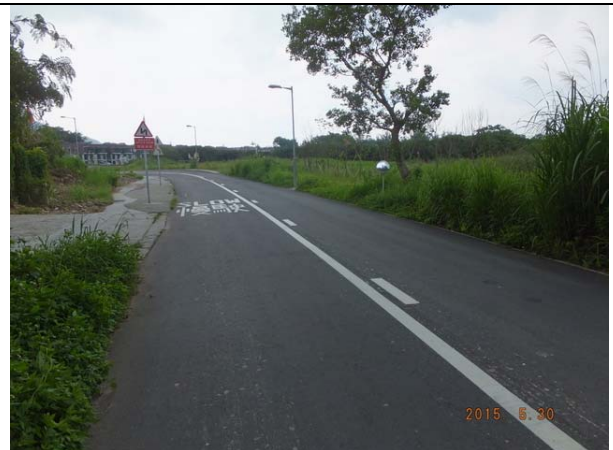
Photo B14 – The original access road (e.g. Tung Tsz Road) was reinstated.

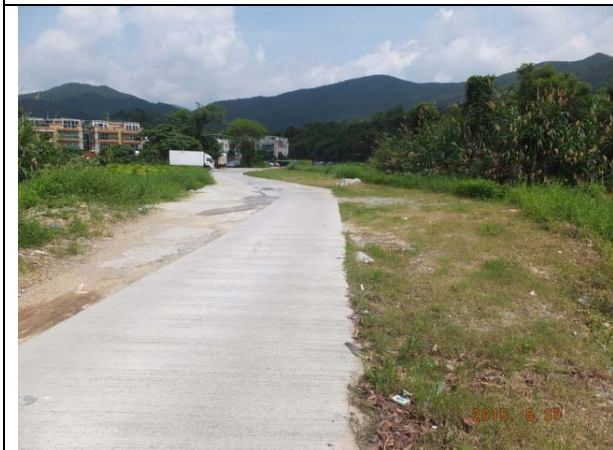
Photo B15 – The access path leading to Treasure Spot Garden II was reinstated.

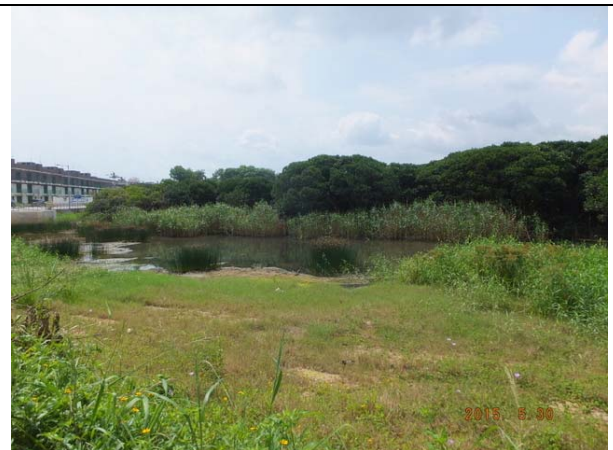
Photo B16 – The low-lying area with wetland character was reinstated in area opposite to Jade View Villa.

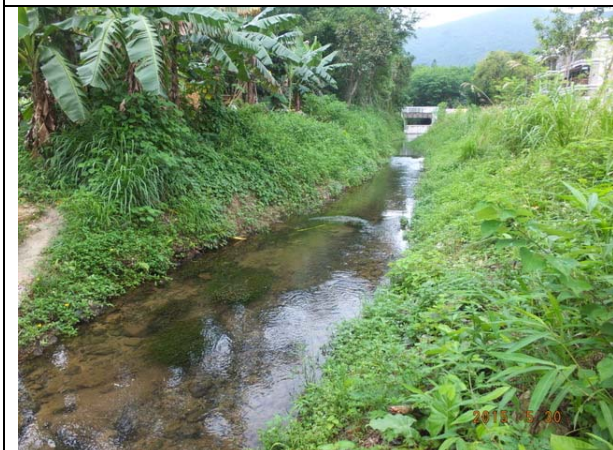
Photo B17 – Both bunds along Wai Ha River were naturally vegetated.
