CONTRACT NO. DC/2009/22
DRAINAGE IMPROVEMENT WORKS IN SHUEN WAN

CONTRACT NO. DC/2010/02
DRAINAGE IMPROVEMENT WORKS IN SHUEN WAN
AND SHEK WU WAI

MONTHLY ENVIRONMENTAL MONITORING AND
AUDIT REPORT FOR OPERATION PHASE-
SEPTEMBER 2015

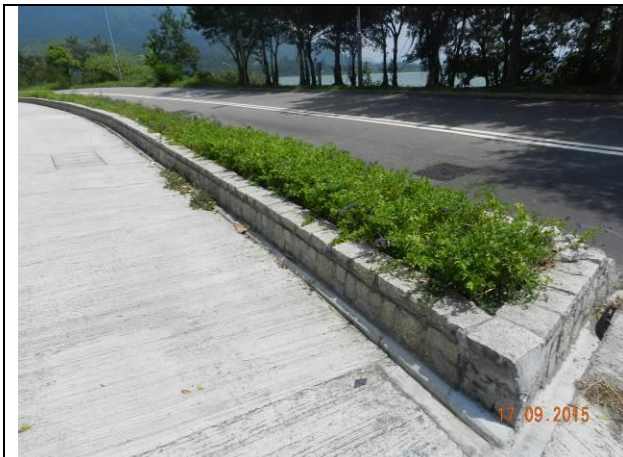
4.1.1 The roadside planters in Ting Kok Road were hydroseeded and planted with shrubs *Duranta erecta* which were in fair condition as observed in September 2015 (**Photo A1**).

Nursery were broken, but the maintenance of these planters were already handed over and accepted by the Nursery in December 2014. The planters along Ting Kok Road were also reinstated (**Photo A1**).

Photo A1 – Planters at Ting Kok Road were hydroseeded and planted with shrubs.

4.1.3 The roadside planters in Ting Kok Road were handed over to Highway Department and under maintenance by the corresponding party. No further recommendation on the growth performance of these planters is given from the current observation.

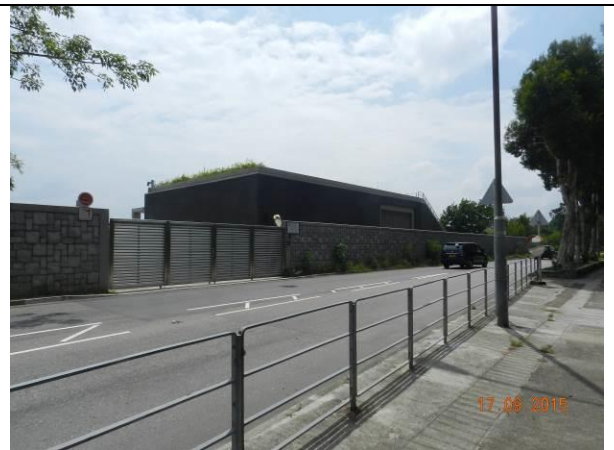
4.2.1 As observed in September 2015, the architectural design of the pump house generally follows the proposed materials and color (e.g. a wall of clay cladding to facilitate the development of climbers for vertical greening) as stated in the approved Landscape Plan (**Photo A2**).

Photo A2 – General appearance of the pump house in Area A.

4.2.2 No specific recommendation is required for this mitigation measure.

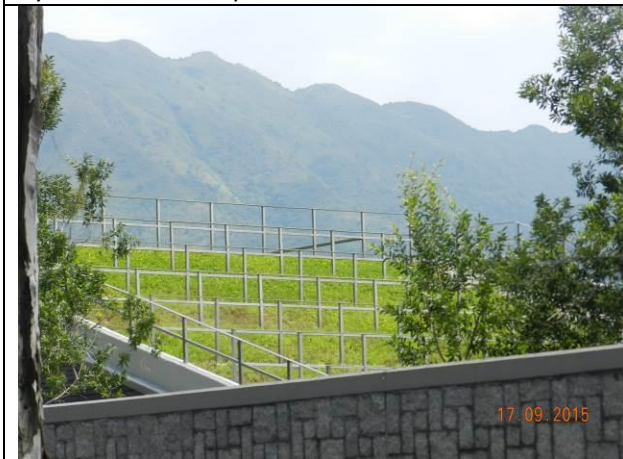
No entry into the Pump House (Area A) was allowed after the formal handover. Monitoring was made by observing the green roof outside the fenced Pump House Area. As observed in September 2015, the planted ground cover *Arachis duranensis* on the green roof was in fair condition (**Photo A3**). Other landscape design (including the planting of ground cover *Iris tectorum*, creeping climbers *Ficus pumila* and *Parthenocissus dalzielii*, shrubs *Ficus microcarpa* (Golden Leaf) and trees *Cinnamomum burmannii* were unobservable in this monitoring due to the inaccessibility of pump house.

Photo A3 – View of sloping area with ground cover on the Pump House.

4.3.1 The daily operation of the pump house were handed over to Drainage Services Department and under maintenance by corresponding party. No further recommendation is given from the current observation on the landscape planting within the pump house.

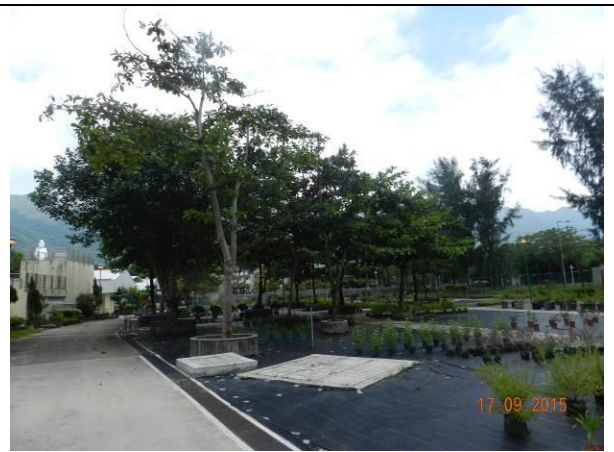
4.5.1 Transplantation of trees was finished during the early construction phase of Contract 1 (**Photo A4**). The health performance of these transplanted trees had been regularly monitored and reported during the construction phase. Any trees of poor performance were reported to the Contractor and replaced accordingly. Area B was handed over to Tung Tze Nursery after the construction phase, and the transplanted trees were under the maintenance of the Nursery Operator.

4.5.2 Some of the locations of the transplanted trees were different from those proposed in the approved Landscape Plan. Moreover, as reported during the construction phase, gap was observed between the root balls of some transplanted trees and the inner surface of their newly built planters. However, these trees were accepted by the Nursery Operator.

Photo A4 – Example of the transplanted trees in Area B.

4.5.5 Area B was handed over to Tung Tze Nursery which will provide routine maintenance of these transplanted trees. No further recommendation is given under this mitigation measures.

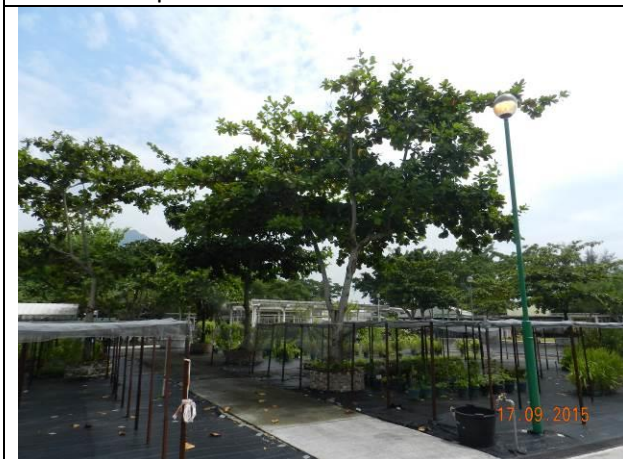
4.7.1 The reinstatement works for the original access paths, ground of the nursery beds, basic nursery utility (such as irrigation pipes and lamp posts), shelters for potted plants, planters for transplanting trees, and wire mesh fences within the nursery were already finished in Area B as observed in September 2015 (**Photo A5**). Some of the individual tree planters in the

Photo A5 – Example of the completed reinstatement works within the nursery (such as lamp posts, shelters for potted plants and new planters for the transplanted tree).

4.7.2 No specific recommendation is required for this mitigation measures.

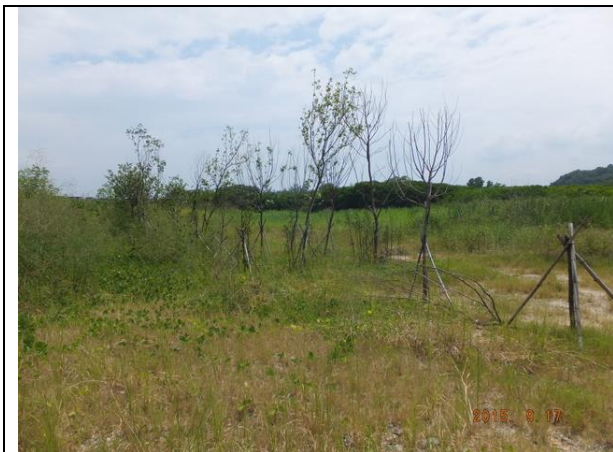
5.4.2 As inspected on 17th September 2015, excavation work related to CLP Project was carried out immediately next to compensatory trees planted opposite to San Tau Kok (i.e. the area at the junction of Contracts 1 and 2) (**Photos B4-B5**). No tree protection measures were applied on the planted compensatory trees during the excavation work. Five compensatory trees (T193 – T196 and T201) were missing and their locations were at the excavation area (**Photo B6**). Such observation was reported to DSD and the Main Contractor. As the area was formally handed over to LandsD, the excavation work was possibly approved officially. Besides, considerable numbers of planted compensatory trees showed poor condition or with no leaves (**Photos B7-B8**).

Photo B7 – Example of compensatory trees had poor health condition.

- 5.4.5 For the replacement of the missing or removed compensatory trees due to previous tree failure under adverse weather(except the five missing trees in relation to the excavation work), the Contractor and DSD will further liaise with the LandsD for any further follow-up action in replacing such compensatory tree within the handed over areas.

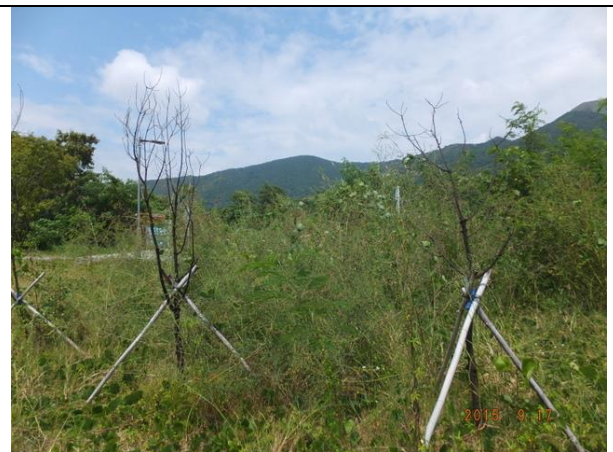
Photo B8 – Example of compensatory trees had poor health condition and located opposite to Wai Ha area.

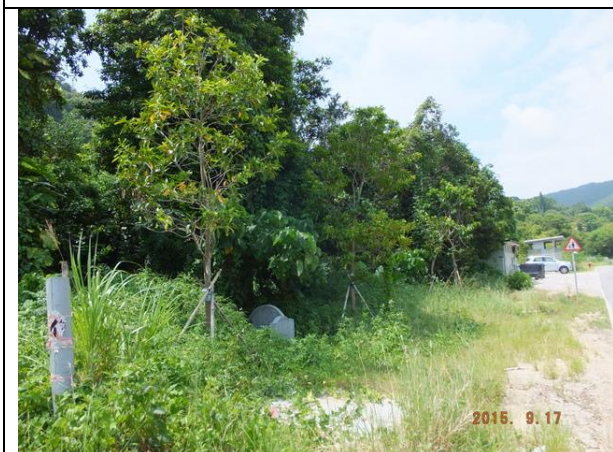
Road (**Photo B9**), as well as the reinstated area above the drain pipe along the access path leading towards Treasure Spot Garden II (**Photo B10**). Grass germination in these hydroseeded areas was in fair condition, and other native grass species have also naturally established in these areas. Overgrown problem by climbers (*Mikania micrantha* and *Pueraria lobata*) and grass was quite obvious along the roadside area (**Photo B11**).

Photo B9 – Hydroseeding was applied on the reinstated soil ground above the alignment of the box-culvert along Tung Tsz Road.

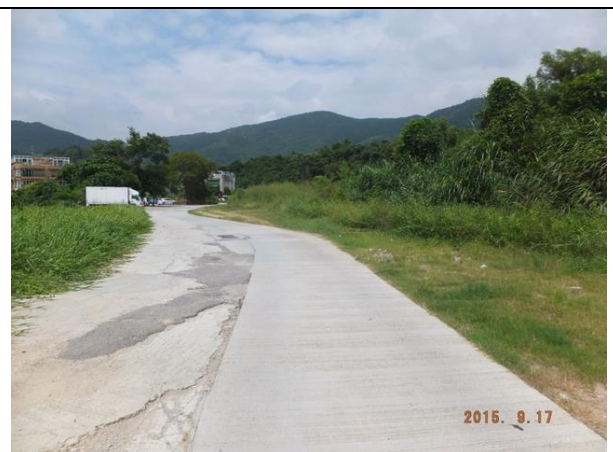
Photo B10 – The reinstated area above the drain pipe along the access path leading towards Treasure Spot Garden II.

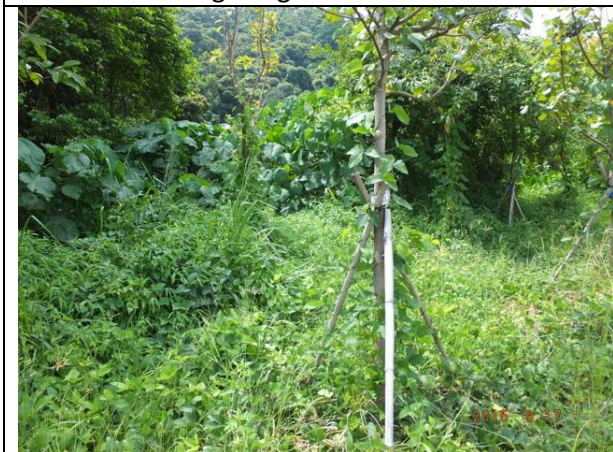
Photo B11 – Overgrown problem caused by climbers and grass was quite obvious along the roadside area.

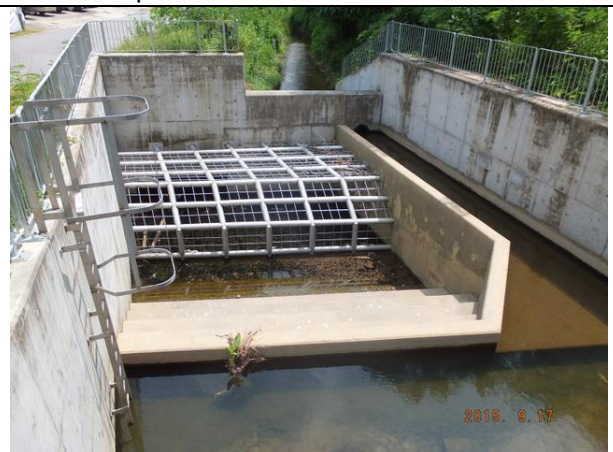
Photo B12 – The box culvert and the associated drainage work were completed at the upper part of Wai Ha River.

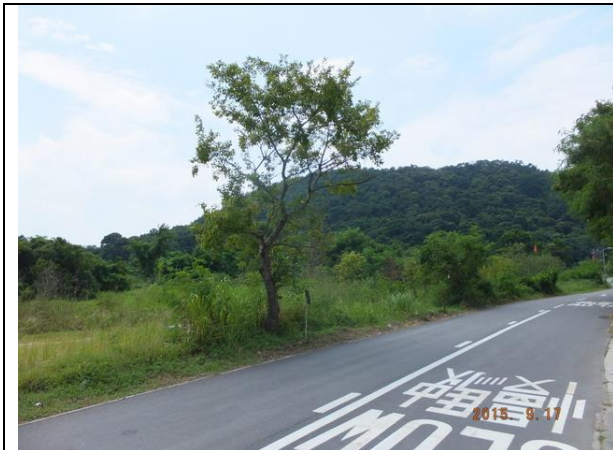
Photo B13 – The original access road, Tung Tsz Road, was reinstated.

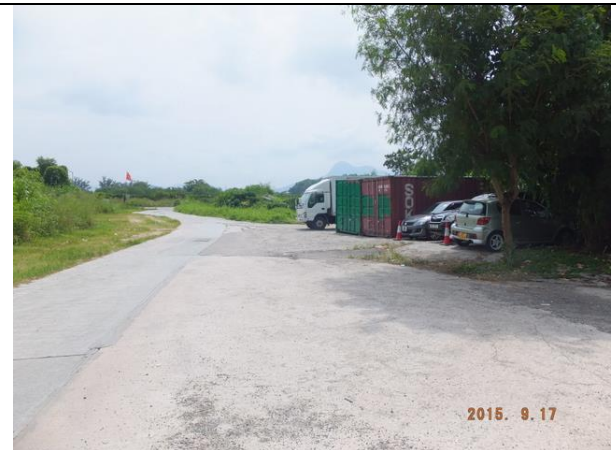
Photo B14 – The access path in Treasure Spot Garden II was reinstated.

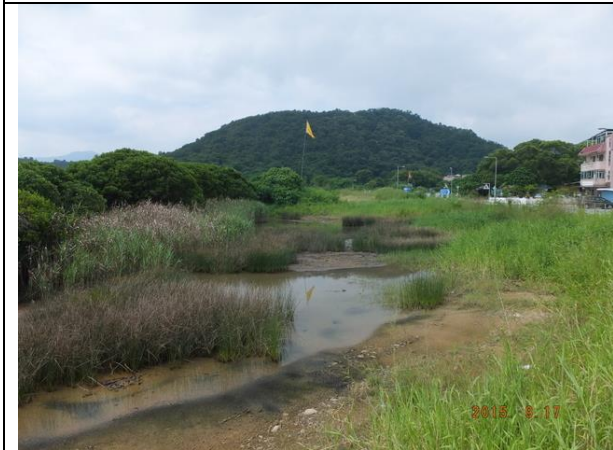
Photo B15 – The low-lying area with wetland character was reinstated in area opposite to Jade View Villa.

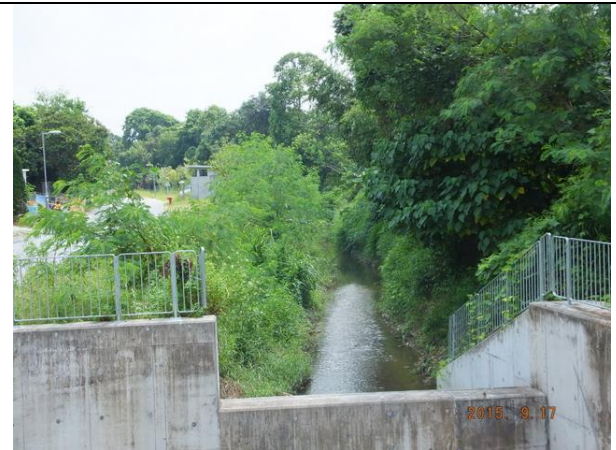
Photo B16 – Both bunds along Wai Ha River were naturally vegetated.
