PROJECT No.: TCS/00553/11

CONTRACT NO. DC/2009/22
DRAINAGE IMPROVEMENT WORKS IN SHUEN WAN

CONTRACT NO. DC/2010/02
DRAINAGE IMPROVEMENT WORKS IN SHUEN WAN
AND SHEK WU WAI

MONTHLY ENVIRONMENTAL MONITORING AND
AUDIT REPORT FOR OPERATION PHASE-
DECEMBER 2015

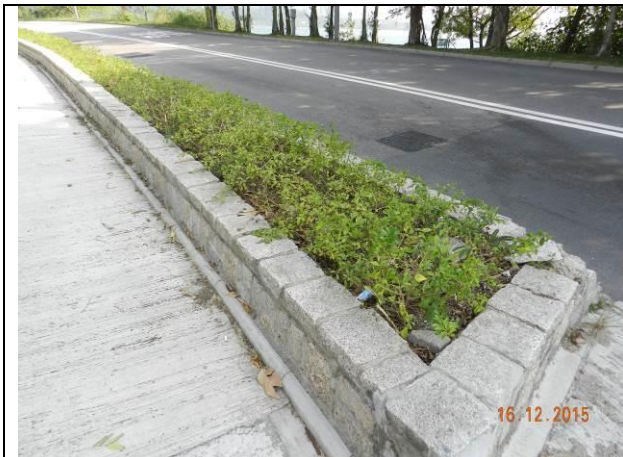
4.1.1 The roadside planters in Ting Kok Road were hydroseeded and planted with shrubs *Duranta erecta* which were in fair condition as observed in December 2015 (**Photo A1**).

Photo A1 – Planters at Ting Kok Road were hydroseeded and planted with shrubs.

4.1.3 The roadside planters in Ting Kok Road were handed over to Highway Department and under maintenance by the corresponding party. No further recommendation on the growth performance of these planters is given from the current observation.

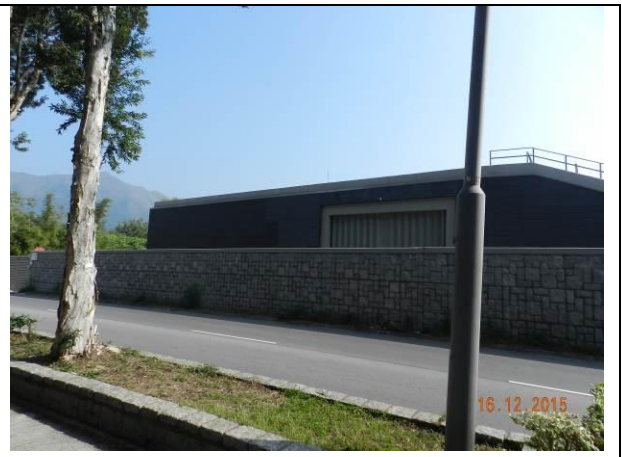
4.2.1 As observed in December 2015, the architectural design of the pump house generally follows the proposed materials and color (e.g. a wall of clay cladding to facilitate the development of climbers for vertical greening) as stated in the approved Landscape Plan (**Photo A2**).

Photo A2 – General appearance of the pump house in Area A.

4.2.2 No specific recommendation is required for this mitigation measure.

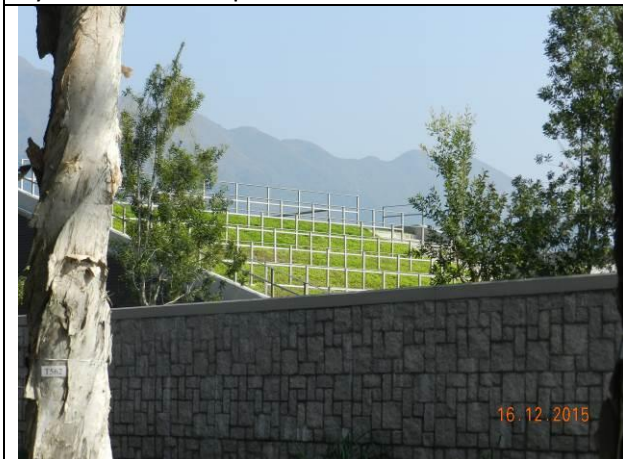
No entry into the Pump House (Area A) was allowed after the formal handover. Monitoring was made by observing the green roof outside the fenced Pump House Area. As observed in December 2015, the planted ground cover *Arachis duranensis* on the green roof was in fair condition (**Photo A3**). Other landscape design (including the planting of ground cover *Iris tectorum*, creeping climbers *Ficus pumila* and *Parthenocissus dalzielii*, shrubs *Ficus microcarpa* (Golden Leaf) and trees *Cinnamomum burmannii* were unobservable in this monitoring due to the inaccessibility of the pump house.

Photo A3 – View of sloping area with ground cover on the Pump House.

4.3.1 The daily operation of the pump house were handed over to Drainage Services Department and under maintenance by the corresponding party. No further recommendation is given from the current observation on the landscape planting within the pump house.

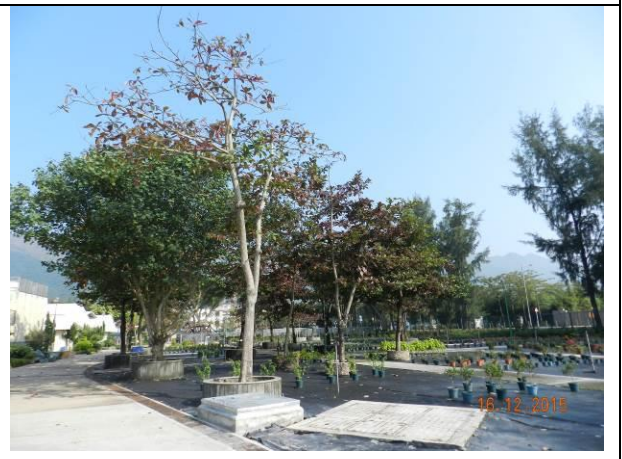
4.5.1 Transplantation of trees was finished during the early construction phase of Contract 1 (**Photo A4**). The health performance of these transplanted trees had been regularly monitored and reported during the construction phase. Any trees of poor performance were reported to the Contractor and replaced accordingly. Area B was handed over to Tung Tze Nursery after the construction phase, and the transplanted trees were under the maintenance of the Nursery Operator.

Photo A4 – Example of the transplanted trees in Area B.

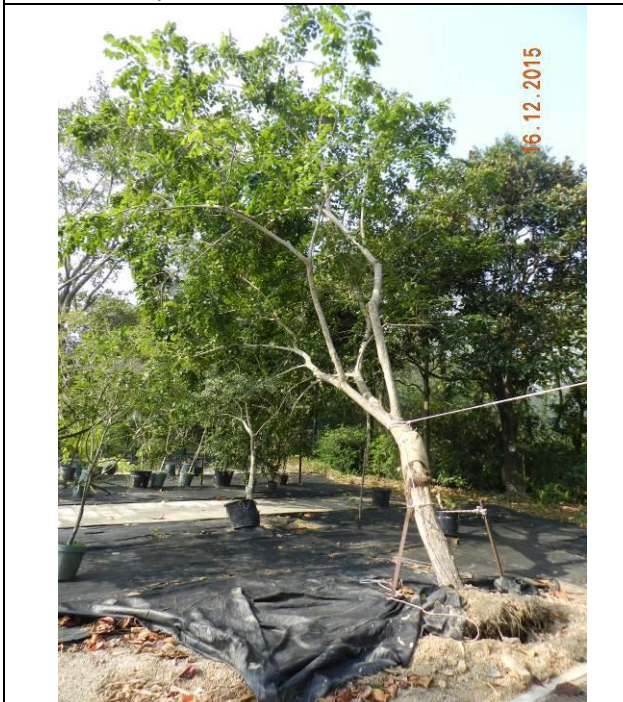
4.5.3 A tree *Pterocarpus indicus* (U-55) was found leaning towards the nursery bed (**Photo A5**). It was uprooted and parts of the roots were exposed to the air. The tree had fair vitality but poor in structure, with several dead branches observed. Its leaning trunk was tied to a healthy tree nearby it by a rope, probably as a mitigation measure carried out by the Nursery Operator to stabilize its leaning trunk (**Photo A6**).

Photo A5 – The overall view of leaning tree *Pterocarpus indicus* (U-55).

4.5.6 It is suggested that the leaning tree found in the Nursery should be re-planted back to an upright position, watered regularly and backfilled with adequate soil. However, since Area B was handed over to Tung Tze Nursery which will provide routine maintenance of all transplanted trees, it is anticipated that the Nursery Operator will implement appropriate mitigation measure to reduce the tree risk on the targets (e.g. nursery workers, visitors and utility).

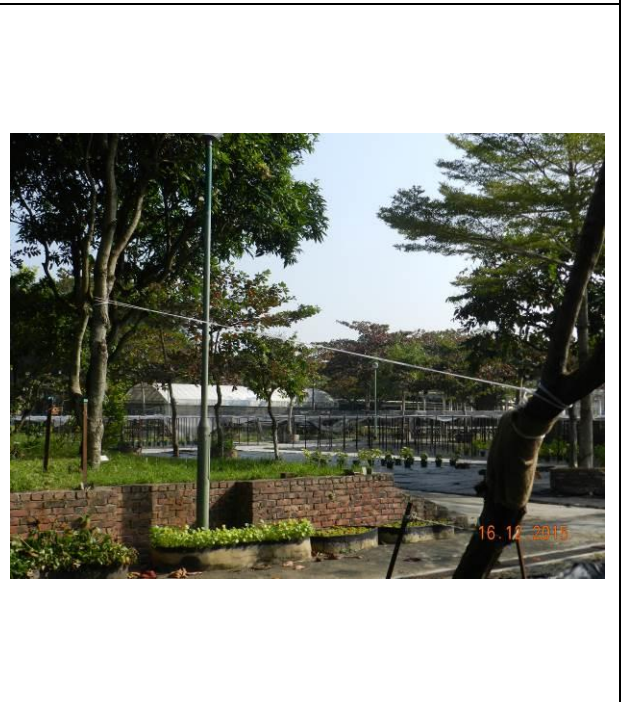
Photo A6 – The leaning tree was tied by a rope to stabilize its leaning tree trunk.

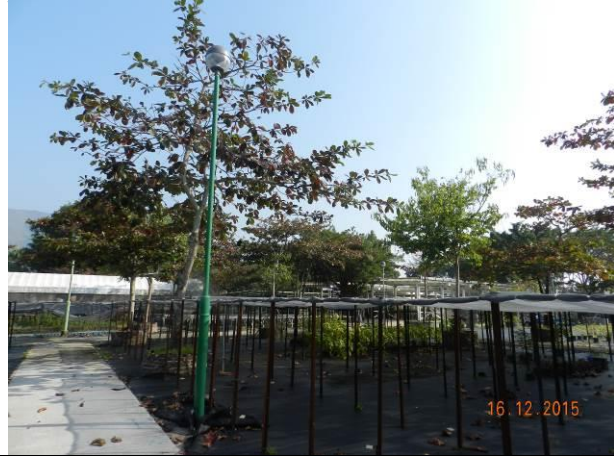
Photo A7 – Example of the completed reinstatement works within the nursery (such as lamp posts, shelters for potted plants and new planters for the transplanted tree).

4.7.2 No specific recommendation is required for this mitigation measures.

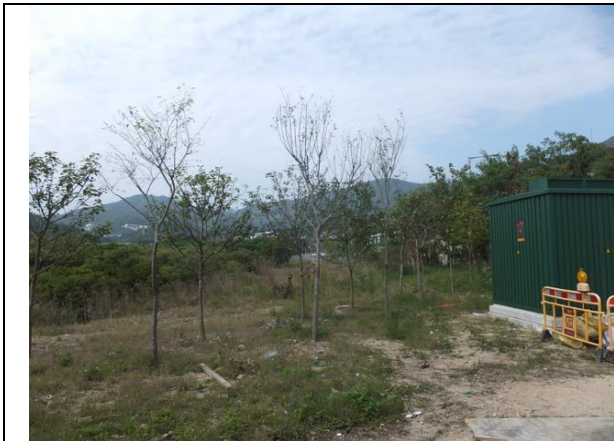
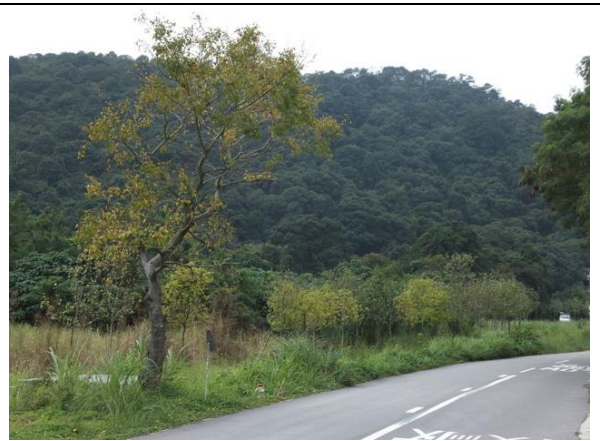
5.4.3 As observed on 29th December 2015, a total of 56 trees were found missing/ removed, including the 8 missing trees reported in Section 5.4.2. All the bamboo stakes used to support the compensatory trees were found being removed. Information from the Main Contractor revealed that the areas planted with compensatory trees were formally handed over to the according Lands Department (LandsD) for long-term management, and the removal of dead trees/ trees of poor condition and bamboo stakes were requested by LandsD. As confirmed by the Main Contractor, no tree replacement was required by the according LandsD. General site condition with the remaining compensatory trees along Tung Tsz Road is shown in **Photos B1-B3**.

Photo B1 – Overall view of the compensatory trees planted opposite to San Tau Kok.

Photo B2 – Overall view of the compensatory trees planted opposite to Wai Ha.

5.4.5 According to the information from DSD and the Contractor, the areas planted with compensatory trees along Tung Tsz Road were formally handed over to LandsD in the previous months. In principle, LandsD will be responsible for maintaining these vegetated areas and provide *ad hoc* tree maintenance if necessary. Since the areas were officially handed over, implementation of any tree maintenance and management practices within these areas should inform and discuss with the corresponding government department. As confirmed by the Main Contractor, no replacement of dead or compensatory trees of poor condition was required by LandsD after the handover. The removal of dead trees and trees of poor condition, bamboo stakes and weedy climbers observed in December 2015 was treated as the final vegetation maintenance work completed by the landscape contractor.

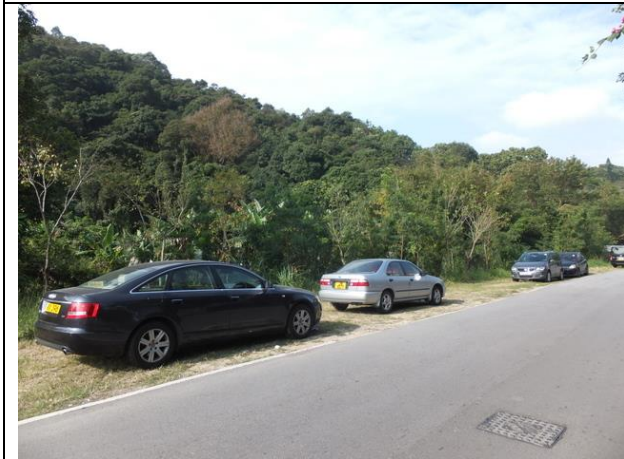
Photo B3 – Overall view of the compensatory trees planted opposite to Wai Ha. Villager's vehicles were parked along the hydroseeded ground.

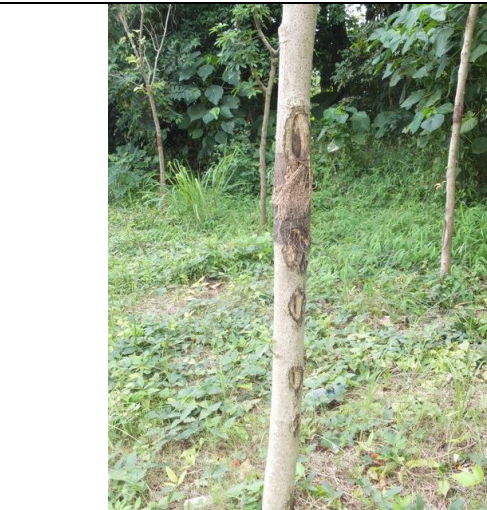
5.4.1 A total of 207 tagged compensatory trees were planted under Contract 2, and the planting work and replacement of trees with poor condition were completed in the end of the construction phase. The health conditions of majority of these compensatory trees were in fair to marginally fair condition (**Photos B1-B3**), but with some trees showing poor structural condition (such as decayed wood found along the trunks, e.g. **Photo B4-B5**).

Photo B4 – Example of a compensatory tree with trunk full of wounds and decayed wood.

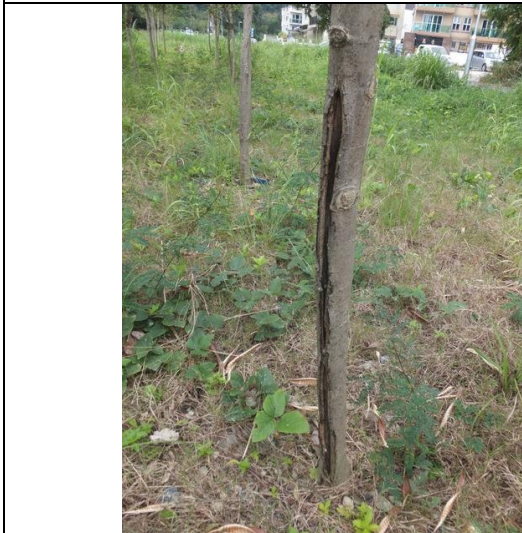
Photo B5 – Example of a compensatory tree with decayed wood along the trunk.

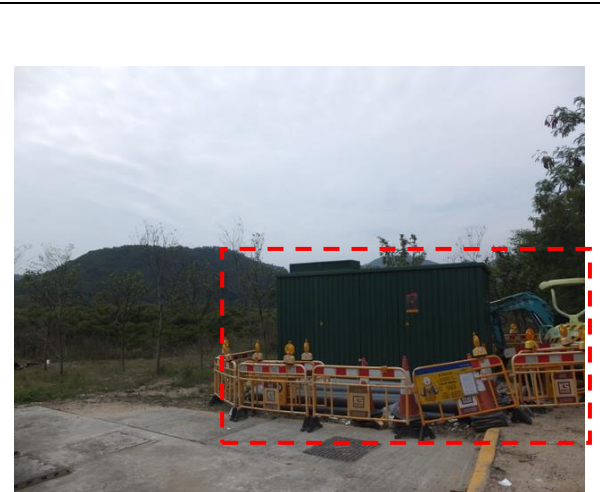
tree failure under adverse weather. Moreover, five compensatory trees (T193-T196 and T201) located in areas opposite to San Tau Kok were found missing and they were located within the CLP's excavation works areas as observed in September 2015 (**Photo B6**). No tree replacement for such tree loss was conducted by CLP as observed in December 2015.

Photo B6 – Previous excavation work related to CLP Project was carried out at the locations where the five missing compensatory trees were planted. No tree replacement was noted.

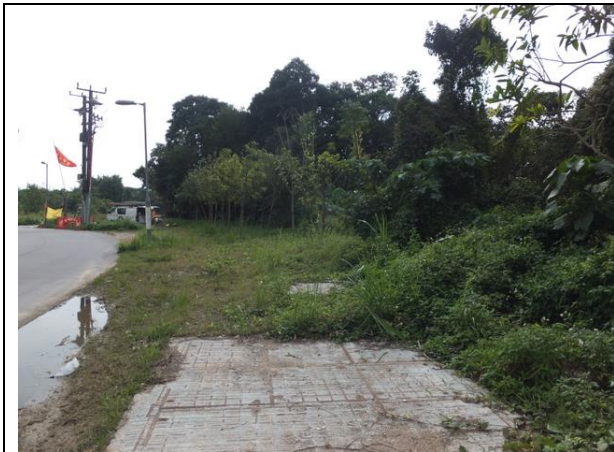
5.4.4 No shrub planting was proposed in the approved Landscape Plan, while hydroseeding was applied on the reinstated soil ground above the alignment of the box-culvert along Tung Tsz Road (**Photo B7**), as well as the reinstated area above the drain pipe along the access path leading towards Treasure Spot Garden II (**Photo B8**). Grass germination in these hydroseeded areas was in fair condition, and other native grass species have also naturally established in these areas. However, localised hydroseeded ground within the village areas was damaged by vehicles.

Photo B7 – Hydroseeding was applied on the reinstated ground above the alignment of the box-culvert along Tung Tsz Road.

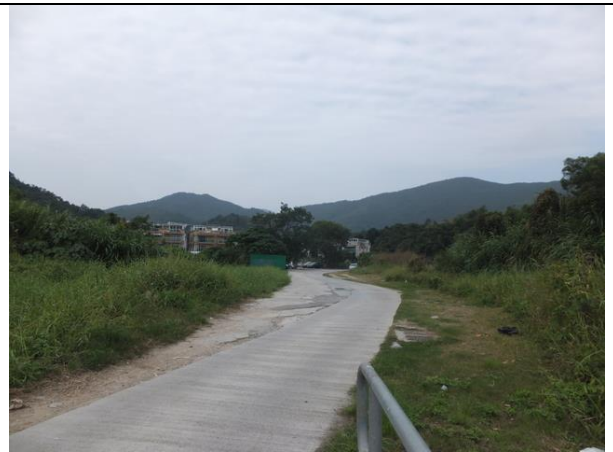
5.8.1 The original access roads (Tung Tsz Road), access paths to the villages, low-lying wetland areas to the south of San Tau Kok, and planting areas for compensatory trees were reinstated (**Photos B8, B10-B13**). All these reinstatement works were completed by end of the construction phase and these reinstated areas have been used daily by the villagers and government department. Information by the Contractor revealed that these reinstated works were handed over to the corresponding government departments. However, a new refuse collection chamber built in area opposite to Wai Ha was found being demolished (**Photo B14**). Information from the Main Contractor revealed that the local villagers and Food and Environmental Hygiene Department (FEHD) had requested to remove such chamber.

Photo B8 – Hydroseeded ground and reinstated area above the drain pipe along the access path leading towards Treasure Spot Garden II.

5.8.2 No specific recommendation is required for the reinstated areas.

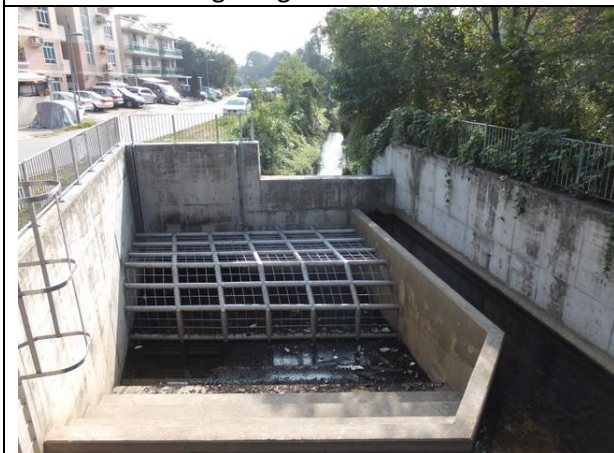
Photo B9 – The box culvert and the associated drainage work were completed at the upper part of Wai Ha River.

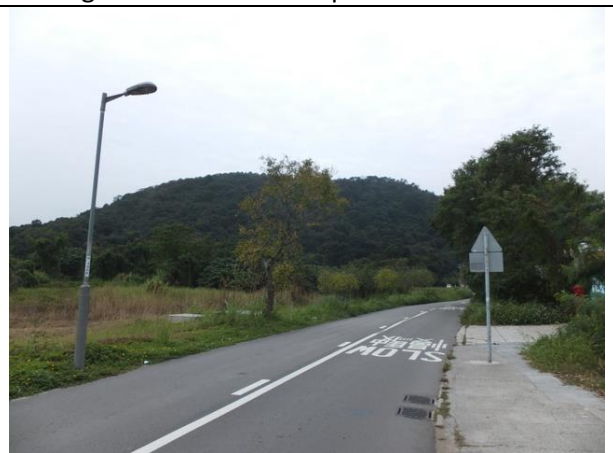
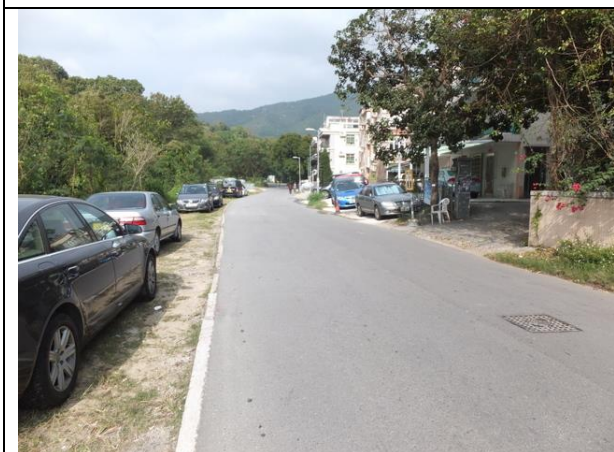
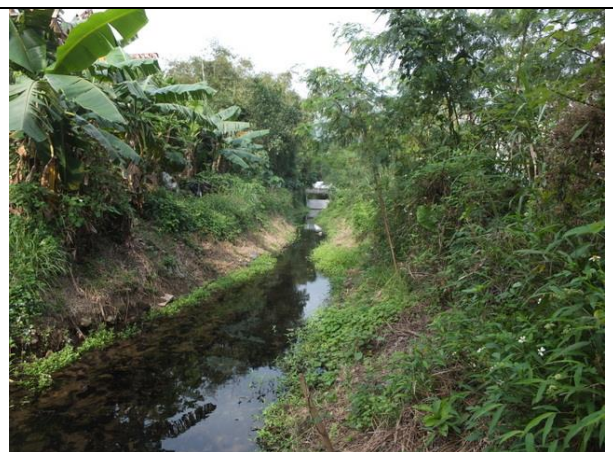
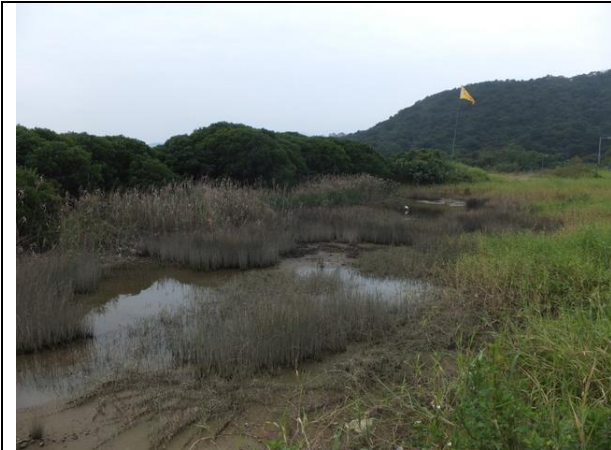
Photo B10 – The original access road, Tung Tsz Road, was reinstated.

Photo B11 – The original Tung Tsz Road in Wai Ha area was reinstated.

Photo B12 – Both stream banks of Wai Ha River were reinstated and naturally vegetated with self-seeded plants.

Photo B13 – The low-lying wetland areas to the south of San Tau Kok was reinstated and naturally colonised by vegetation.

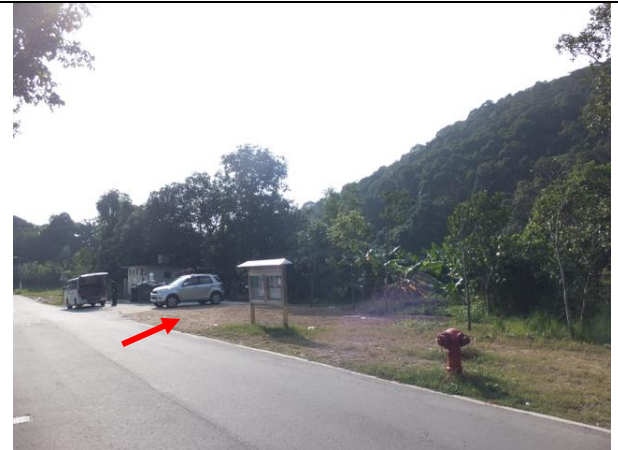
Photo B14 – The new refuse collection chamber (location indicated in red arrow) built in area opposite to Wai Ha was found being demolished.
