**CONTRACT NO. DC/2010/02
DRAINAGE IMPROVEMENT WORKS IN SHUEN WAN
AND SHEK WU WAI**

**MONTHLY ENVIRONMENTAL MONITORING AND
AUDIT REPORT FOR OPERATION PHASE-
MARCH 2016**

PREPARED FOR
KWAN LEE-KULY JOINT VENTURE

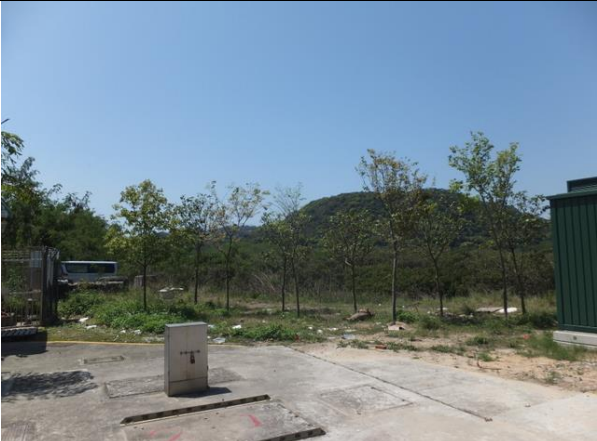
of poor condition and bamboo stakes were requested by LandsD. As confirmed by the Main Contractor, no tree replacement was required by the according LandsD. General site condition with the remaining compensatory trees along Tung Tsz Road is shown in **Photos 1-4**.

<p>Photo 1 – Overall view of the compensatory trees planted opposite to San Tau Kok.</p>	<p>Photo 2 – Overall view of the compensatory trees planted opposite to Wai Ha.</p>

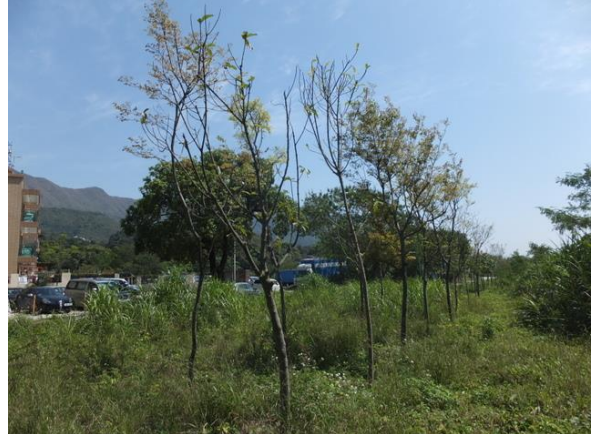
<p>Photo 3 – Overall view of the compensatory trees planted opposite to Wai Ha.</p>	<p>Photo 4 – Overall view of the compensatory trees planted opposite to Wai Ha area. Location of the previous newly built refuse collection chamber is indicated.</p>

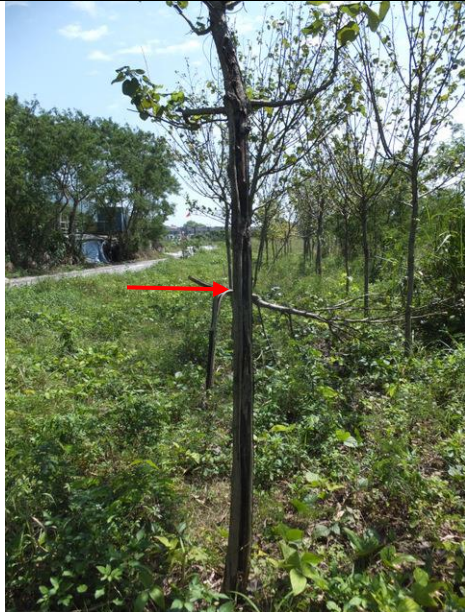
5.4.1 A total of 207 tagged compensatory trees were planted under Contract 2, and the planting work and replacement of trees with poor condition were completed in the end of the construction phase. The health conditions of majority of these compensatory trees were in fair to marginally fair condition (**Photos 1-4**), but with certain number of trees showing poor structural condition (such as decayed wood and peeled tree bark found along the trunks, and broken tree trunks, e.g. **Photo 5-8**) and trees with leaning or fallen tree trunks (**Photos 9-10**).

<p>Photo 5 – Example of a compensatory tree with trunk full of wounds and decayed wood.</p>	<p>Photo 6 – Example of a compensatory tree with trunk full of wounds and decayed wood.</p>

- 5.4.5 According to the information from DSD and the Contractor, the areas planted with compensatory trees along Tung Tsz Road were formally handed over to LandsD in the previous months. In principle, LandsD will be responsible for maintaining these vegetated areas and provide *ad hoc* tree maintenance if necessary. Since the areas were officially handed over, implementation of any tree maintenance and management practices within these areas should inform and discuss with the corresponding government department. As confirmed by the Main Contractor, no replacement of dead or compensatory trees of poor condition was required by LandsD after the handover. The removal of dead trees and trees of poor condition, bamboo stakes and weedy climbers observed in March 2016 was treated as the final vegetation maintenance work completed by the landscape contractor.

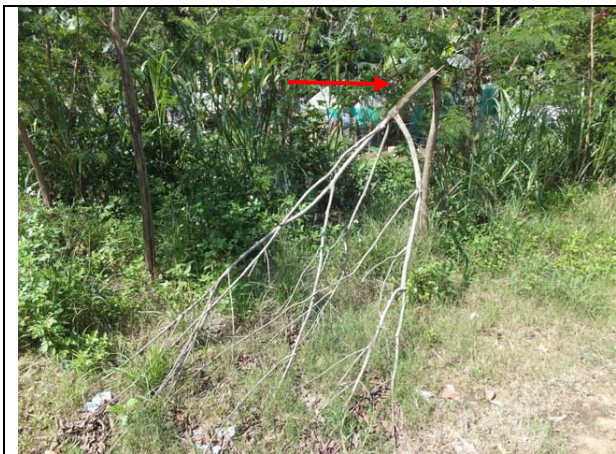
<p>Photo 7 – Compensatory tree with a broken tree trunk.</p>	<p>Photo 8 – Compensatory tree with a broken tree trunk.</p>

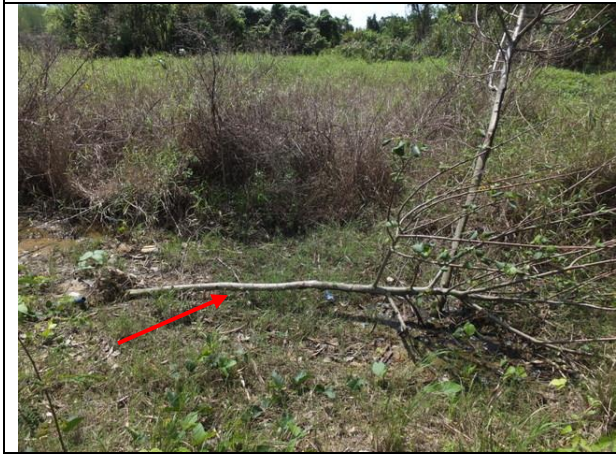
<p>Photo 9 – An uprooted and fallen compensatory tree was noted.</p>	<p>Photo 10 – A compensatory tree with leaning tree.</p>

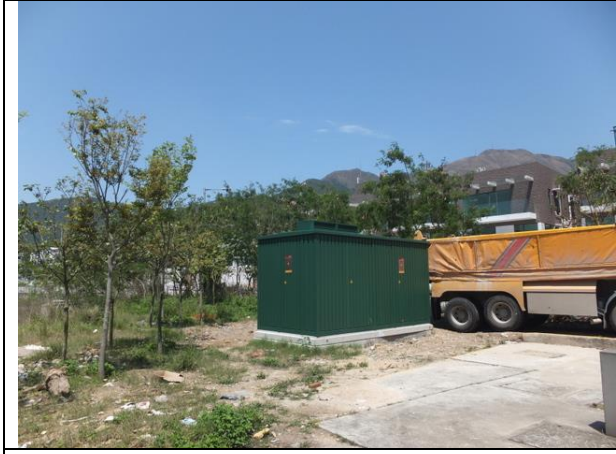
5.4.2 As reported in the previous quarterly report for the observation made in September 2015, four compensatory trees, including three *Hibiscus tiliaceus* (tree tag no. T111, T127 and T148) and one *Cleistocalyx operculatus* (tree tag no. T021) were missing, probably due to the previous tree failure under adverse weather. Moreover, five compensatory trees (T193-T196 and T201) located in areas opposite to San Tau Kok were found missing and they were located within the CLP's excavation works areas as observed in September 2015 (**Photo 11**). No tree replacement for such tree loss was conducted by CLP as observed in March 2016.

<p>Photo 11 – Previous excavation work related to CLP Project was carried out at the locations where the five missing compensatory trees were planted. No tree replacement was noted.</p>	<p>Photo 12 – New leaves have been developed on a compensatory tree of <i>Celtis sinensis</i>.</p>

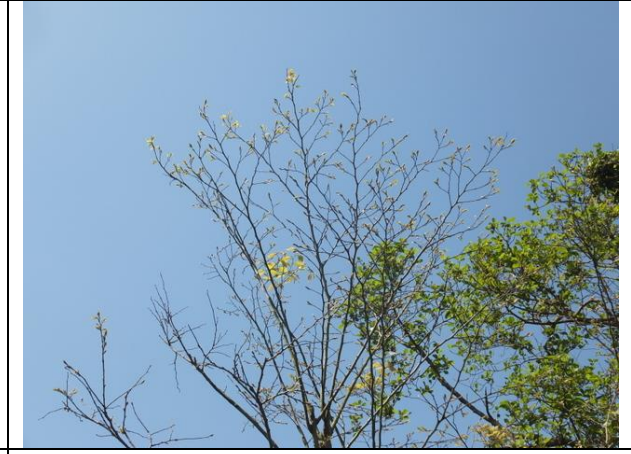
5.4.3 As observed on 26th March 2016, almost all of the remaining compensatory trees had resprouted and regenerated new leaves after the heavy rains in late dry season (**Photos 12-14**). However, a total of 58 trees were found missing/ removed, including the 8 missing trees reported in Section 5.4.2. Two additional compensatory trees, including one *Hibiscus tiliaceus* (tree tag no. T047) and one *Cinnamomum burmannii* (tree tag no. T147) were not found on-site, possibly removed by an unknown party due to their previous tree failure. In addition, one *Litsea glutinosa* (tree tag no. T058) was found with a broken trunk, possibly damaged by the nearby construction work or vehicle (**Photo 15**). All the bamboo stakes used to support the compensatory trees were already removed. Information from the Main Contractor revealed that the areas planted with compensatory trees were formally handed over to the according Lands Department (LandsD) for long-term management, and the removal of dead trees/ trees

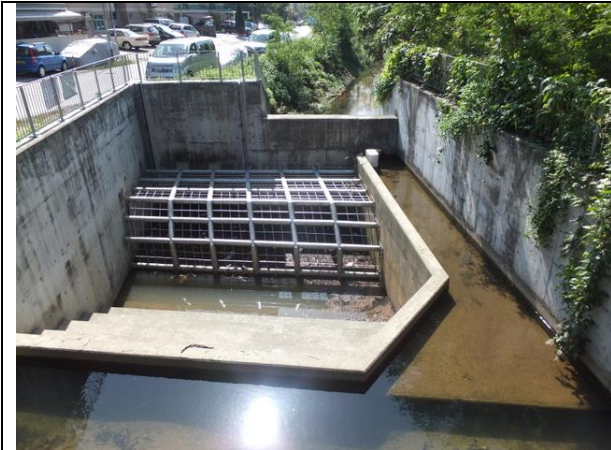
Photo 19 – The box culvert and the associated drainage work were completed at the upper part of Wai Ha River.

5.8.2 No specific recommendation is required for the reinstated areas.

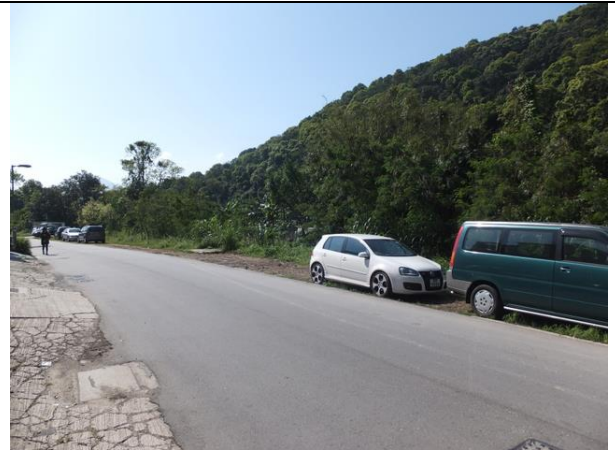
Photo 20 – The original access road, Tung Tsz Road, was reinstated.

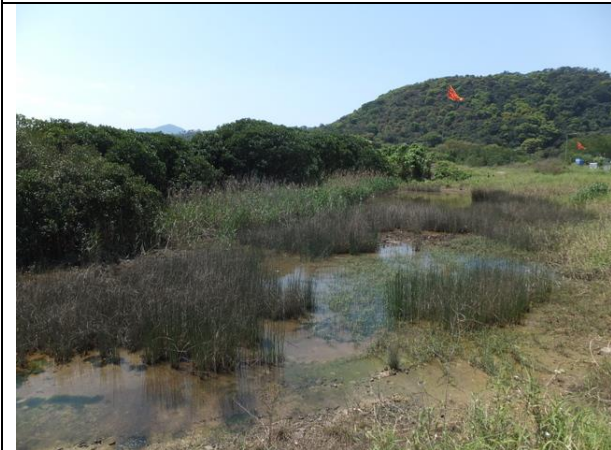
Photo 21 –The low-lying wetland areas to the south of San Tau Kok was reinstated and naturally colonised by vegetation.

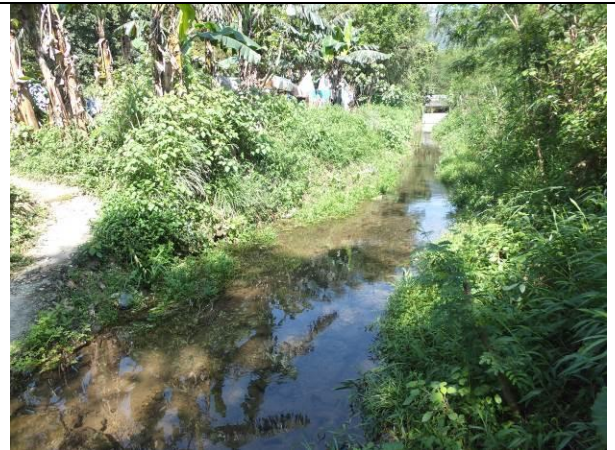
Photo 22 – Both stream banks of the upper Wai Ha River have been vegetated naturally in the Operation Phase.
