**Contract No. EP/SP/58/08 – Sludge Treatment Facilities
Environmental Monitoring Results in Operation Phase – Landscape and Visual Impact
Monitoring Reports – June 2016**

Monthly EM & A Record for Landscape and Visual Impact
(June 2016)

Table 1.1 Record of Implementation of the Proposed Landscape and Visual Mitigation Measures in Operation Phase (June 2016)

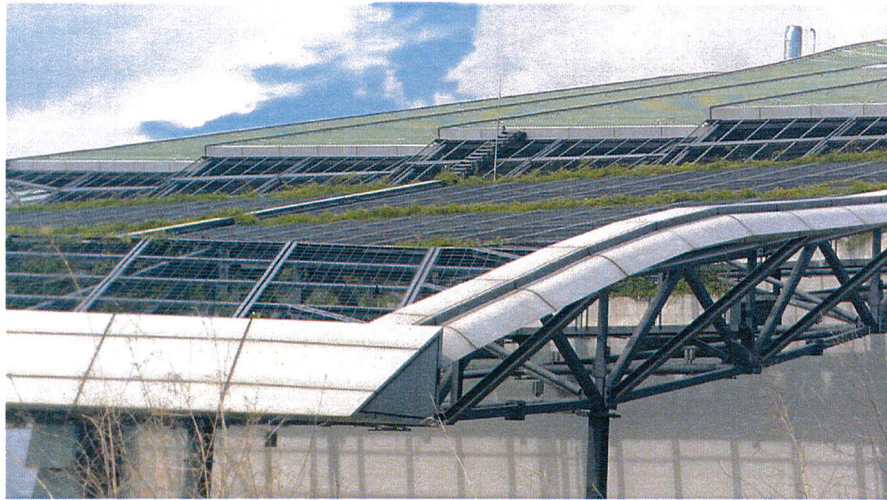
1. Photographic record of main building and climber planting on pergola

The climber planting on pergola is well established and provides a greening effect on the roof.

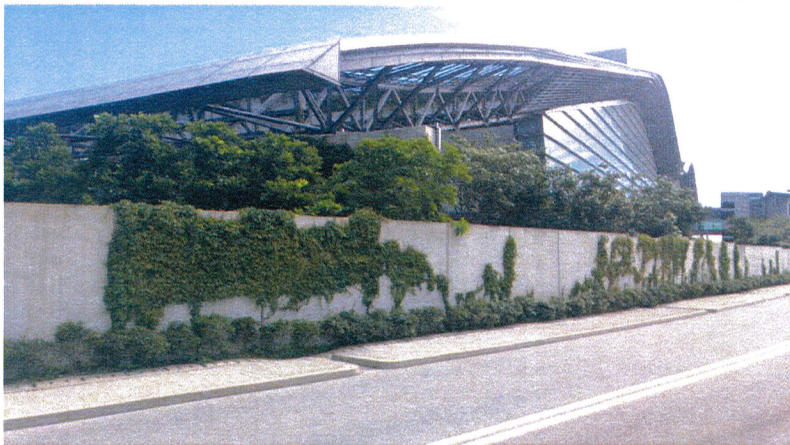
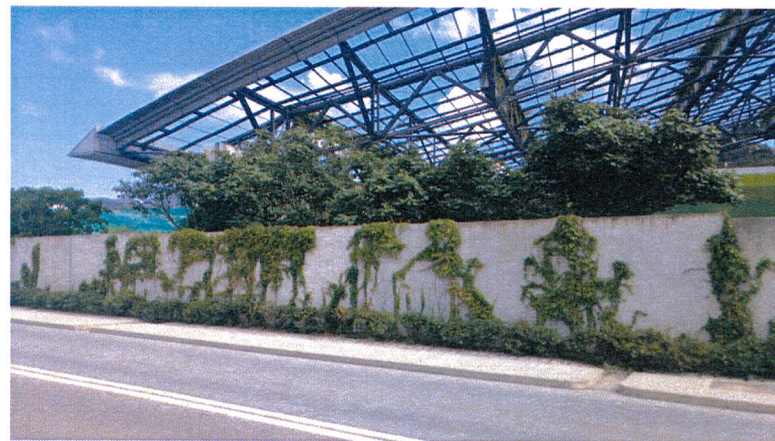
2. Photographic record of climbing planting

The proposed climbing planting along the boundary fence wall is well established, and provide a green screening effect together with tree planting within the site area and shrub planting at the bottom of the fence wall.

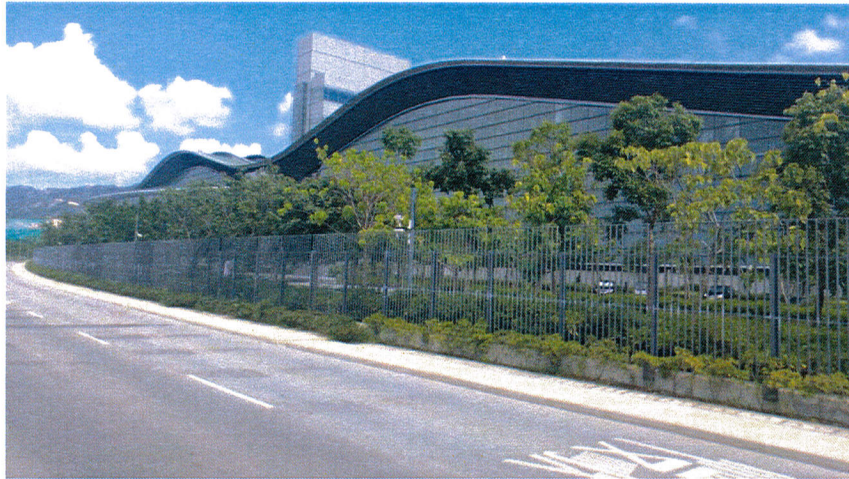
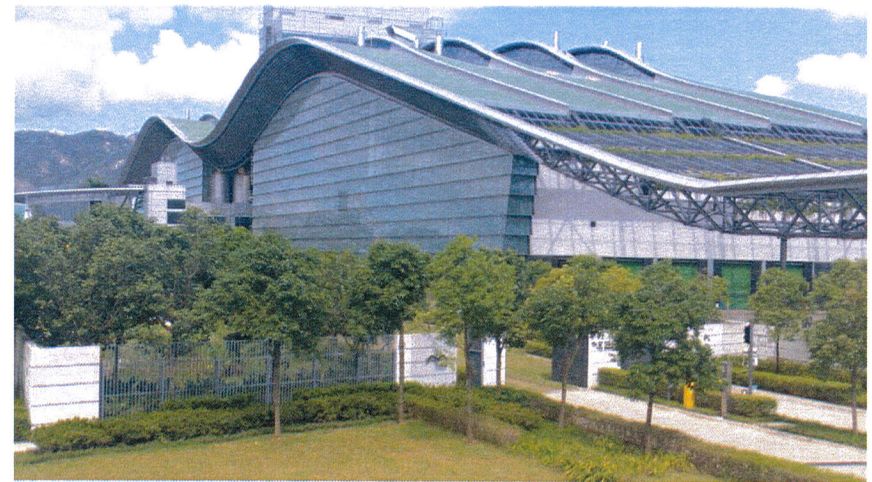
3. Photographic record of the buffer trees

Heavy standard tree plantings have been planted and well established along the entrance road to screen the structures and enhance the environment.

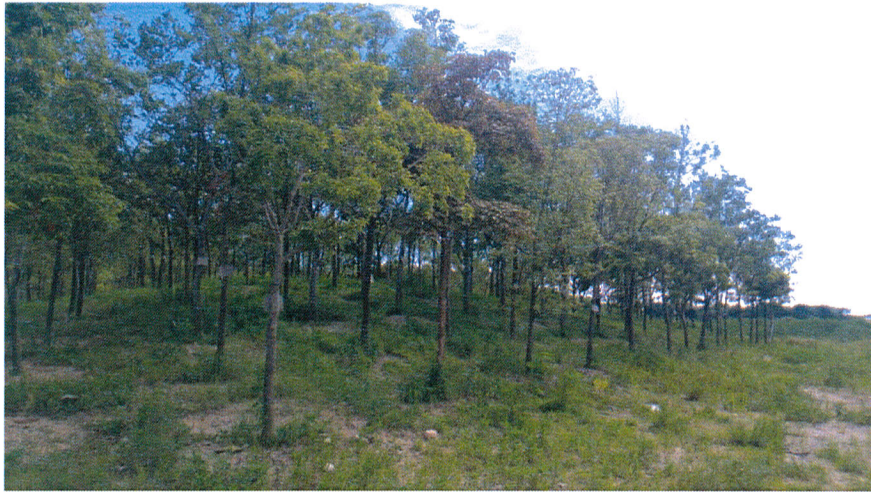
4. Photographic record of reinstated area

The disturbed area has been reinstated with heavy standard tree planting.
The trees are well established
