**FUGRO TECHNICAL SERVICES LIMITED**

**Contract No. EP/SP/58/08**  
**Sludge Treatment Facilities**  
**Quarterly Environmental Monitoring and Audit Report**  
**For**  
**June 2012 to August 2012**

The requisite construction works for the Environmental Protection Department Contract No. EP/SP/58/08 Sludge Treatment has commenced construction activity on 22 December 2010. The requisite impact environmental monitoring comprising of water quality, ecology, landscape and visual impact was conducted throughout this reporting quarter.

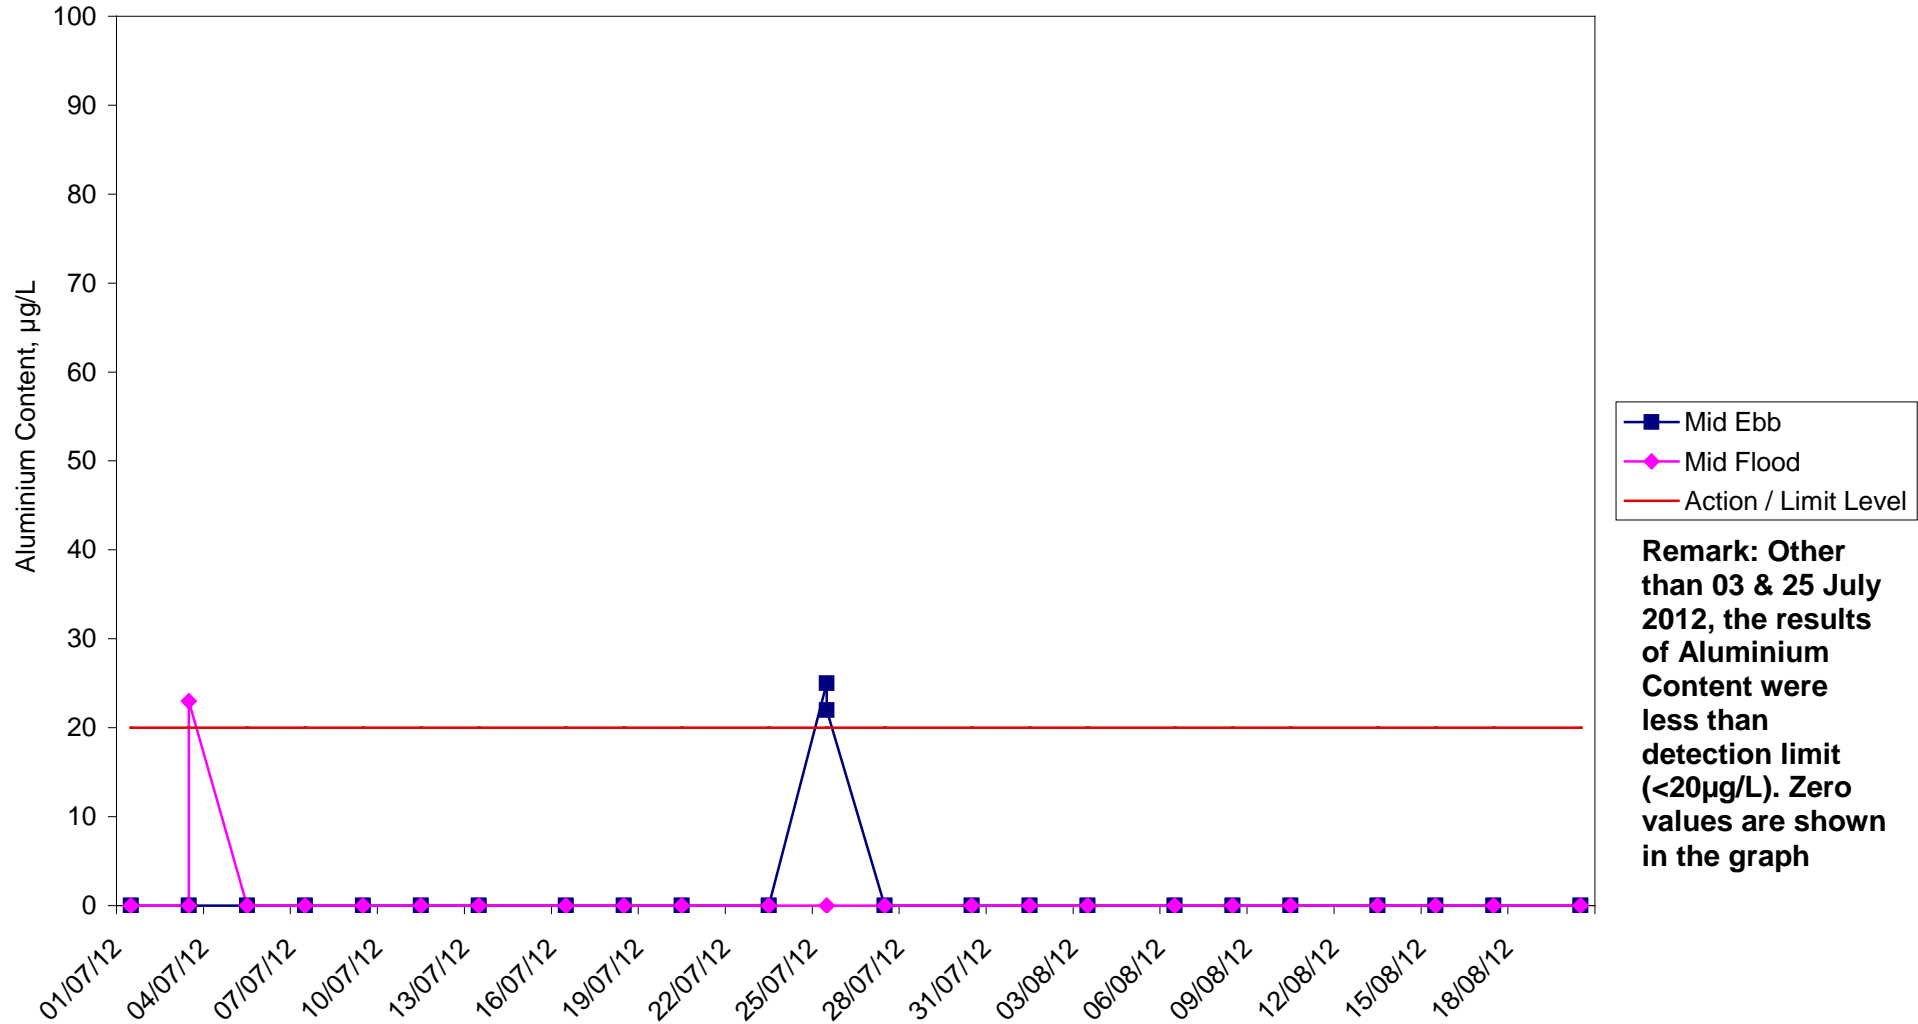
## M1 - Aluminium Content

Month	The reasons for the exceedances of marine water quality
July 2012	<ul style="list-style-type: none"> <li>1 event of exceedance of aluminium was recorded at mid-flood on 03 July 2012 at M1. Since the pre-bore operation for sheet piling has not commenced yet, so that the exceedance was not caused by the construction work. The aluminium content in the afternoon (mid-ebb) returned to &lt;20 µg/L. No potential source of impact was identified and hence, the exceedance should not be related to the Project.</li> </ul>
Aug 2012	<ul style="list-style-type: none"> <li>2 events of exceedance of aluminium were recorded at mid-ebb on 25 July 2012 at M1. Since the pre-bore operation for sheet piling has not commenced yet, so that the exceedance was not caused by the construction work. Heavy rainstorm occurred in the morning, the seabed sediment was stirred up by rainstorm also contributed to the aluminium level at M1. The marine water quality monitoring conducted on 27 July 2012 indicated that the aluminium content returned to &lt;20 µg/L. No potential source of impact was identified and hence, the exceedance should not be related to the Project.</li> </ul>

During this reporting quarter, non-compliance of aluminium content was recorded according to the A/L levels stated in Table 3.2. The causes were substantially attributable to heavy rainstorm and the seabed sediment was stirred up by rainstorm contributed to the aluminium level. Hence, the exceedance recorded is not related to the construction activities.

**Remark: Other than 03 & 25 July 2012, the results of Aluminium Content were less than detection limit (<20µg/L). Zero values are shown in the graph**
