**Consultancy for Environmental Monitoring on the
Major Restoration of the Residence of Ip Ting-Sz,
Lin Ma Hang Tsuen, Sha Tau Kok**

Monthly Environmental Monitoring and Audit Report

August 2011

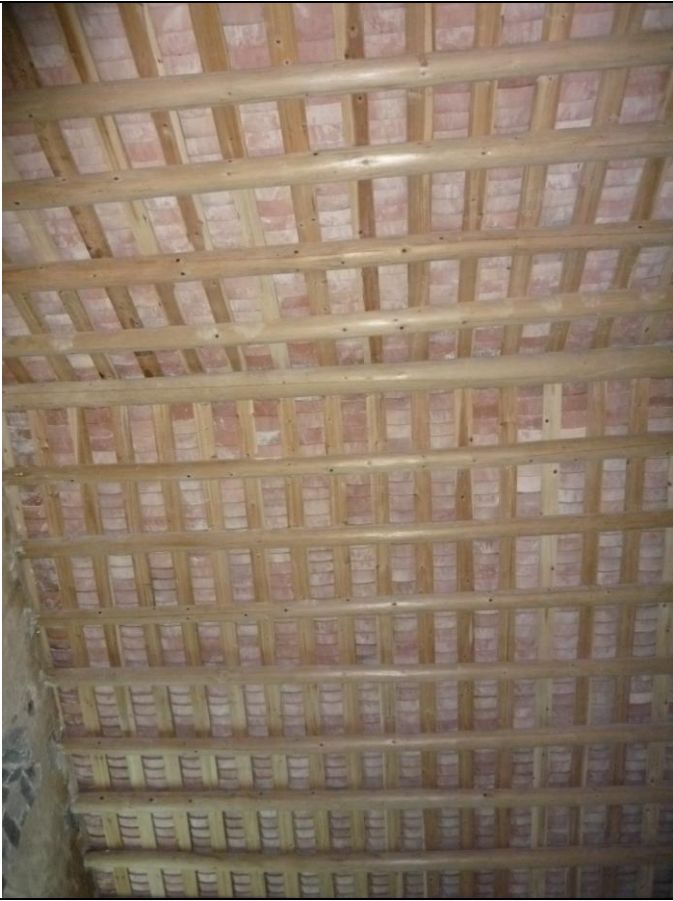
Kitchen Annex - Roof (15/8)

- 3.5 No bat was found hanging under the roof of the Main Building and the Kitchen Annex in both monitoring.
- 3.6 However, evidence that supported the utilization of the annex as a bat roost could be seen. There were bat faeces and remains of eaten moths. These were located in the inner part of the Kitchen Annex away from the door. This showed bat's preference on the microclimate and the light condition in this area.

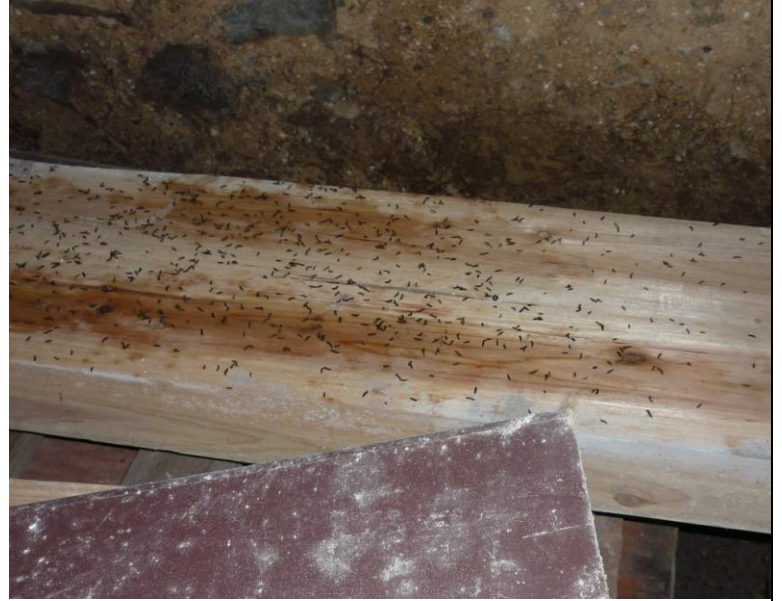
Kitchen Annex – Bat Faeces (15/8)

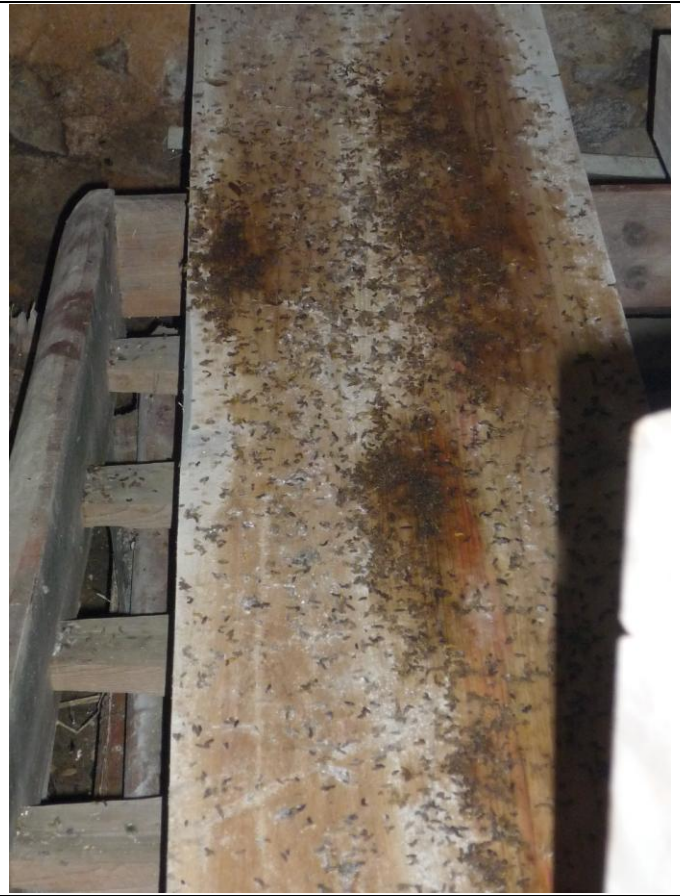
Kitchen Annex – Bat Faeces (30/8)

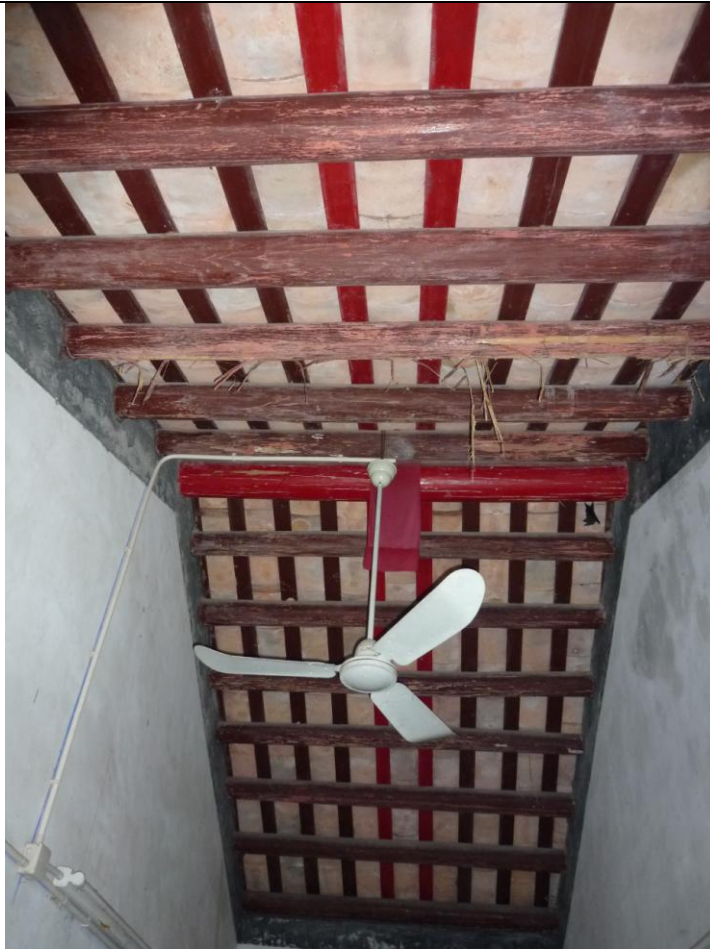
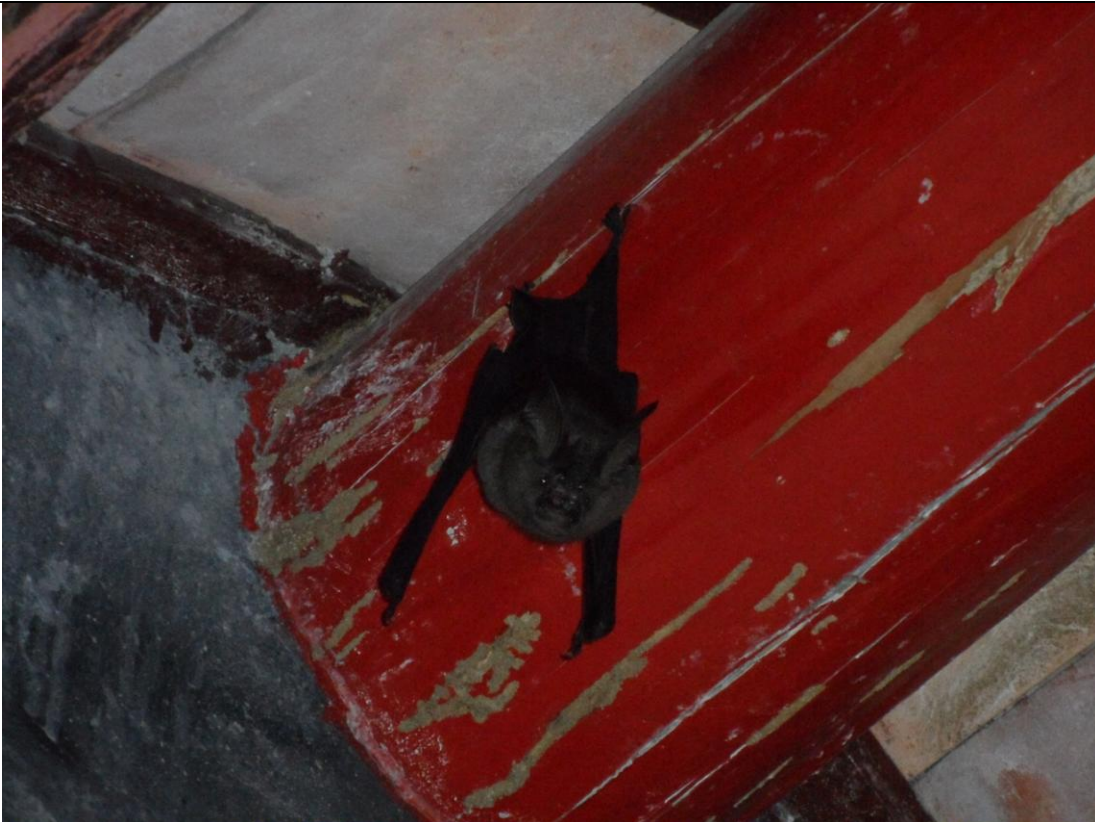
- 3.7 Around 200m away from the Ip Ting Sz Residence, there is an Ip's Ancestral Hall in the Lin Ma Hang Tsuen. 1 Himalayan Leaf-nosed Bat (*Hipposideros armiger*) was observed on both days. The presence of bats and juveniles in the past visits showed that the ancestral hall served as an alternative habitat and maternity roost. The location of the ancestral hall can be found in **Appendix A**. The bats might have already adapted to the environment in the ancestral hall so that very few returned to the Ip Ting-Sz Residence this year. This may account for no or low bat count in the Residence.

Ip's Ancestral Hall - Ceiling (30/8)

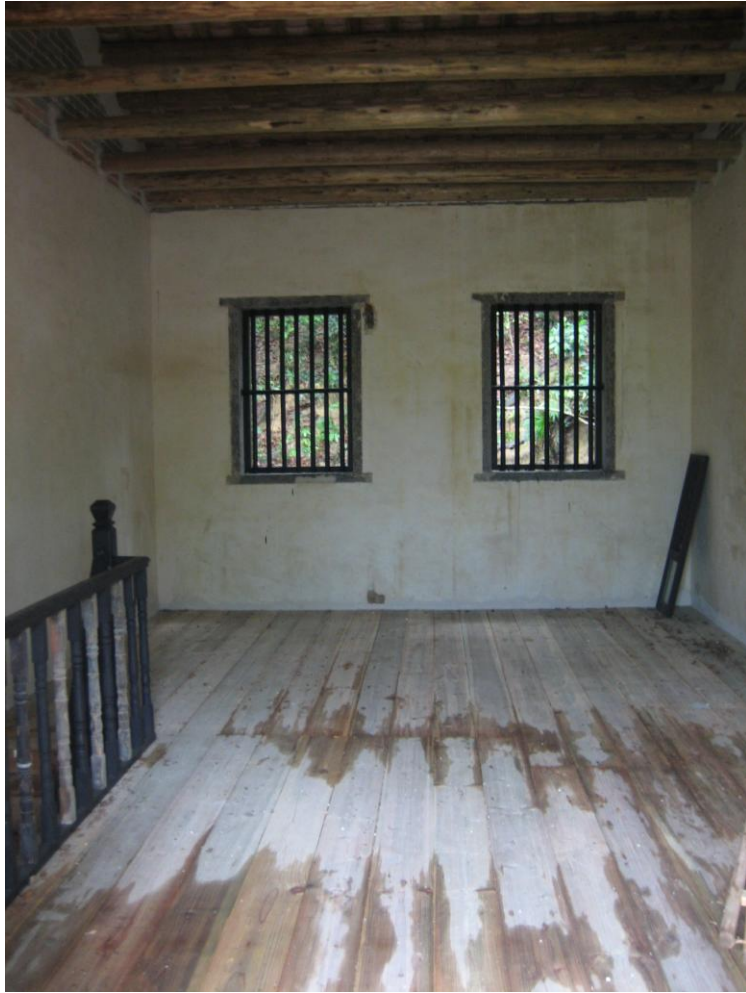
Date	Event
13.5.2011	Leakage was found from the tiled roof of the Main Building
24.6.2011	Scaffolding was set up for this defect rectification
24.6.2011-22.7.2011	Part of the tiles were re-laid to rectify the leakage problem (a few days of work were carried out over this period)
22.7.2011-10.8.2011	Scaffolding was kept on site for monitoring of roof leaks repair
11.8.2011	Leakage was still found in a few locations
11.8.2011-17.8.2011	Part of the tiles were re-laid to rectify the leakage problem (1-2 days of work were carried out over this period)
18.8.2011-31.8.2011	Scaffolding was kept on site while the leakage problem is under monitoring

Leakage at Main Building (13/5)

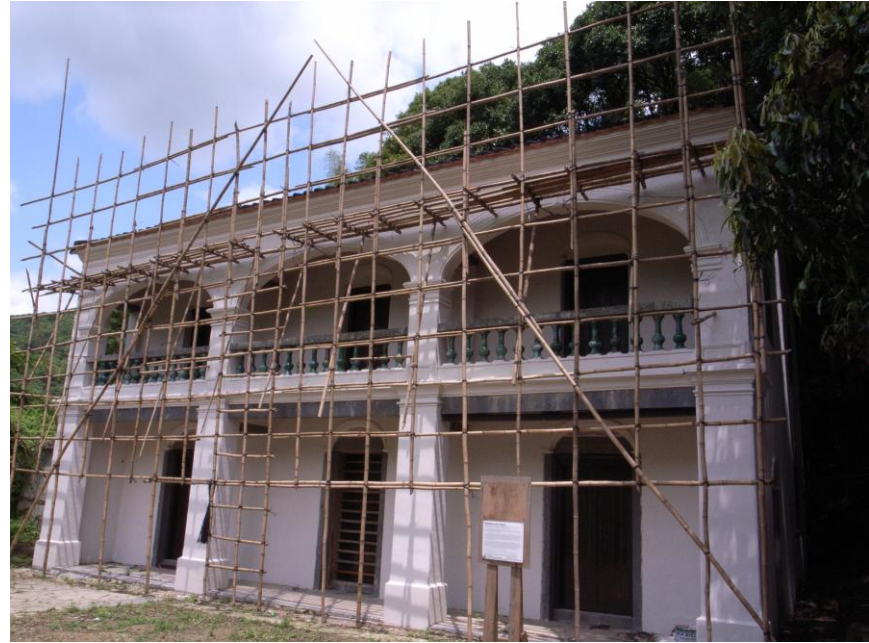
Scaffolding at Main Building (14/7)

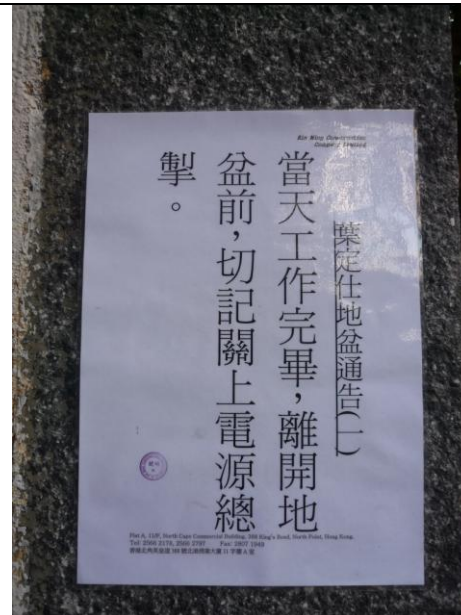
Notice to Contractor (15/8)

- 4.2 Photographs showing water leakage and scaffolding can be found in **Appendix C**.
- 4.3 The contractor was reminded not to disturb any bats roosting in the Kitchen Annex and to minimise noise production. A notice was put up to remind the contractor to turn off the lighting before leaving the site to provide a dark environment for any returning bats.
