Central Police Station Conservation and Revitalization Project Condition Survey

Central Police Station As Build Photo record surrounding

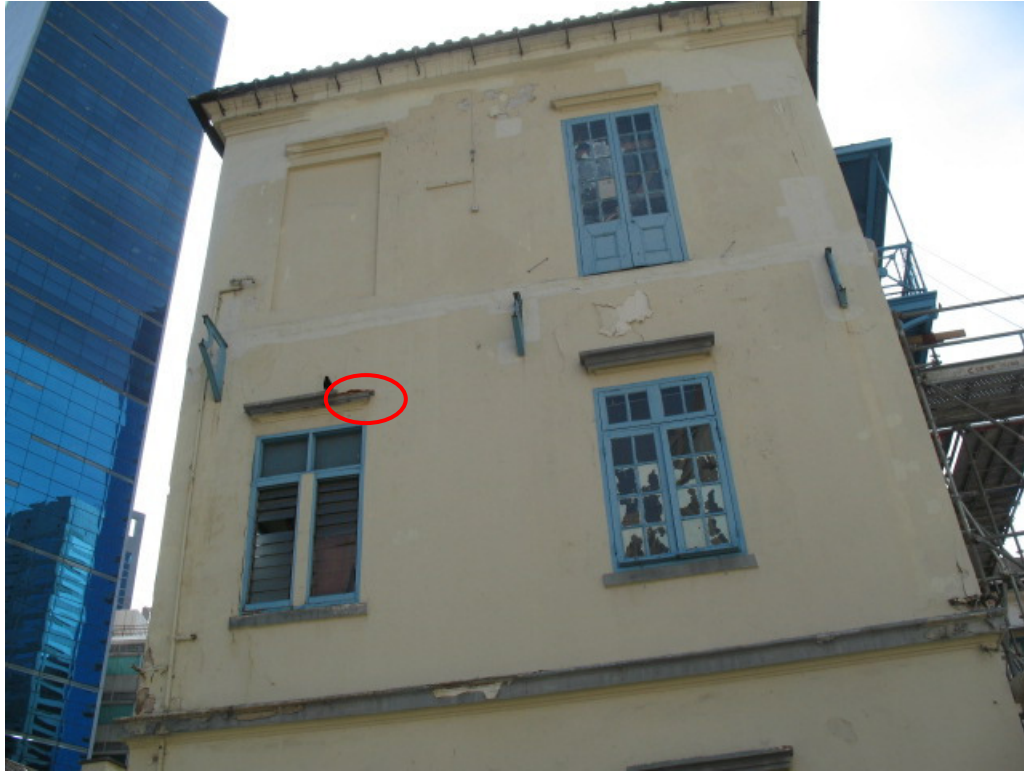
01

Photo ex 01a – The wall feature is chipped.

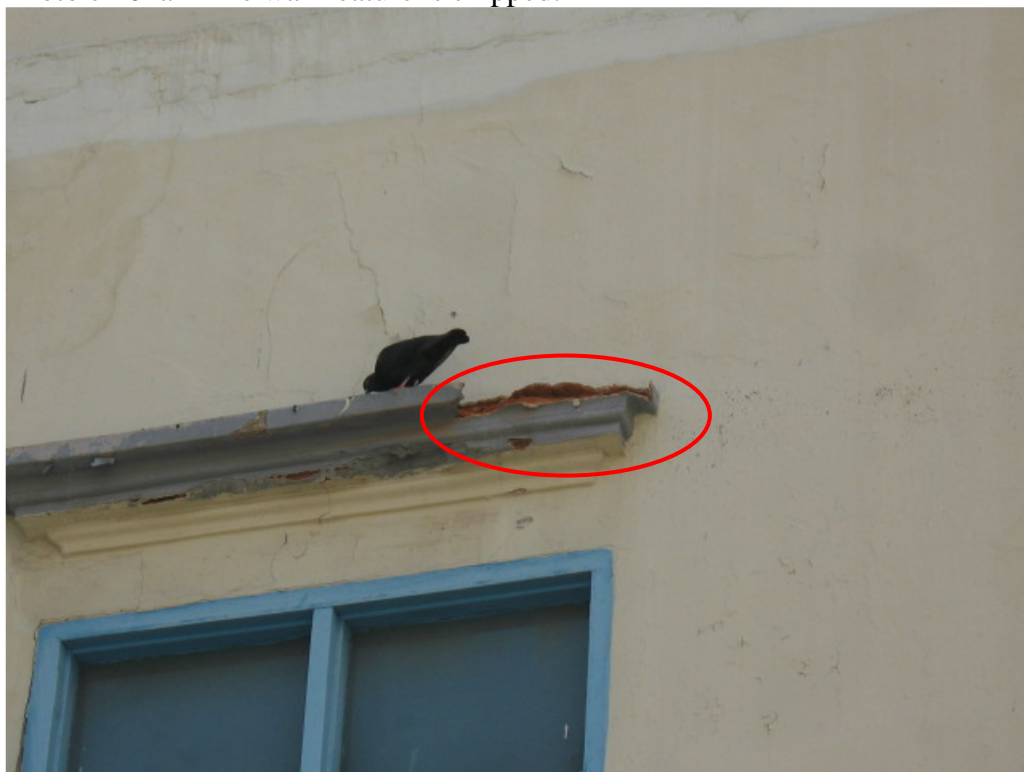
Photo ex 01b – The wall feature is chipped.

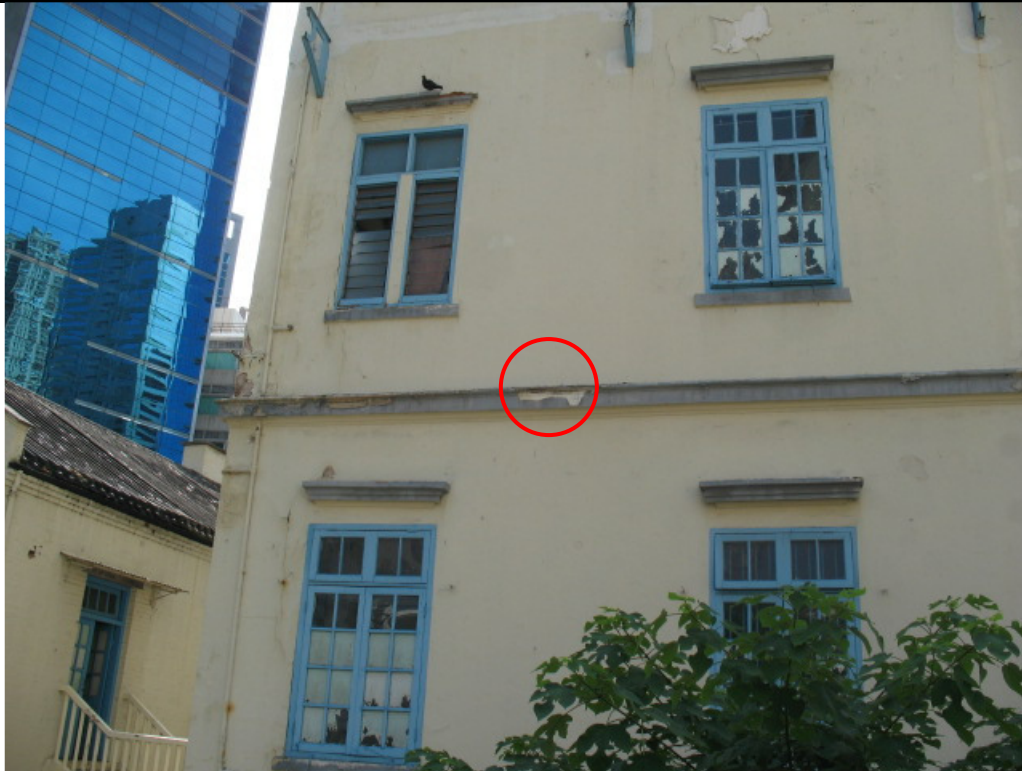
Photo ex 01c – The wall feature is damaged.

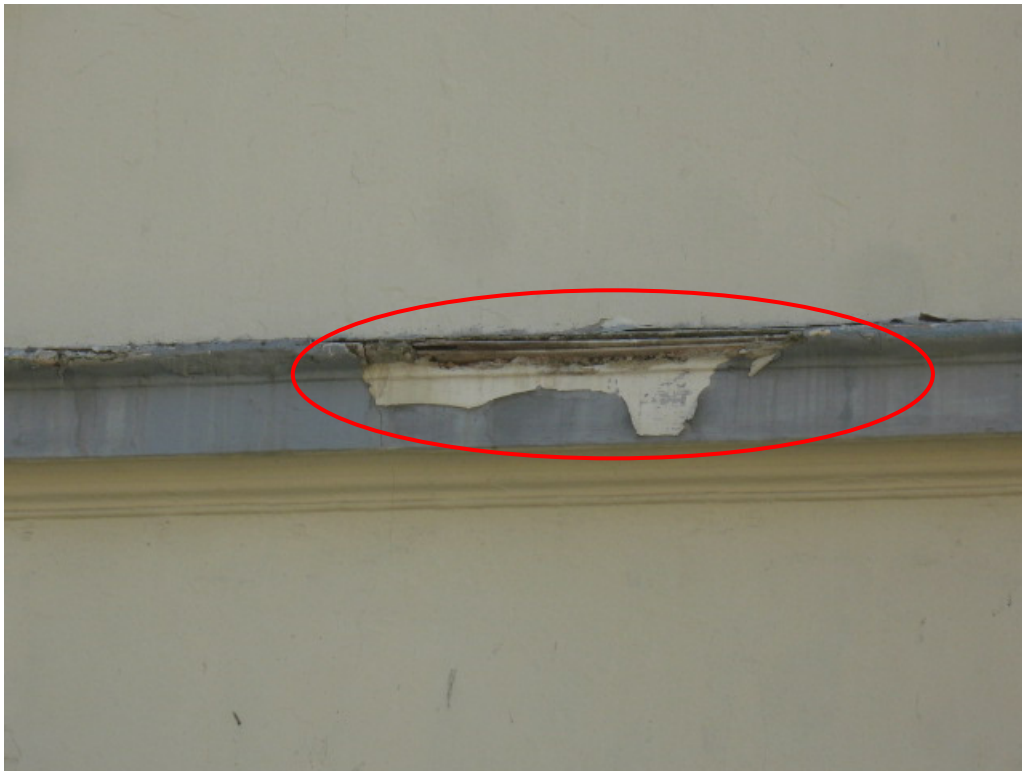
Photo ex 01d – The wall feature is damaged.

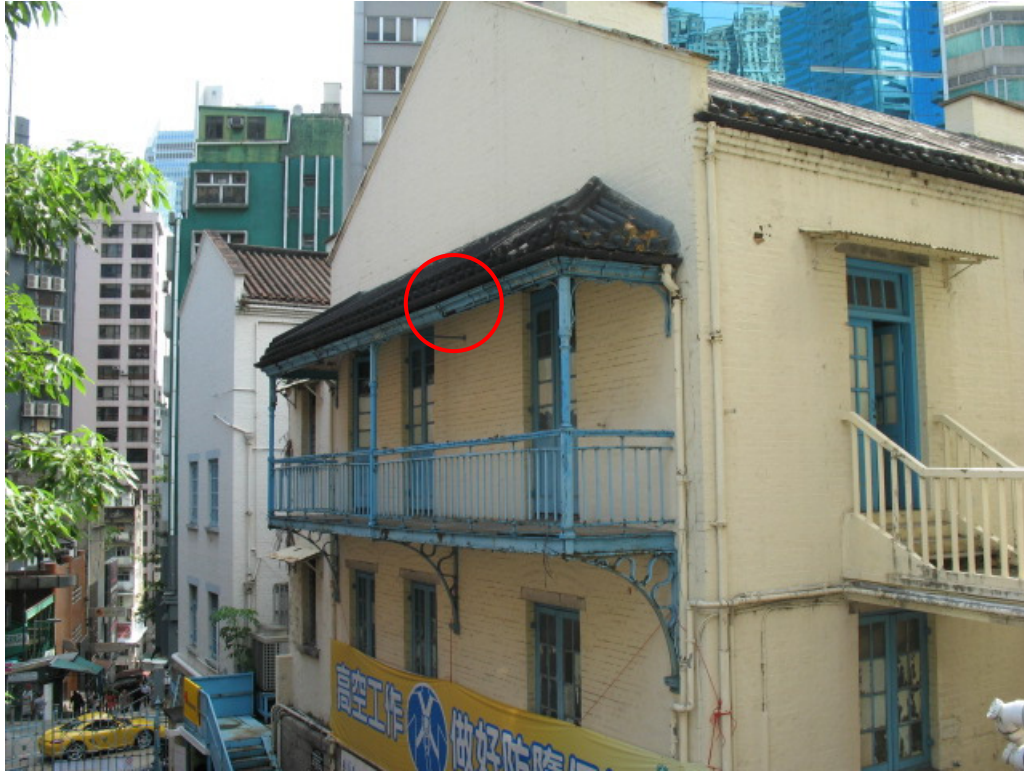
02

Photo ex 02a – The balcony is damaged.

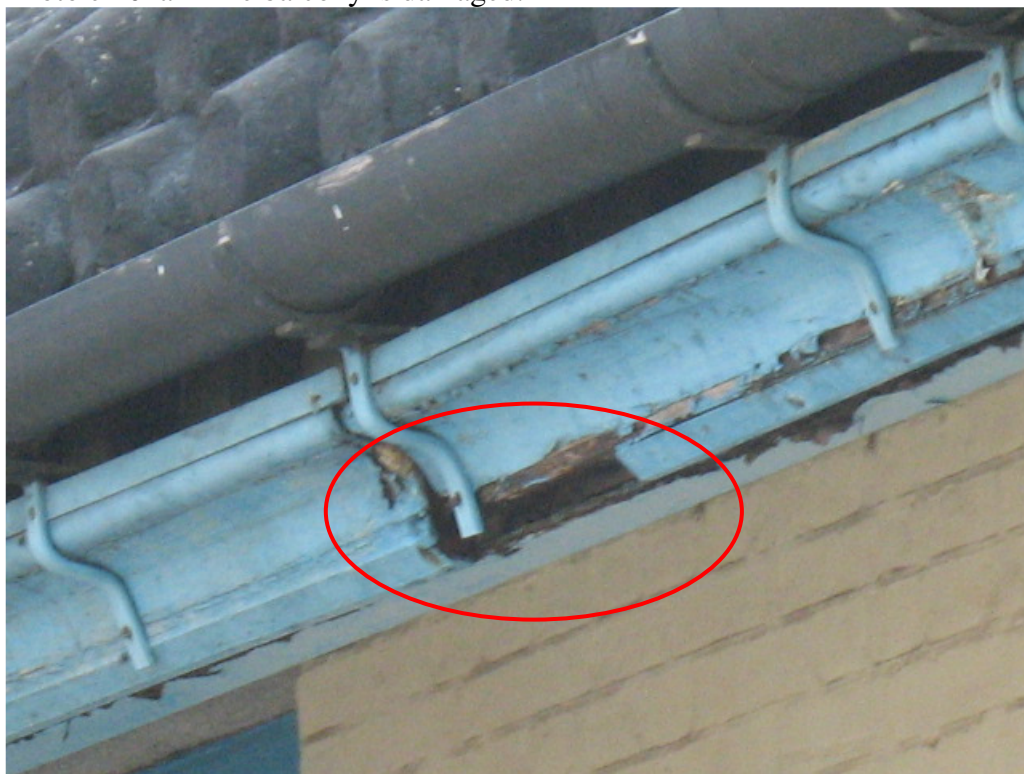
Photo ex 02b – The balcony is damaged.

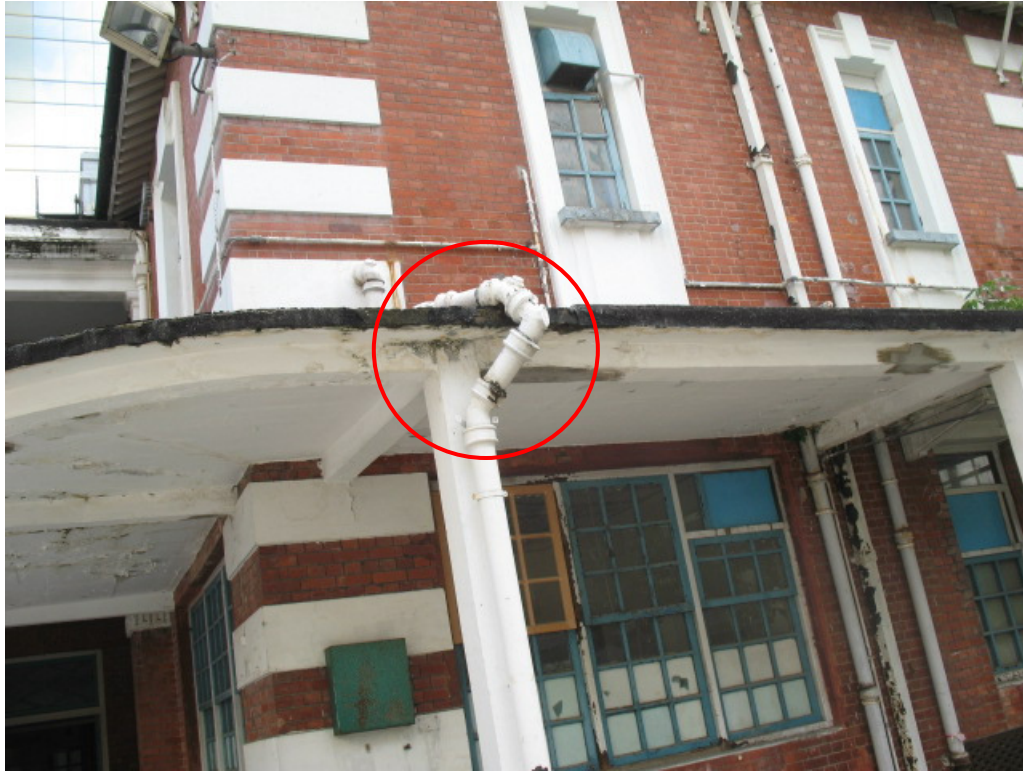
03

Photo ex 03a – Water stain is found is at the canopy.

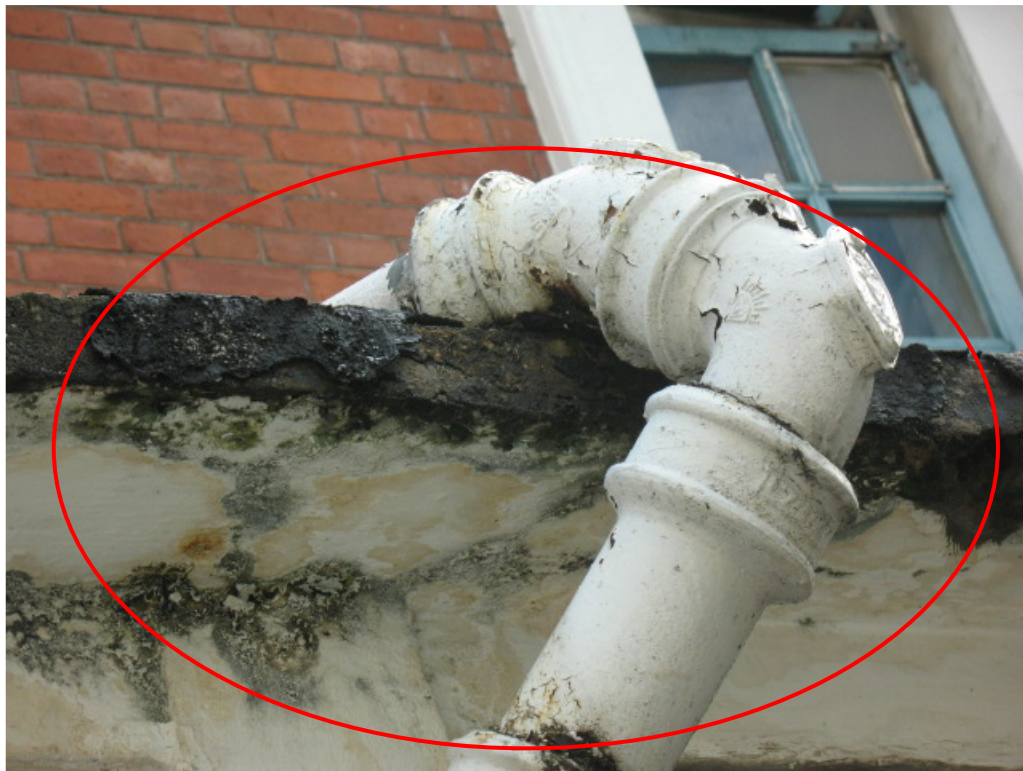
Photo ex 03b – Water stain is found at the canopy.

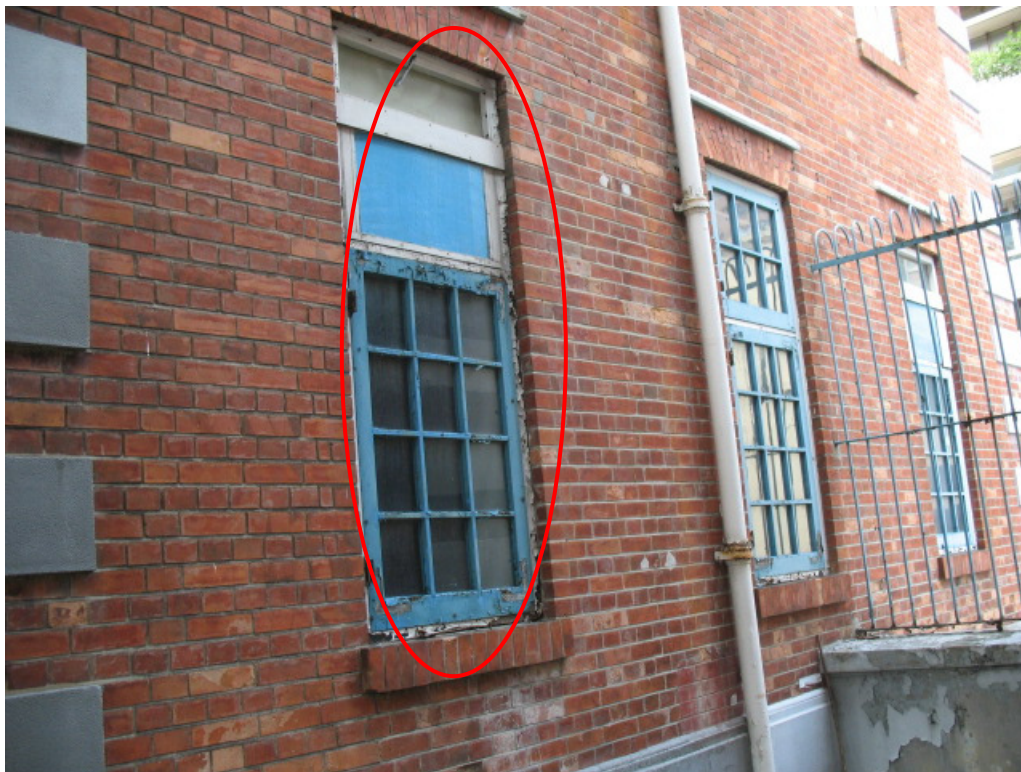
04

Photo ex 04a – The window frame is damaged.

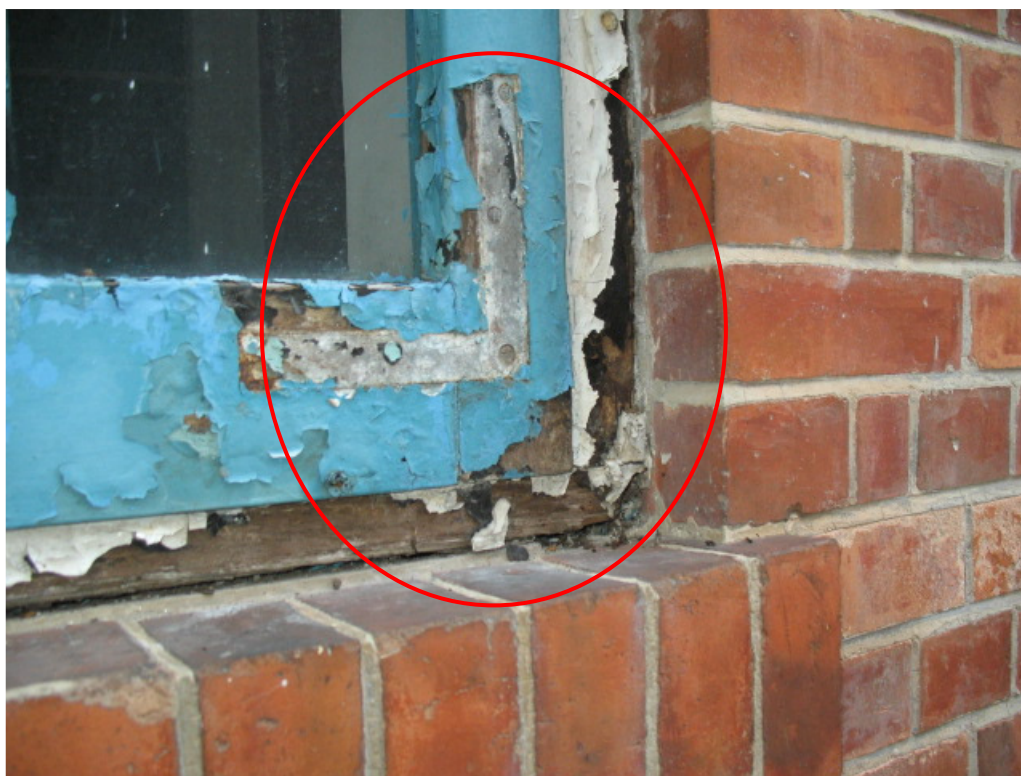
Photo ex 04b – The window frame is damaged.

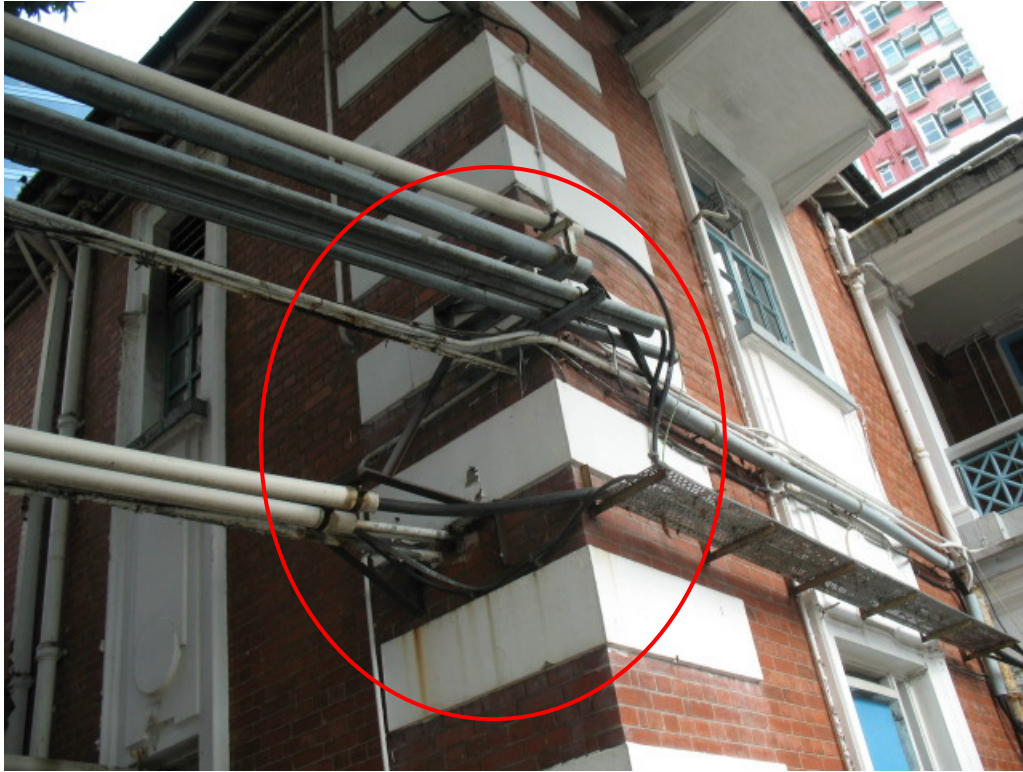
05

Photo ex 05a – The wall is damaged.

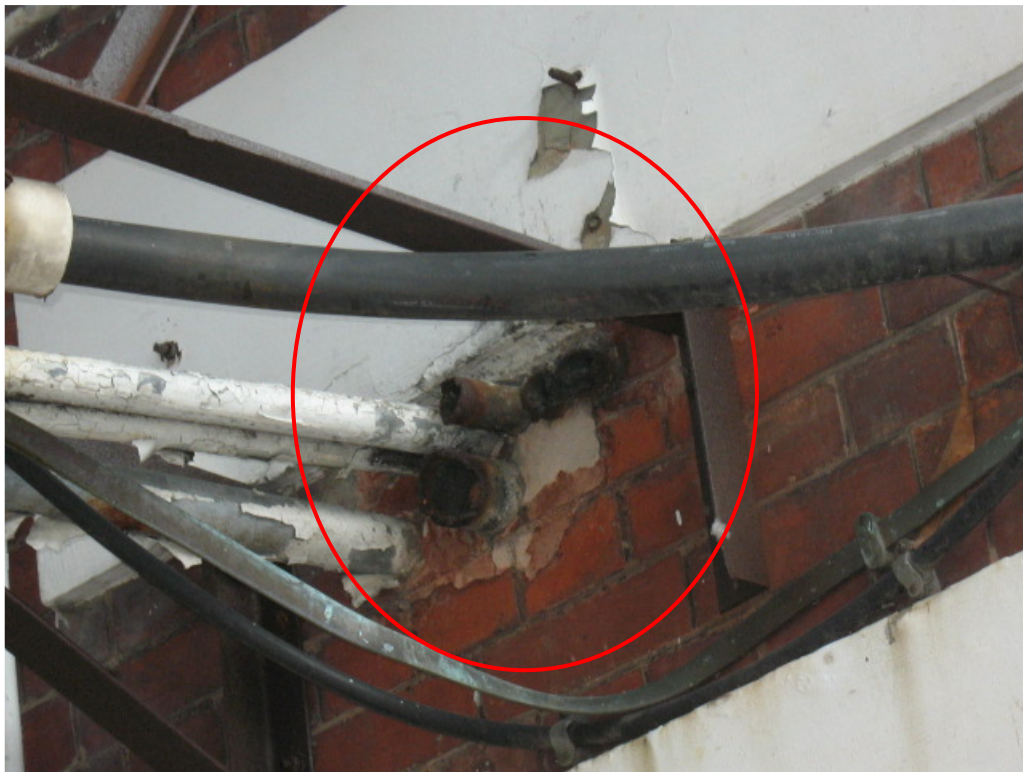
Photo ex 05b – The wall is damaged.

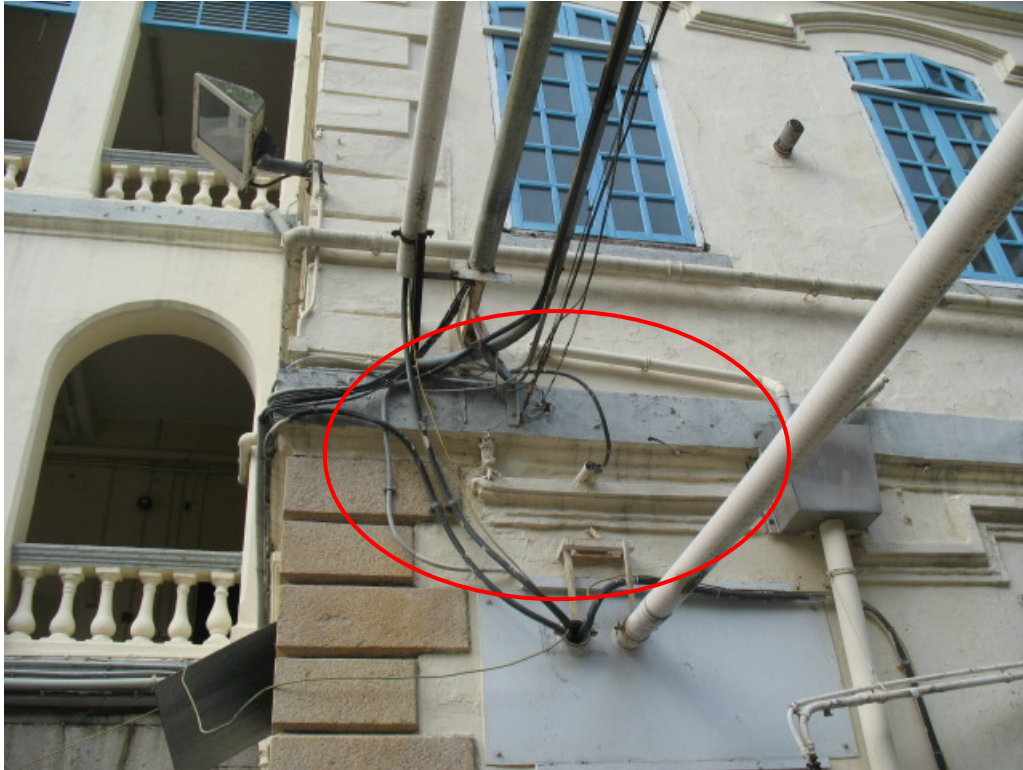
06

Photo ex 06a – The wall is damaged.

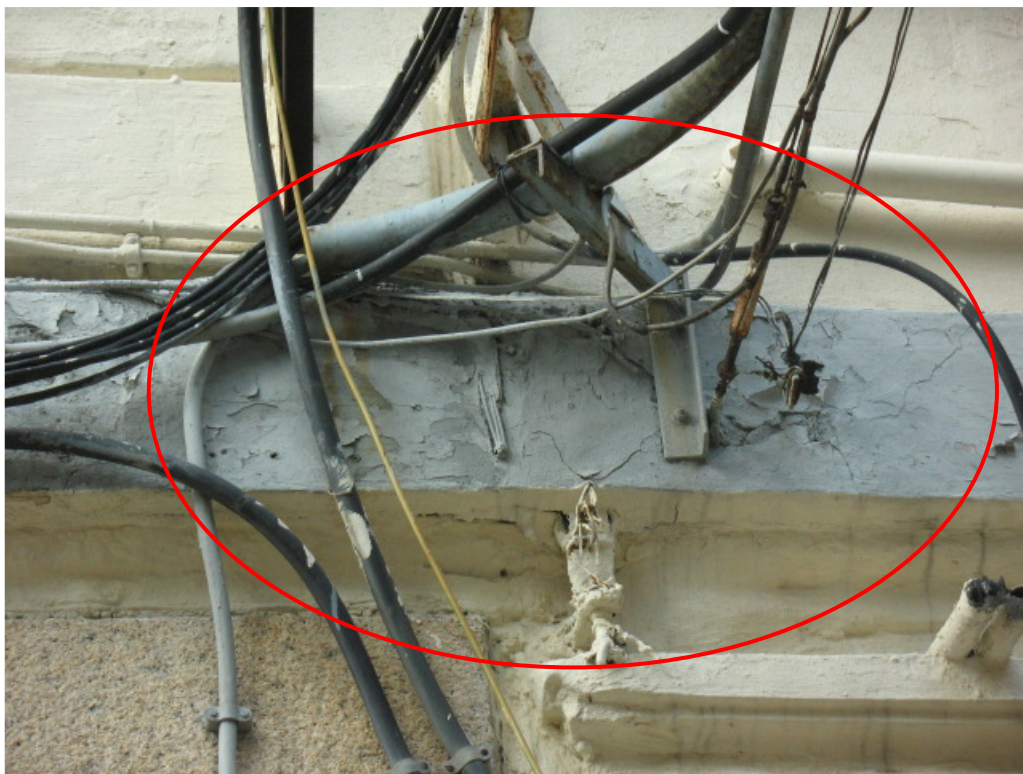
Photo ex 06b – The wall is damaged.

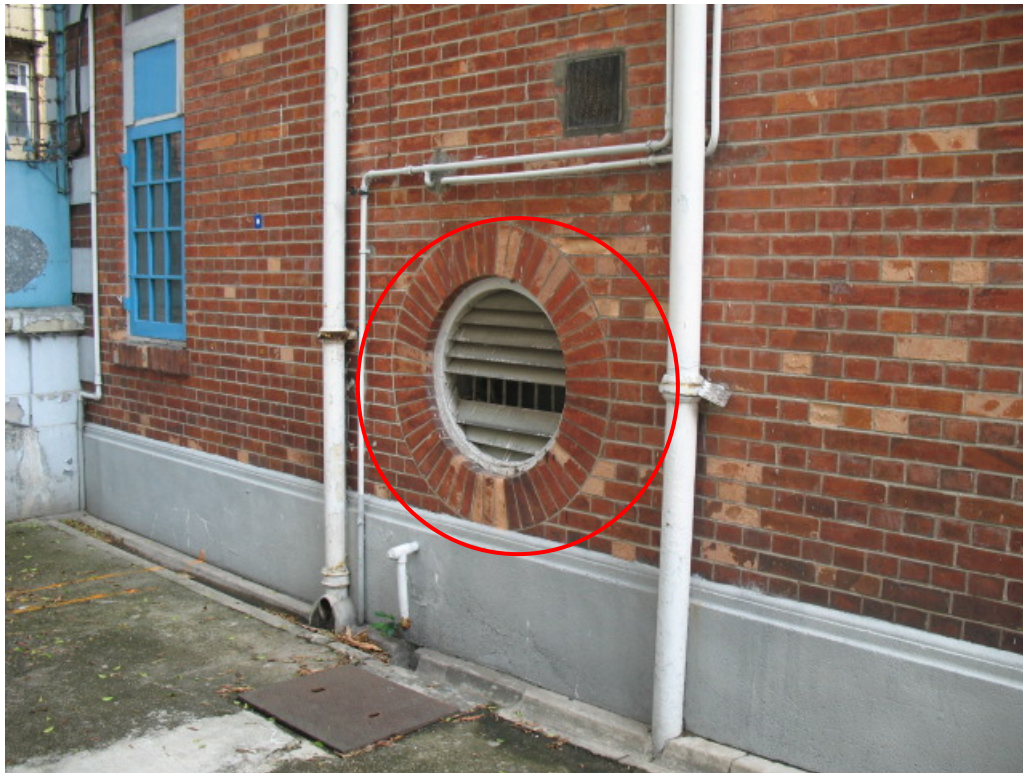
07

Photo ex 07a – The window is damaged.

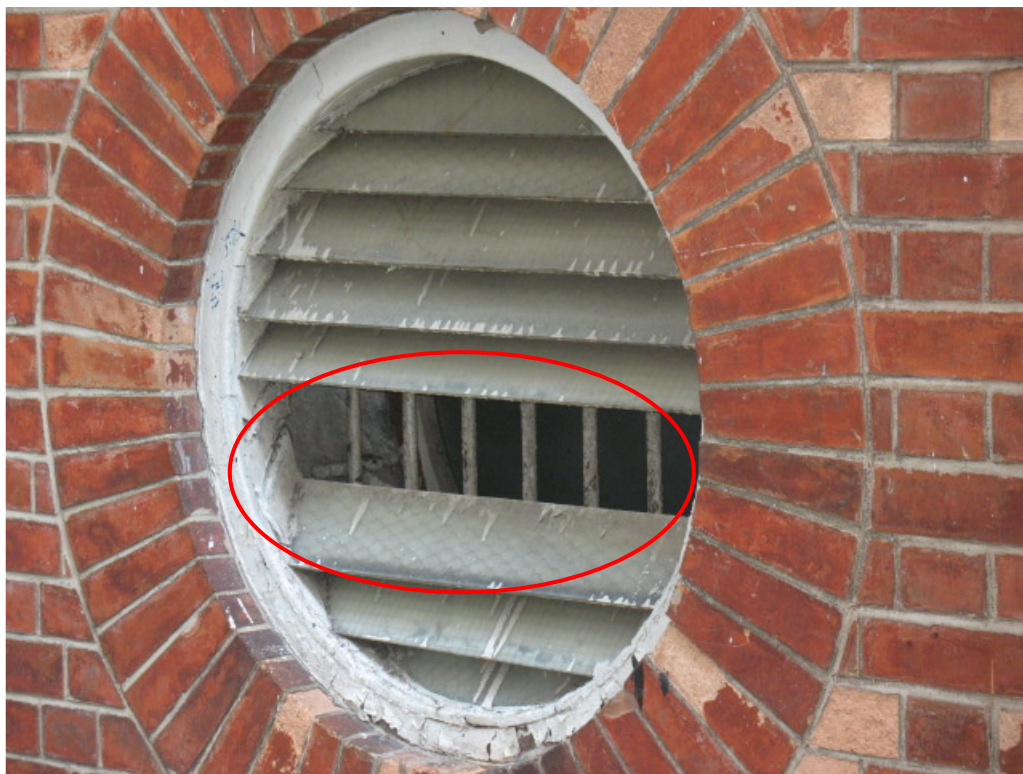
Photo ex 07b – The window is damaged.

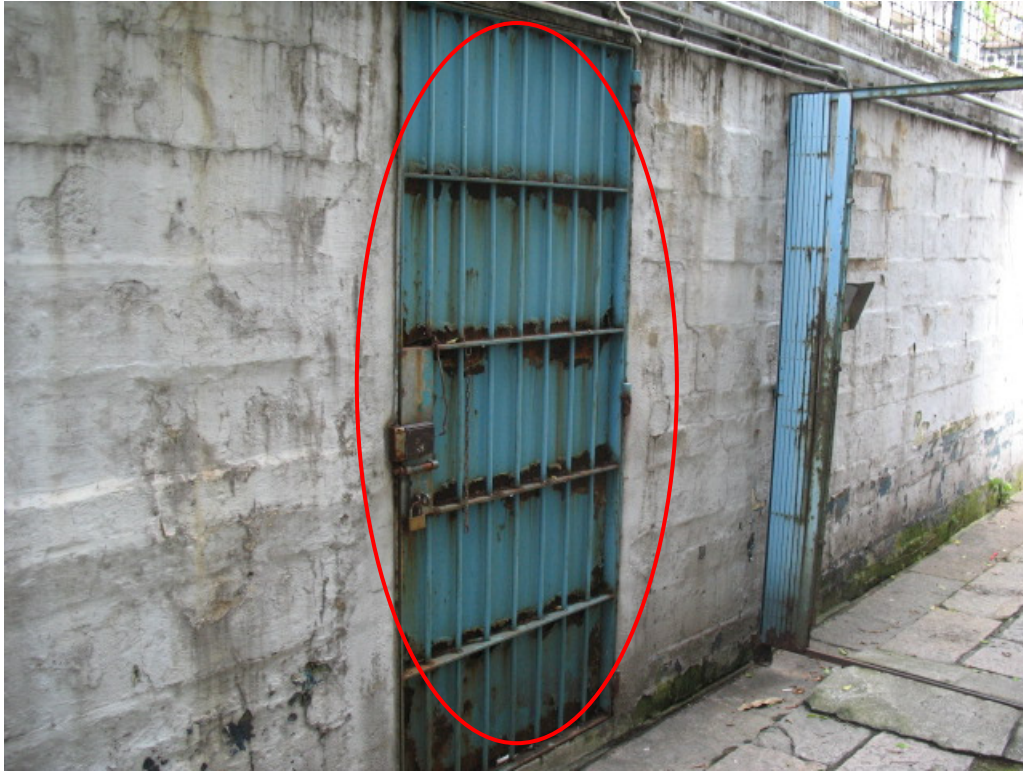
08

Photo ex 08a – Corrosion is found on the gate.

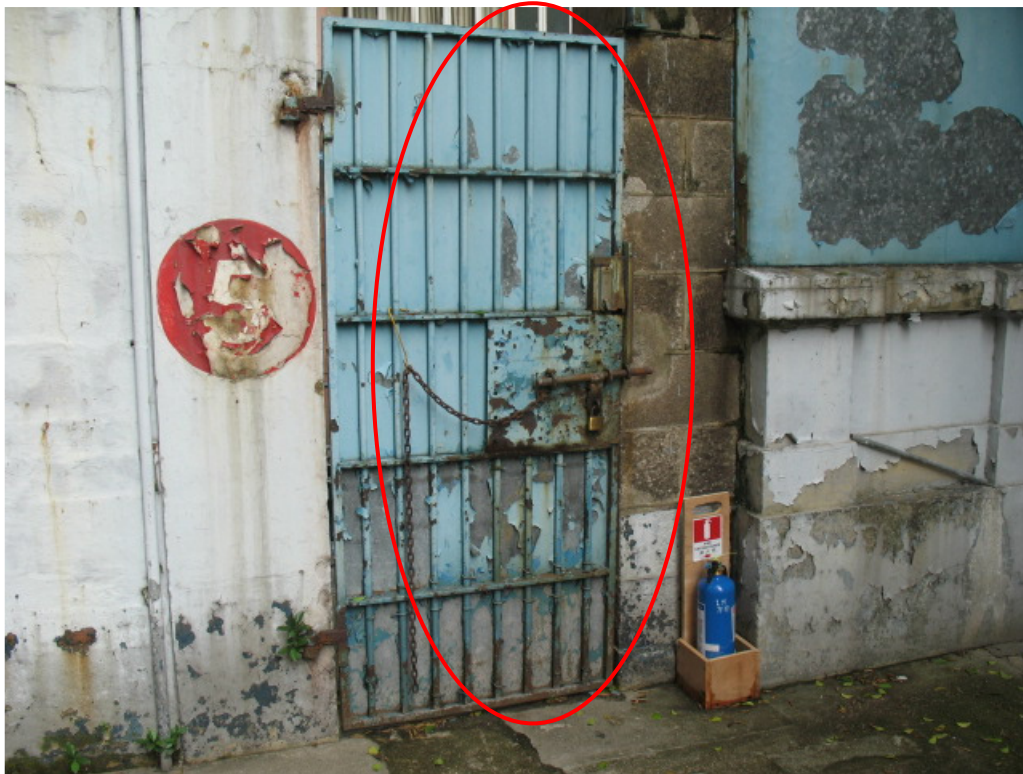
Photo ex 08b – Corrosion is found on the gate.

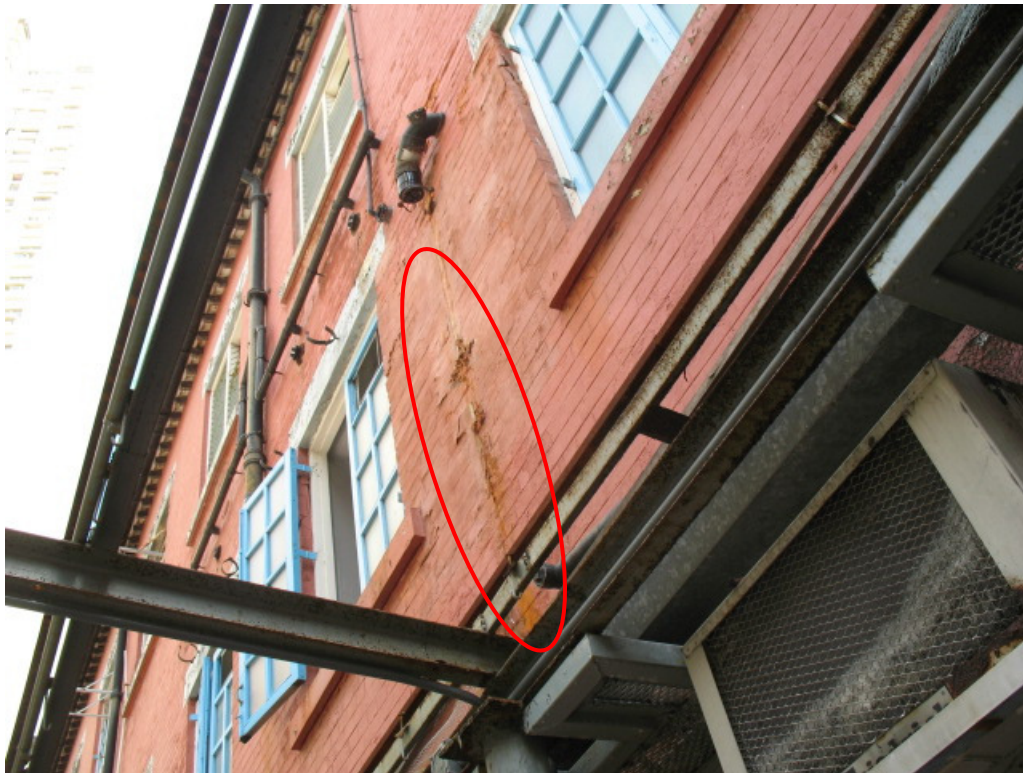
09

Photo ex 09a – The wall is damaged.

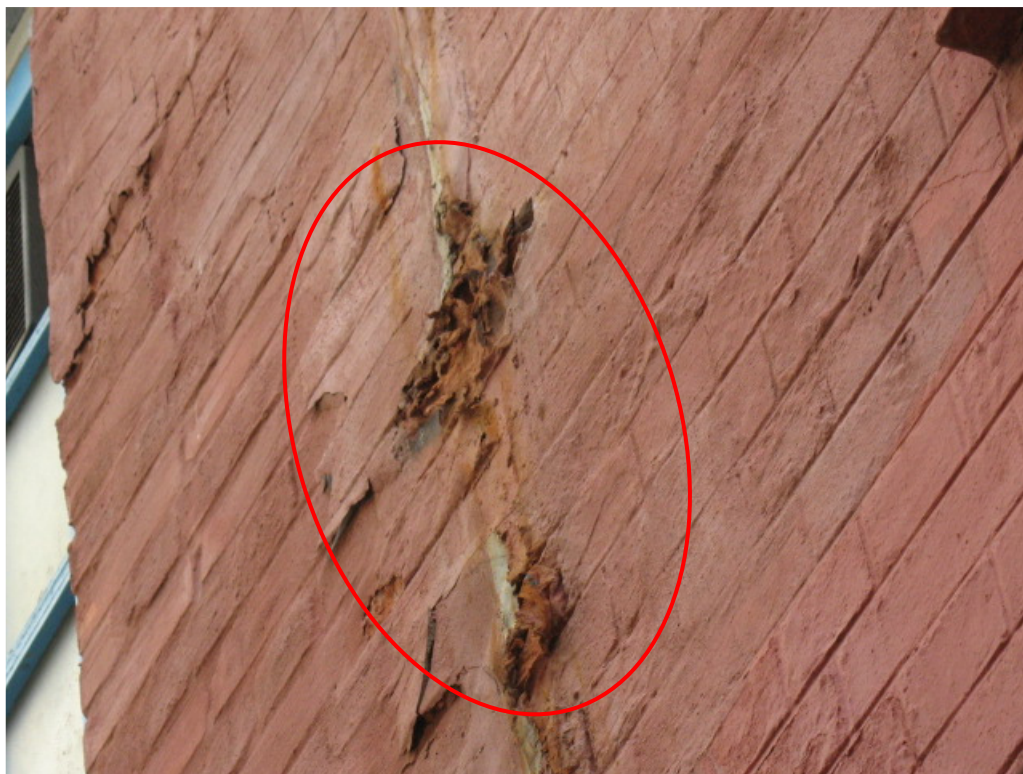
Photo ex 09b – The wall is damaged.

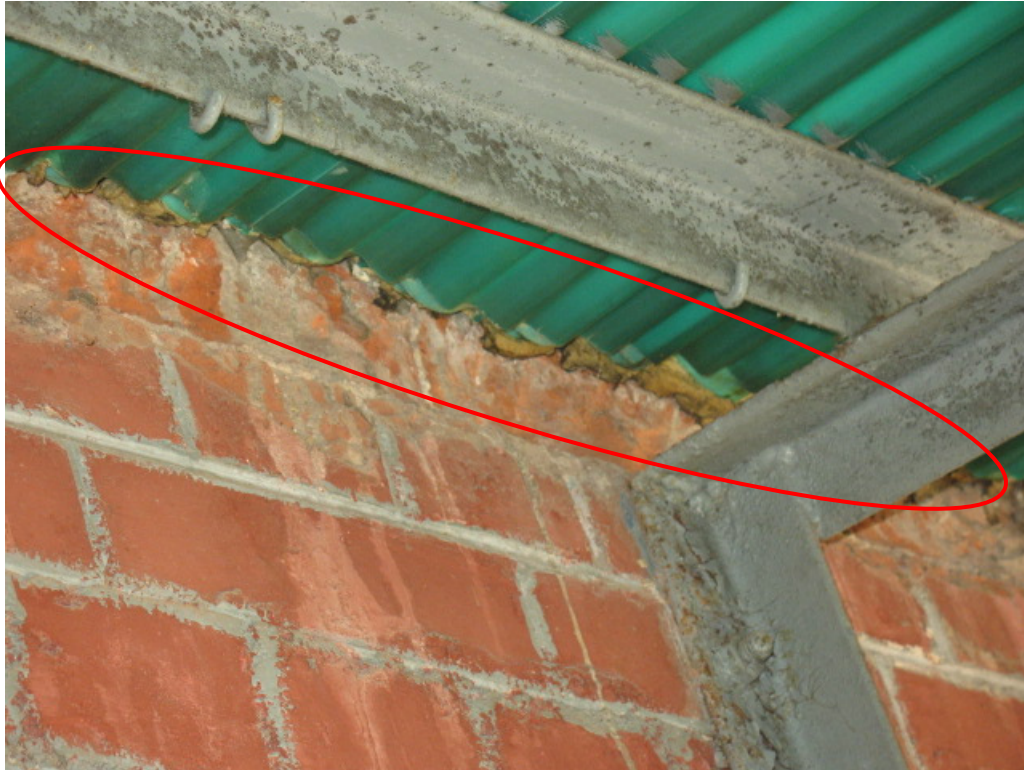
10

Photo ex 10a – The brickwork is chipped.

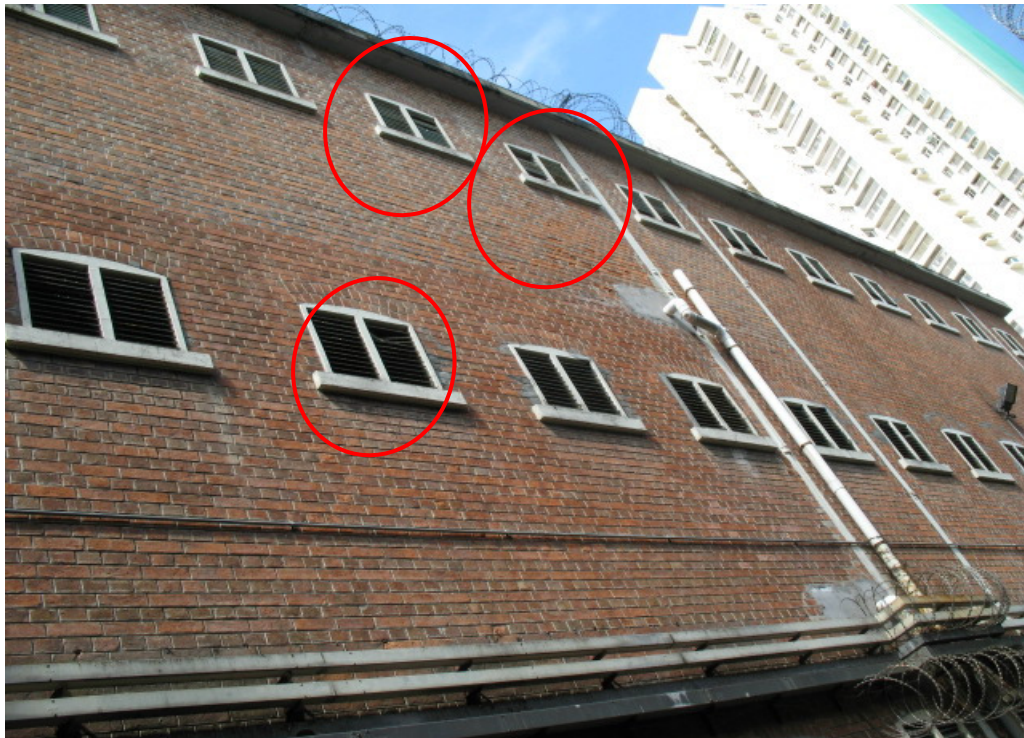
11

Photo ex 11a – The windows are damaged.

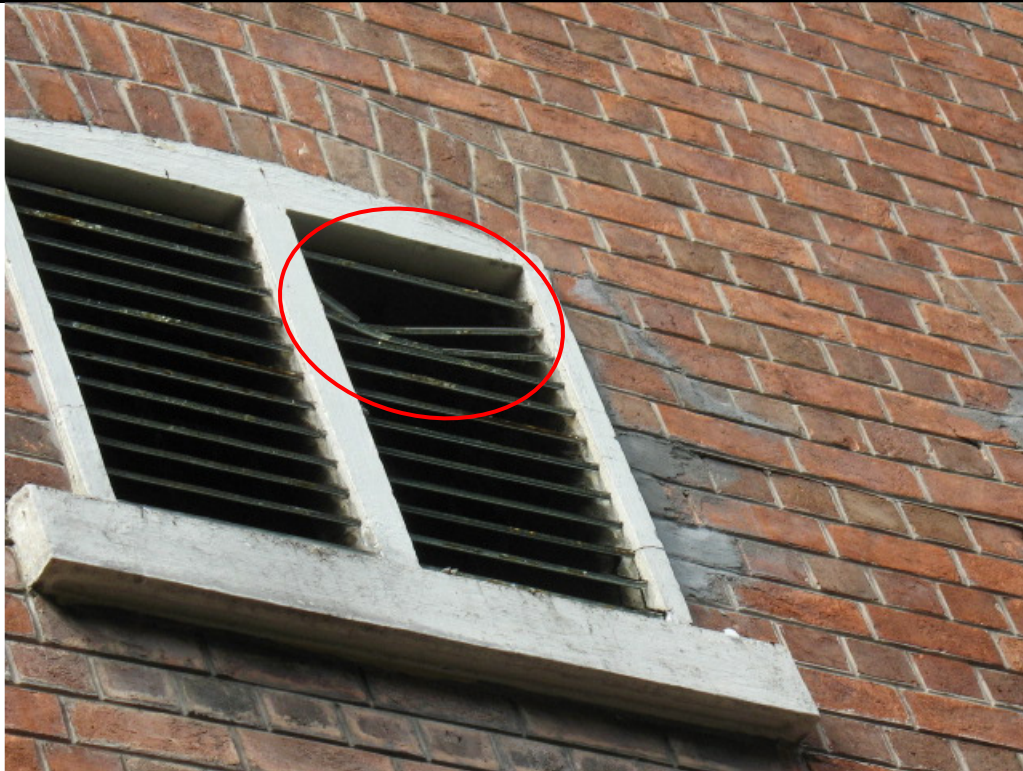
Photo ex 11b – The window is damaged.

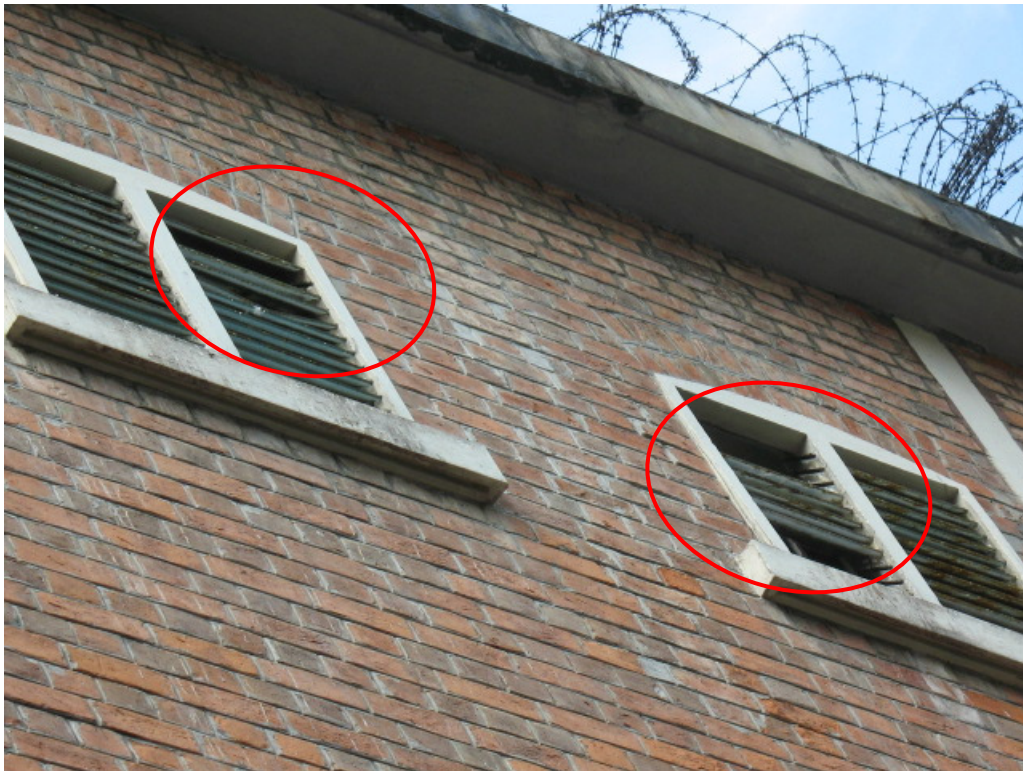
Photo ex 11c – The windows are damaged.

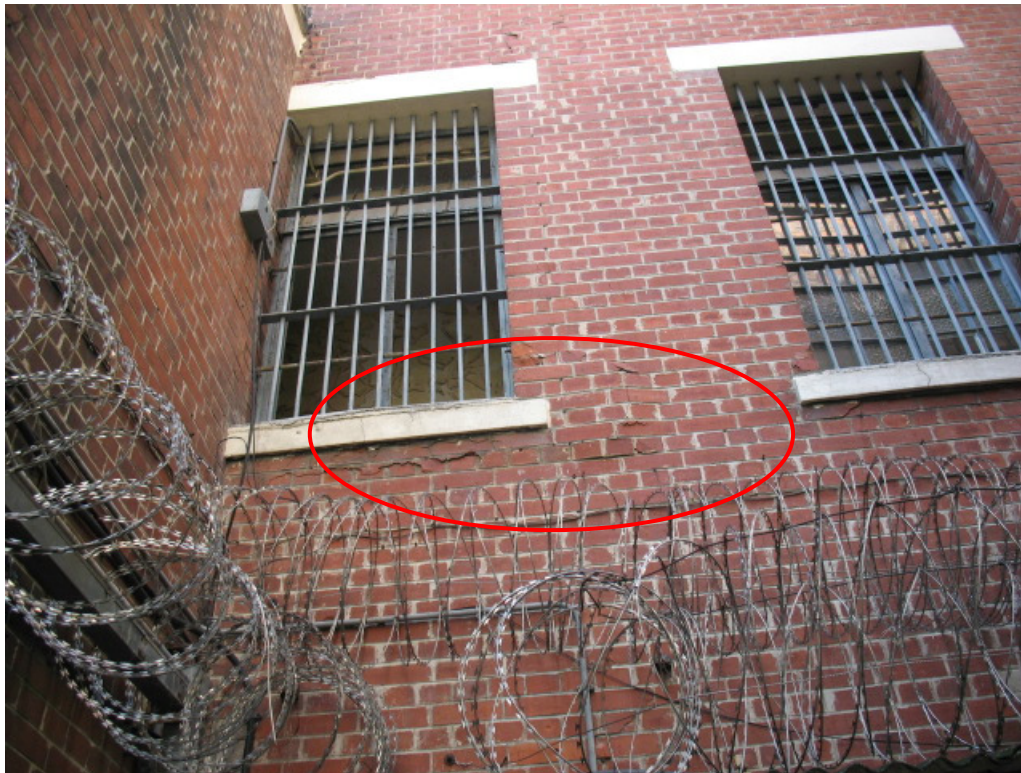
12

Photo ex 12a – The wall is damaged.

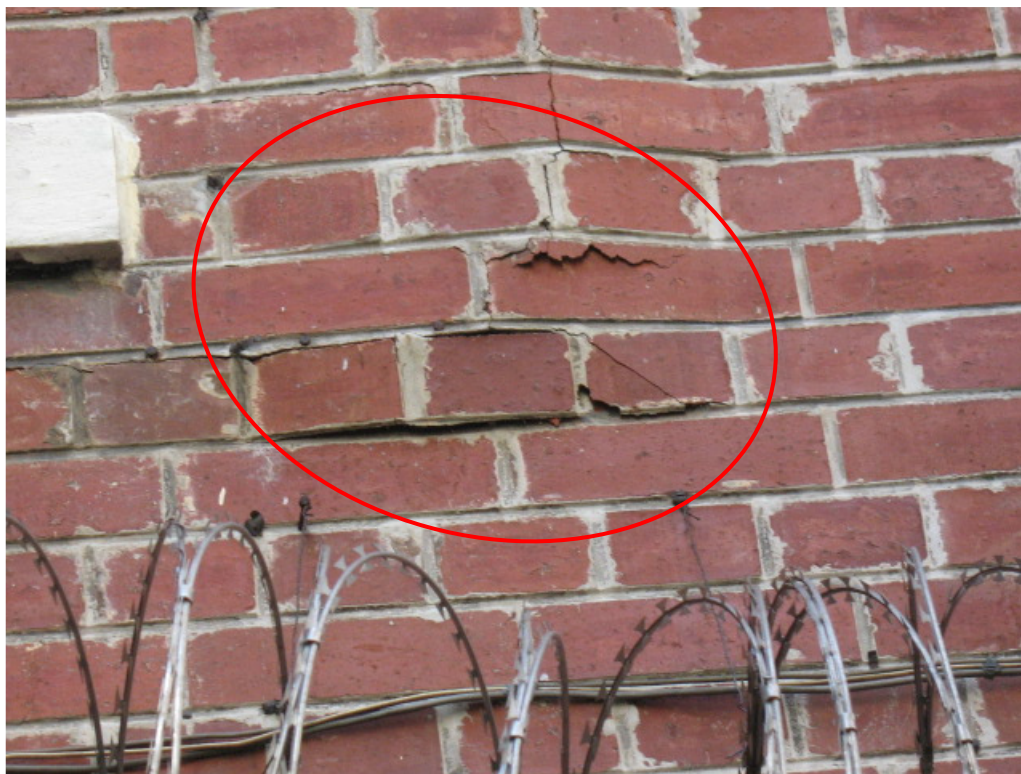
Photo ex 12b – The wall is damaged.

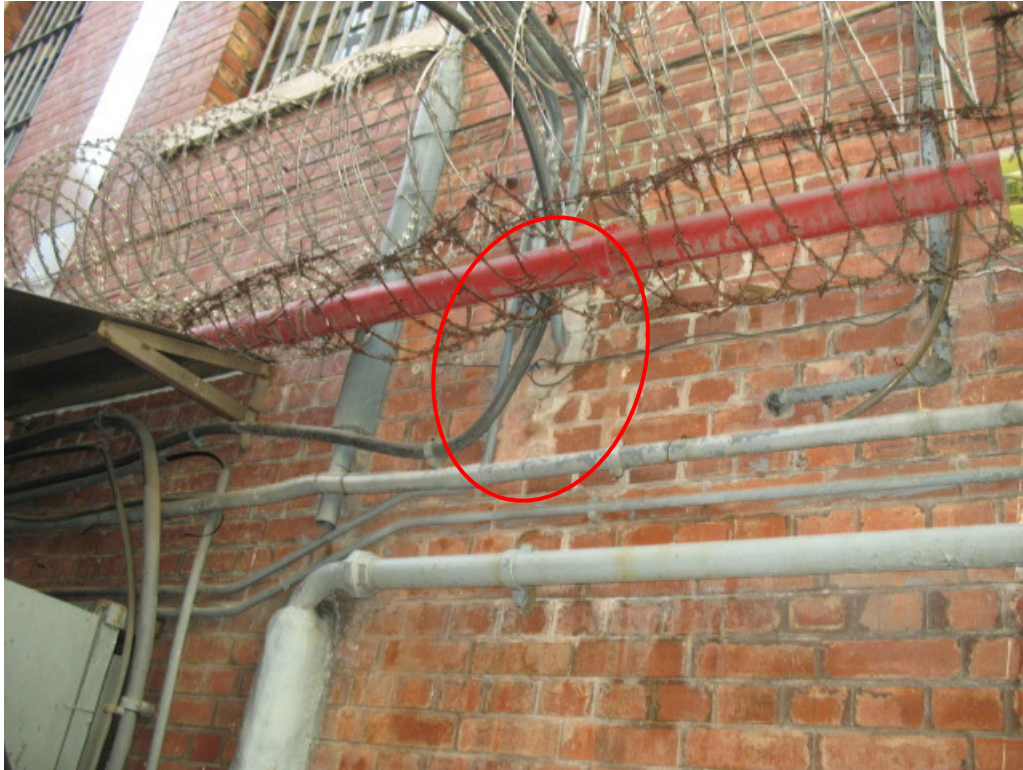
13

Photo ex 13a – The wall is damaged.

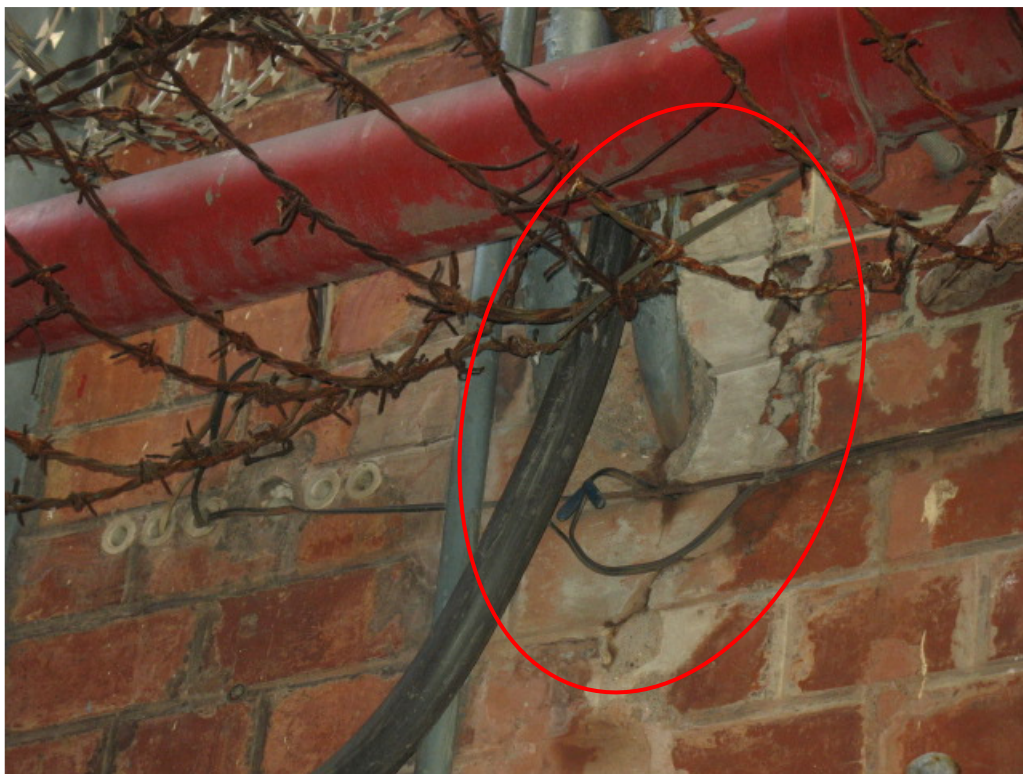
Photo ex 13b – The wall is damaged.

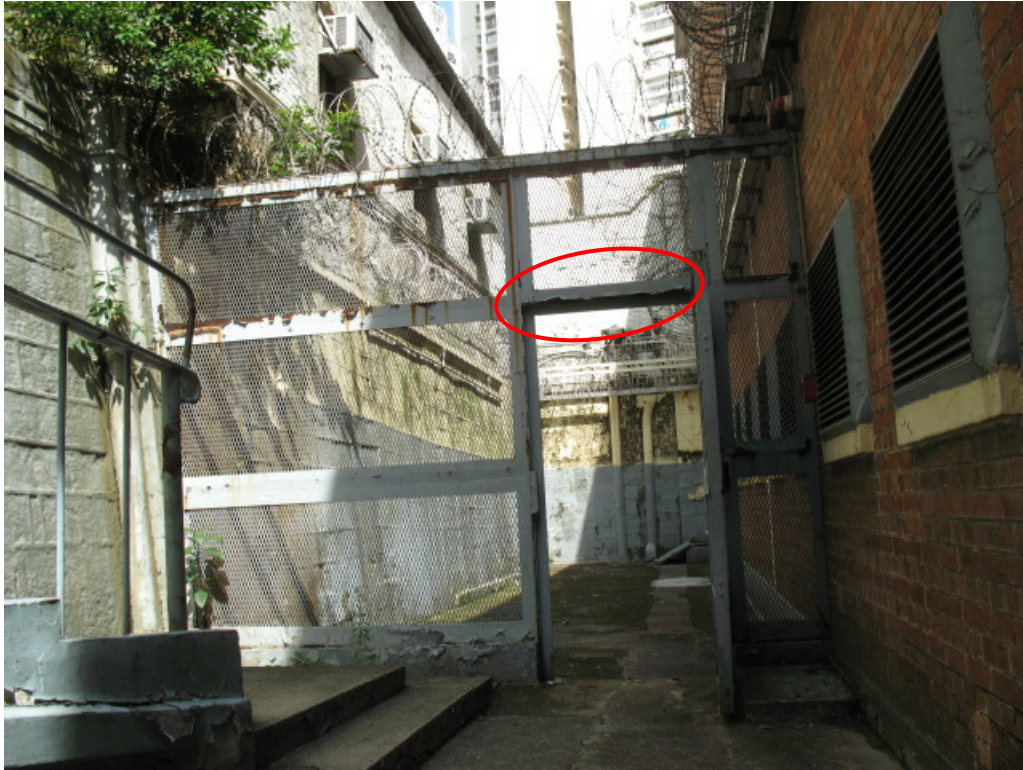
14

Photo ex 14a – Corrosion is found on the gate.
