Central Police Station Conservation and Revitalization Project Condition Survey

Central Police Station As Build Photo record surrounding

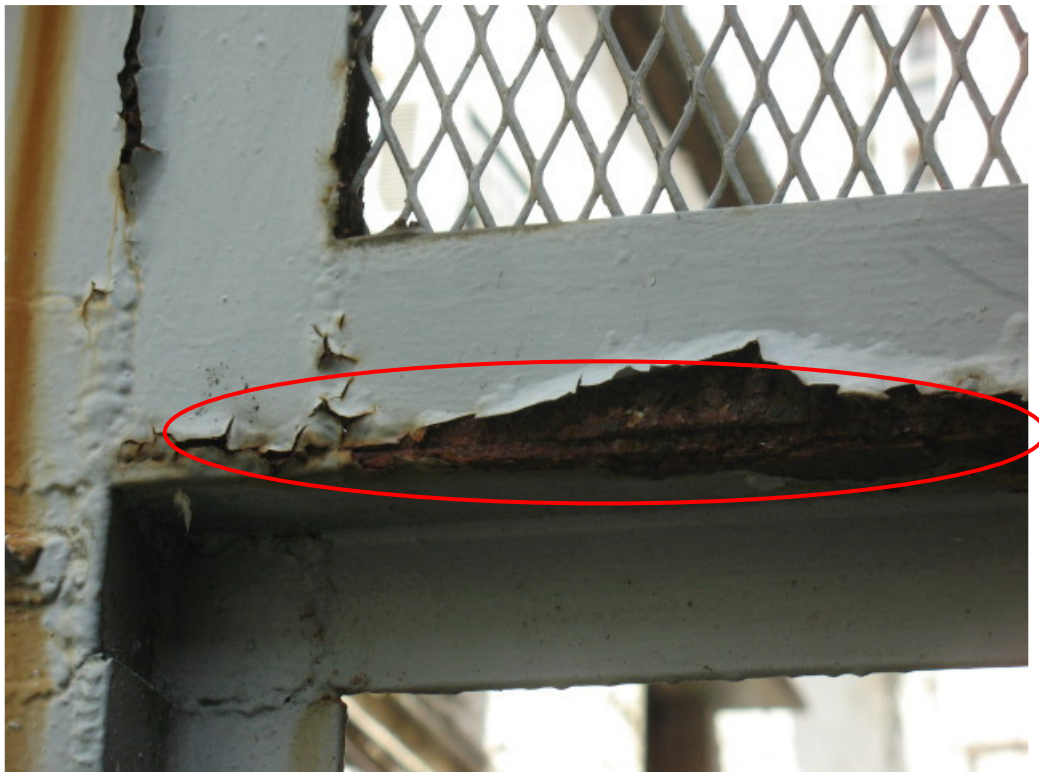
Photo ex 14b – Corrosion is found on the gate.

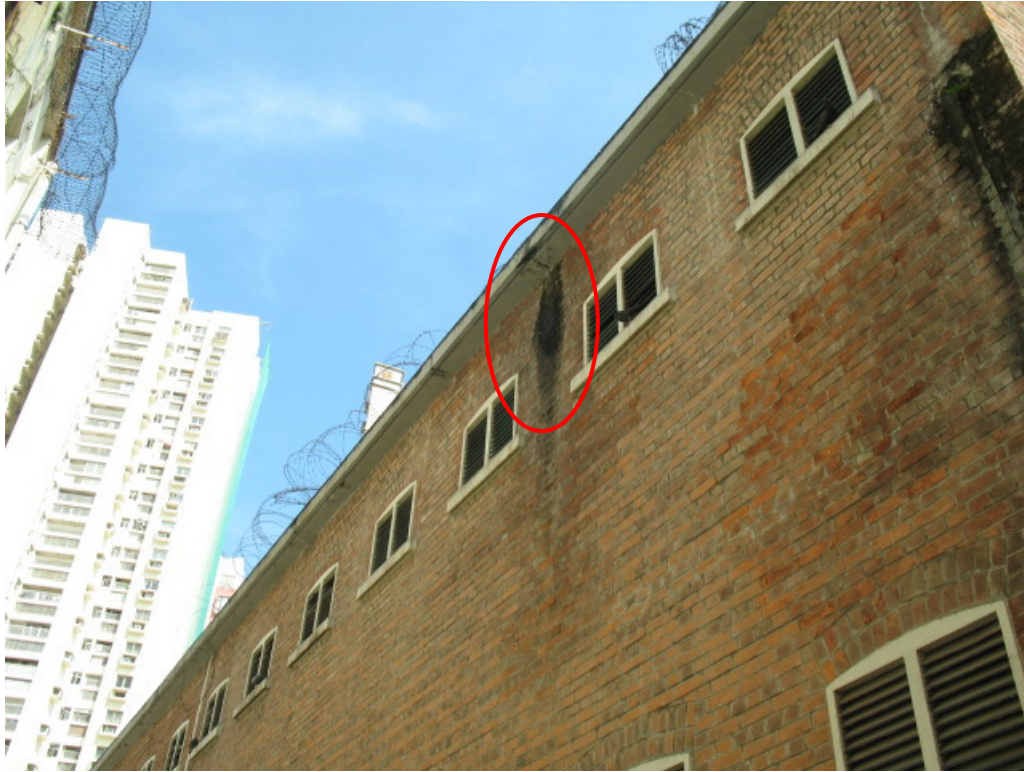
Photo ex 15a – Crack and water stain are found on the wall.

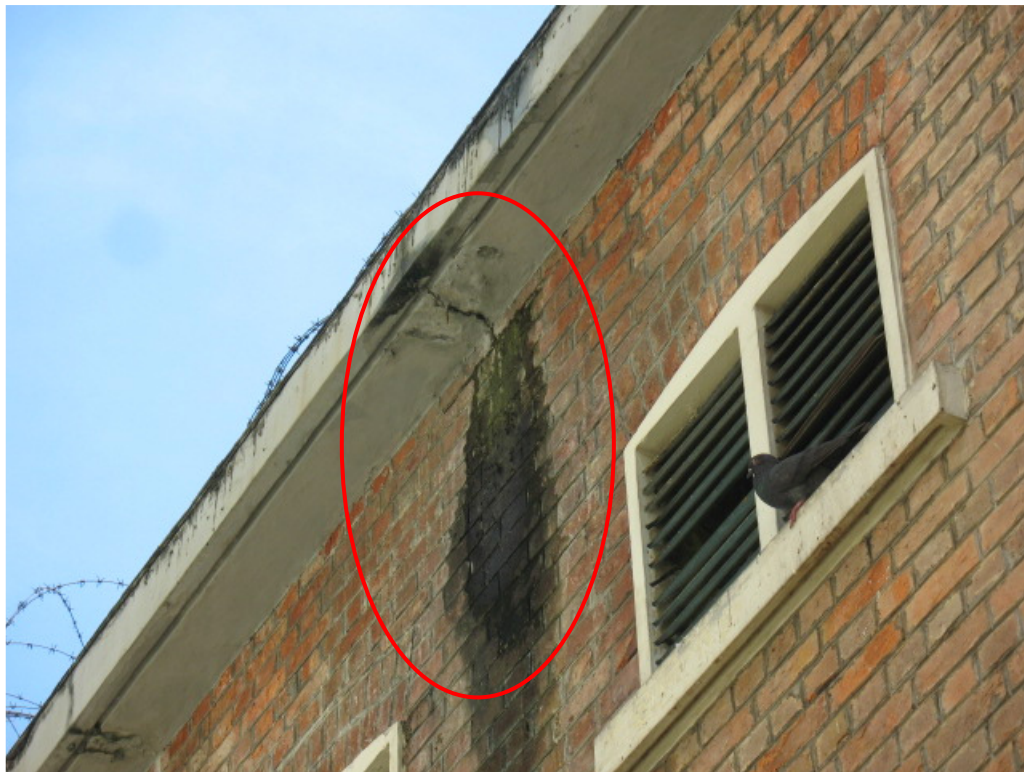
Photo ex 15b – Crack and water stain are found on the wall.

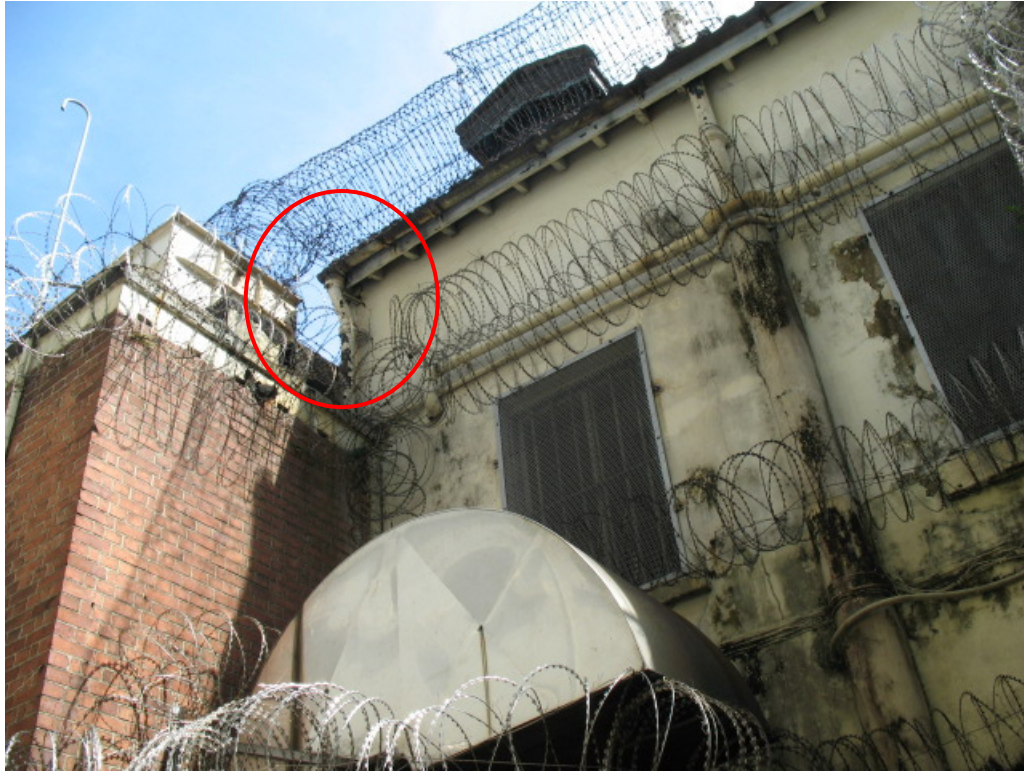
16

Photo ex 16a – Crack is found on the wall.

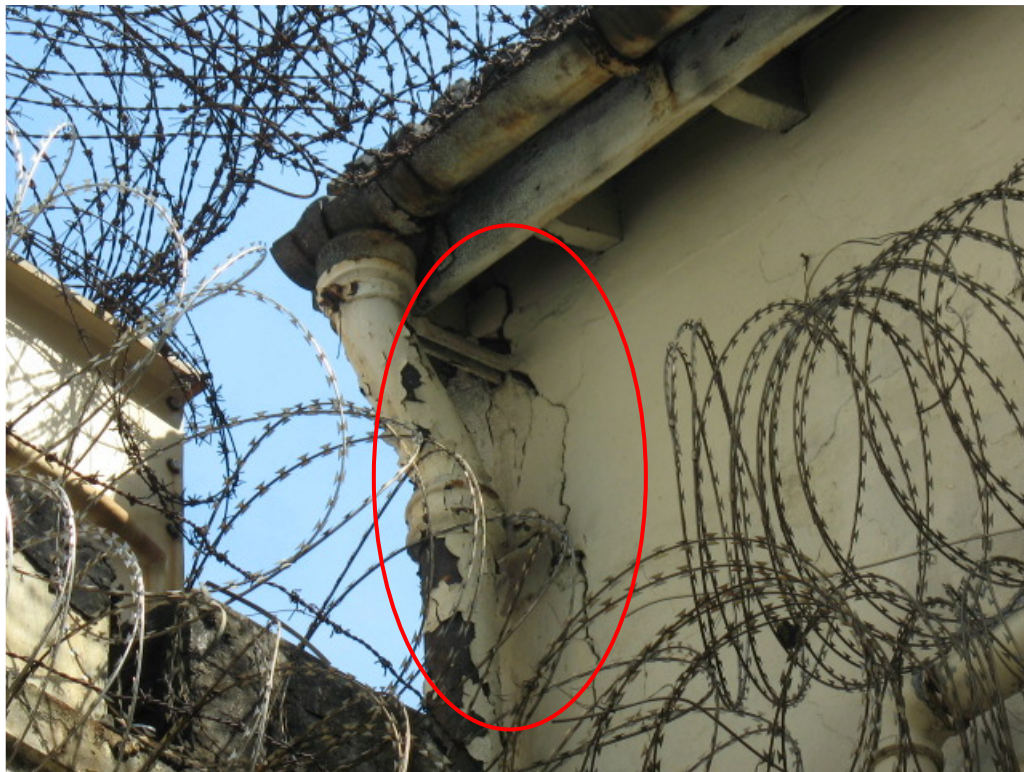
Photo ex 16b – Crack is found on the wall.

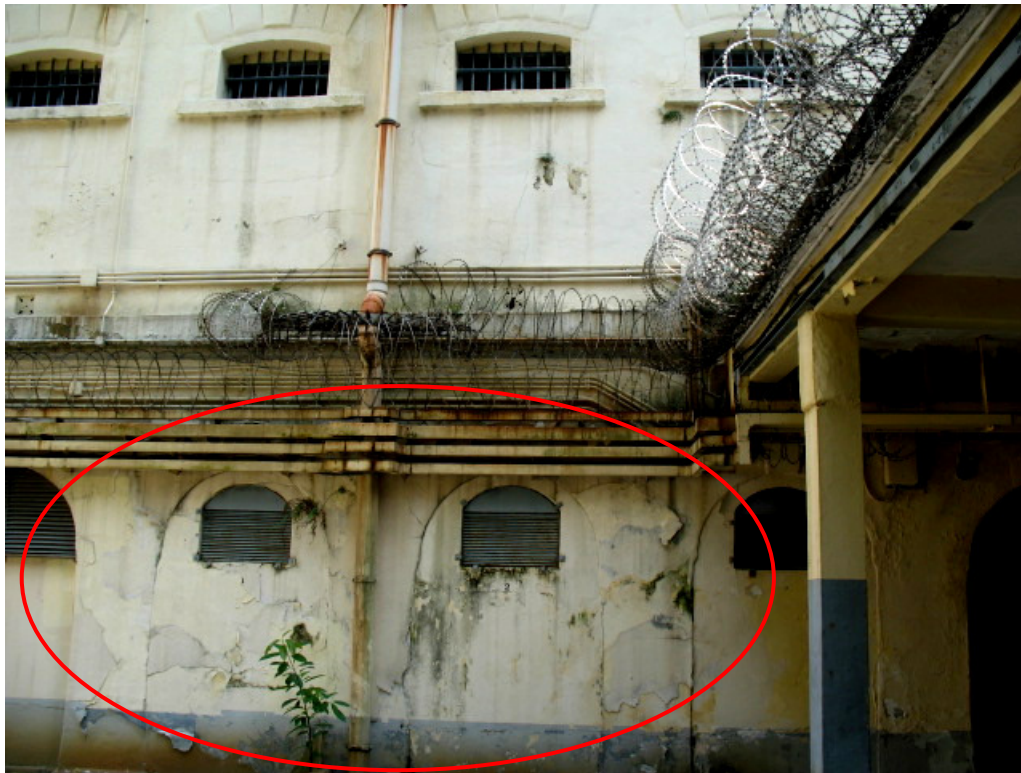
17

Photo ex 17a – Crack is found on the wall.

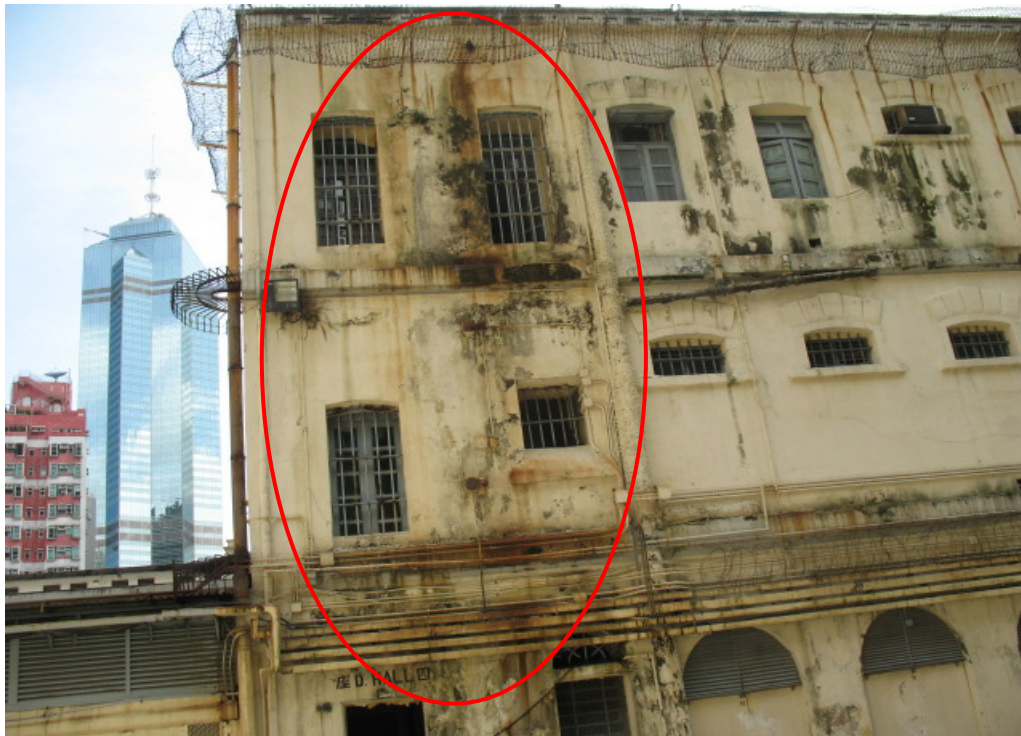
18

Photo ex 18a – Crack is found on the wall.

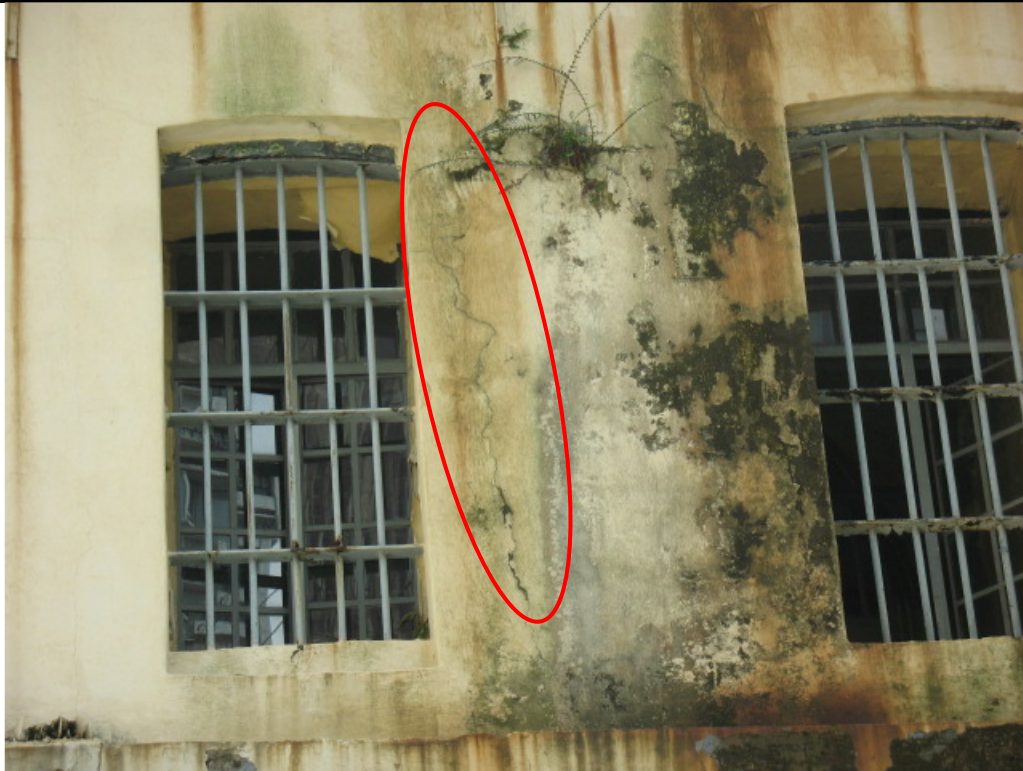
Photo ex 18b – Crack is found on the wall.

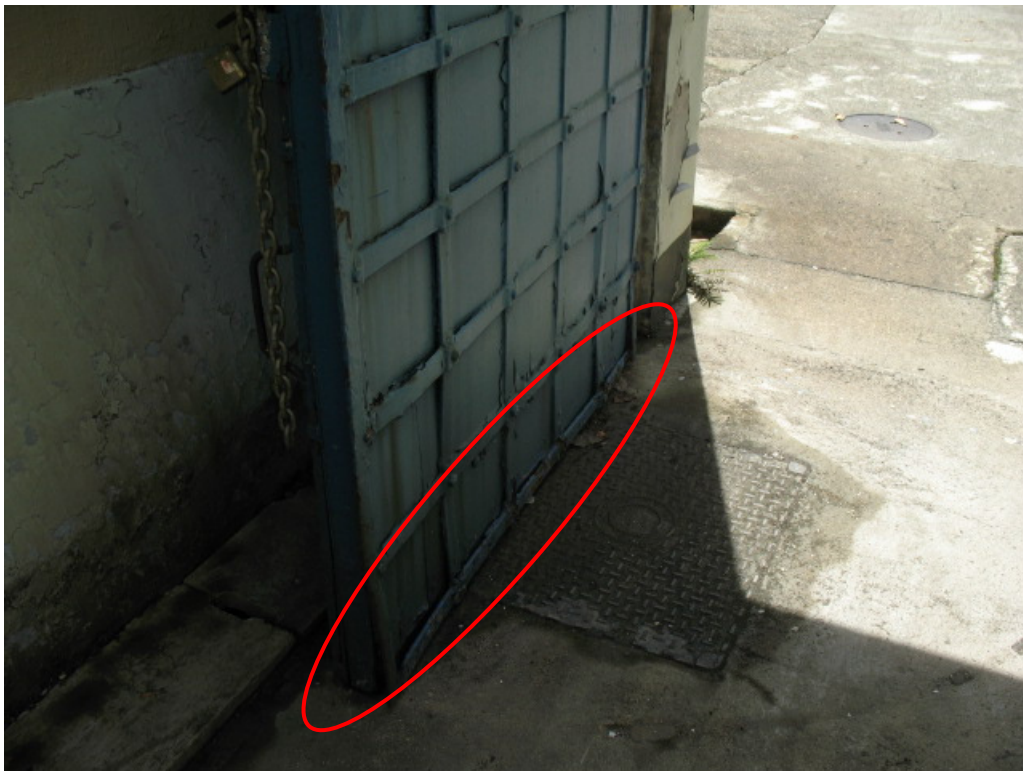
19

Photo ex 19a – Corrosion is found on the gate.

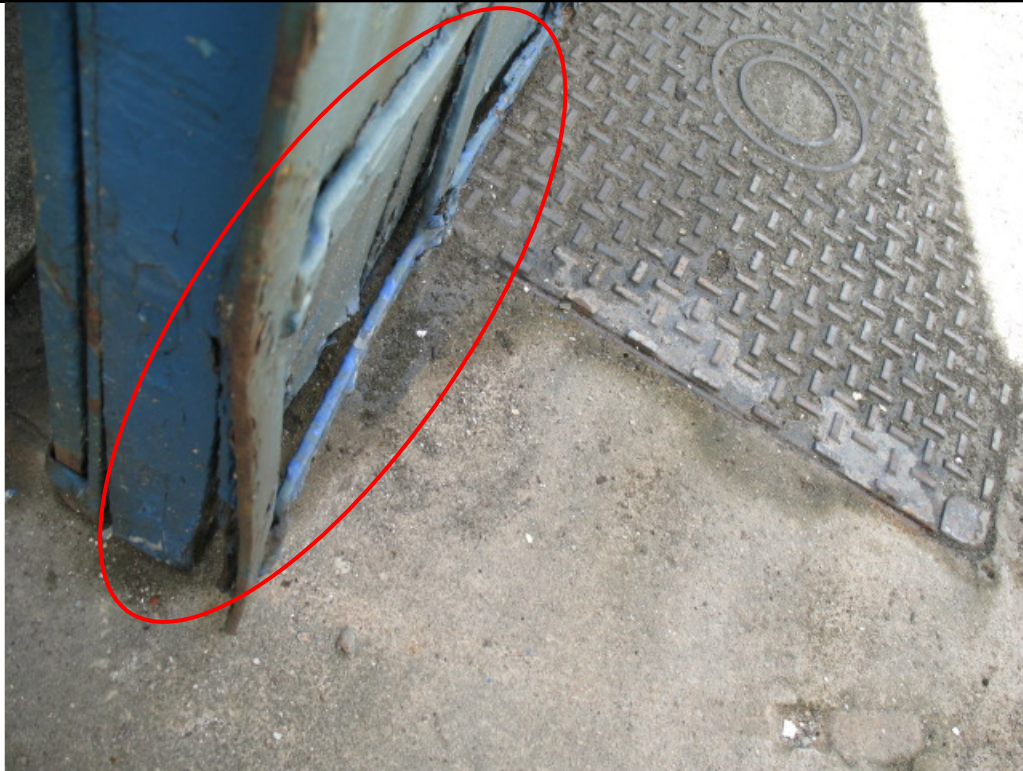
Photo ex 19b – Corrosion is found on the gate.

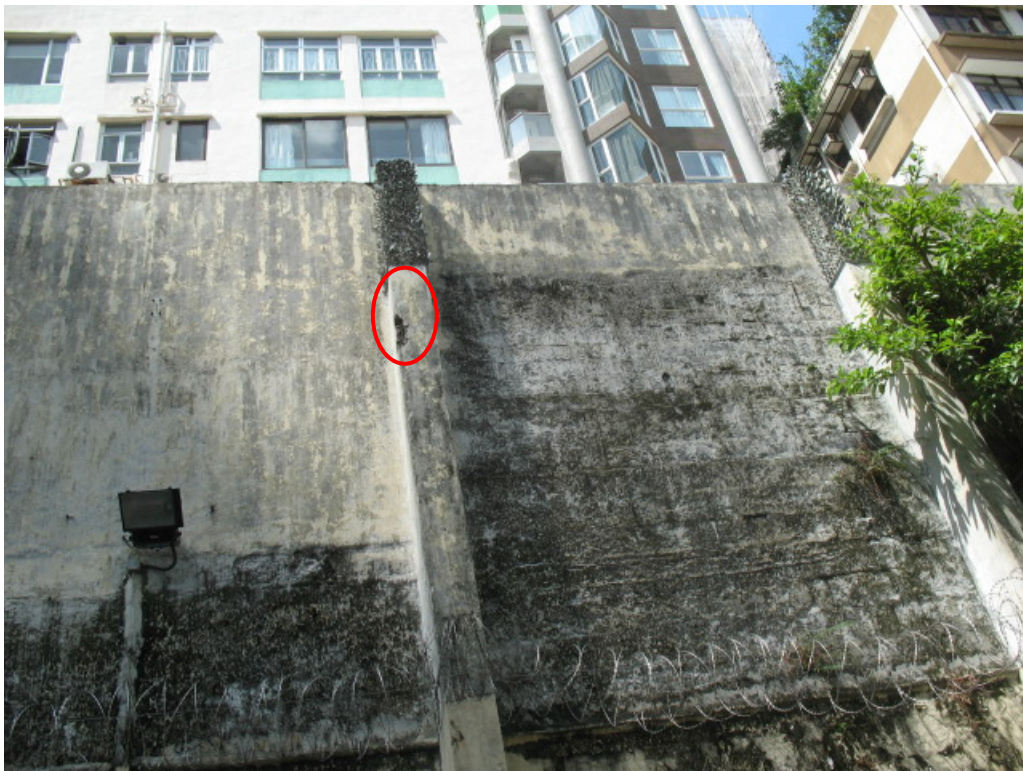
20

Photo ex 20a – The wall is damaged and steel bar is exposed.

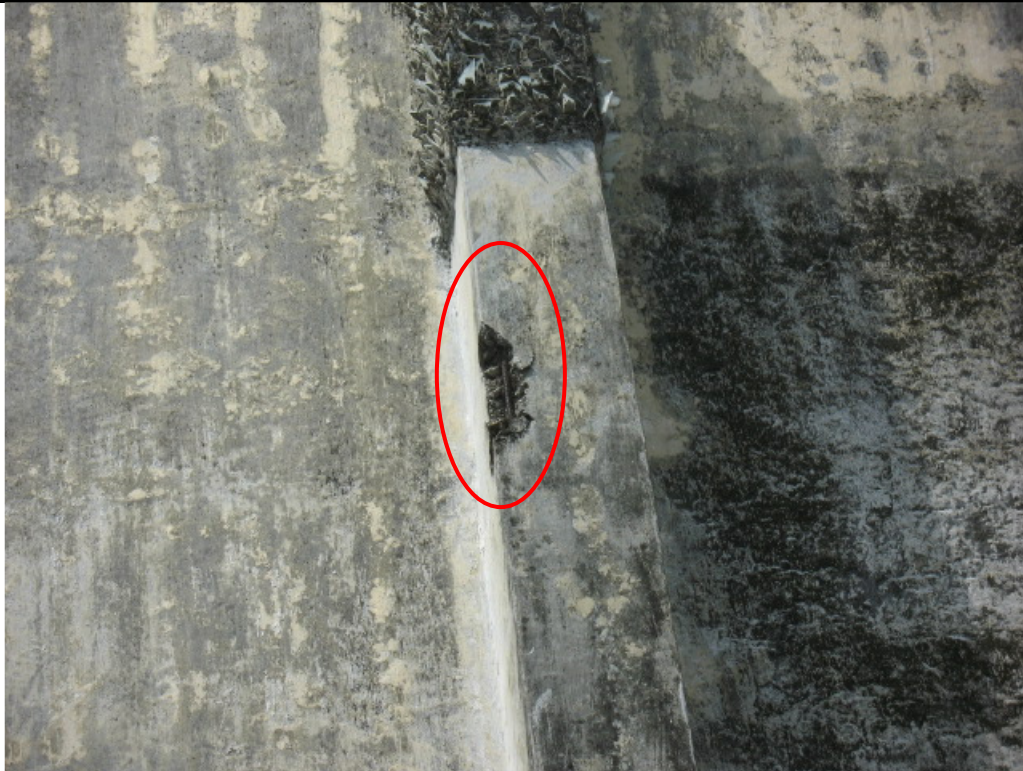
Photo ex 20b – The wall is damaged and steel bar is exposed.

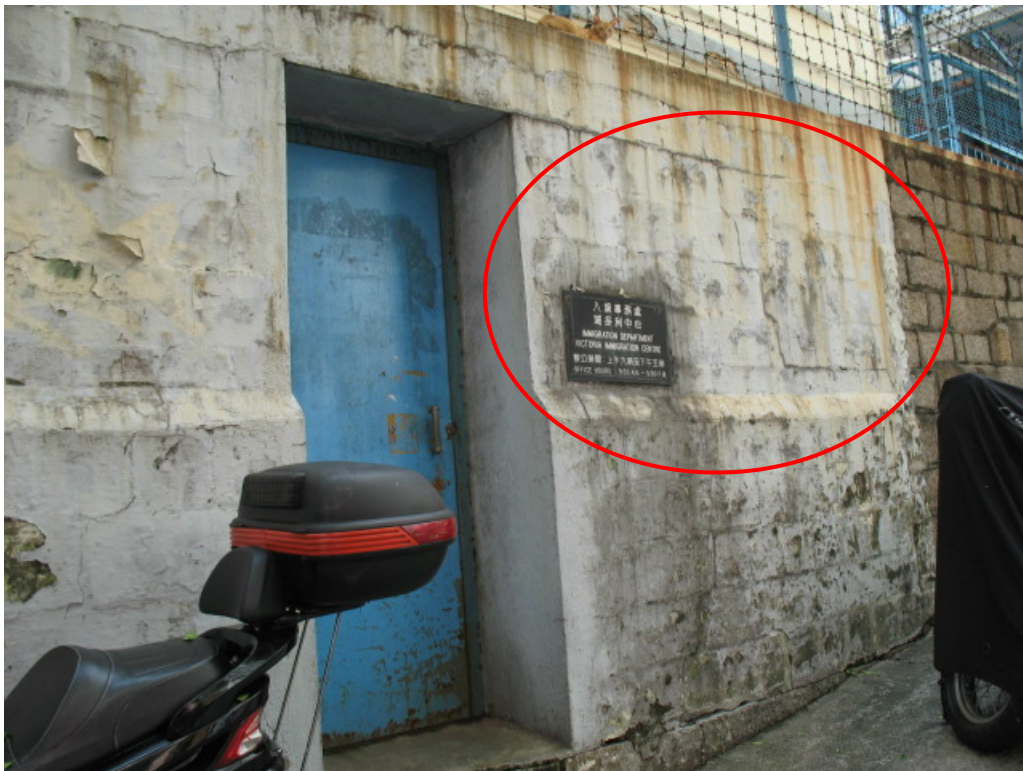
21

Photo ex 21a – Crack is found on the wall.

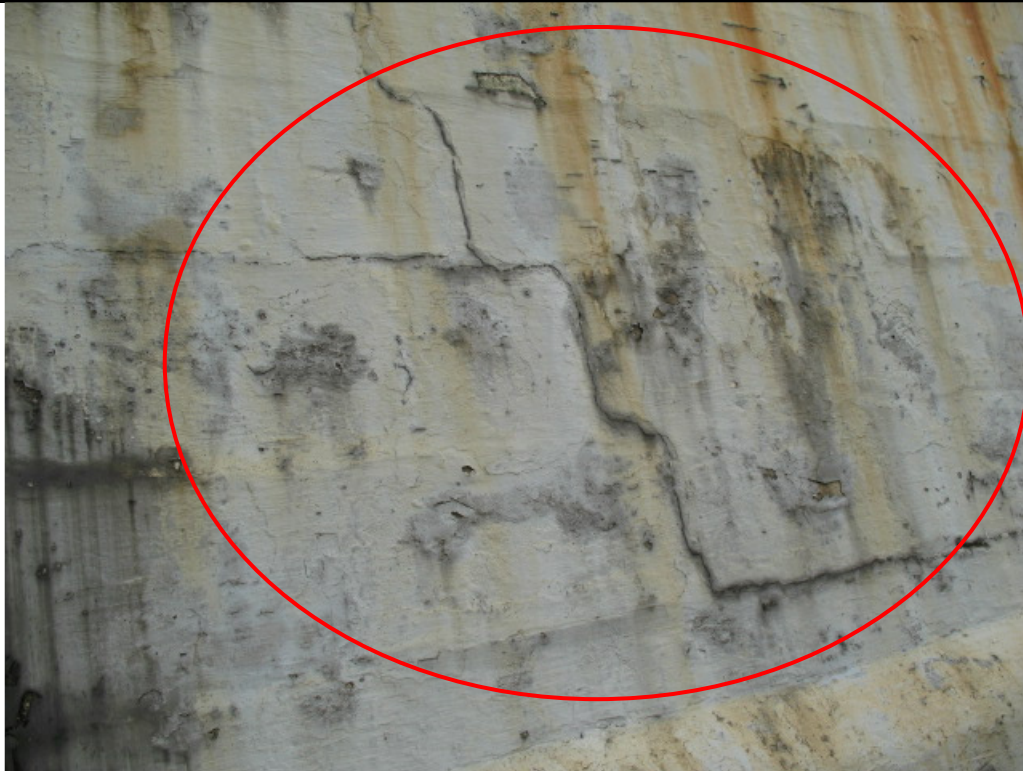
Photo ex 21b – Crack is found on the wall.

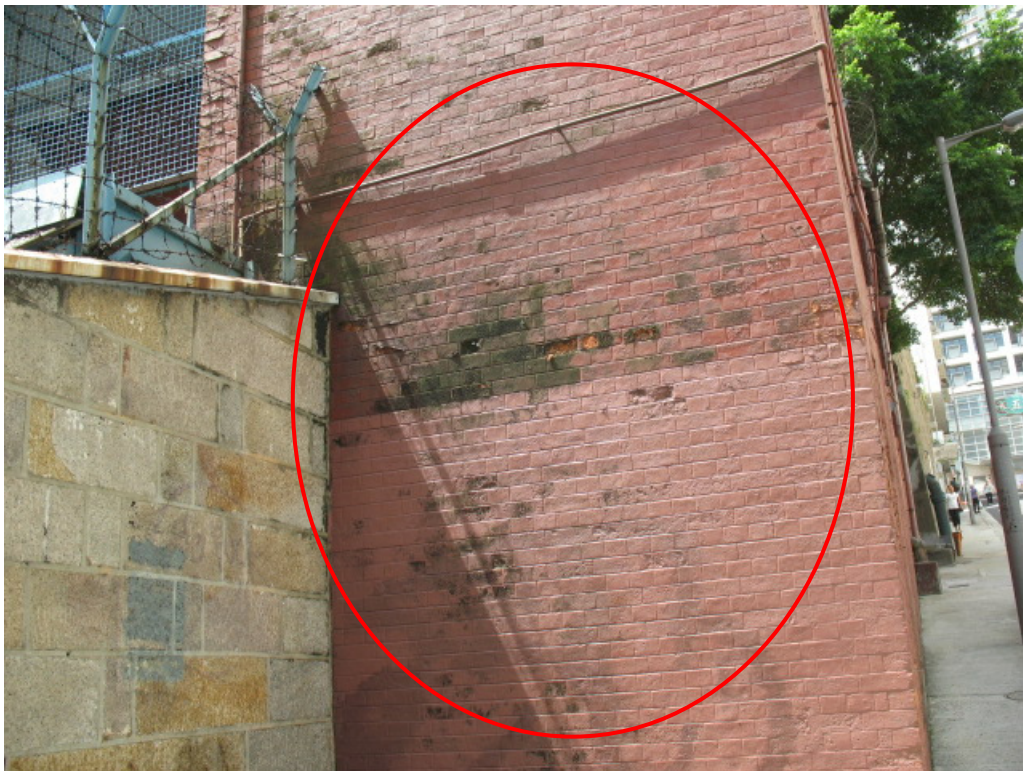
22

Photo ex 22a – The brick wall is damaged.

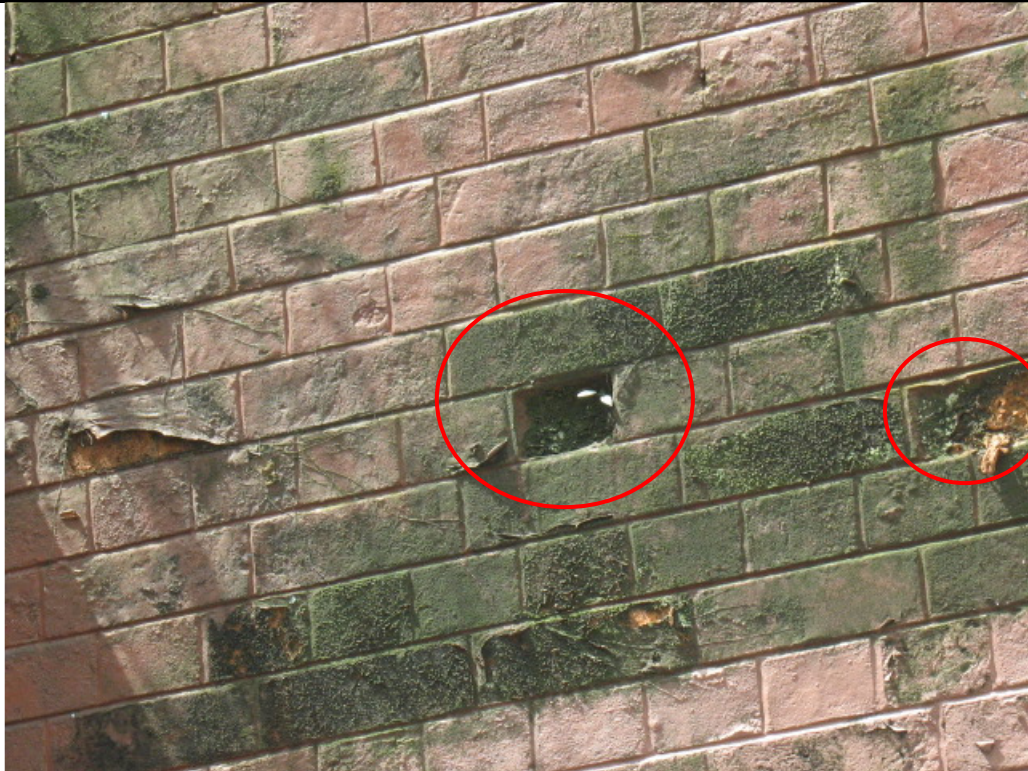
Photo ex 22b – The brickwork is damaged.

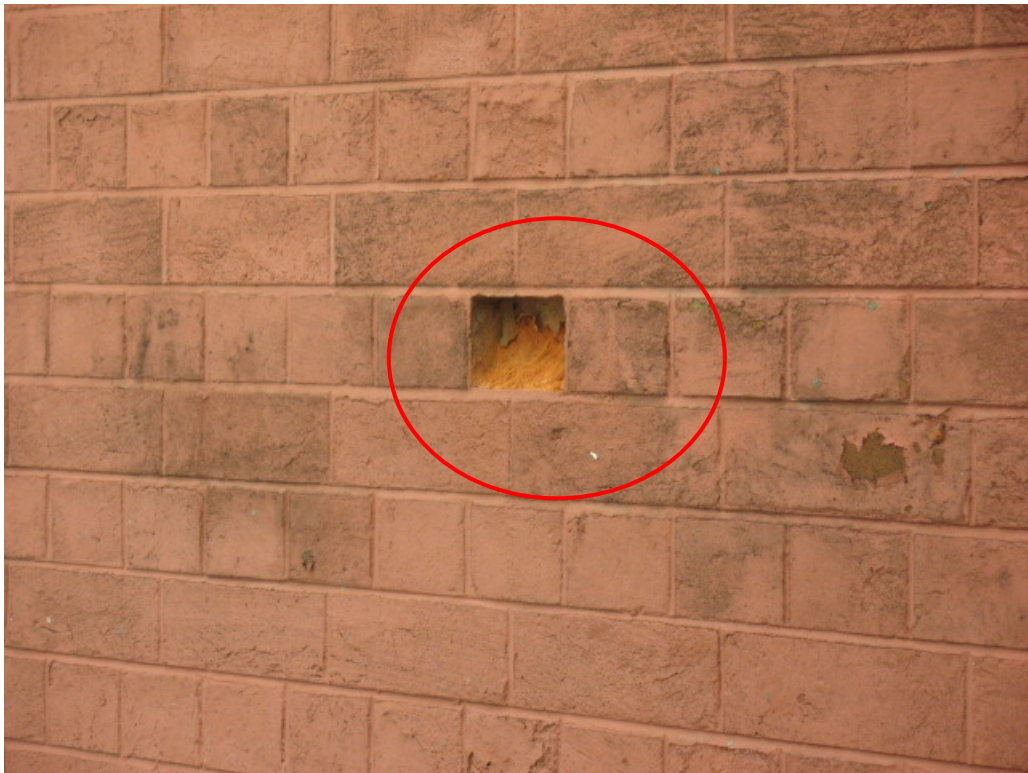
Photo ex 22c – The brickwork is damaged.

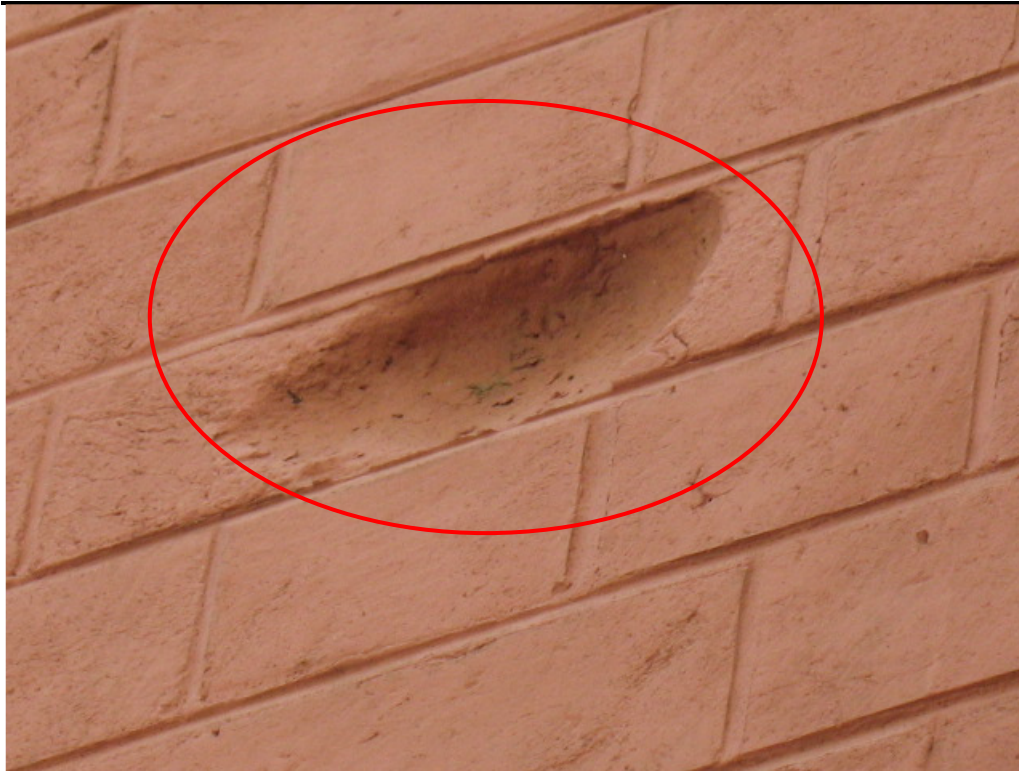
Photo ex 22d – The brick is chipped.

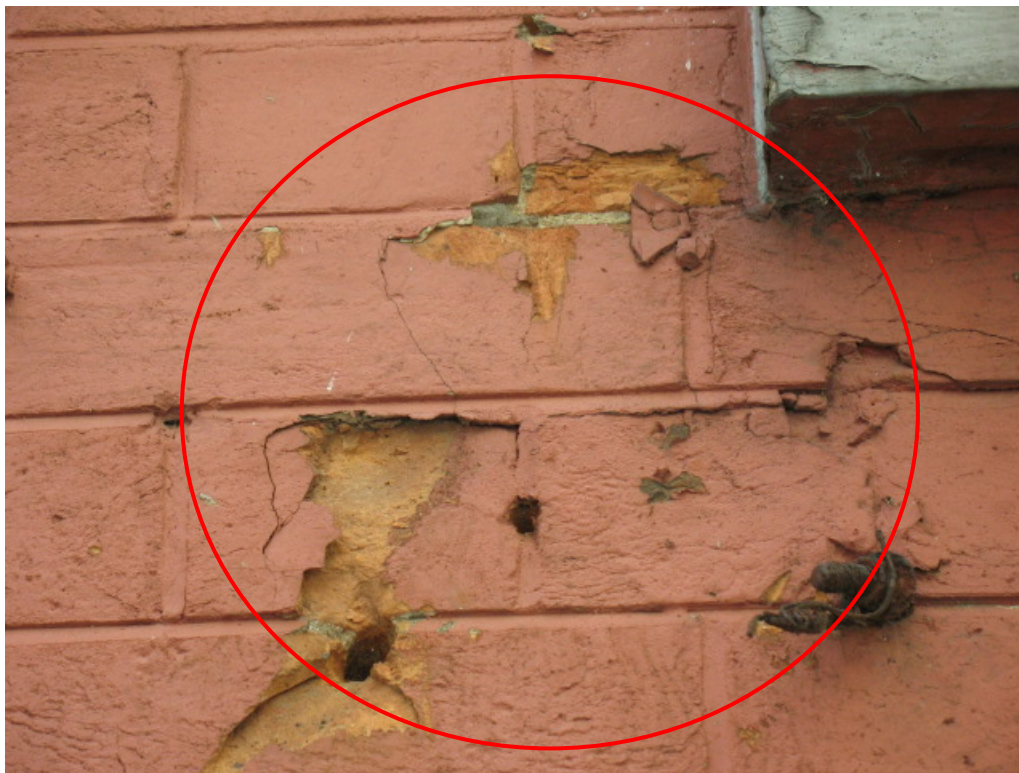
Photo ex 22e – The brickwork is damaged.

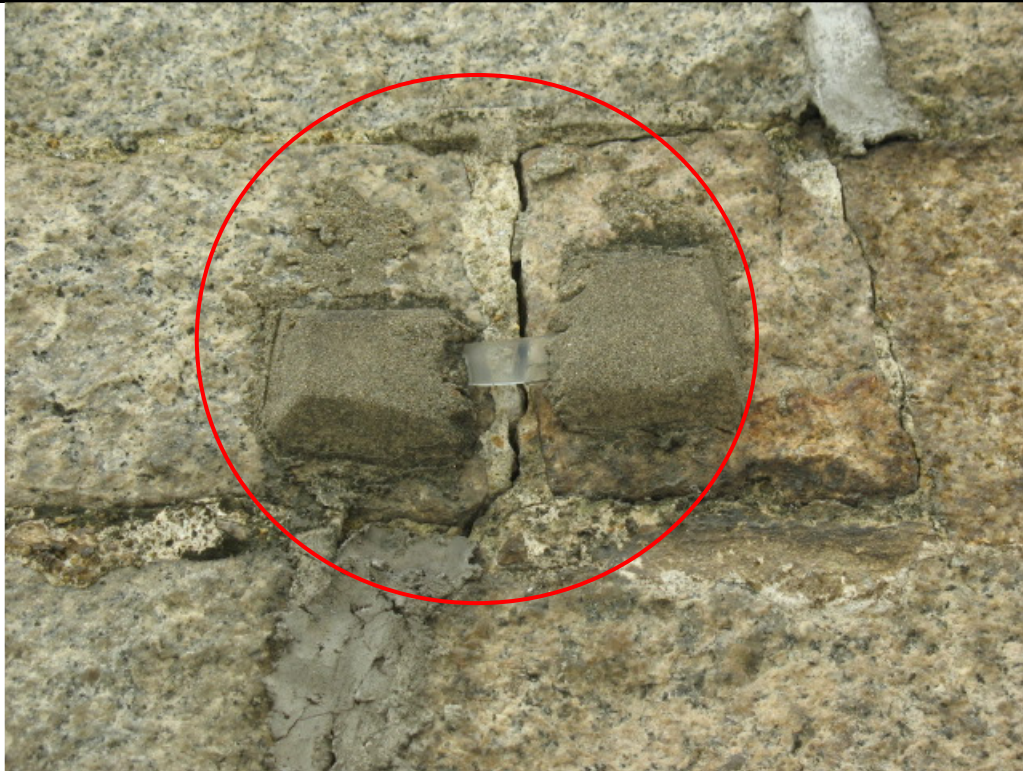
Photo ex 22f – Crack is found on the wall.

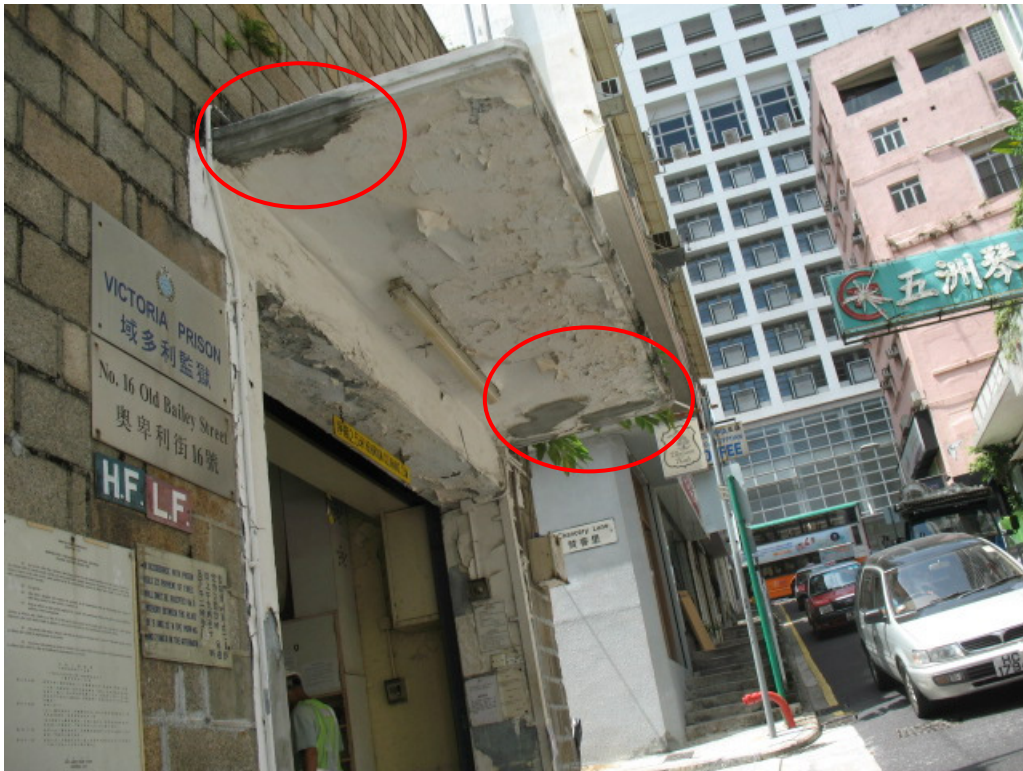
23

Photo ex 23a – The canopy is repaired.

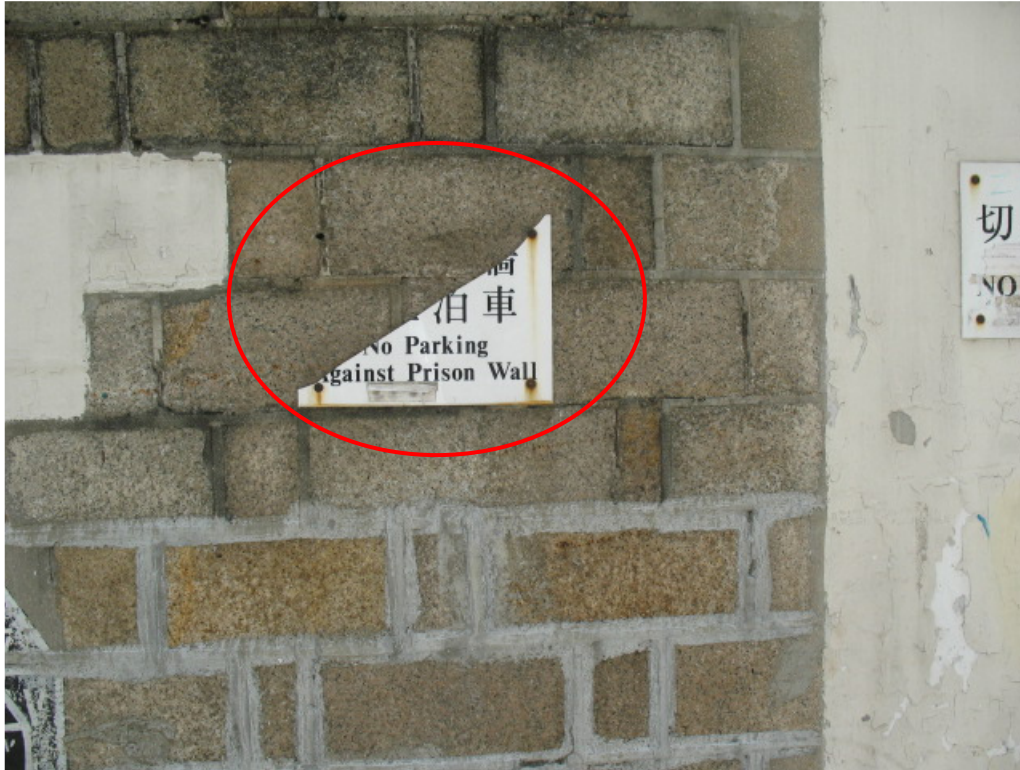
24

Photo ex 24a – The notice plaque is damaged.

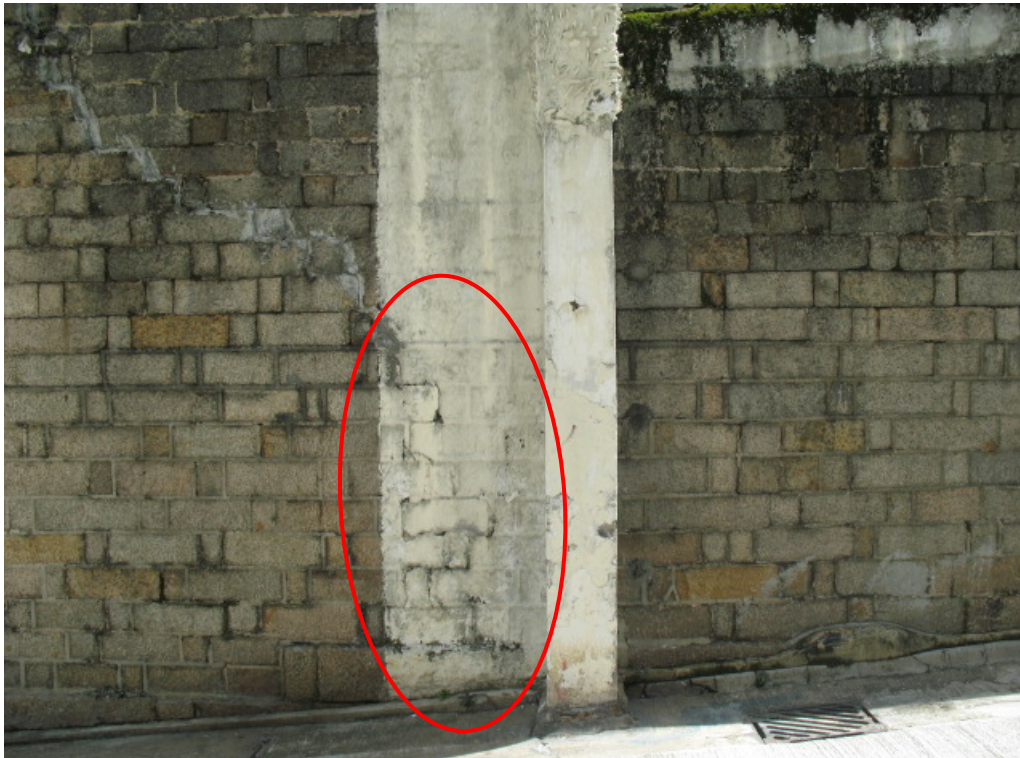
25

Photo ex 25a – Crack is found on the wall.

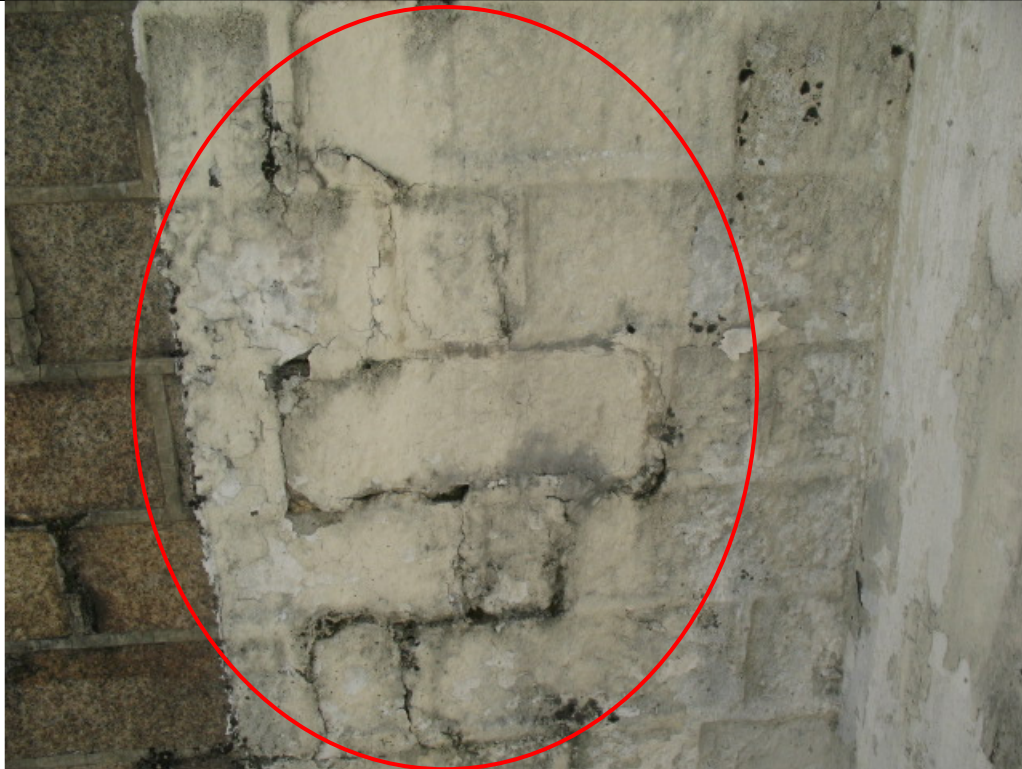
Photo ex 25b – Crack is found on the wall.

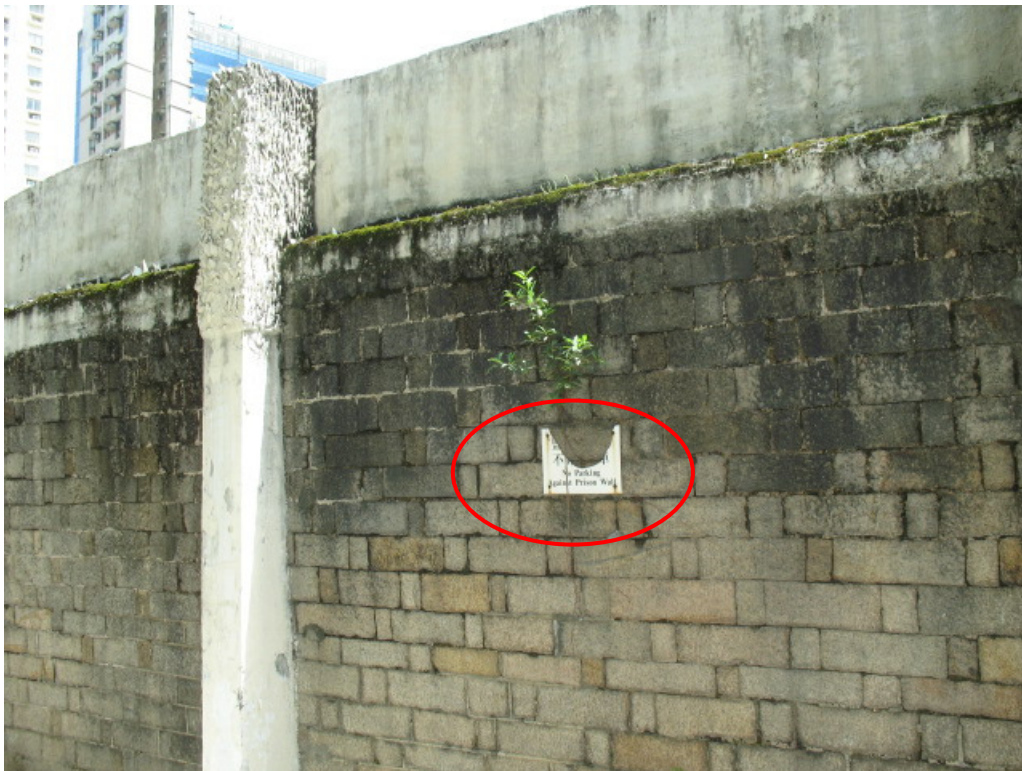
26

Photo ex 26a – The notice plaque is damaged.

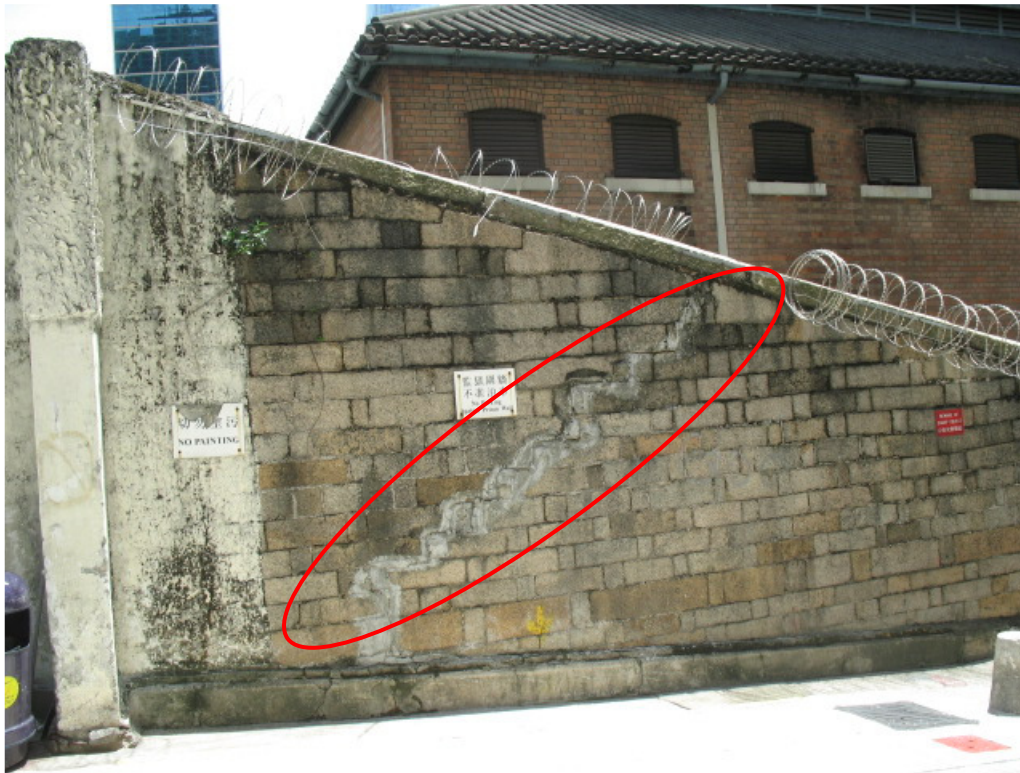
27

Photo ex 27a – Crack is found on the wall.

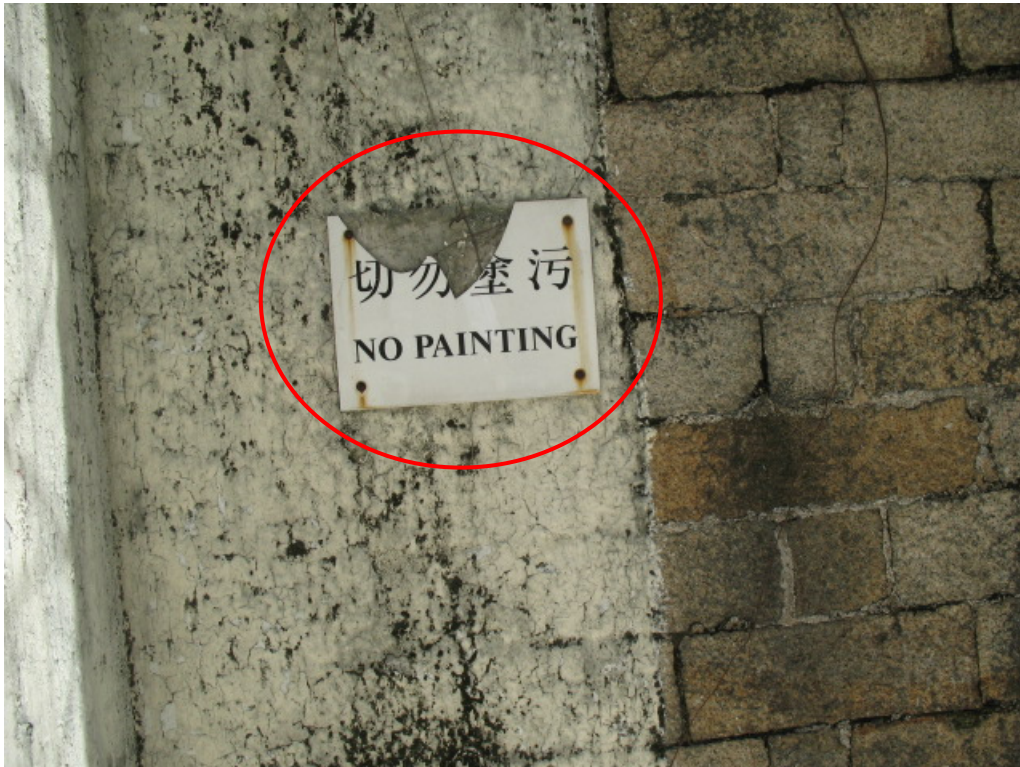
28

Photo ex 28a – The notice plaque is damaged.

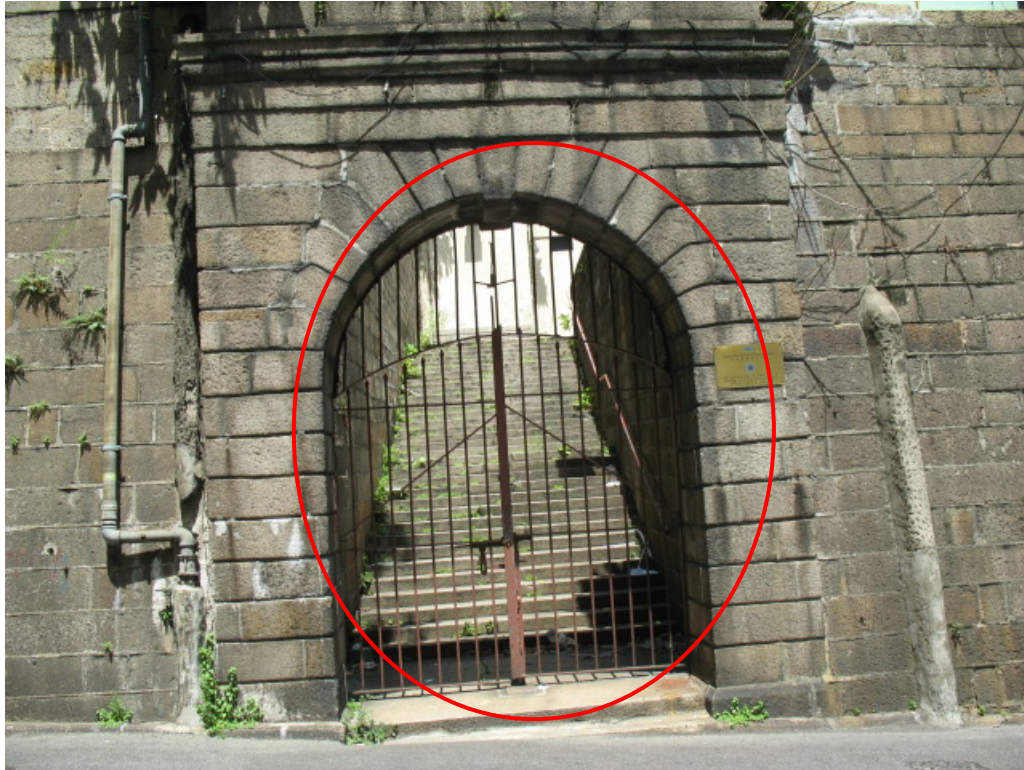
Photo ex 29a –Corrosion is found on the gate.

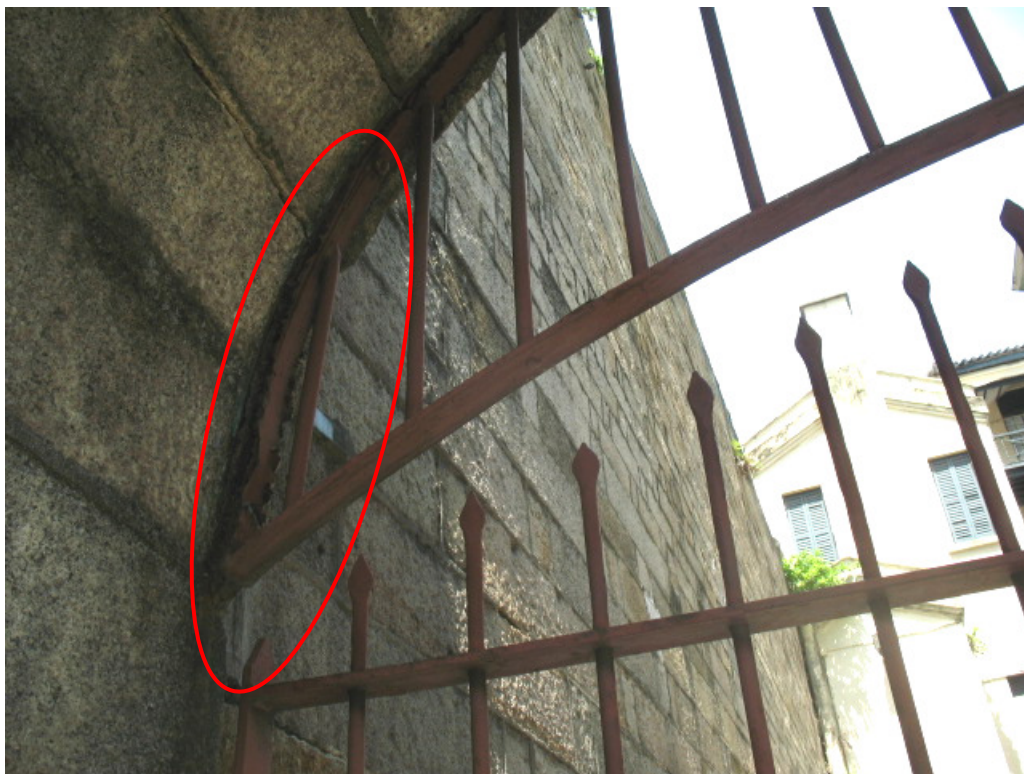
Photo ex 29b – Corrosion is found on the gate.
