Central Police Station Conservation and Revitalization Project Condition Survey

Central Police Station As Build Photo record surrounding

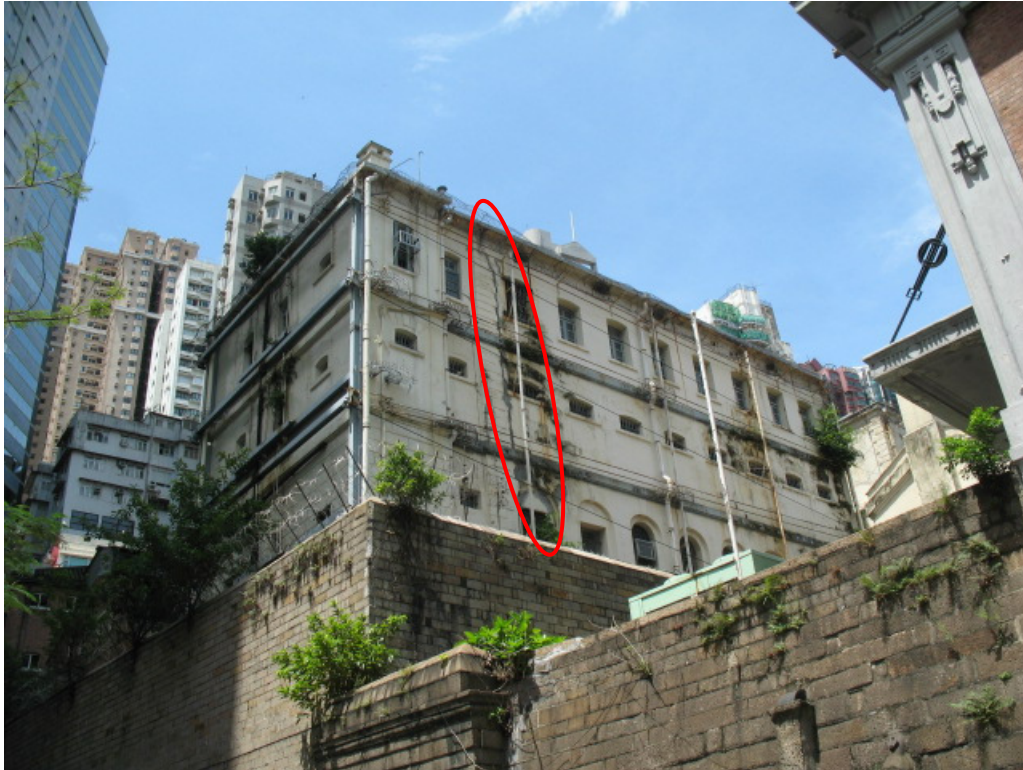
30

Photo ex 30a – Crack is found on the wall.

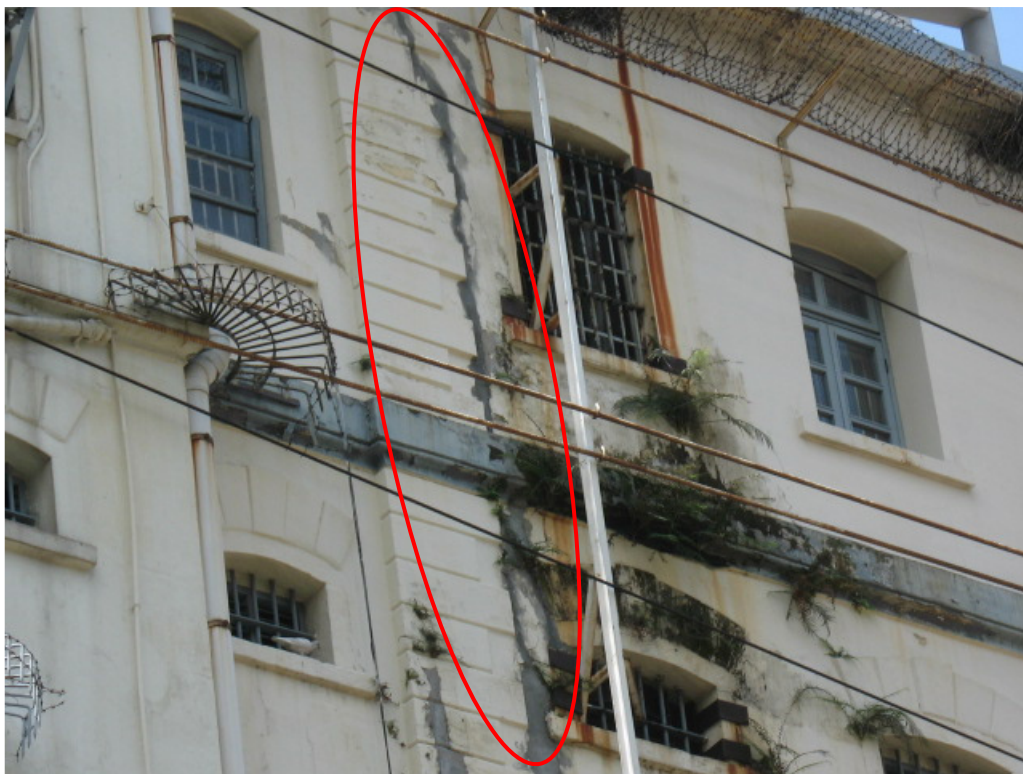
Photo ex 30b – Crack is found on the wall.

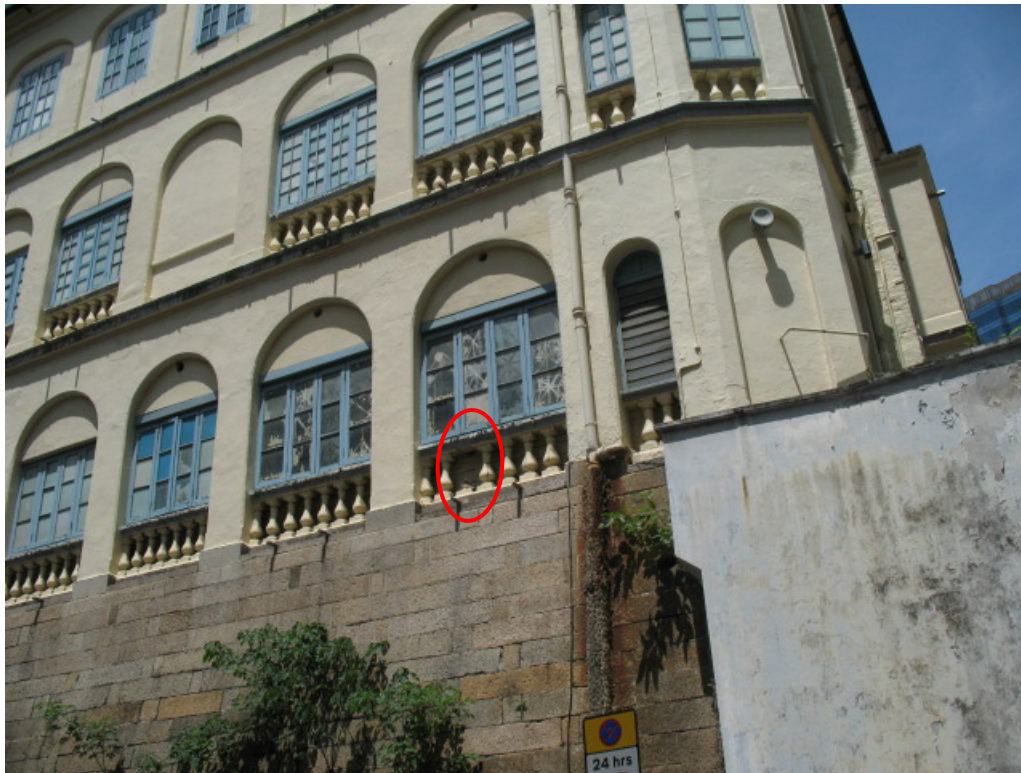
31

Photo ex 31a – One of the feature is missing.

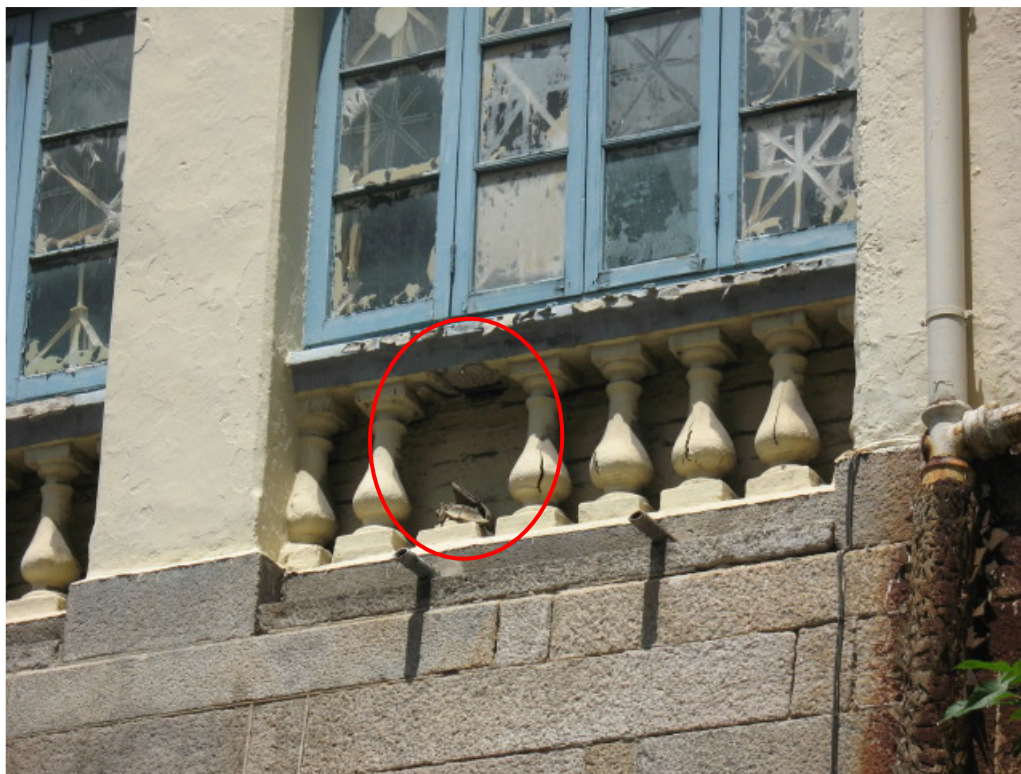
Photo ex 31b – One of the feature is missing.

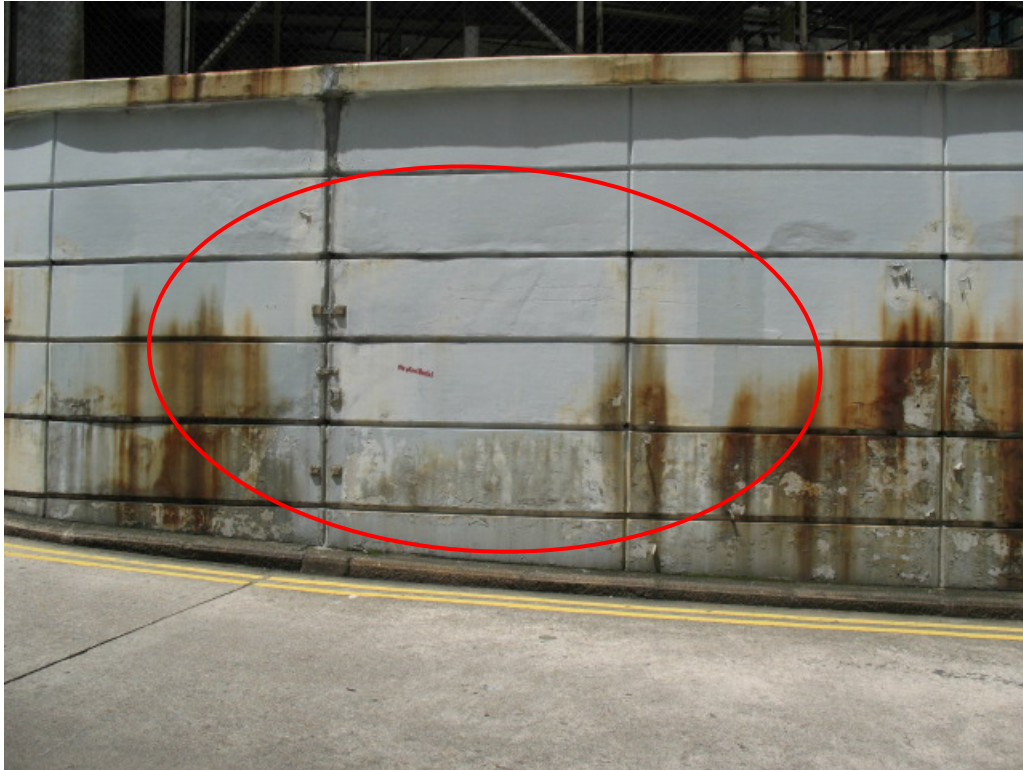
Photo ex 32a – Crack is found is found on the wall.

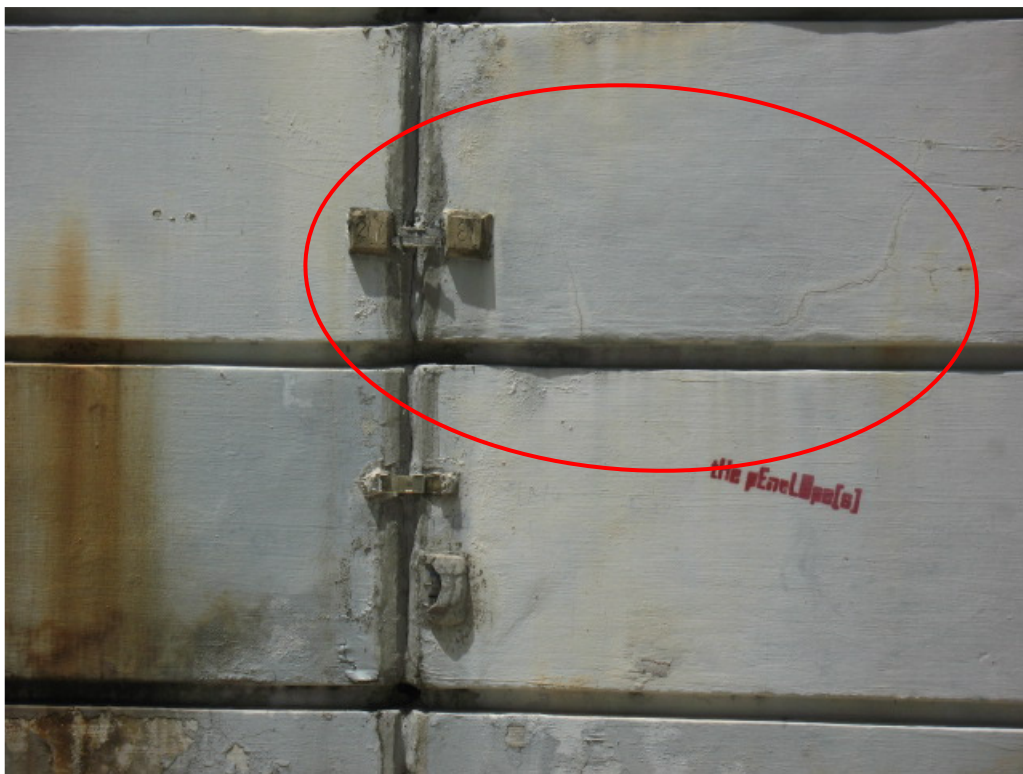
Photo ex 32b – Crack is found on the wall.

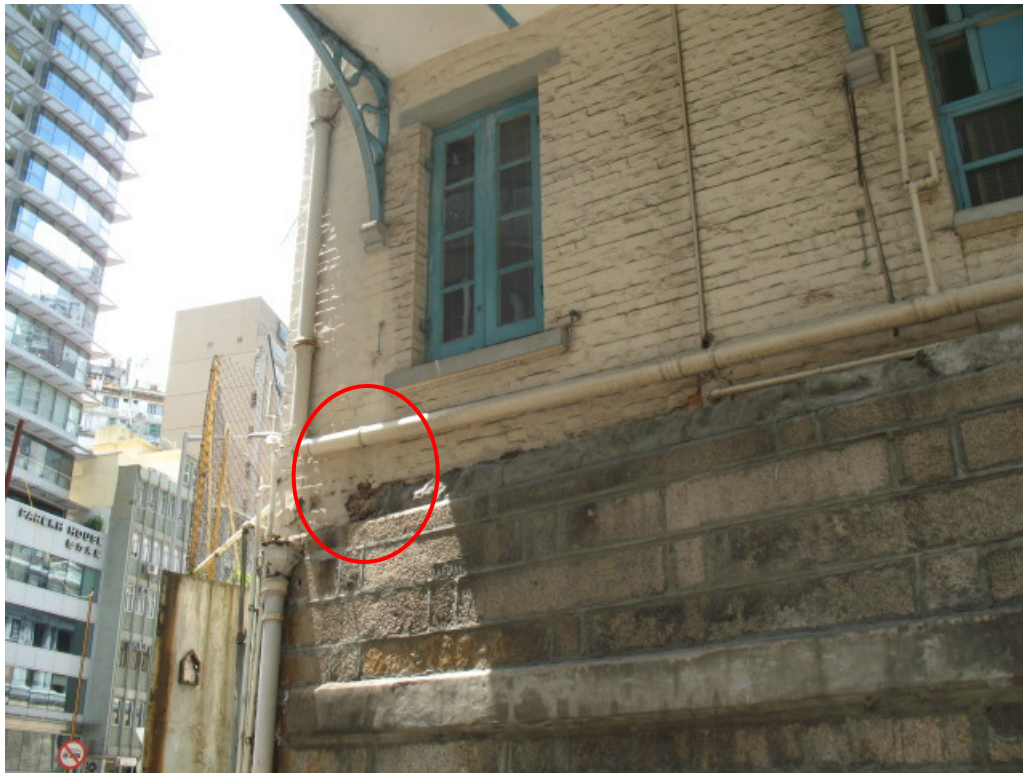
33

Photo ex 33a – The wall is damaged.

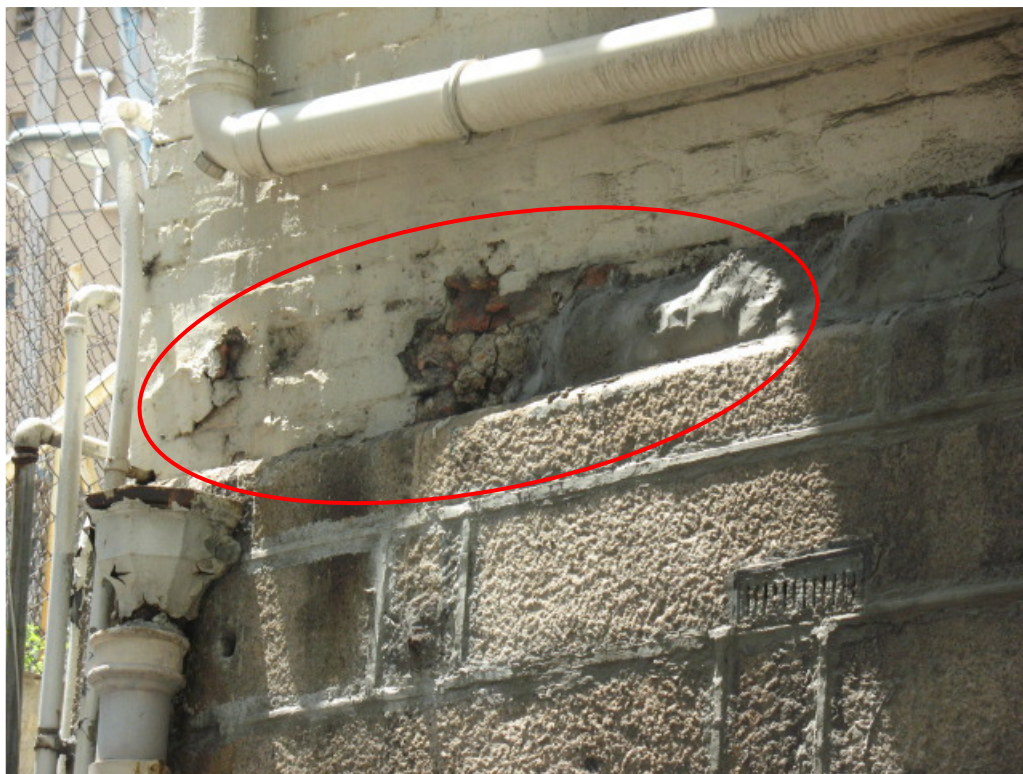
Photo ex 33b – The wall is damaged.

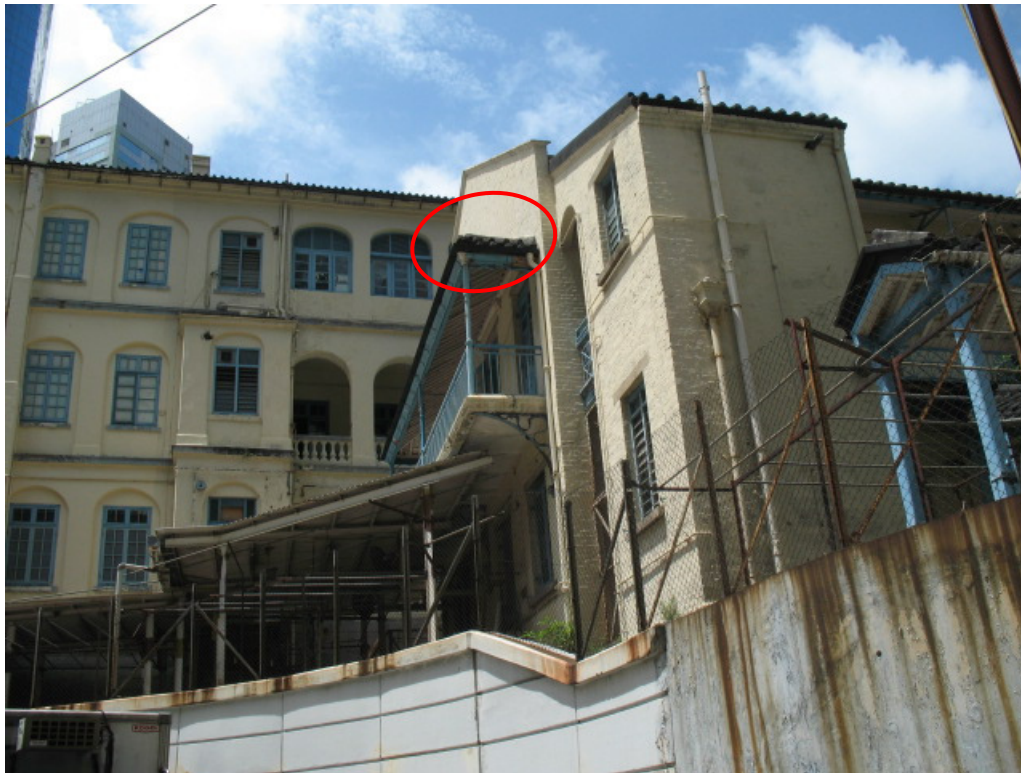
34

Photo ex 34a – The wooden balcony is damaged.

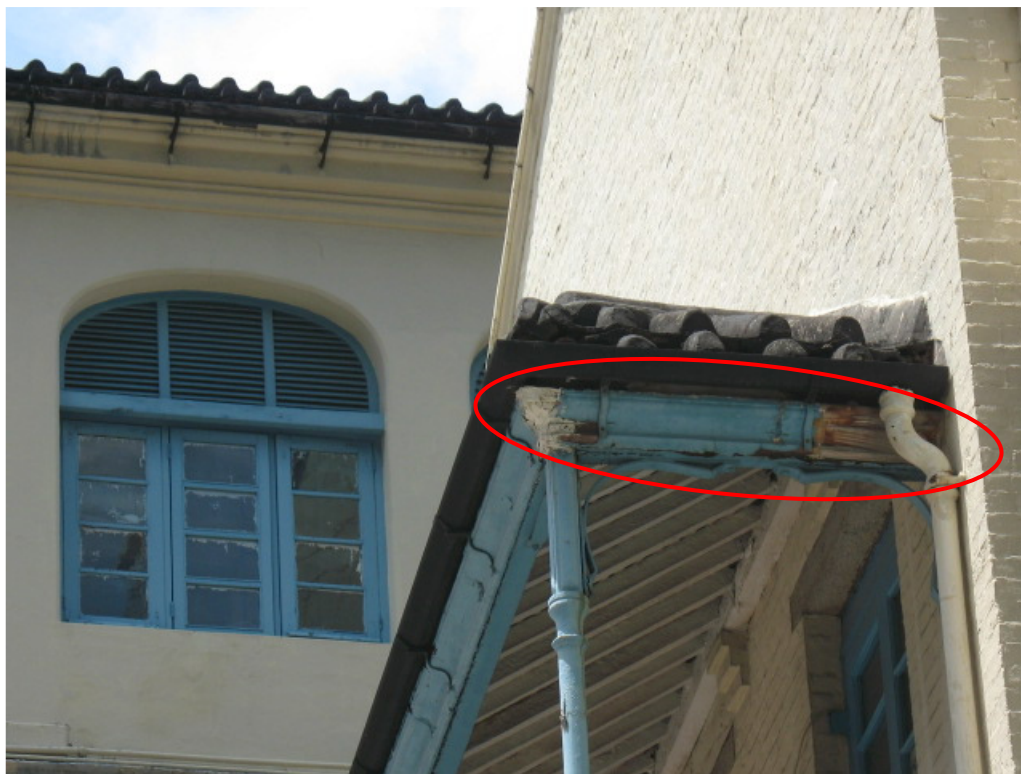
Photo ex 34b – The wooden balcony is damaged.
