The Jockey Club CPS Limited

Central Police Station Conservation  
and Revitalisation Project:  
*First Monthly EM&A Report*  
*(From 24 October 2011 to 30*  
*November 2011)*

Issue Date: December 2011

**Environmental Resources Management**

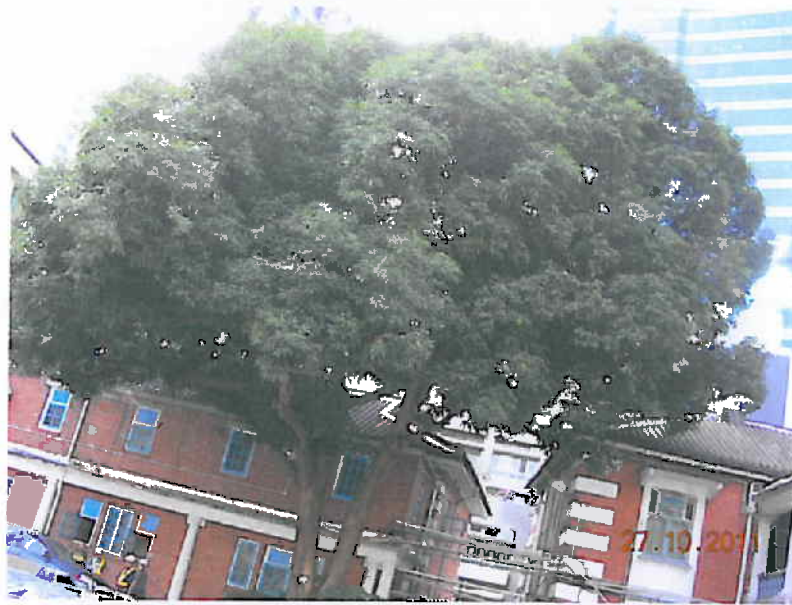
Photo 3. Condition of tree crown  
The tree is healthy and strong. Foliage size, density and color are normal.

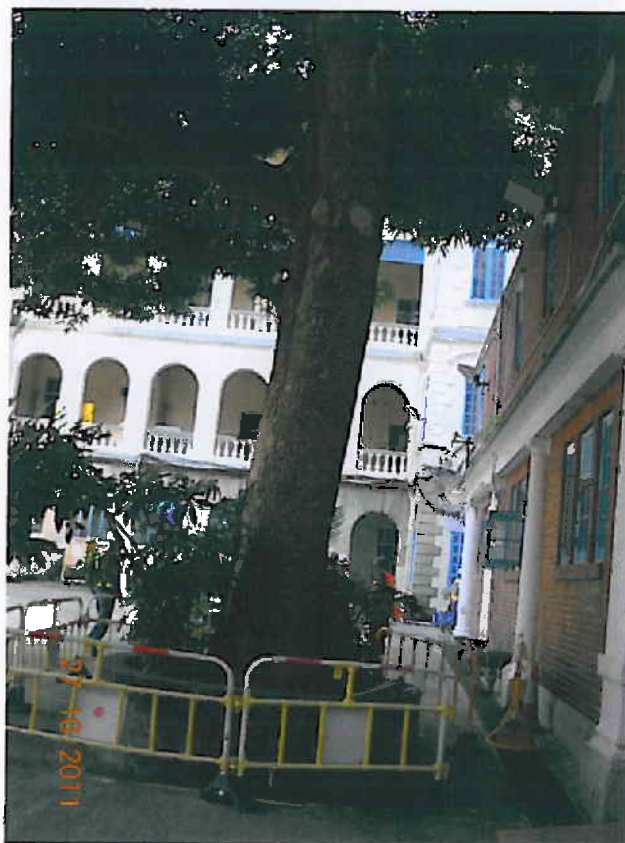
Photo 4. Condition of the trunk  
No decay, or wound were found on trunk.

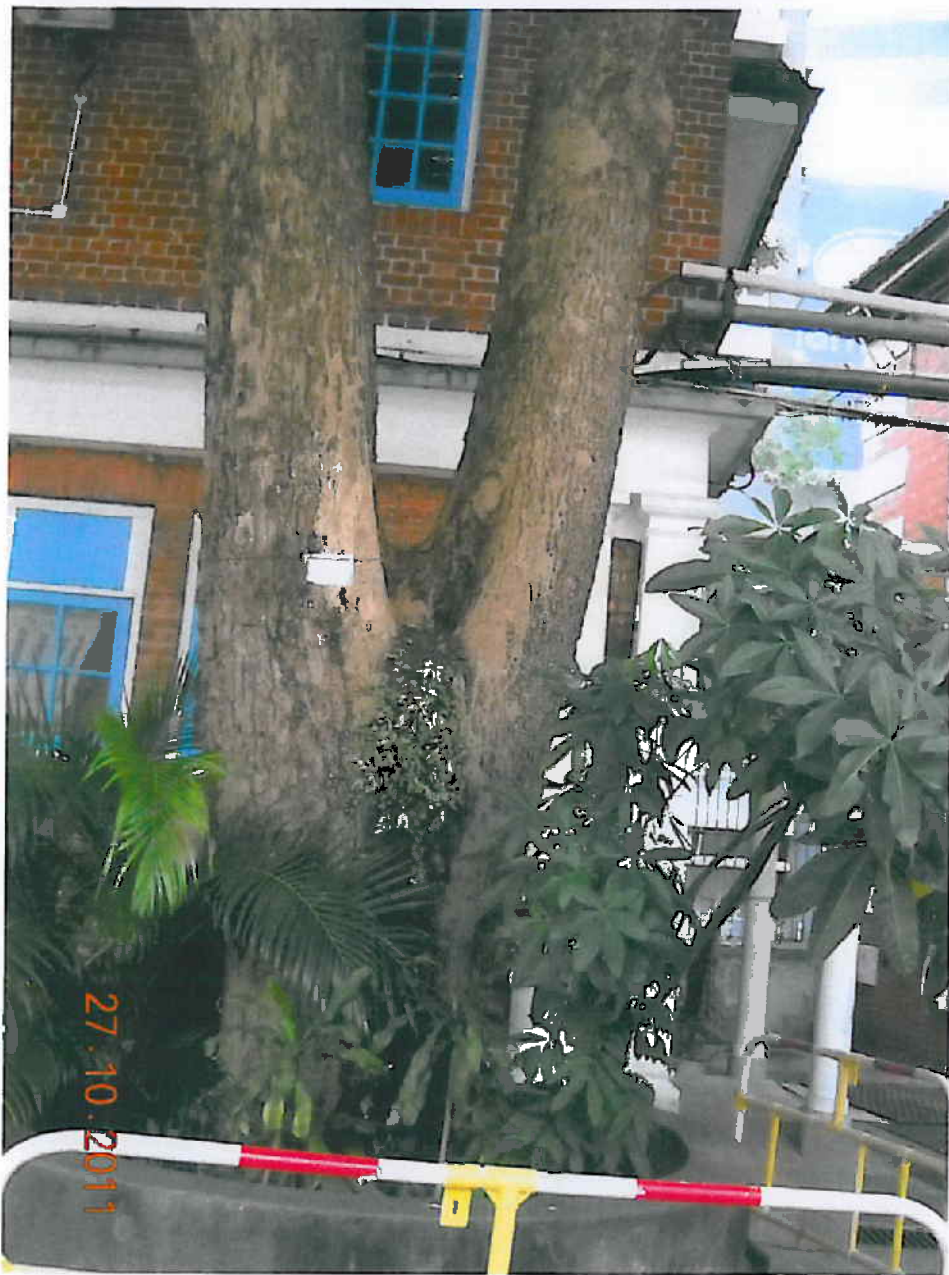
Photo 5. Co-dominant stem with included bark and a slight cavity on the middle part of the trunk.

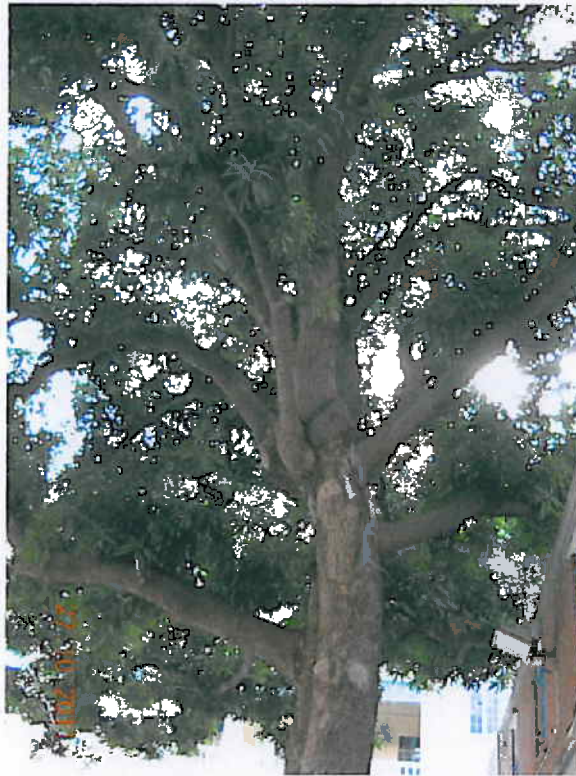
Photo 6. Condition of the branches  
Branches are well built. No signs of pests and disease were found.

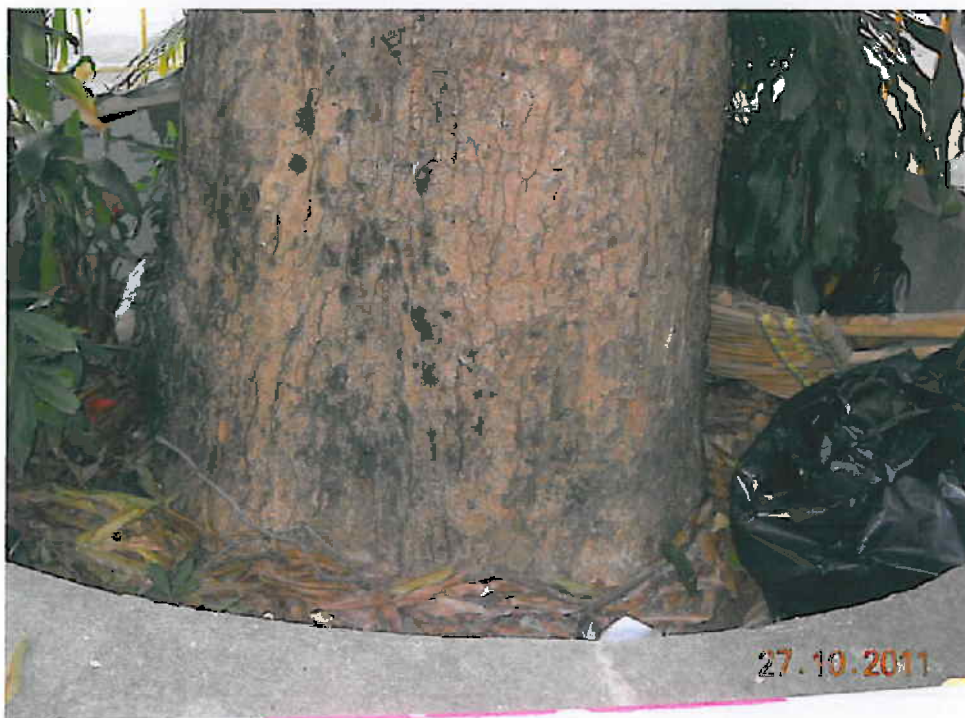
Photo 7. Condition of root flare  
Soil level in the planter flare has been raised, root flare is invisible.  
Rooting area was restricted by the planter.

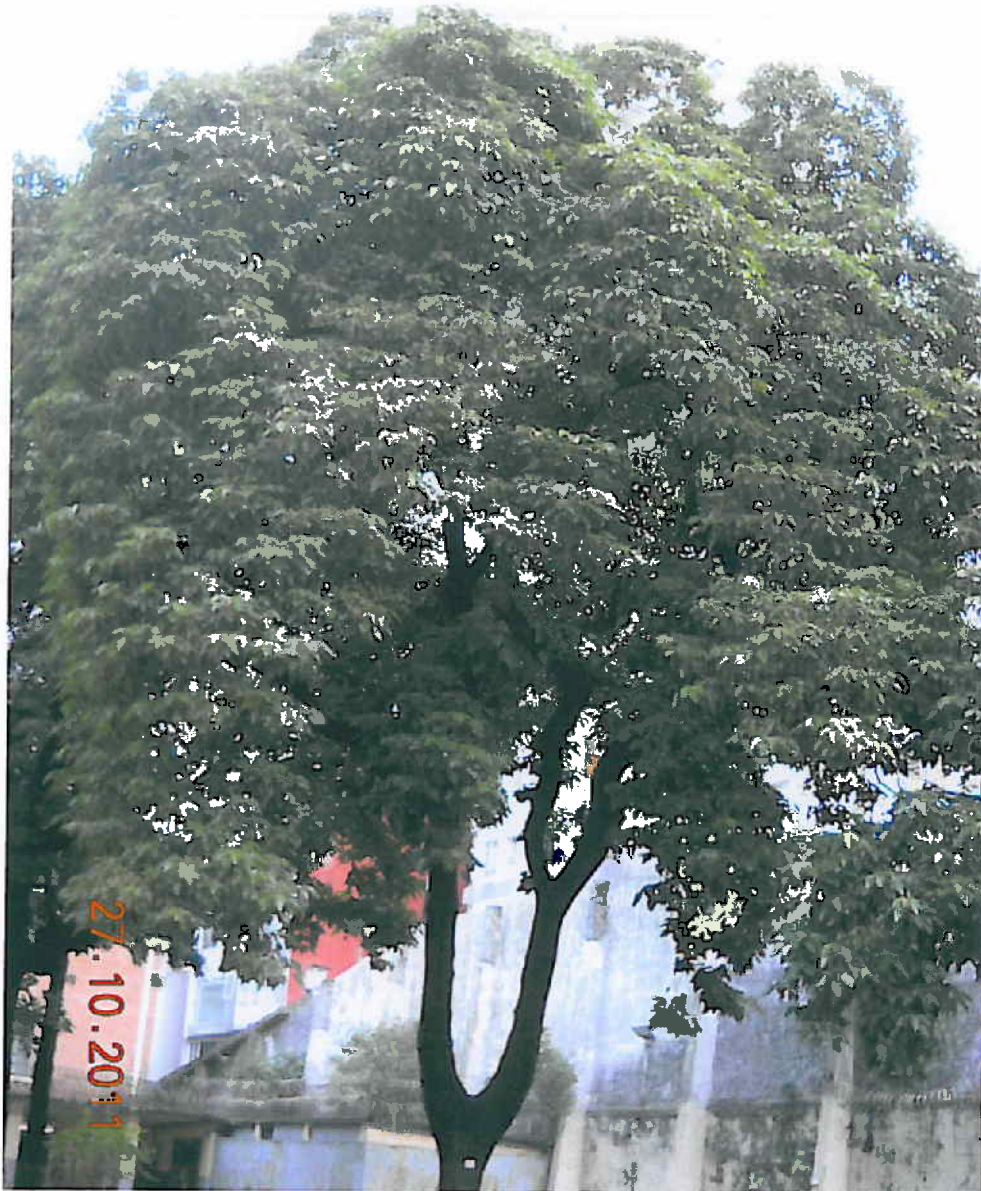
Photo 3. Condition of tree crown  
Foliage size, density and color are normal.

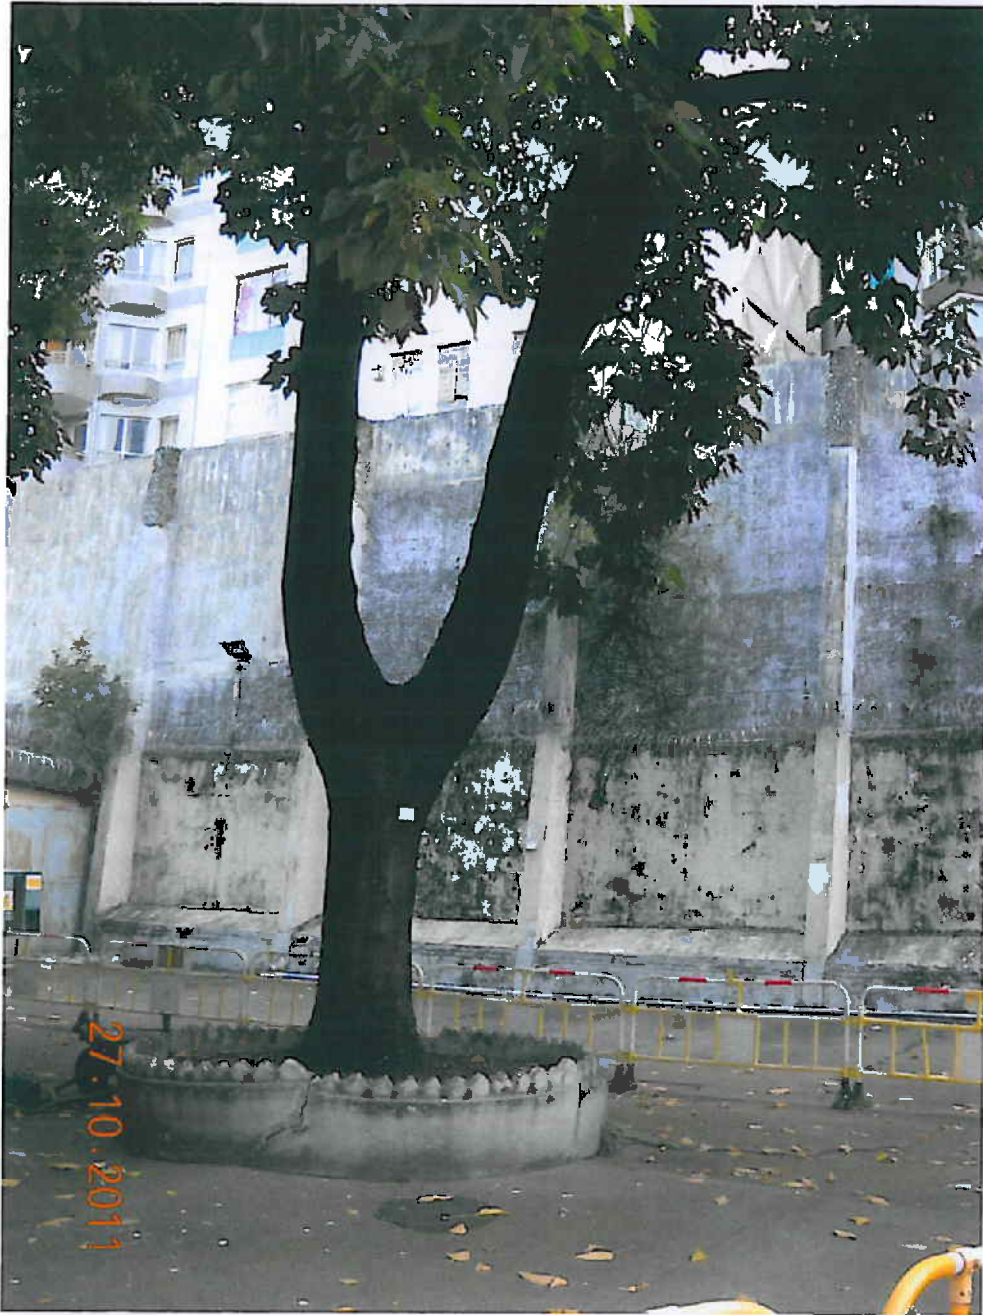
Photo 4. Condition of the trunk  
No decay, cavity and wound were found on the trunk

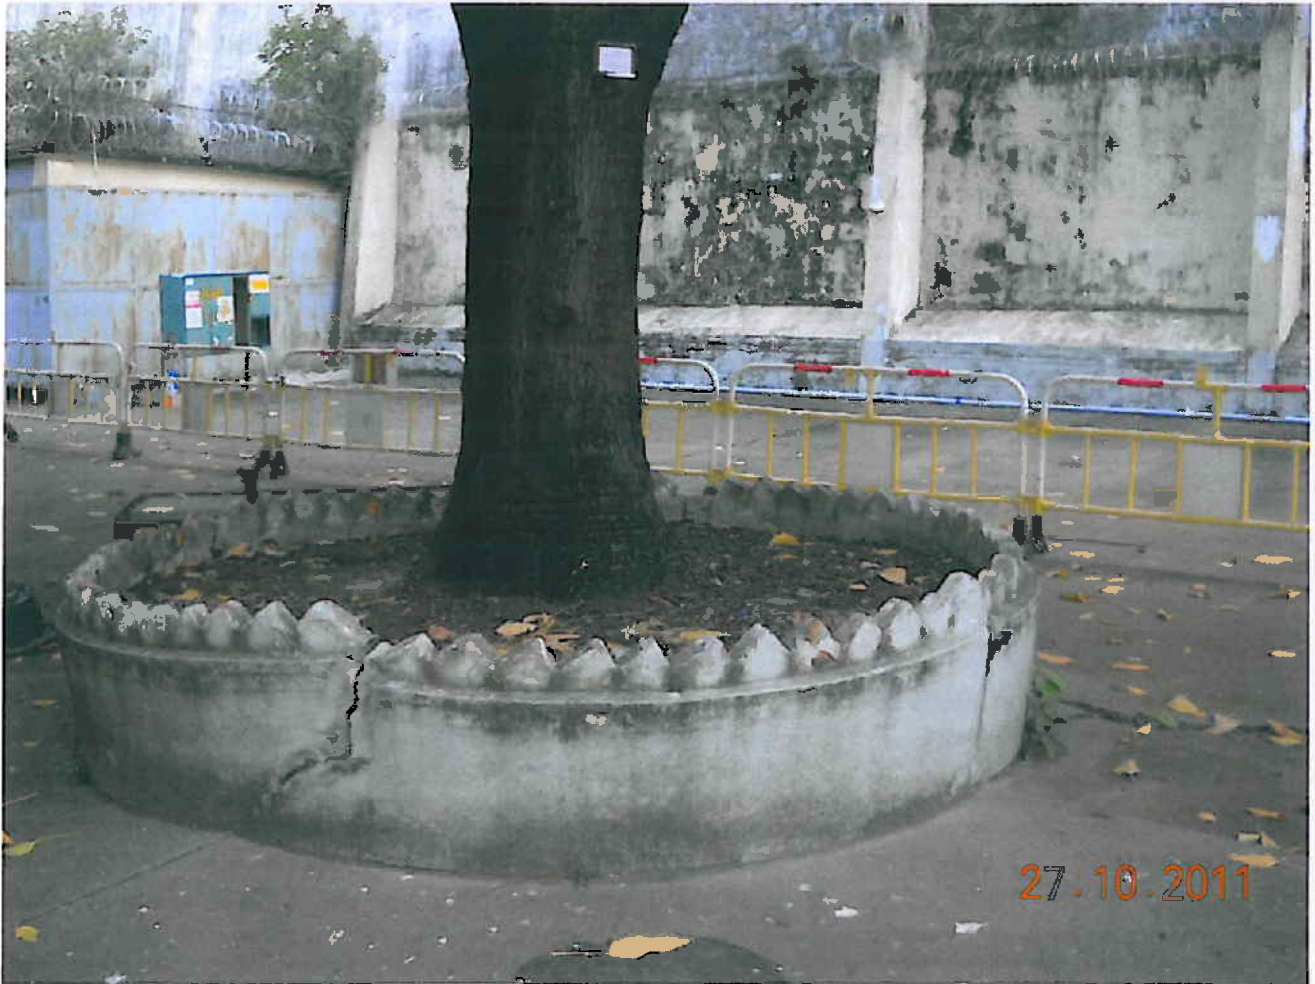
Photo 5.

Condition of root flare

Tree was surround by a raised planter, rooting area was restricted

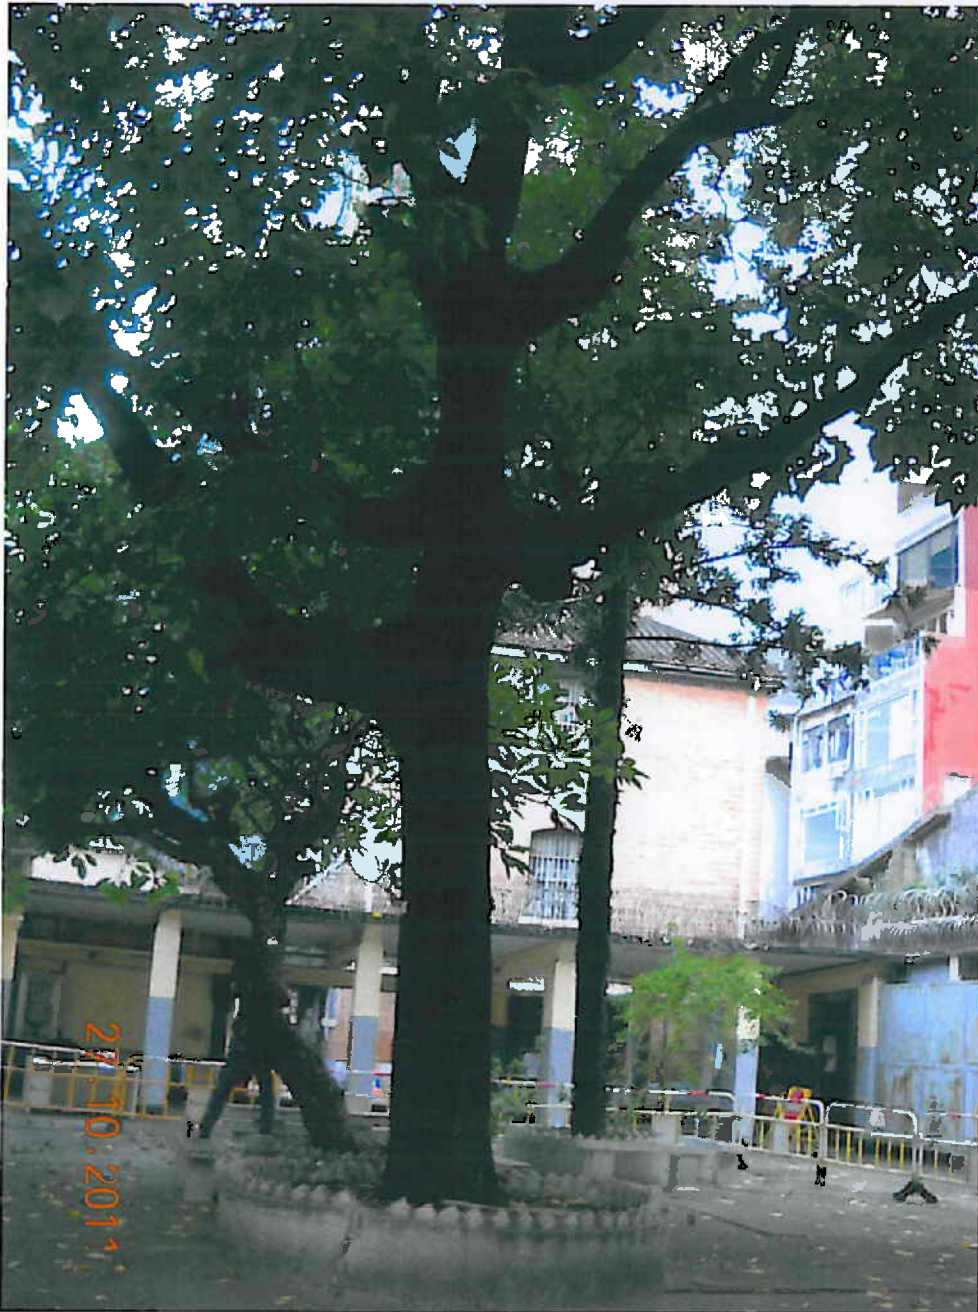
Photo 3. Condition of tree trunk  
No decay, cavity and wound were found on trunk.

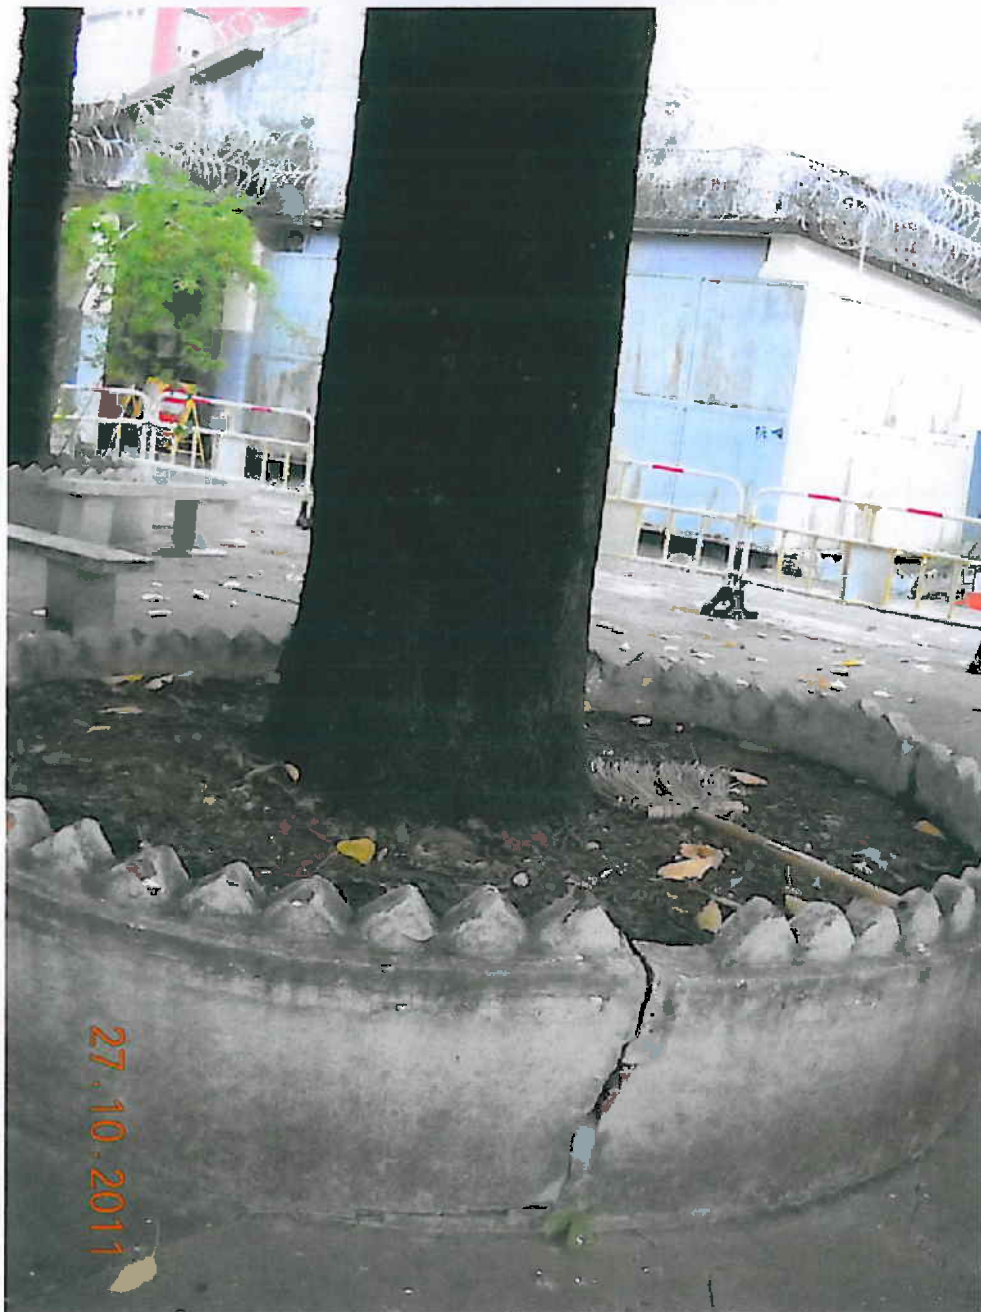
Photo 4. Condition of root flare  
Tree is growing in the raised planter. Root flare not visible.  
Rooting area are restricted by the planter.

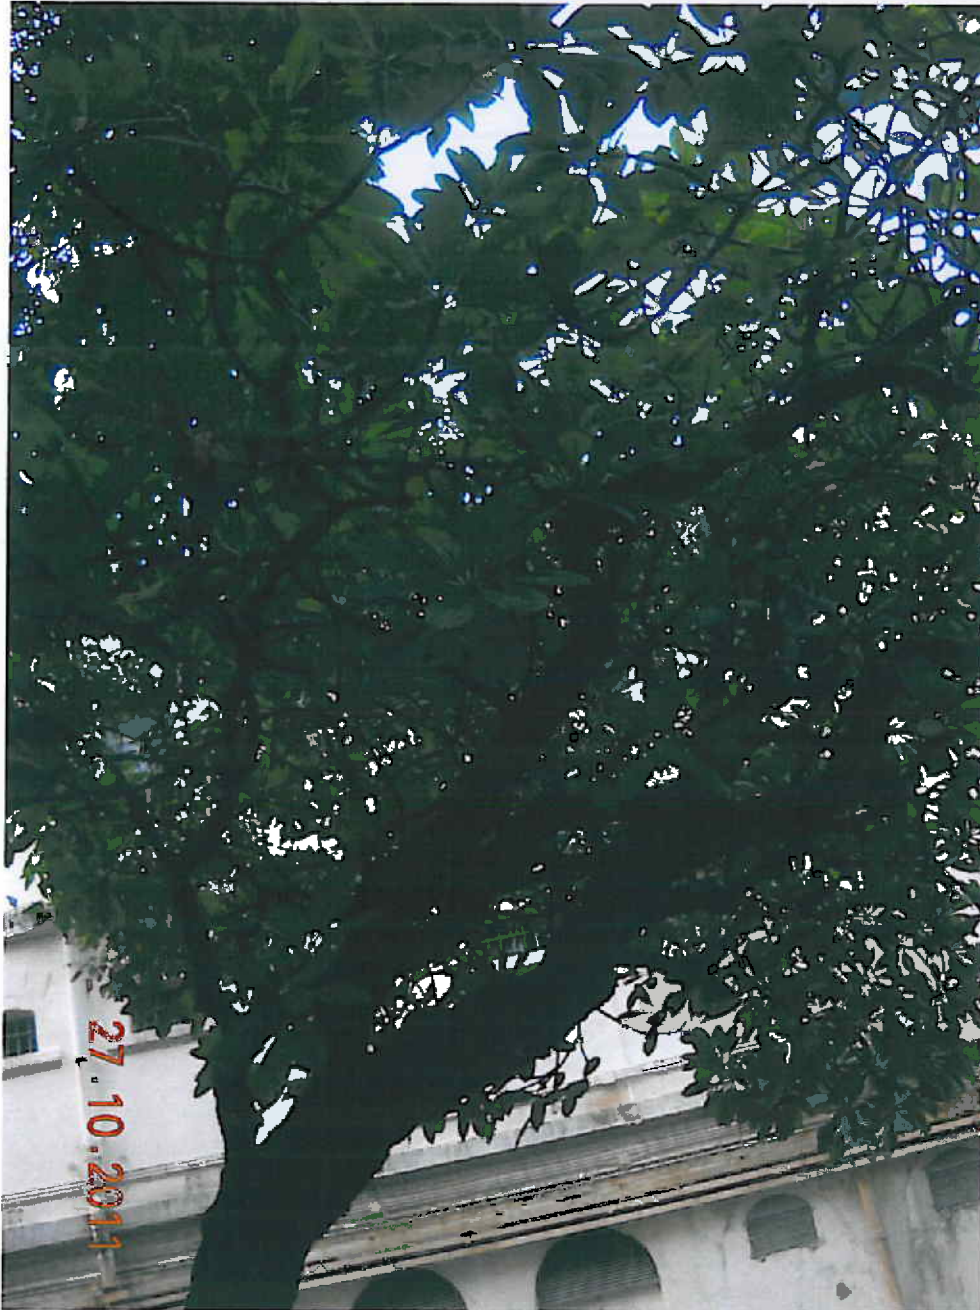
Photo 3. Condition of tree crown  
Foliage size density and color are normal.

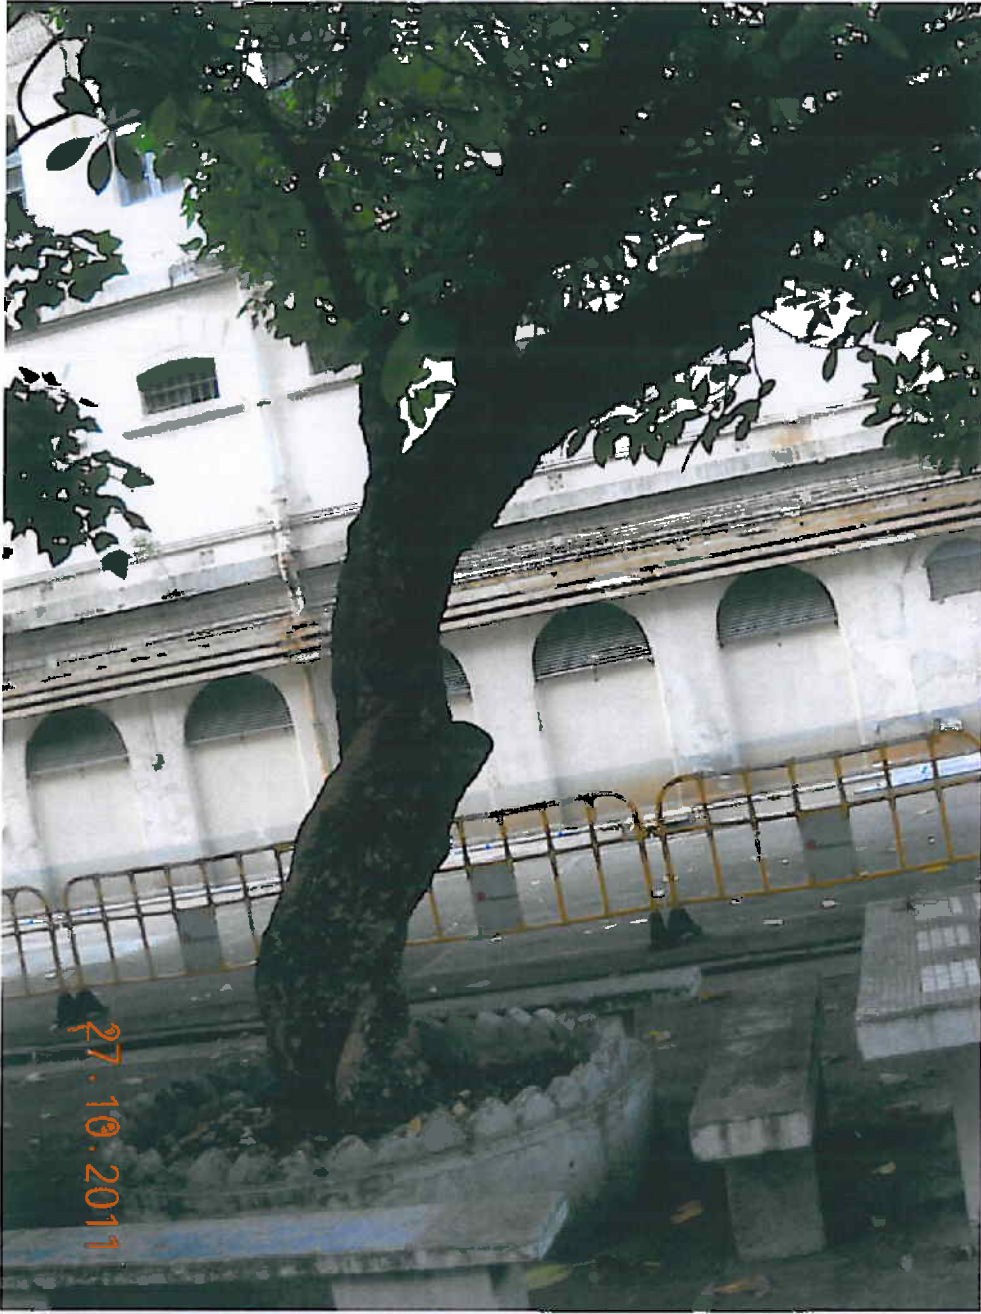
Photo 4. Condition of tree trunk  
Cavities were found on tree trunk.

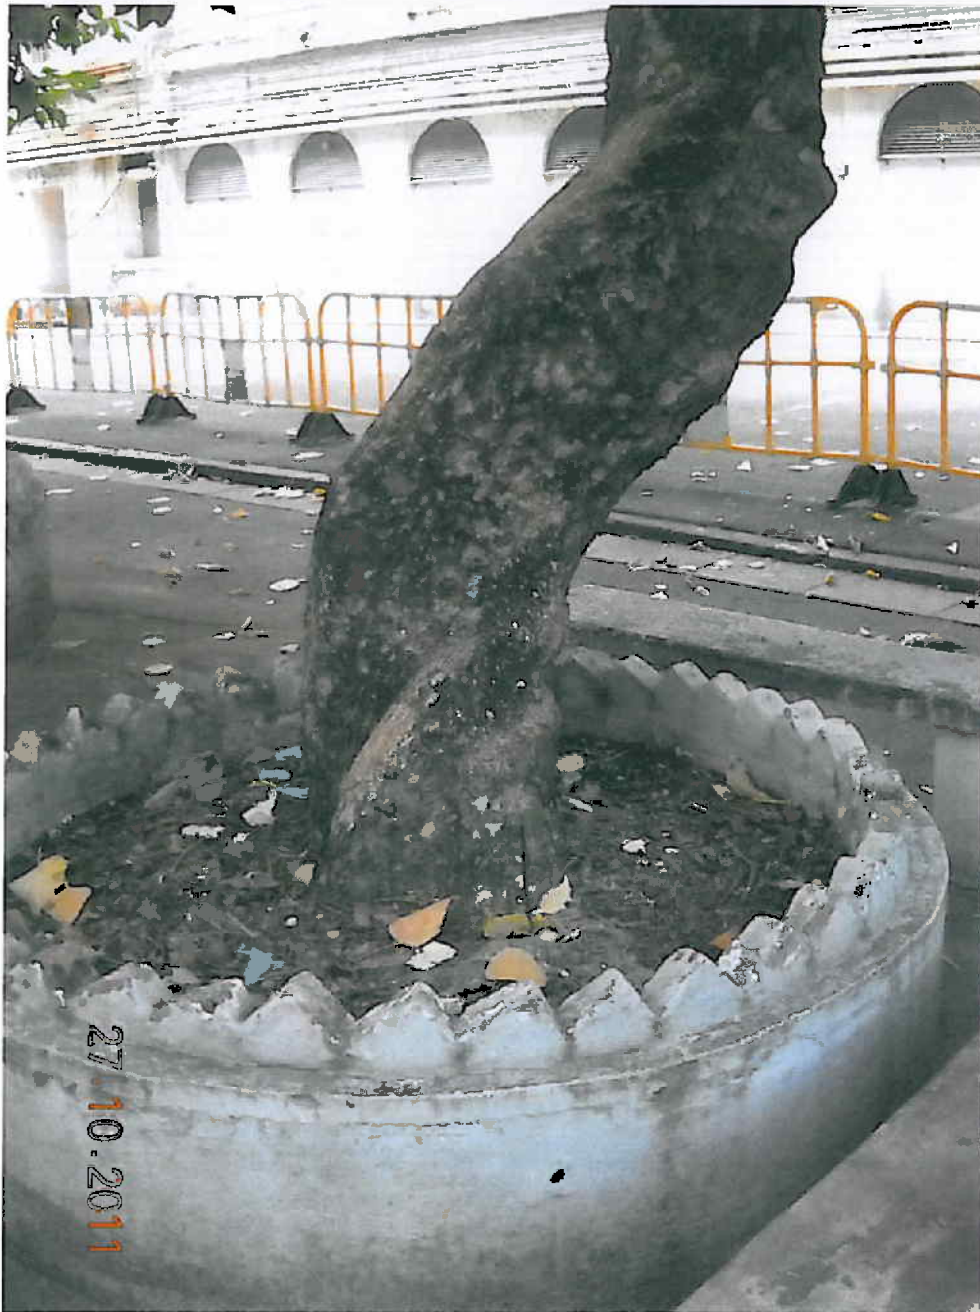
Photo 5. Condition of root flare.  
Tree is growing in a raised planter, rooting area was restricted

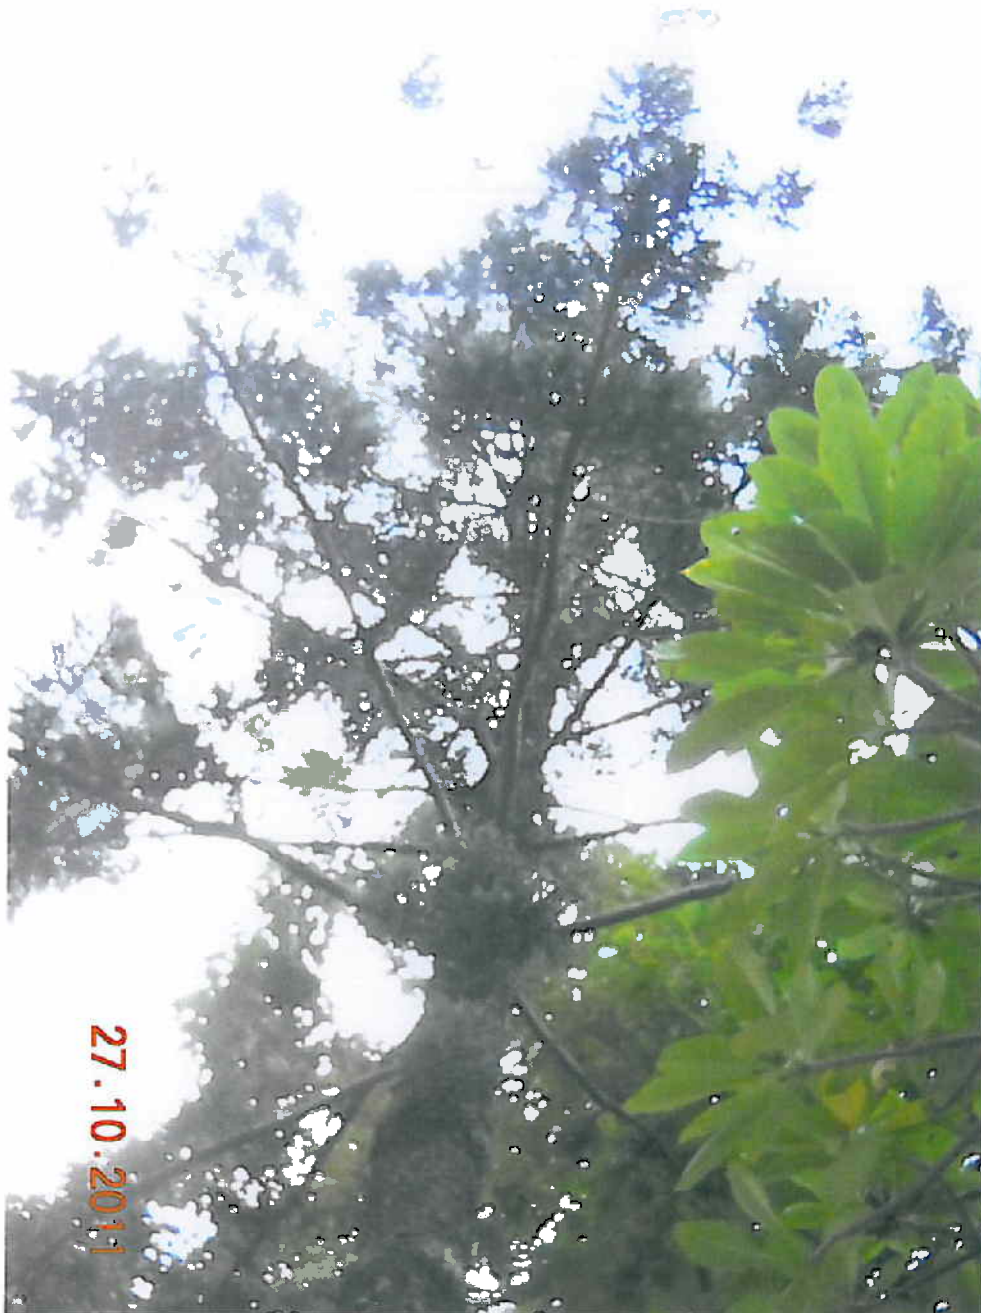
Photo 3. Condition of the tree crown  
Foliage size, density and color are normal.

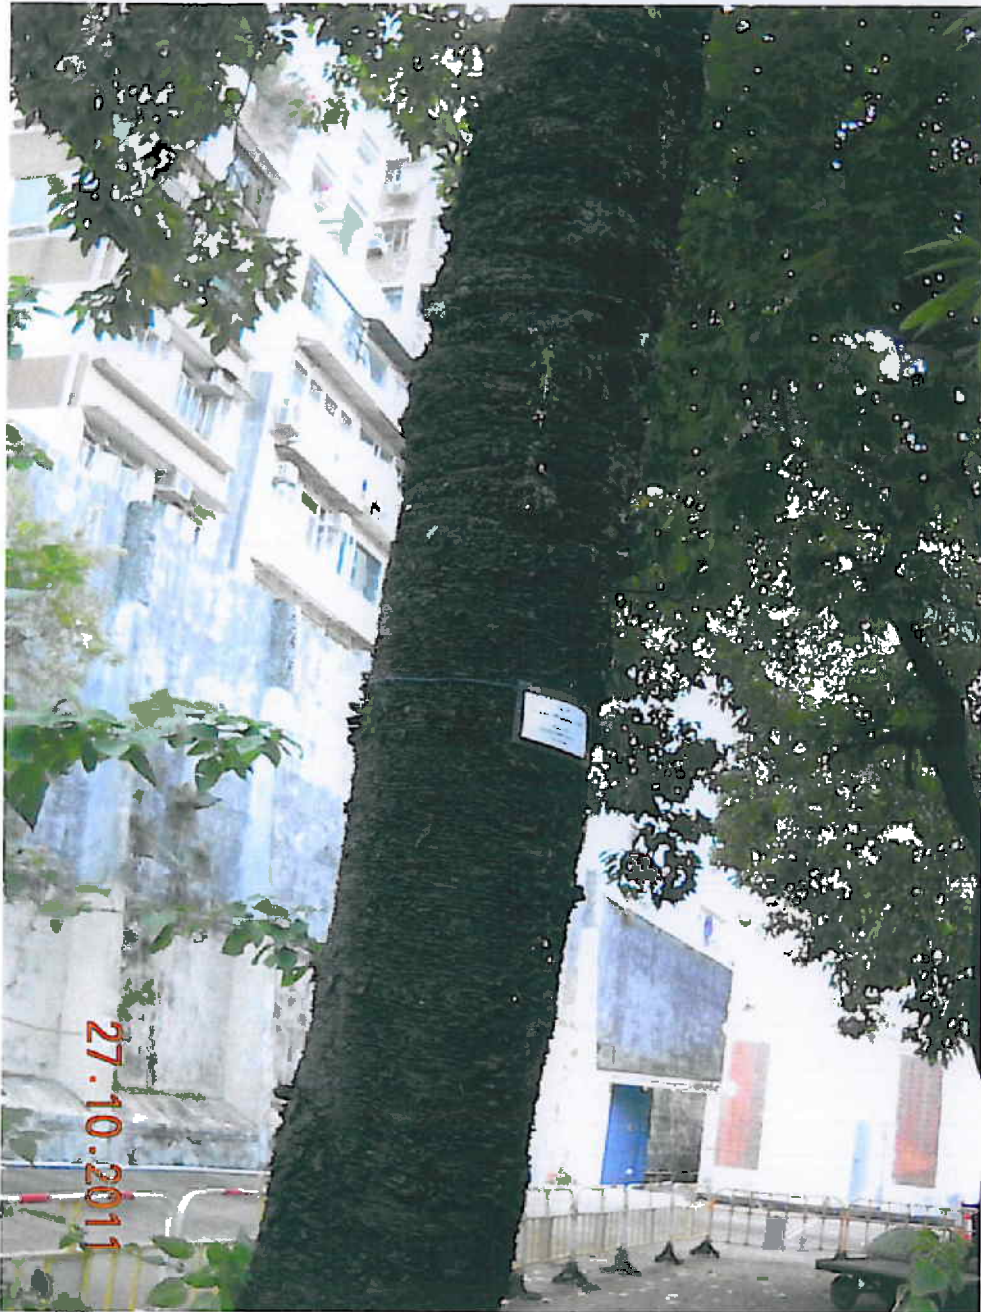
Photo 4. Condition of the trunk  
There are some signs of insects attack on trunk.

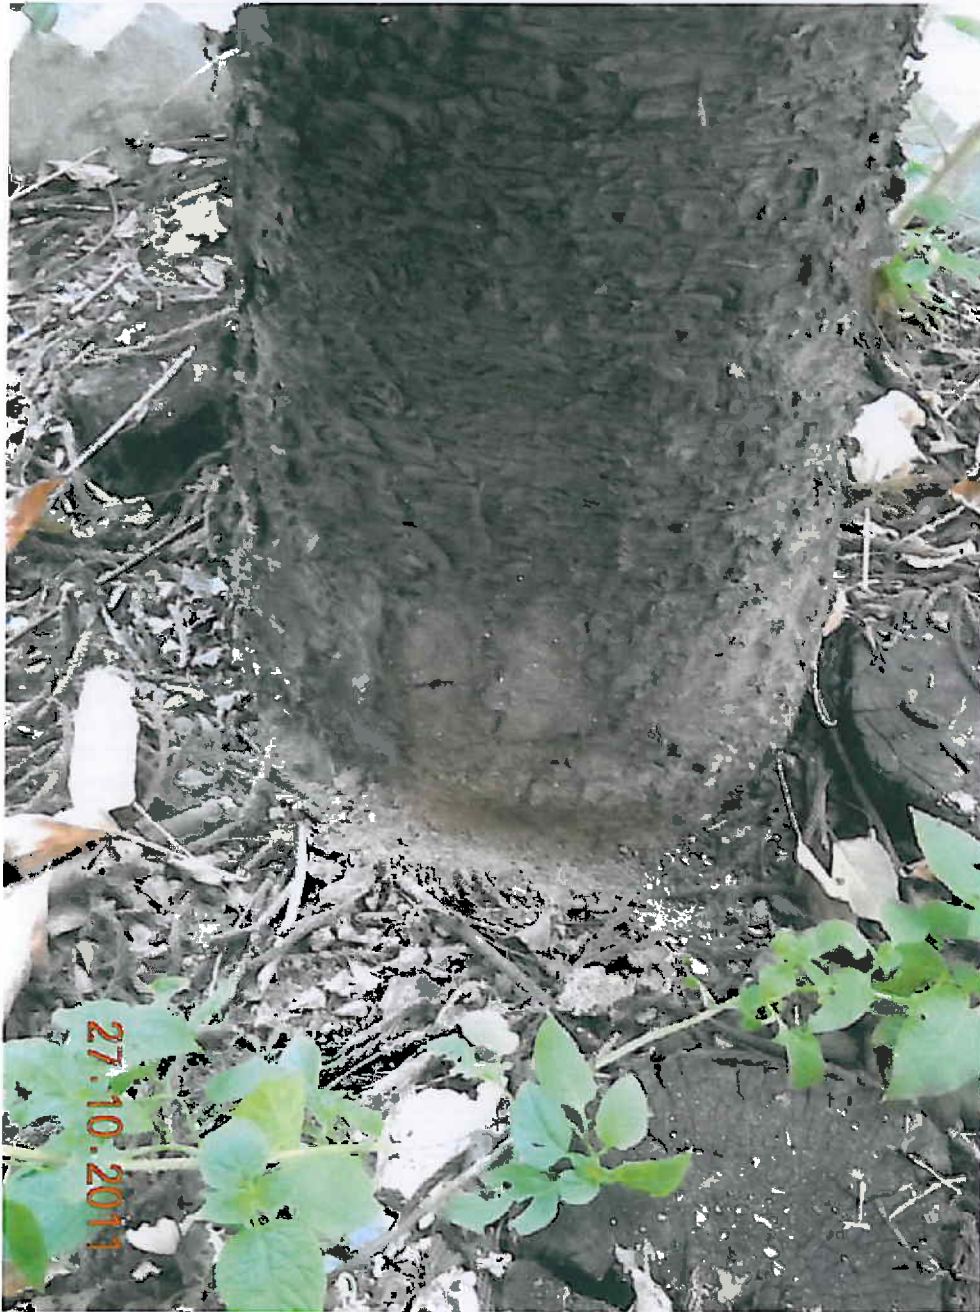
Photo 5. Condition of root flare.  
Root flare invisible.  
Decayed barks were found at the base.
