Independent Environmental Checker (IEC)
Monthly Audit Report No. 1
12 February to 28 February 2014

(182663/B&V/001/Issue 1)

| EZ B&V | Report Memorandum | | |
|---|--|--|---|
| Project Title CEDD Contract No. GE/2013/16 Landslip Prevention and Mitigation P Landslip Prevention and Mitigation V Above Leung Fai Tin along Clear War Study Area No.: 12NW-C/SA1 (Study | Vorks in New Territories<br>ter Bay Road, Sai Kung | Job No. 182663/2000 | |

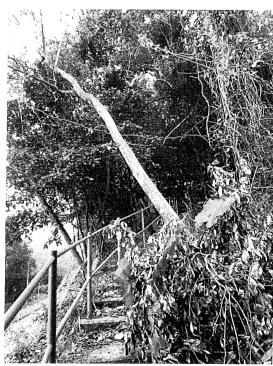
- During the reporting period, one IEC joint site inspection among CHMHC and KOCCL was conducted on 12 February 2014. One (1) *Aquilaria sinensis* (土沉香) was found collapsed during the site audit which is not related to construction work.

Photo 1: Aquilaria sinensis (T599) was found collapsed.

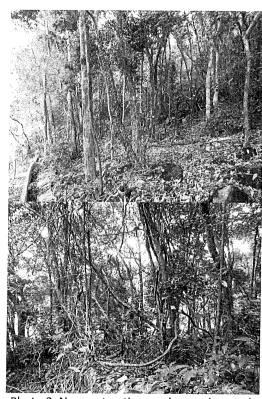
Photo 2: No construction work was observed.
