**CEDD Contract No. GE/2013/06
Landslip Prevention and Mitigation Programme, 2008, Package J,
Landslip Prevention and Mitigation Works in New Territories
Above Leung Fai Tin along Clear Water Bay Road, Sai Kung
Study Area No.: 12NW-C/SA1 (Study Area H)**

Independent Environmental Checker (IEC)
Monthly Audit Report No. 2
1 April to 30 April 2014

(182663/B&V/003/Issue 1)

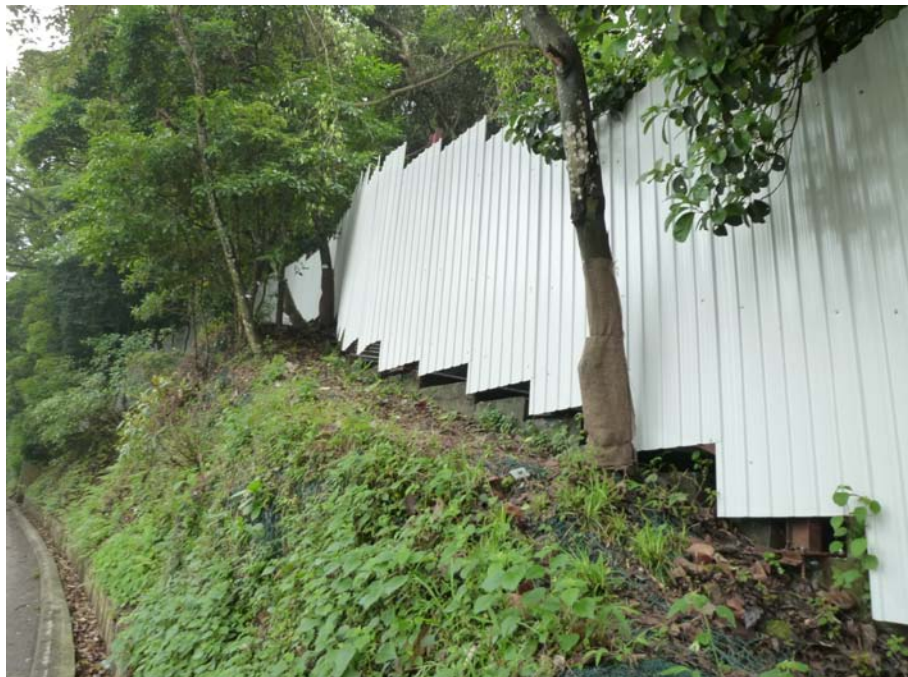
2.2.1 The construction work of the Project has been commenced on 15 January 2014. During the reporting period, no construction work was being carried out during the site inspection. Partial site hoarding adjacent to Clear Water Bay Road was hoisted during the site audit (Photos 1 to 2).

Photo 1 View from Outside the Project Boundary

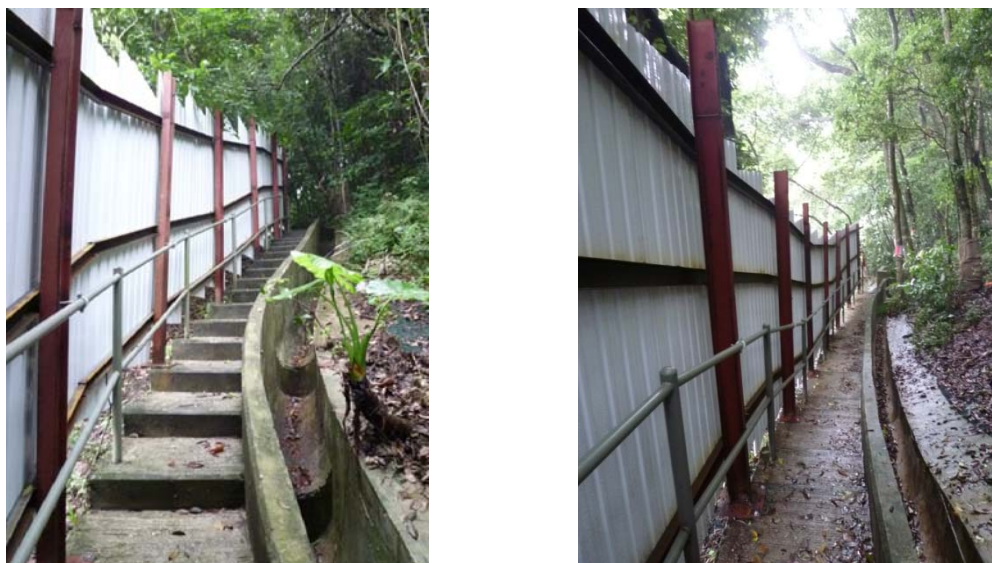
Photo 2 Internal View of Site Hoarding along the Project Boundary

- 2.3.1 According to the approved Landscape and Compensatory Planting Plan, no tree will be felled due to the site hoarding erection. The Contractor is reminded to position the site hoarding to protect all trees along the alignment.
