Contract No. GE/2013/06

Landslip Prevention and Mitigation Programme, 2008, Package J

Above Leung Fai Tin along Clear Water Bay Road, Sai Kung

Independent Environmental Checker (IEC) Monthly Audit Report No. 4 1 May to 31 May 2014

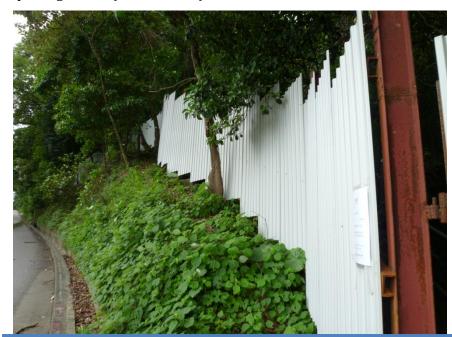
2.2.1 The construction work of the Project has been commenced on 15 January 2014. During the reporting period, no construction work was being carried out during the site inspection. Erection of site hoarding is in progress and will be carried out during the coming reporting month (Photos 1 to 2).

Photo 1 View from Outside the Project Boundary

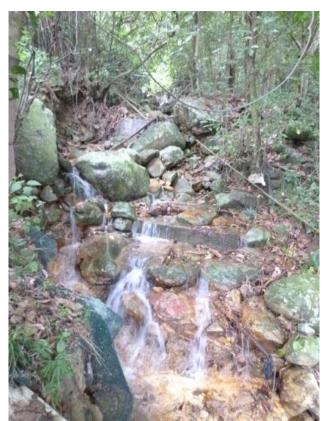
2.2.2 No flexible barrier is built across the stream within the Works Area at present stage (Photo 3).

**Photo 3 Existing Stream Condition within the Project Site**
