Landslip Prevention and Mitigation Programme, 2008, Package J

Above Leung Fai Tin along Clear Water Bay Road, Sai Kung

Study Area: 12/NW-C/SA1 (Study Area H)

Independent Environmental Checker (IEC) Monthly Audit Report No. 6 1 July to 31 July 2014

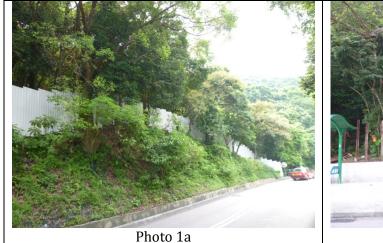
2.2.1 The Project has been commenced on 15 January 2014. During the reporting period, no construction work was being carried out during the site inspection. Erection of site hoarding and chain link fencing were in progress and will be carried out during the coming reporting month (Photos 1a and 1b).
