**Landslip Prevention and Mitigation
Programme, 2008, Package J**

**Landslip Prevention and Mitigation
Works in New Territories**

**Independent Environmental Checker
(IEC)**

Monthly Audit Report No. 8

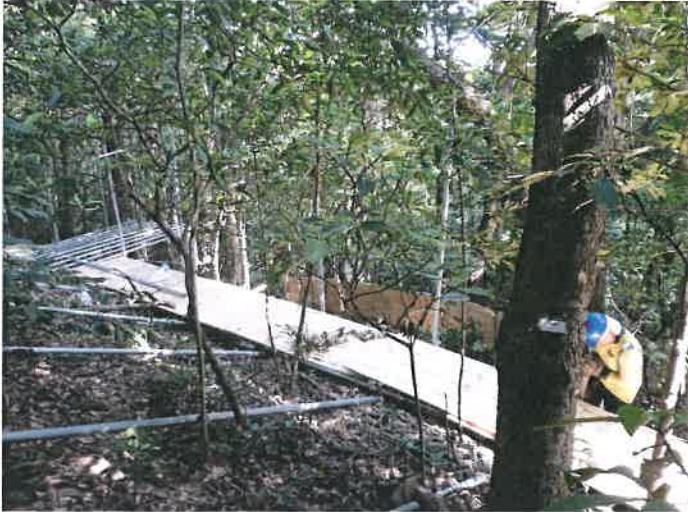
Observation 1:

2.3.2 It was observed that some of the existing trees adjacent to works area were not fencing off properly. The Contractor shall provide protective measures to prevent tree damage during construction.

It was observed that one of the existing trees near to the works area was not fenced off properly. The Contractor shall provide protective measures to prevent tree damage during construction.

The Contractor shall provide protective measures to prevent tree damage during construction

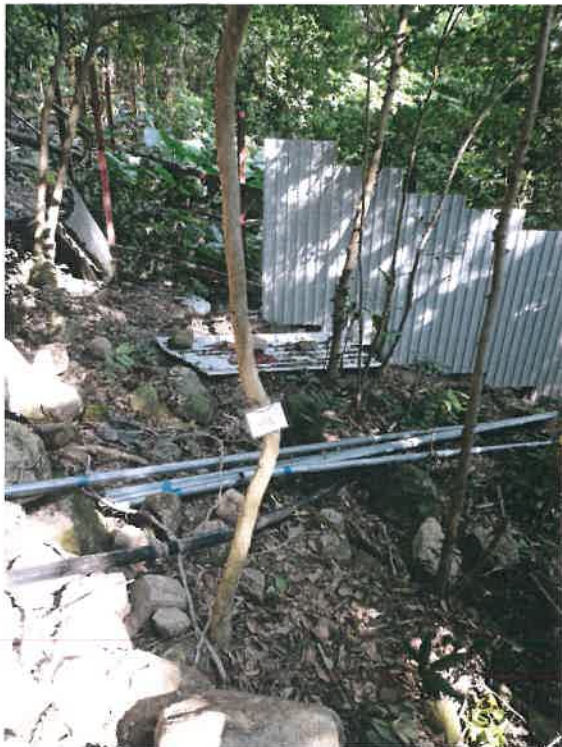
Observation 2:

2.3.3 It was observed that one of the *Aquilaria sinensis* (土沉香) (Tree No. 480A) was not properly fenced off and protected. According to the Project Profile, each individual of *Aquilaria sinensis* and *Pavetta hongkongensis* (香港大沙葉) within the works area of the Project shall be retained in-situ, tagged and fenced off either in groups or individually to prevent being damaged/disturbed during construction. The Contractor shall provide all required protective measures to all *Aquilaria sinensis* and

It is observed that one of the *Aquilaria sinensis* (土沉香) (Tree No. 480A) is not properly fenced off and protected.

According to the Project Profile, each individual of *Aquilaria sinensis* and *Pavetta hongkongensis* (香港大沙葉) within the works area of the Project shall be retained in-situ, tagged and fenced off either in groups or individually to prevent being damaged/disturbed during construction.

The resident site supervisory staff will closely monitor the conditions of the *Aquilaria sinensis* and *Pavetta hongkongensis* individuals during the construction phase.

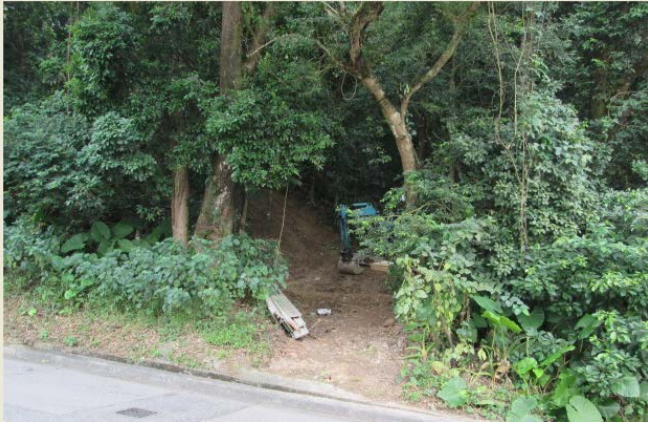
Observation 3:

2.3.1 Join site audit was carried with CHMHC and KOCCL on 23rd September 2014. During the site audit, it was observed that a temporary access was formed for material and equipment transportation. It was noted that the temporary access was outside the works area. Erection of scaffolding and setting up of flexible barrier alignment were observed within the works area. A meeting was held with CHMHC and KOCCL on 30th September 2014 and the Contractor agreed to carry out remedial work at the temporary access and confined all works within works area during the construction period as stated in the EP. The temporary access shall be fenced off properly. It is agreed that no work shall be carried out outside the permitted boundary. The Contractor will propose and submit the reinstatement work for the temporary access and proactive measures to prevent recurrence to the Engineer. The propose reinstatement work is subject to the agreement of land owner.

Temporary access was formed for material and equipment transportation. It was noted that the temporary access was outside the works area. The Contractor will assist to rectify and carry out remediation work subject to agreement with CEDD and the Engineer.

It was noted that the temporary access was outside the works area. The Contractor will assist to rectify and carry out remediation work subject to agreement with CEDD and the Engineer.
