**Landslip Prevention and Mitigation  
Programme, 2008, Package J**

**Above Leung Fai Tin along Clear Water  
Bay Road, Sai Kung**

**Monthly Audit Report No. 9**

**1 October to 31 October 2014**

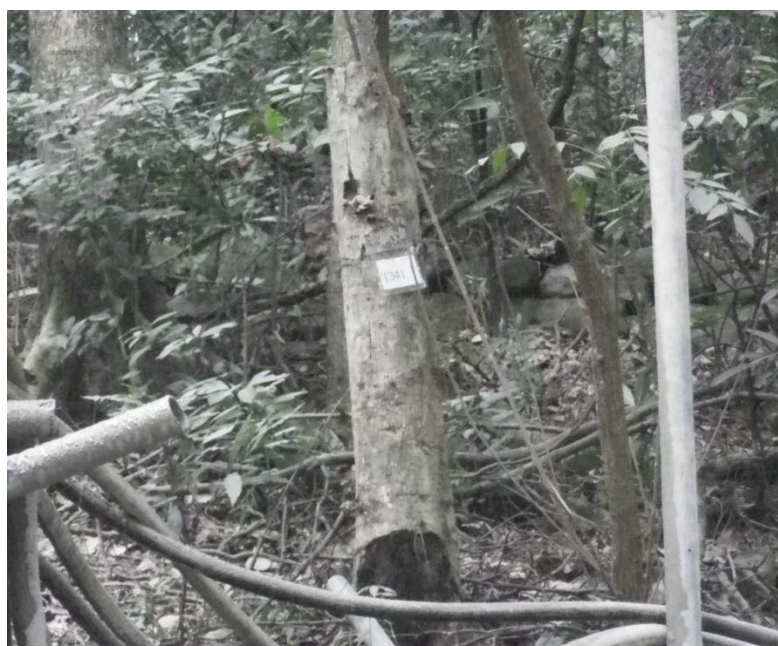
**Photo 1 T341 (*Aquilaria sinensis*)**

2.3.4 22 nos. of *Aquilaria sinensis* located near or adjacent to the temporary works area were inspected and summarized in Table 2-3. Three (3) of them were found missing and were recorded as missing in the submitted baseline tree survey report before commencement of construction work. Five (5) of them were not inspected during the site audit as they are not close to the temporary works area. One (1) of them (T341) was found topped and bottom part damaged during the site audit which is located about 5 m away from the temporary works areas. It is considered not related to construction works nearby (Please refer to Photo 1).

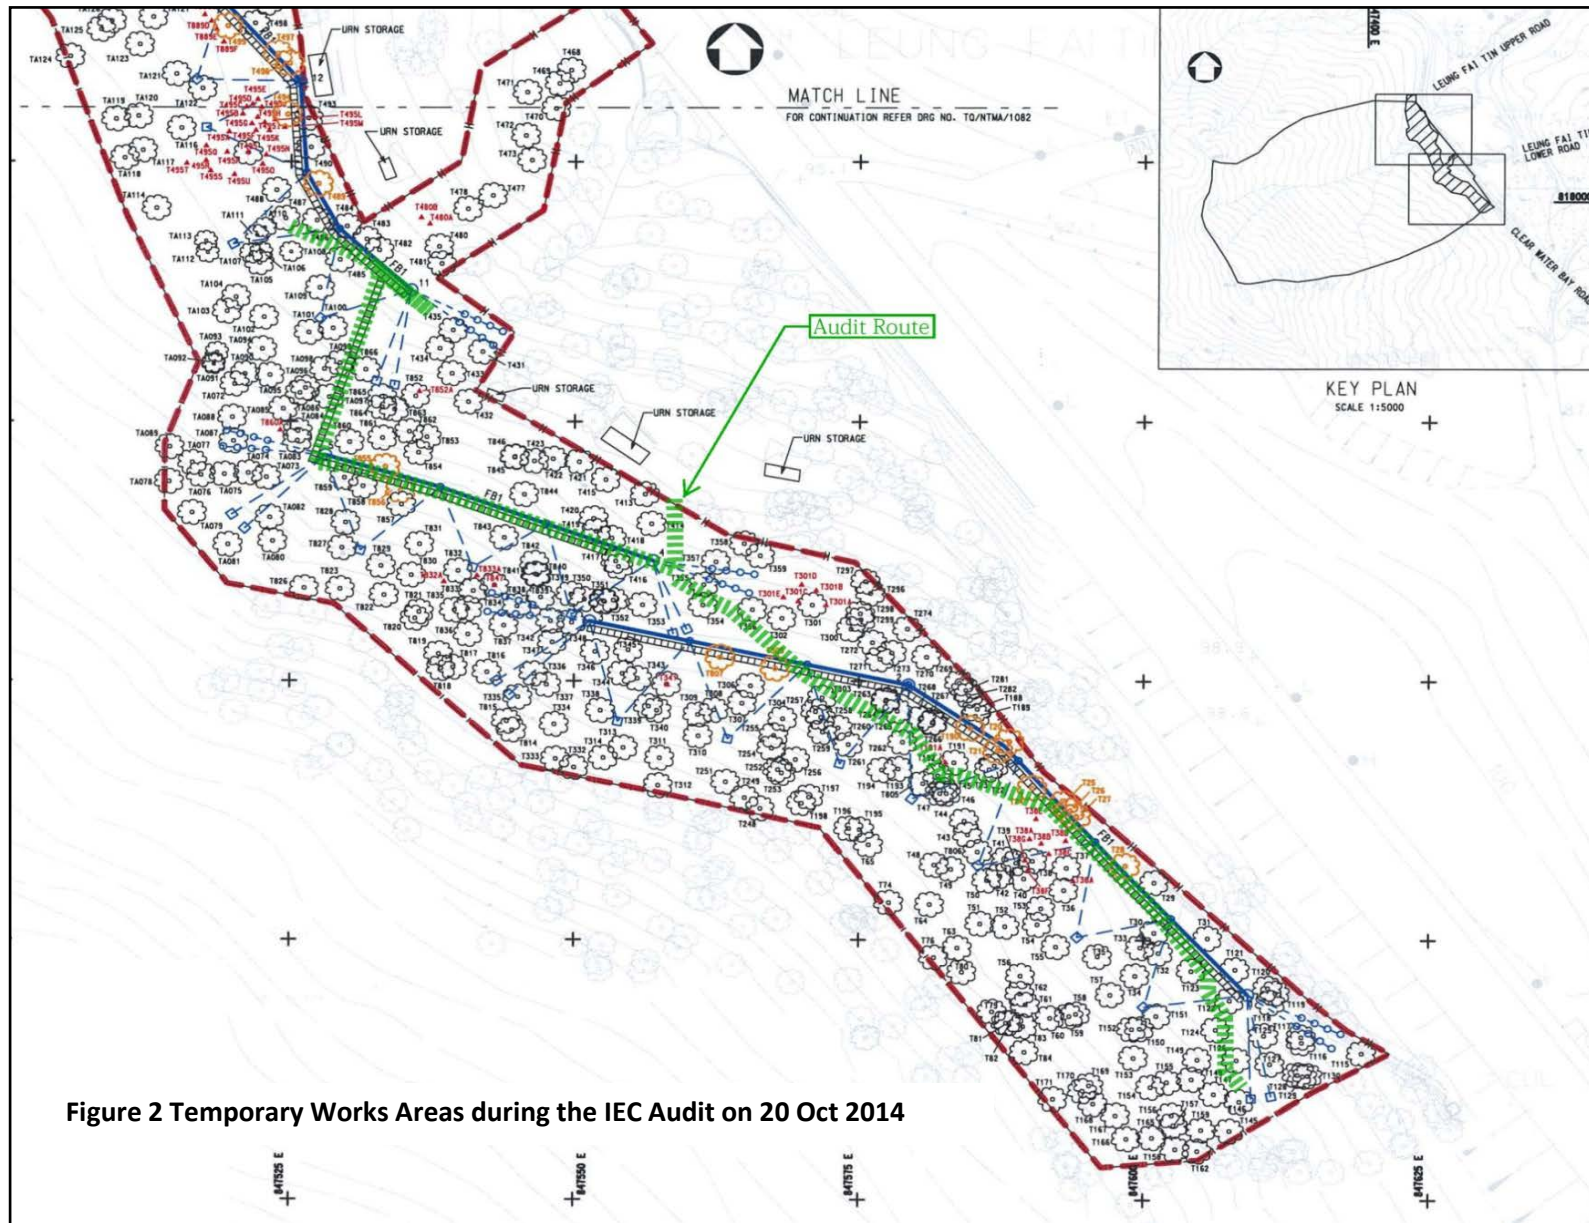
Figure 2 Temporary Works Areas during the IEC Audit on 20 Oct 2014

2.2.1 The Project has been commenced on 15 January 2014. During the reporting period, temporary access, erection of scaffolding and foundation works of the flexible barriers were being carried out during the site inspection. Site audit was carried out along the temporary works areas as shown in **Figure 2**.

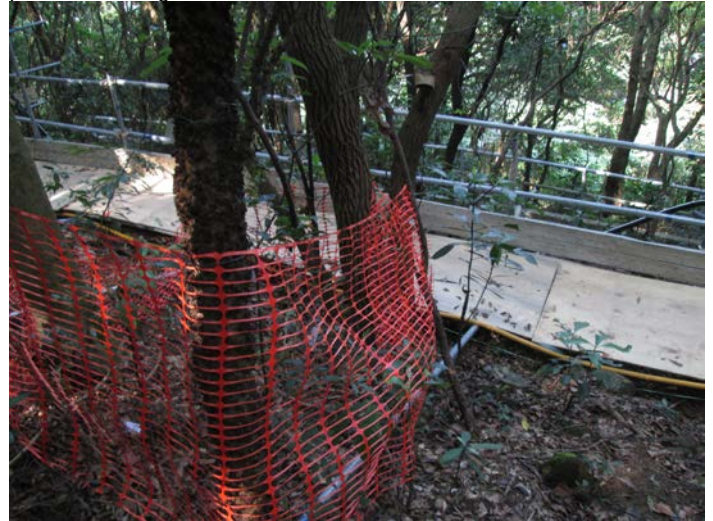
**Follow up action 1**

It was observed that one of the existing trees near to the works area was not fenced off properly. The Contractor shall provide protective measures to prevent tree damage during construction.

The Contractor provided fencing at the tree groups to tree prevent damage.

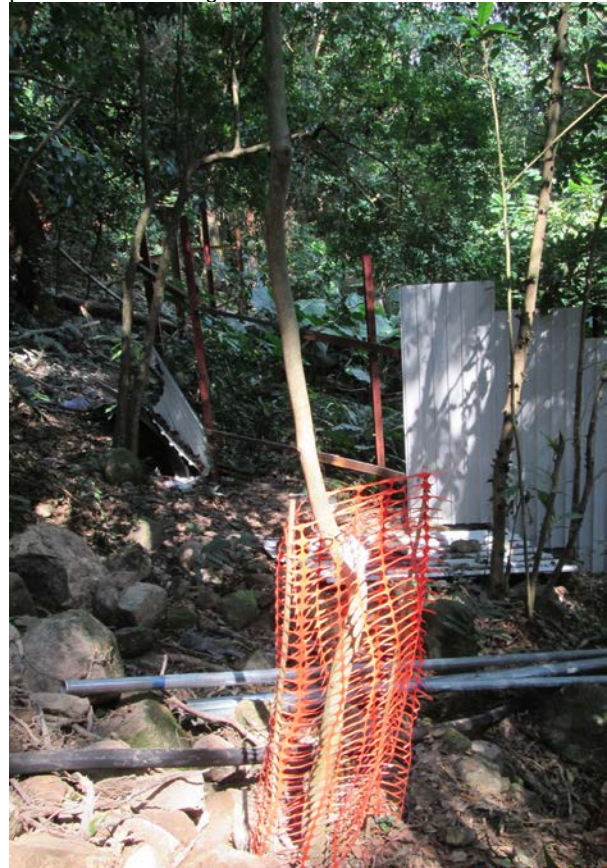
**Follow up action 2**

It is observed that one of the *Aquilaria sinensis* (土沉香) (Tree No. 480A) is not properly fenced off and protected.

According to the Project Profile, each individual of *Aquilaria sinensis* and *Pavetta hongkongensis* (香港大沙葉) within the works area of the Project shall be retained in-situ, tagged and fenced off either in groups or individually to prevent being damaged/disturbed during construction.

The Contractor provided fencing at T480A with tree tag to prevent tree damage.

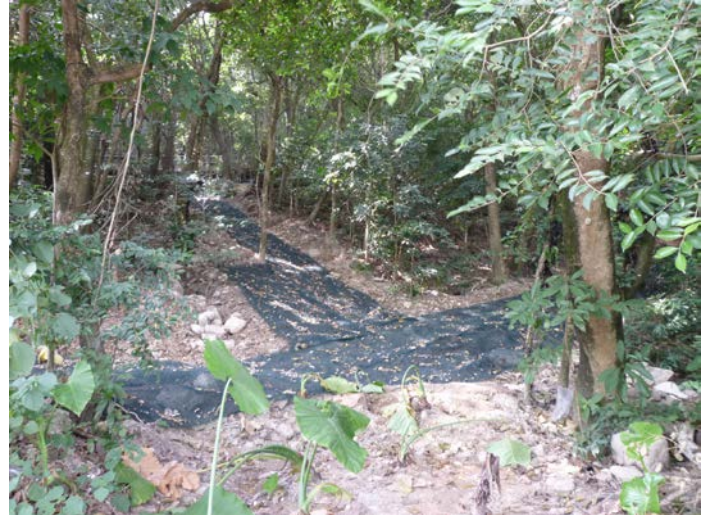
Follow up action 3

Temporary access was formed for material and equipment transportation. It was noted that the temporary access was outside the works area. The Contractor will assist to rectify and carry out remediation work subject to agreement with CEDD and the Engineer.

Temporary access was fenced off.
