Contract No. GE/2013/06

Landslip Prevention and Mitigation Programme, 2008, Package J

Above Leung Fai Tin along Clear Water Bay Road, Sai Kung

Independent Environmental Checker (IEC)
Monthly Audit Report No. 10

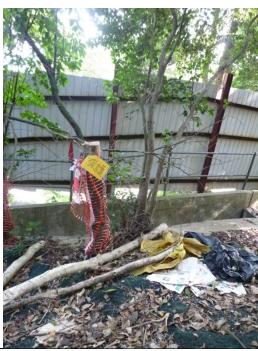
Photo 6 T606 *Aquilaria sinensis* was felled by others.

- 2.3.10 We suggested to put warning signs at various locations, e.g. near the felled *Aquilaria sinensis*, to warn the trespasser not to damage the trees.

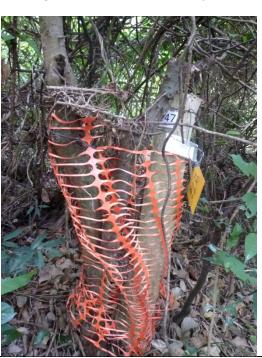
Photo 7 T607 *Aquilaria sinensis* was felled by others.

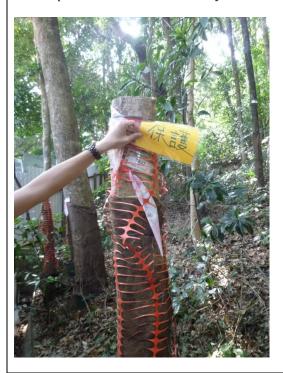
Photo 8 T627 *Aquilaria sinensis* was felled by others.
