Contract No. GE/2013/06

Landslip Prevention and Mitigation Works in New Territories

Above Leung Fai Tin along Clear Water Bay Road, Sai Kung

Independent Environmental Checker (IEC)
Monthly Audit Report No. 14
March 2015

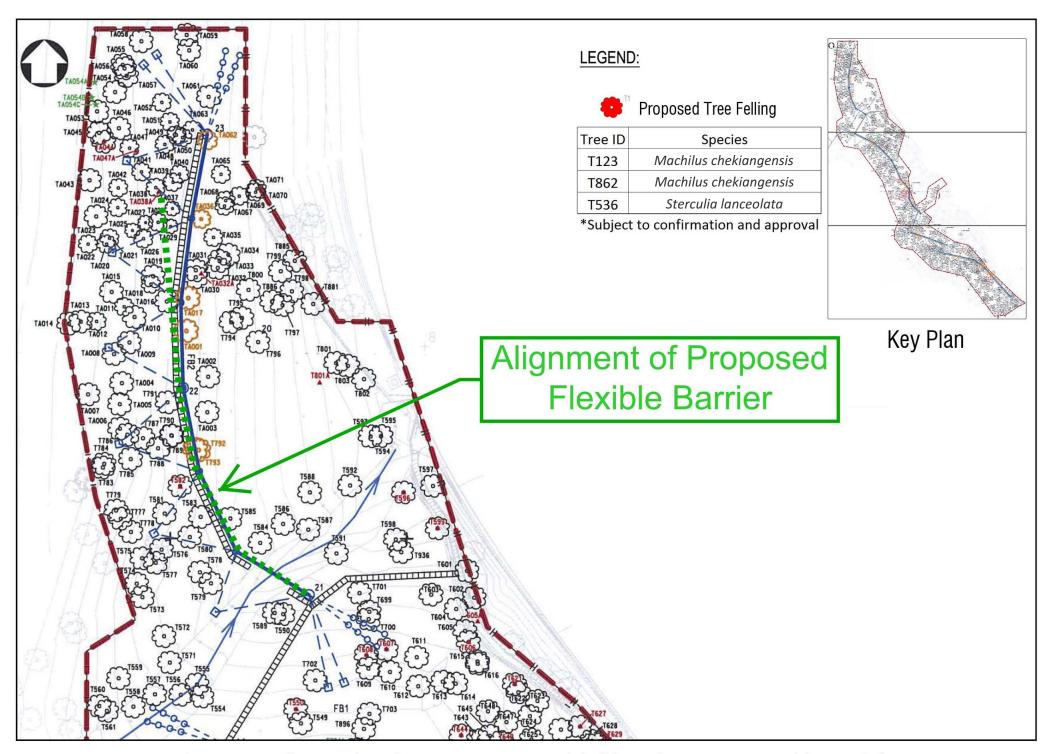
Figure 2 IEC Audit Route along the Temporary Access and Flexible Barrier on 27 Mar 2015 (Sheet 1 of 3)

2.2.1 The Project has been commenced on 15 January 2014. During the reporting period, installation of ground anchors, construction of concrete footings, erection of post and net of flexible barrier and construction of maintenance access were carried out. Site audit was carried out along the works areas as shown in **Figure 2**.

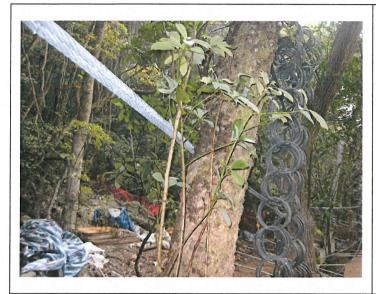
Comment 1:

2.3.7 No observation was recorded during the site inspection and audit in the reporting month. No tree felling was recorded. Minor deficiencies were noted and the Contractor was reminded to rectify these deficiencies as soon as possible. The Contractor was reminded to provide temporary protection measures to the retained trees near the wire of the flexible barrier (**Photo 5**) and to properly labelled / stored oil container (**Photo 6**).

Temporary protection measures should be provided to the retained trees near the flexible wires.

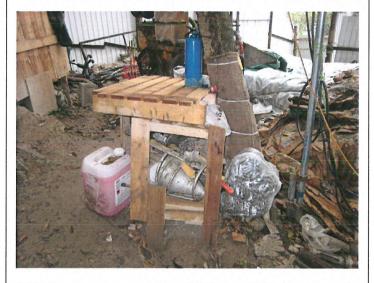
Comment 2:

Diesel oil container should be properly stored and labelled.
