**Landslip Prevention and Mitigation
Programme, 2008, Package J**

**Above Leung Fai Tin along Clear Water
Bay Road, Sai Kung**

**Independent Environmental Checker
(IEC)**

Monthly Audit Report No. 15

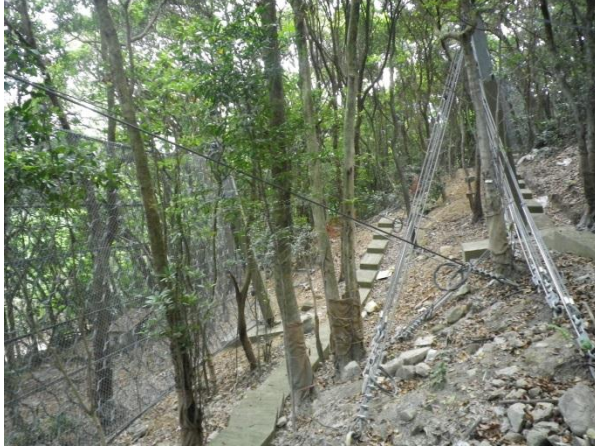
2.3.2 Joint site audit was carried out with CHMHC and KOCCL on 27 April 2015. Construction of flexible barrier and maintenance access were observed within the works area. **Photos 1 to 3** show the construction work progress within permitted works areas. The temporary access was extended beyond to the stream course.

Photo 1
Temporary works area within the project boundary

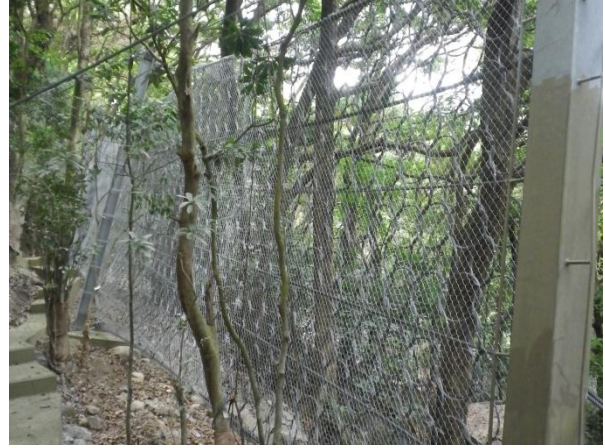
Photo 2
Temporary works area within the project boundary

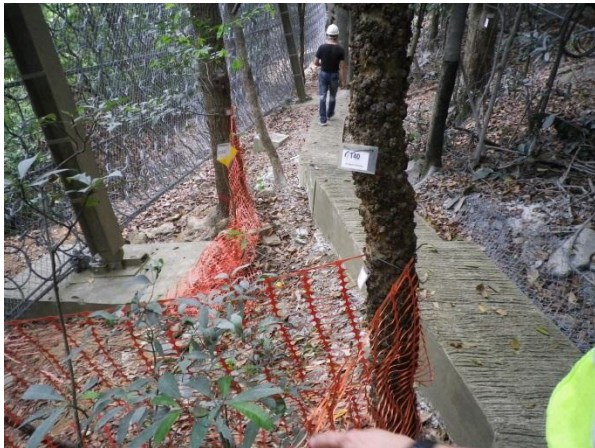
- 2.3.5 Bright colour tree protection signage was provided at protective trees (**Photo 3**). Protective tree measures have also been provided. Information sheet with colour photos of *Aquilaria sinensis* and *Pavetta hongkongensis* were displayed conspicuously within the construction site.
- 2.3.6 Three individual of *Aquilaria sinensis* (T629, T630 & T649) were observed felled by others on 25 April 2015 (**Photos 4, 5 & 6**). The Contractor has reported the case to HKPF. Similar cases were noted in February and November 2014. The Contractor was reminded to review its site security measures and implement appropriate measures to prevent similar recurrence.
- 2.3.7 No tree damage was observed and recorded. All trees were protected with tree tags and bright colour signage.

Photo 3
Protected trees were fenced off

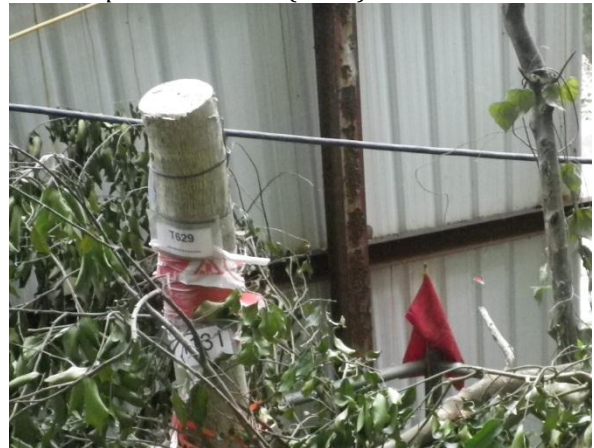
Photo 4
Felled *Aquilaria sinensis* (T629)

4.03	Are protected plants species are retained in-situ?	<input type="checkbox"/>	<input checked="" type="checkbox"/>	<input type="checkbox"/>	<input type="checkbox"/>	ILLEGAL FELLING OF AQUILARIA SINENSIS BY OTHERS (SEE NOTE 1)

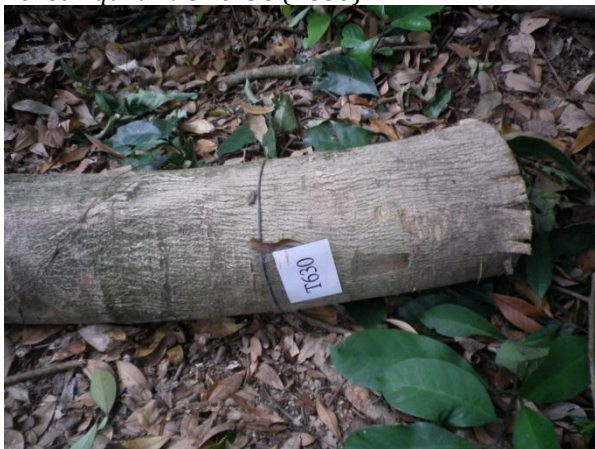
Photo 5
Felled *Aquilaria sinensis* (T630)

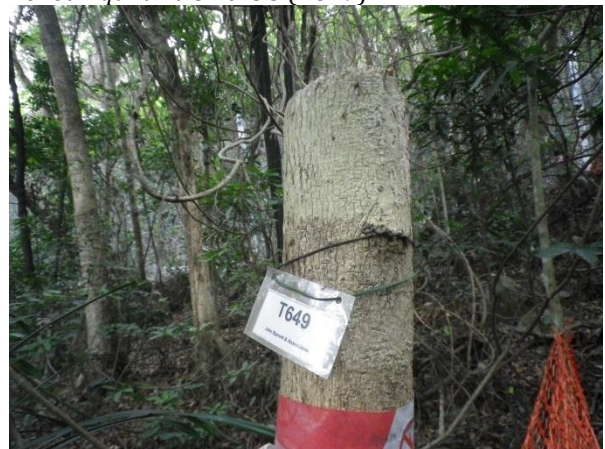
Photo 6
Felled *Aquilaria sinensis* (T649)
