**Landslip Prevention and Mitigation
Programme, 2008, Package J**

**Above Leung Fai Tin along Clear Water
Bay Road, Sai Kung**

**Independent Environmental Checker
(IEC)**

Monthly Audit Report No. 16

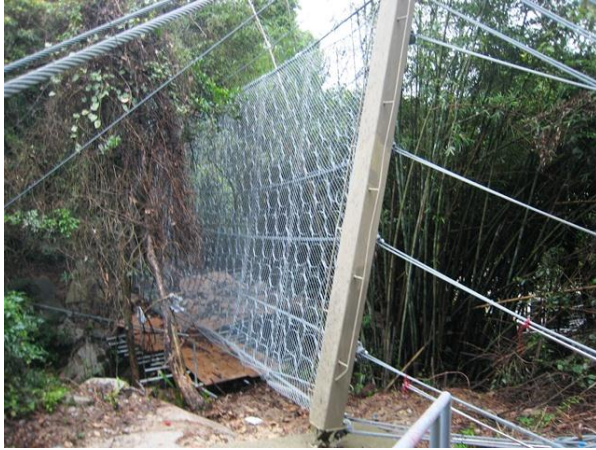
2.3.2 Joint site audit was carried out with CHMHC and KOCCL on 26 May 2015. No construction works were in progress during the site audit. **Photos 1 to 3** show the construction work progress within permitted works areas. The temporary access was extended beyond to the stream course.

Photo 1
Temporary works area within the project boundary

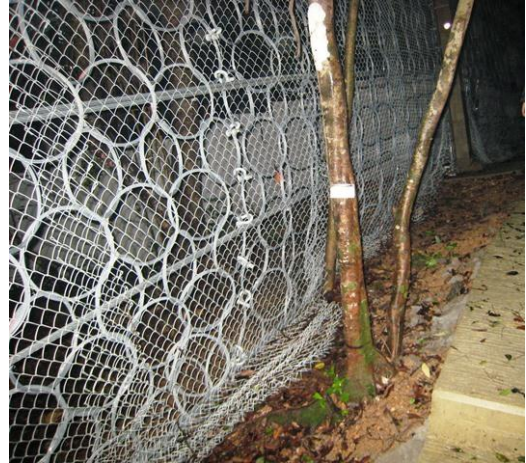
Photo 2
Temporary works area within the project boundary

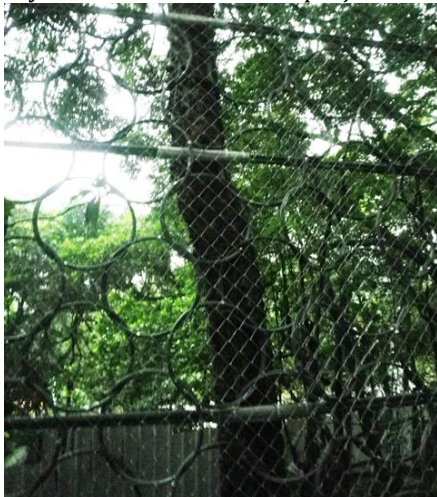
Photo 3
Temporary works area within the project boundary

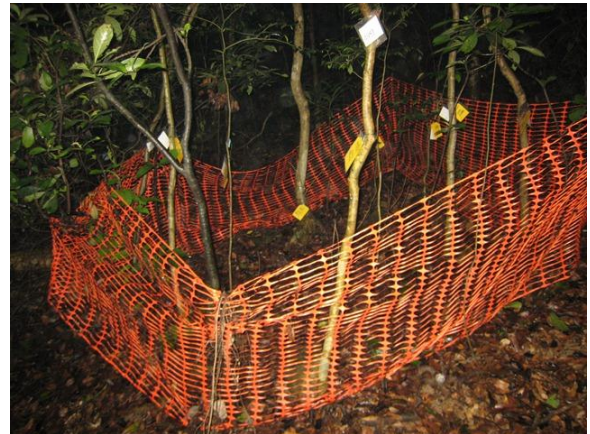
2.3.5 Bright colour tree protection signage was provided at protective trees (**Photo 4**). Protective tree measures have also been provided. Information sheet with colour photos of *Aquilaria sinensis* and *Pavetta hongkongensis* were displayed conspicuously within the construction site.

Photo 4
Protected trees were fenced off
