**Landslip Prevention and Mitigation
Programme, 2008, Package J**

**Landslip Prevention and Mitigation
Works in New Territories**

**Above Leung Fai Tin along Clear Water
Bay Road, Sai Kung**

Monthly Audit Report No. 17

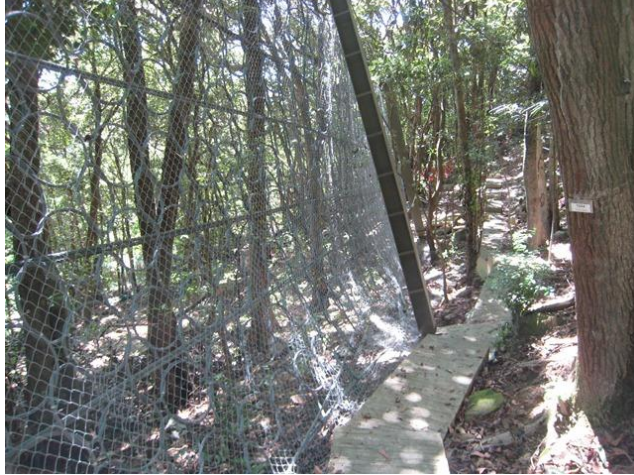
2.3.2 Joint site audit was carried out with CHMHC and KOCCL on 29 June 2015. Dismantling works were in progress during the site audit. **Photos 1 to 2** show the construction work progress within permitted works areas. The temporary access was extended beyond to the stream course. Landscaping works (**Photo 3**) were being carried out in accordance with the approved Landscape and Compensatory Planting Plan.

Photo 1
Temporary works area within the project boundary

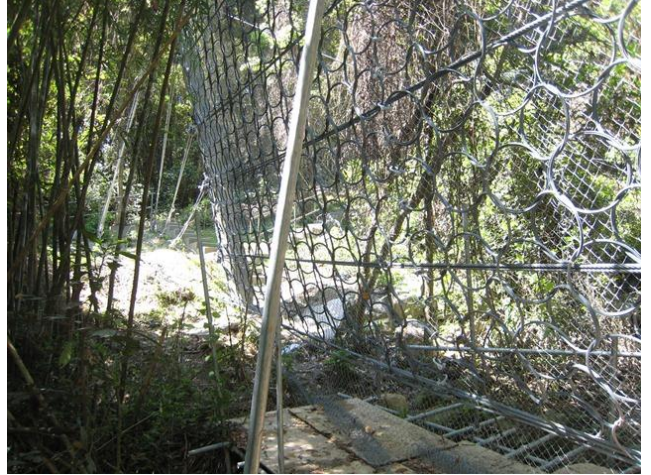
Photo 2
Temporary works area within the project boundary

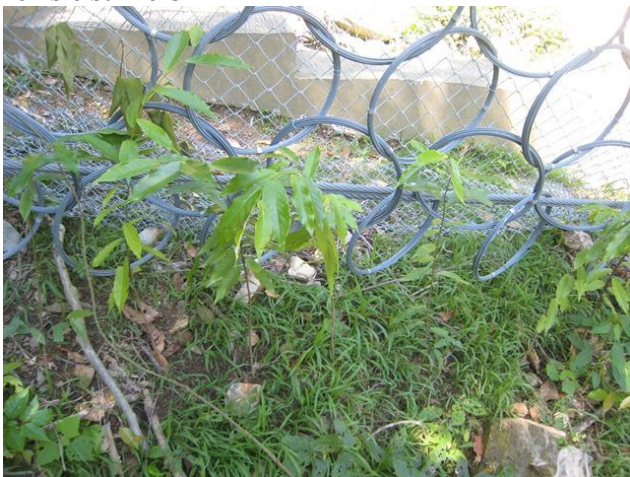
Photo 3
Climbers (*Desmos chinensis*) were planted near the flexible barriers

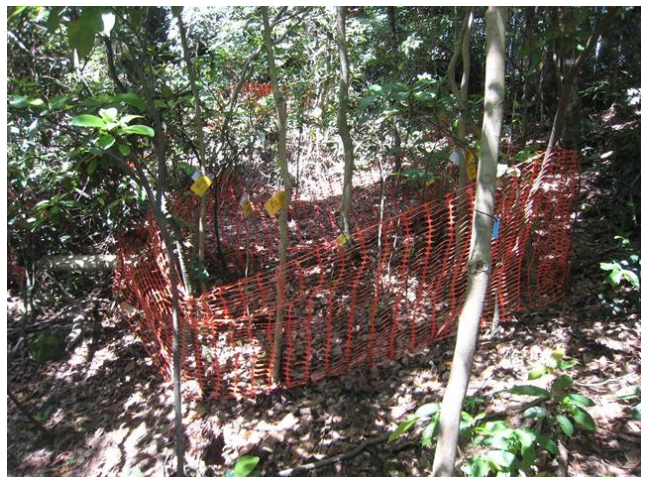
- 2.3.5 Bright colour tree protection signage was provided at protective trees (**Photo 4**). Protective tree measures have also been provided. Information sheet with colour photos of *Aquilaria sinensis* and *Pavetta hongkongensis* were displayed conspicuously within the construction site.
- 2.3.6 One individual *Aquilaria sinensis* (T596) was found felled by others on 29 June 2015 (**Photos 5 and 6**). The Contractor has reported the case to HKPF (report no. TKORN 15019816).
- 2.3.7 No tree damage was observed and recorded. All trees were protected with tree tags and bright colour signage.

Photo 4
Protected trees were fenced off

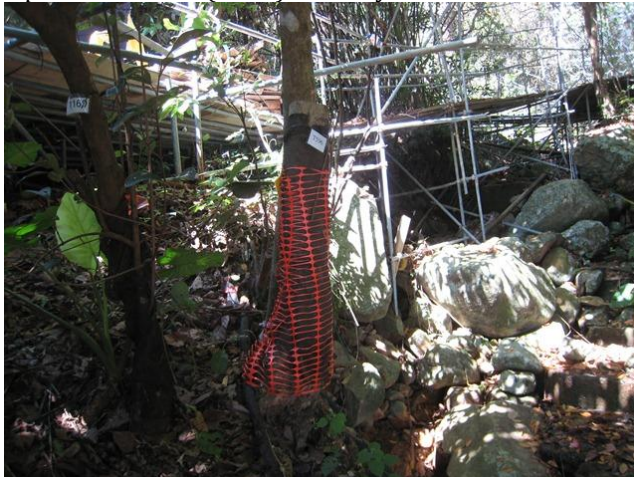
Photo 5
Aquilaria sinensis (T596) felled by others

NOTE 1 = ONE NUMBER OF AQUILARIA SINENSIS (T596) WAS FOUND
FELLED BY OTHERS. CONTRACTOR WILL REPORT THE INCIDENTS
TO POLICE.

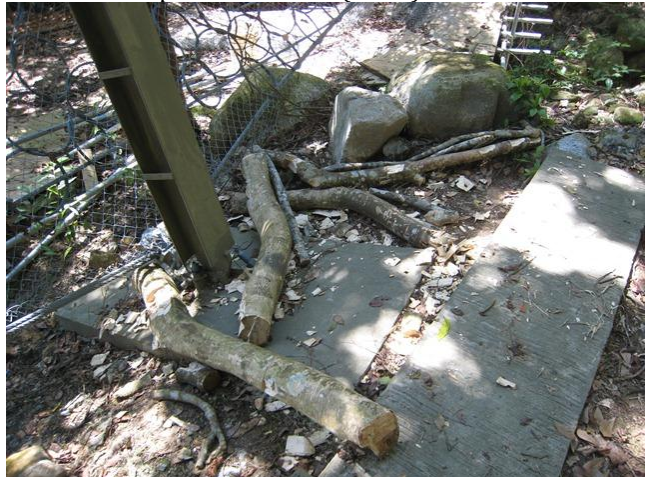
Photo 5
Remains of *Aquilaria sinensis* (T596)
