Landslip Prevention and Mitigation Programme, 2008, Package J

Above Leung Fai Tin along Clear Water Bay Road, Sai Kung

Independent Environmental Checker (IEC)
Monthly Audit Report No. 21
October 2015

182663/B&V/021/Issue 1

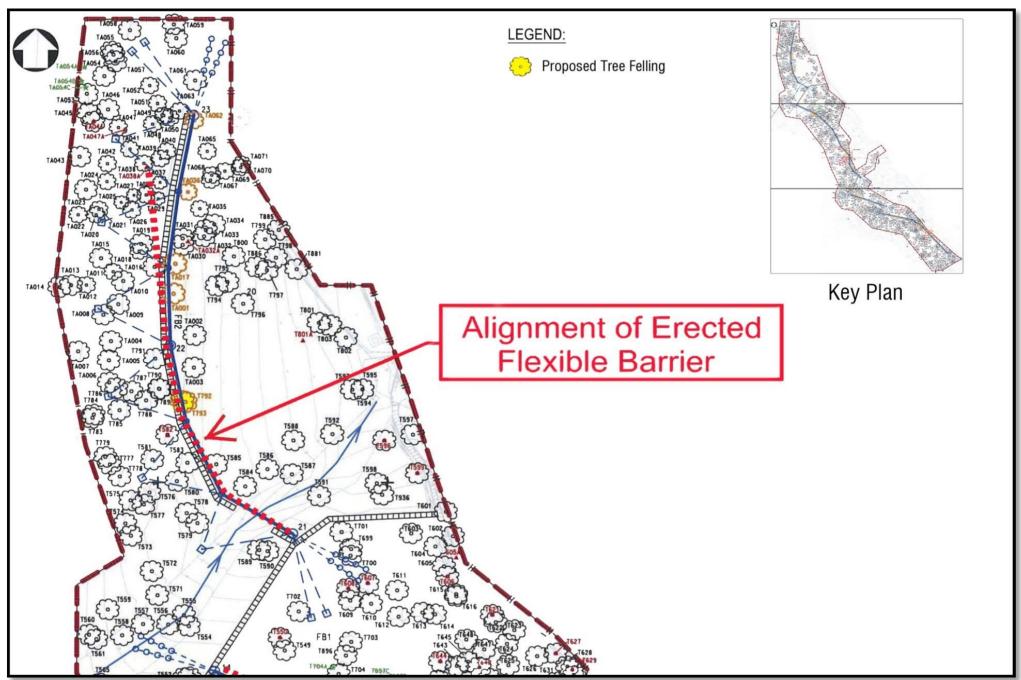
Figure 2 IEC Audit Route along the Erected Flexible Barrier on 27 October 2015 (Sheet 1 of 3)

2.2.1 The Project has been commenced on 15 January 2014. During the reporting period, no construction works were carried out. Site audit was carried out along the works areas as shown in **Figure 2**.
