Landslip Prevention and Mitigation Programme, 2008, Package J

Above Leung Fai Tin along Clear Water Bay Road, Sai Kung

Independent Environmental Checker (IEC) Monthly Audit Report No. 24 January 2016

182663/B&V/024/Issue 1

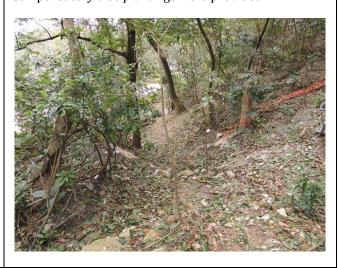
Photo 4 Compensatory tree plantings were provided
