Contract No. GE/2013/06

Landslip Prevention and Mitigation Works in New Territories

Above Leung Fai Tin along Clear Water Bay Road, Sai Kung

Independent Environmental Checker (IEC) Monthly Audit Report No. 27 April 2016

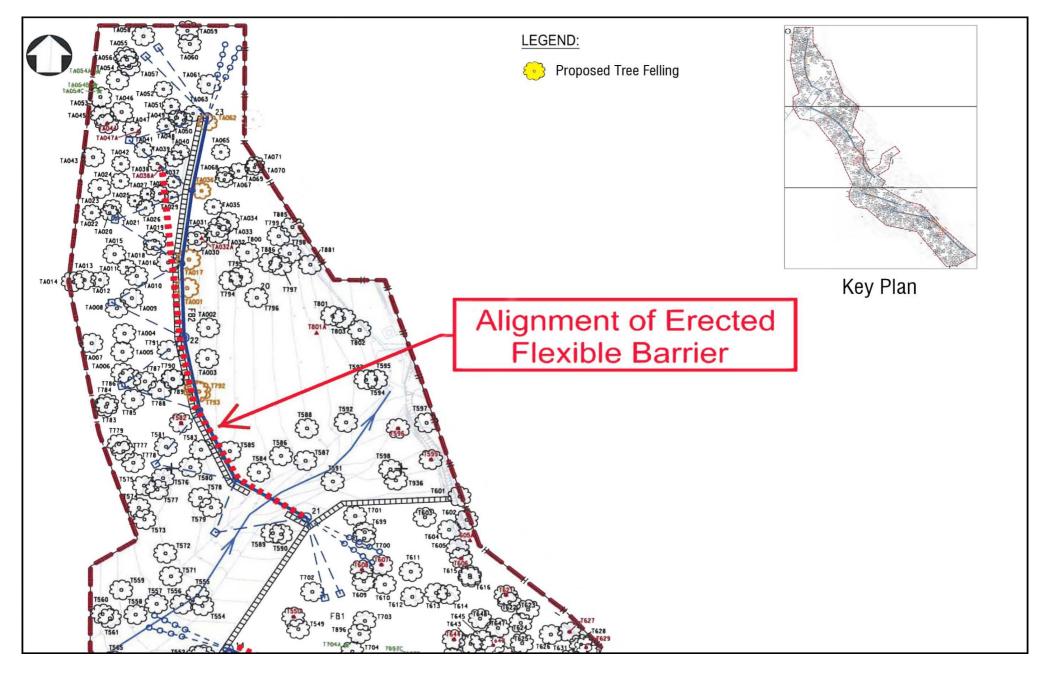
Figure 2 IEC Audit Route along the Erected Flexible Barrier on 27 April 2016 (Sheet 1 of 3)

2.2.1 The Project has been commenced on 15 January 2014. During the reporting period, construction of masonry finish for the maintenance access was being conducted and completed. Site audit was carried out along the works areas as shown in **Figure 2**.
