#### CONTRACT NO. SPW 25/2018 ENVIRONMENTAL TEAM FOR RELOCATION OF SHA TIN SEWAGE TREATMENT WORKS TO CAVERNS – SITE PREPARATION AND ACCESS TUNNEL CONSTRUCTION

#### SUPPLEMENTARY CONTAMINATION ASSESSMENT PLAN FOR THE EXISTING DSD STAFF QUARTER REVISION 2.1

DRAINAGE SERVICES DEPARTMENT

#### Lam Environmental Services Limited

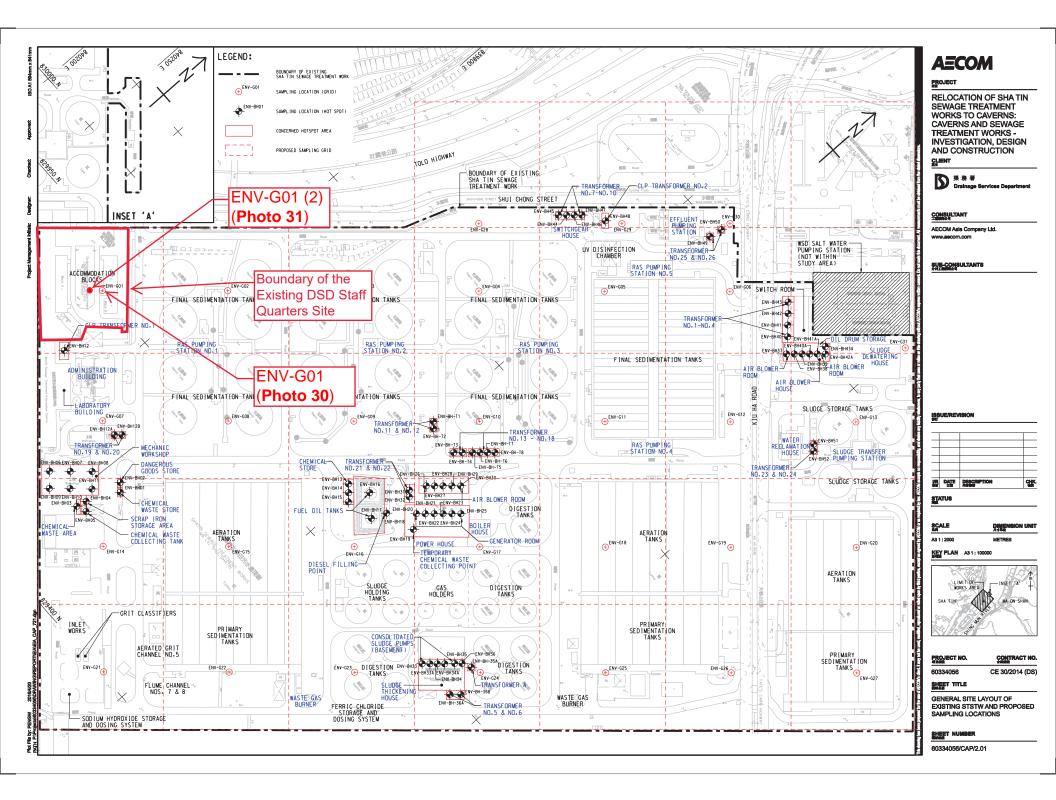
Location Plan of ENV-G01 Extracted from Figure 2.01 of the CAP and Location of Alternative Grid Sampling Point - ENV-G01 (2)

- 3.1.1 According to the CAP, one grid sampling point ENV-G01 was proposed to study the vertical profile of possible contamination within the existing STSTW. The location of ENV-G01 is indicated in the location plan at *Appendix A*, which is extracted from Figure 2.01 of the CAP. After reviewing the actual site conditions, the grid sampling point ENV-G01 is very close to the existing building structure and it might disturb the user of the existing building during SI and impose unnecessary safety concern. In view of the above, an alternative grid sampling point ENV-G01 (2) for grid sampling point ENV-G01 is proposed and indicated in the location plan at *Appendix A*. The alternative grid sampling point ENV-G01 (2) is considered representative to ENV-G01 as they also are in the same grid and they are located within a short distance about ~10m. Location of ENV-G01 and ENV-G01 (2) were indicated in *Photo 30* and *Photo 31*.

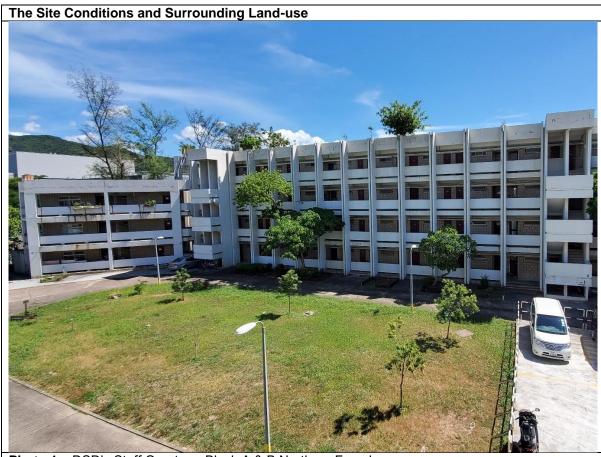
Photo 1 – DSD's Staff Quarter – Block A & B Northern Façade

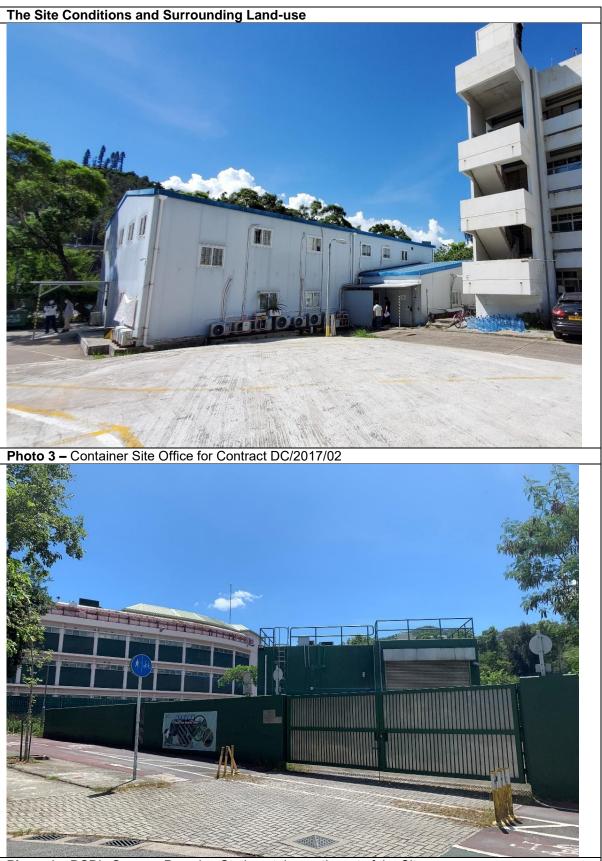
Photo 4 – DSD's Sewage Pumping Station at the northwest of the Site

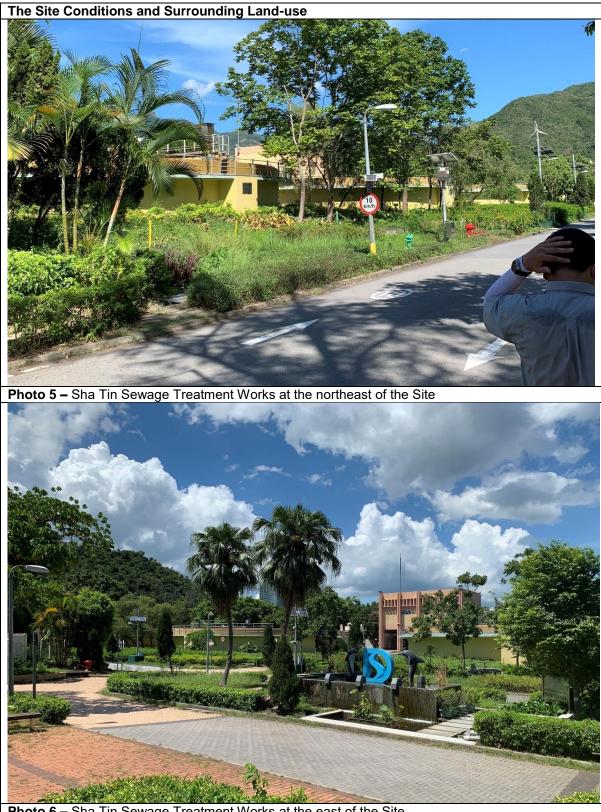
Photo 6 - Sha Tin Sewage Treatment Works at the east of the Site

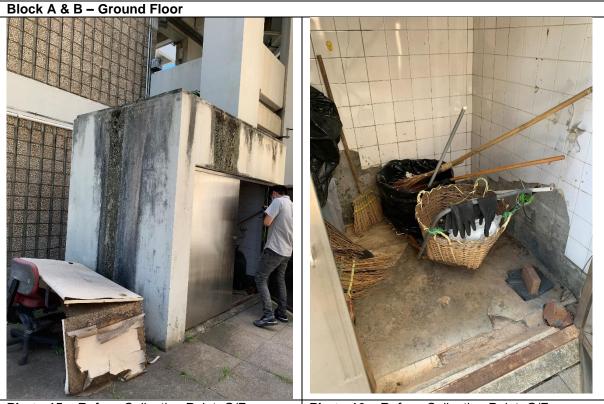
Photo 15 - Refuse Collection Point, G/F

Photo 16 - Refuse Collection Point, G/F

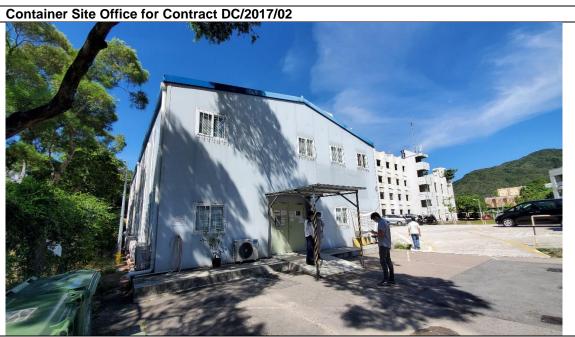
Floor Level	Inspected Area	Building Block	Findings	Rationale for Need of Intrusive Site Investigation (S.I.)	Require S.I.?	Photo Ref. in Appendix F
	Refuse Collection Point	-	<ul> <li>Bamboo brooms and buckets were stored.</li> <li>No potential contamination source was identified.</li> </ul>	No potential contamination source was identified at the ground and further soil investigation is not necessary.	No	Photo 15 & Photo 16
	Container Site Office for Contract DC/2017/02	-	<ul> <li>The site office was a container site office built on a concrete slab.</li> <li>As advised by the staff in the site office, no chemical was stored or used in the office.</li> <li>The floor was paved with vinyl floor tile.</li> <li>No potential contamination source was identified.</li> </ul>	No potential contamination source was identified at the ground and further soil investigation is not necessary.	No	Photo 28 & Photo 29

Photo 28 - Entrance of the Site Office

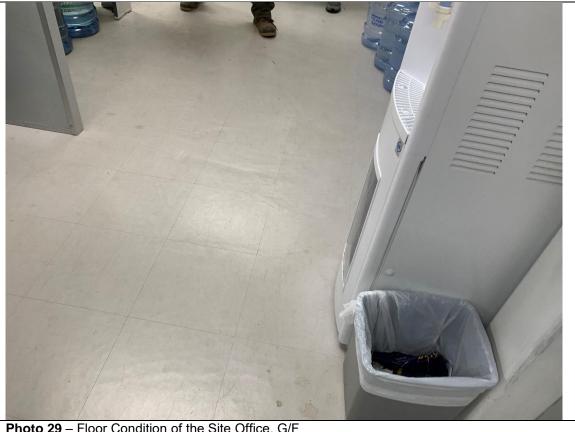
- 2.4.6 The container site office for DSD's Contract DC /2017/02 at the north edge of the Site was also visited during the walkover. The container site office was built on top of concrete block and floor condition of the site office was good. No use and storage of chemical was observed in the site office. No potential land contamination source or hotspot was identified in the site office.

Photo 29 - Floor Condition of the Site Office, G/F
