## **MONTHLY ENVIRONMENTAL MONITORING AND AUDIT (EM&A) REPORT (NO. 12)**

**Expansion of Research and Residential Facilities for the Swire Institute of  
Marine Science, The University of Hong Kong at Cape D'Aguilar, Shek O**

**(Rev. 0)**

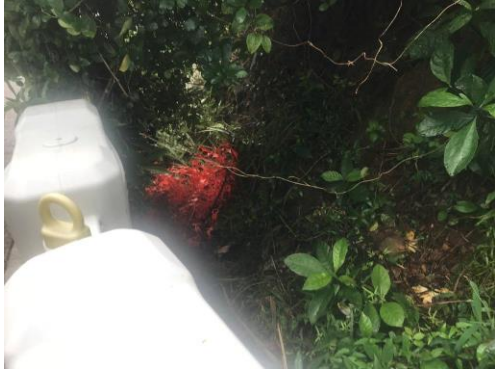
<p>26- Sep-2018</p>	<p>Waste was found inside protection zone</p> <p><i>Millettia ovia</i></p>

<p>Rectified by HKU on 5-Oct-2018</p> <p>Waste inside protection zone was removed</p>

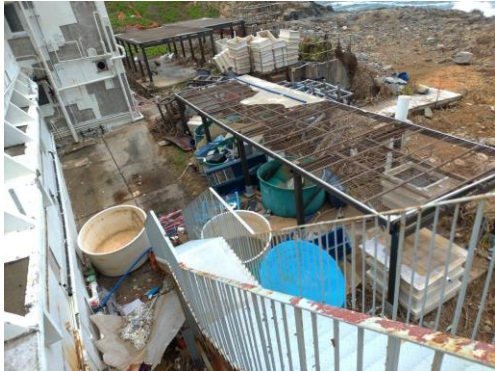
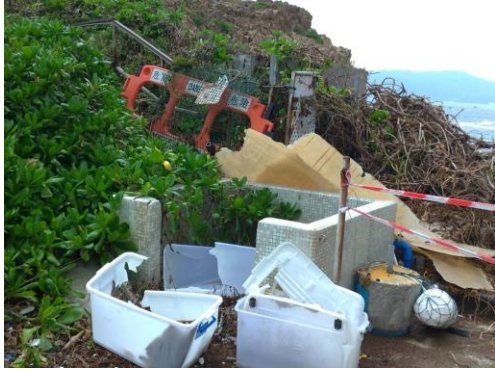
<p>26- Sep-2018</p>	<p>Site should be cleaned on a regular basis.</p>

<p>Rectified by HKU on 5-Oct-2018</p> <p>Site debris was removed.</p>
