**MONTHLY ENVIRONMENTAL MONITORING AND AUDIT**  
**(EM&A) REPORT (NO. 26)**

**Expansion of Research and Residential Facilities for the Swire Institute of  
Marine Science, The University of Hong Kong at Cape D'Aguilar, Shek O**

**(Rev. 0)**

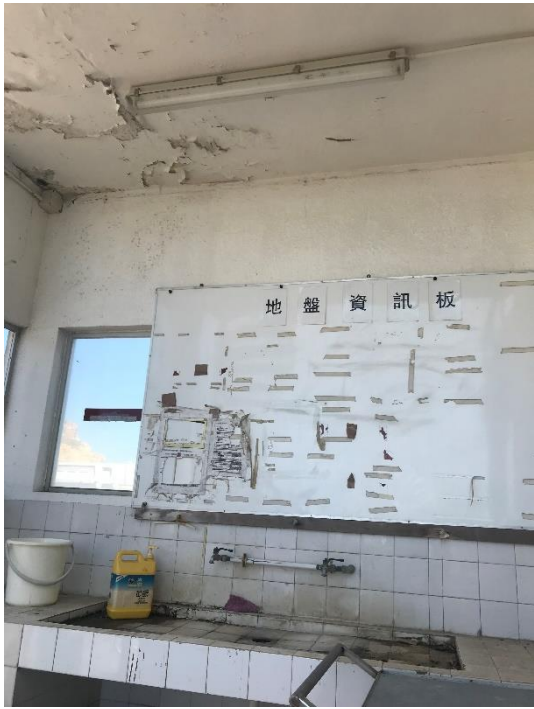
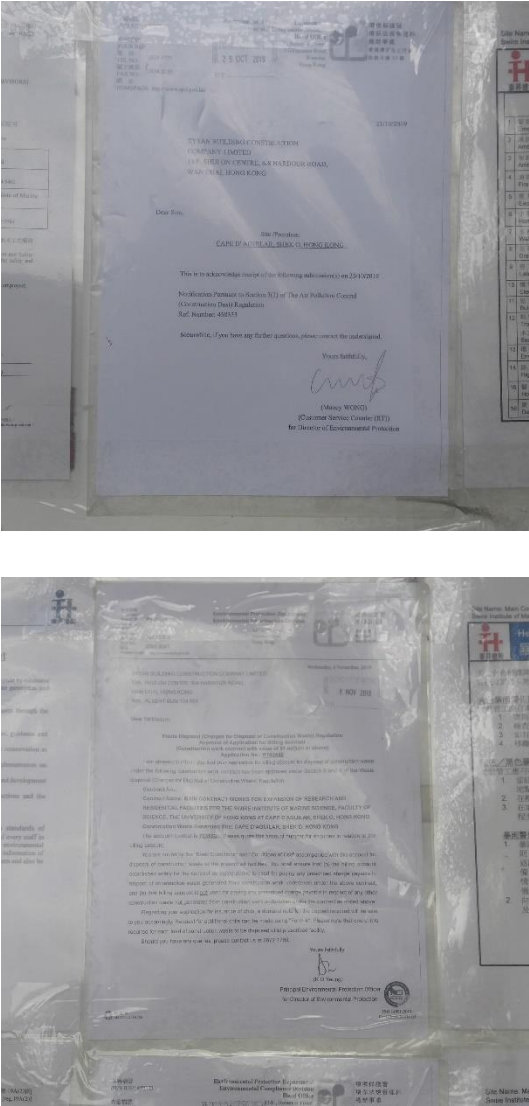
Date	Environmental Observations	Follow-up Status
22-Nov-2019	Copy of Environmental Permit should be posted on site.	Rectified by TYSAN site contractor on 4 Dec 2019 Copy of Environmental Permit posted on site.

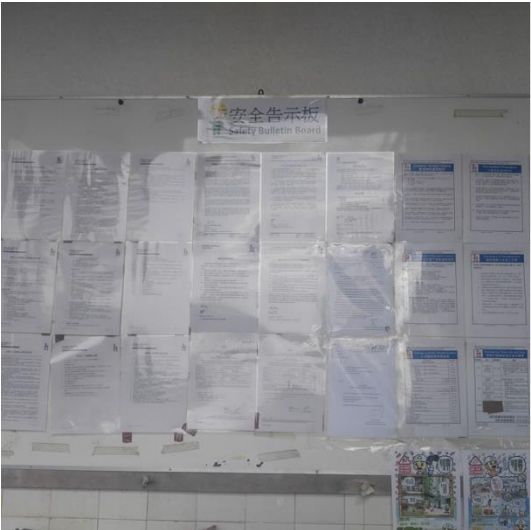
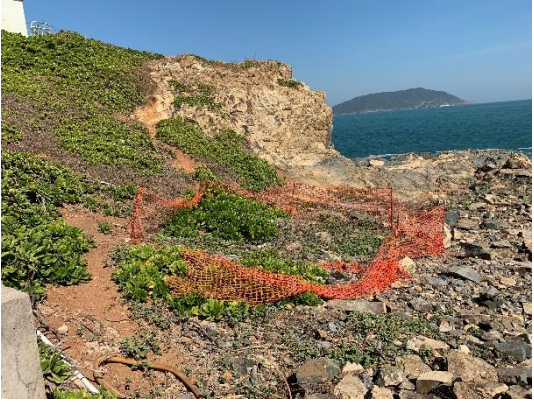
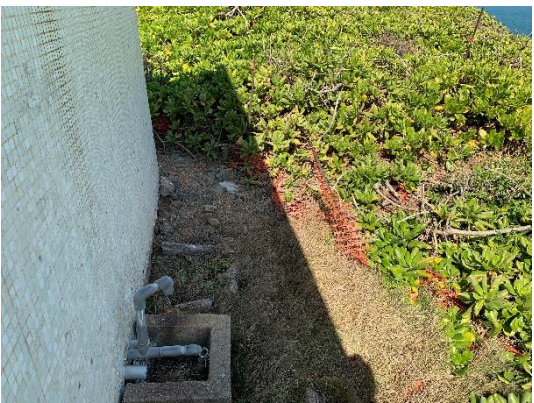
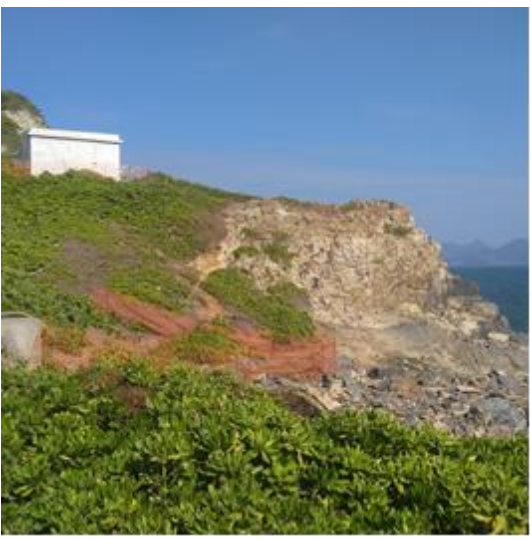
22-Nov-2019	Orange net not erected at 1.5m height.	Rectified by TYSAN site contractor on 4 Dec 2019 Orange net re-erected at 1.5m height.

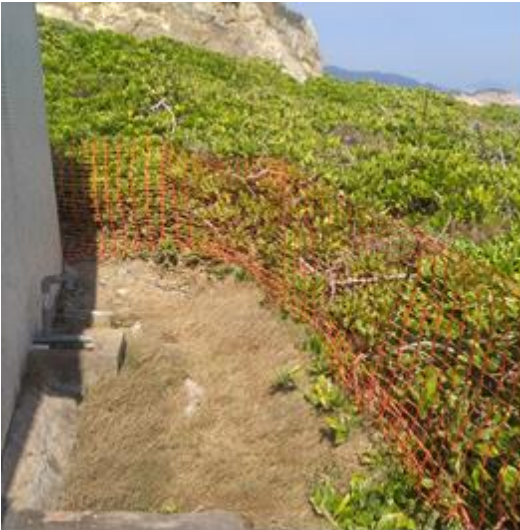
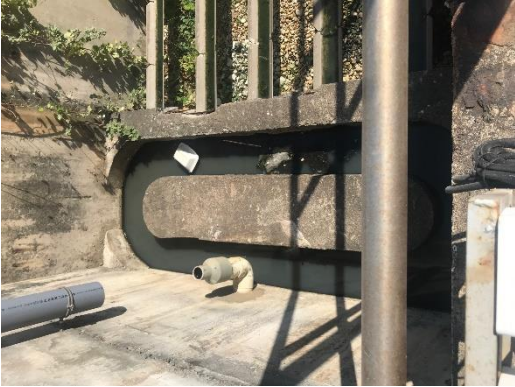
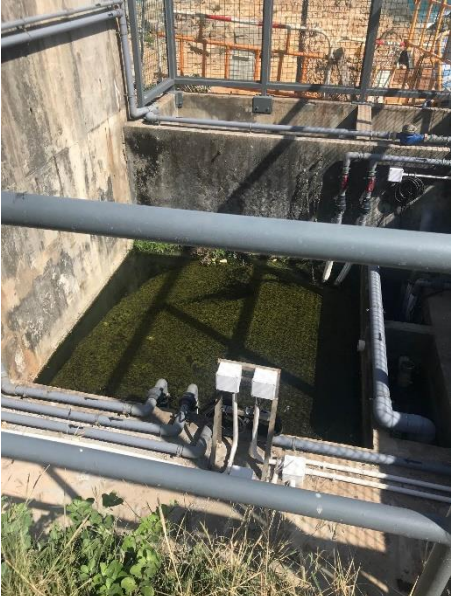
22-Nov-2019	<p>Stagnant water on site should be cleaned.</p>

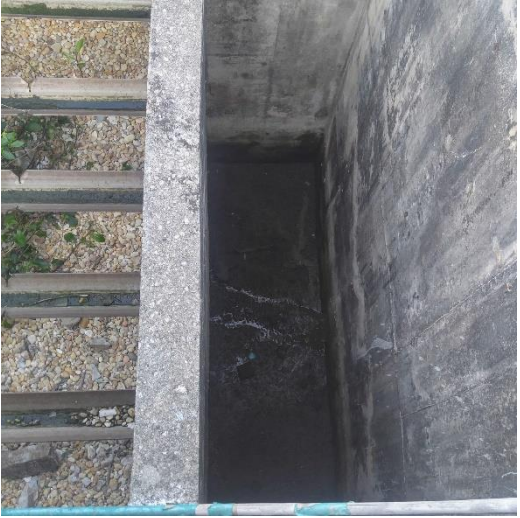
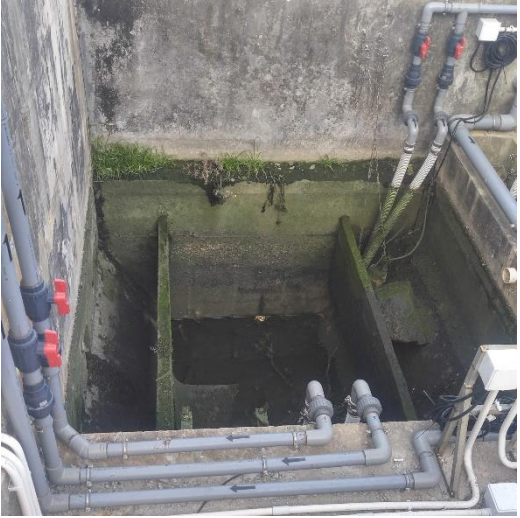
<p>Rectified by TYSAN site contractor on 4 Dec 2019</p> <p>Stagnant water on site cleaned.</p>

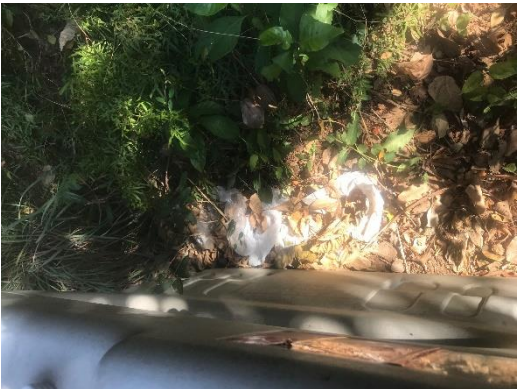
Date	Environmental Observations	Follow-up Status
22-Nov-2019	Broken sand bags at the site boundary should be replaced.   	Rectified by TYSAN site contractor on 4 Dec 2019 Broken sand bags at the site boundary replaced.   
22-Nov-2019	Wastes observed inside the protection zone.
