**Expansion of Research and Residential Facilities for
The Swire Institute of Marine Science, Faculty of Science,
The University of Hong Kong at Cape d' Aguilar, Shek O, Hong Kong
Submission of Monthly Environmental Monitoring and Audit Report No.27**

**MONTHLY ENVIRONMENTAL MONITORING AND AUDIT
(EM&A) REPORT (NO. 27)**

**Expansion of Research and Residential Facilities for the Swire Institute of
Marine Science, The University of Hong Kong at Cape D'Aguilar, Shek O**

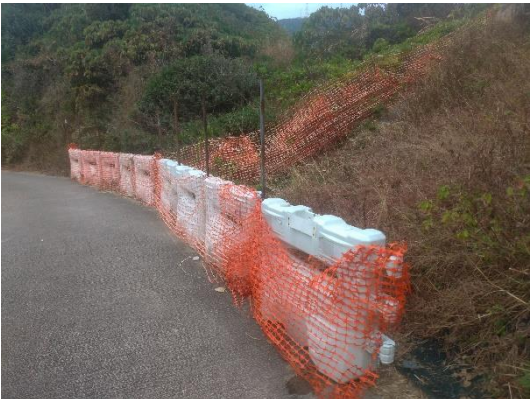
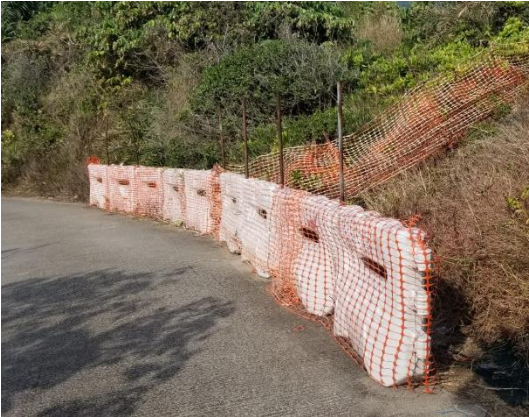
Date	Environmental Observations	Follow-up Status
20-Dec-2019	Damaged orange nets were observed.	Rectified by TYSAN site contractor on 4 Jan 2020 Damaged orange nets were re-fixed or replaced.
	<p data-bbox="395 528 539 555"><i>Millettia oraria</i></p>

Date	Environmental Observations	Follow-up Status
	<p data-bbox="395 286 587 320"><i>Pittosporum tobiral</i></p>

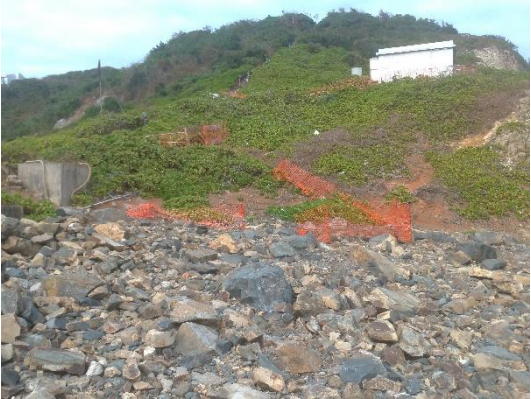
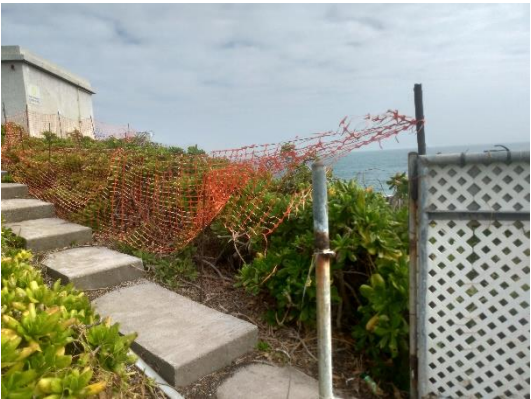
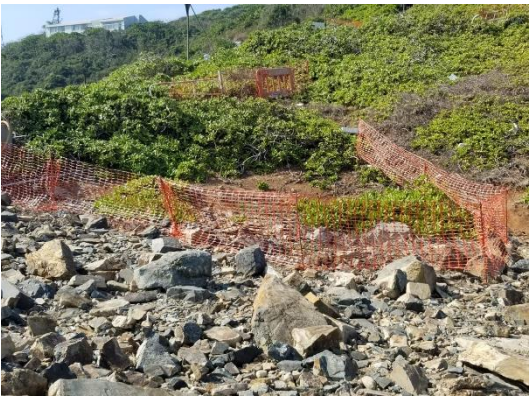
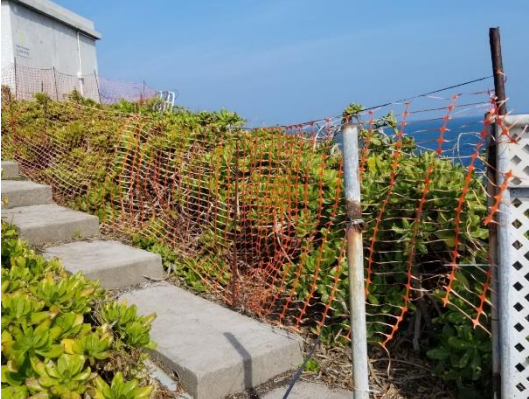
<p data-bbox="395 768 608 801"><i>Lysimachia mauritiana</i></p>

20-Dec-2019	<p>Water barriers were missing.</p>  	<p>Rectified by TYSAN site contractor on 4 Jan 2020</p> <p>Water barriers were removed for providing adequate sunlight to <i>Millettia oraria</i> (to be protected by nets).</p>  
20-Dec-2019	<p>General refuse was found in protection zone.</p>  	<p>Rectified by TYSAN site contractor on 4 Jan 2020</p> <p>Refuse was cleaned up.</p>
